Barron Mountain
Rock Reinforcement Evaluation – Phase II
I-93, Woodstock, New Hampshire
Validation of NDT Results for Condition Assessment of
Rock Reinforcements

1. Report No. FHWA-NH-RD-14282C		2. Gov. Acc. No.	3. Recipient's Catalog No.
4. Title and Subtitle PHASE II: CONDITION ASSESSMENT AND EVALUATION OF ROCK REINFORCEMENT ALONG I-93 BARRON MOUNTAIN ROCK CUT, WOODSTOCK, NH Validation of NDT Results for Condition Assessment of Rock Reinforcements		5. Report Date SEPTEMBER, 2005

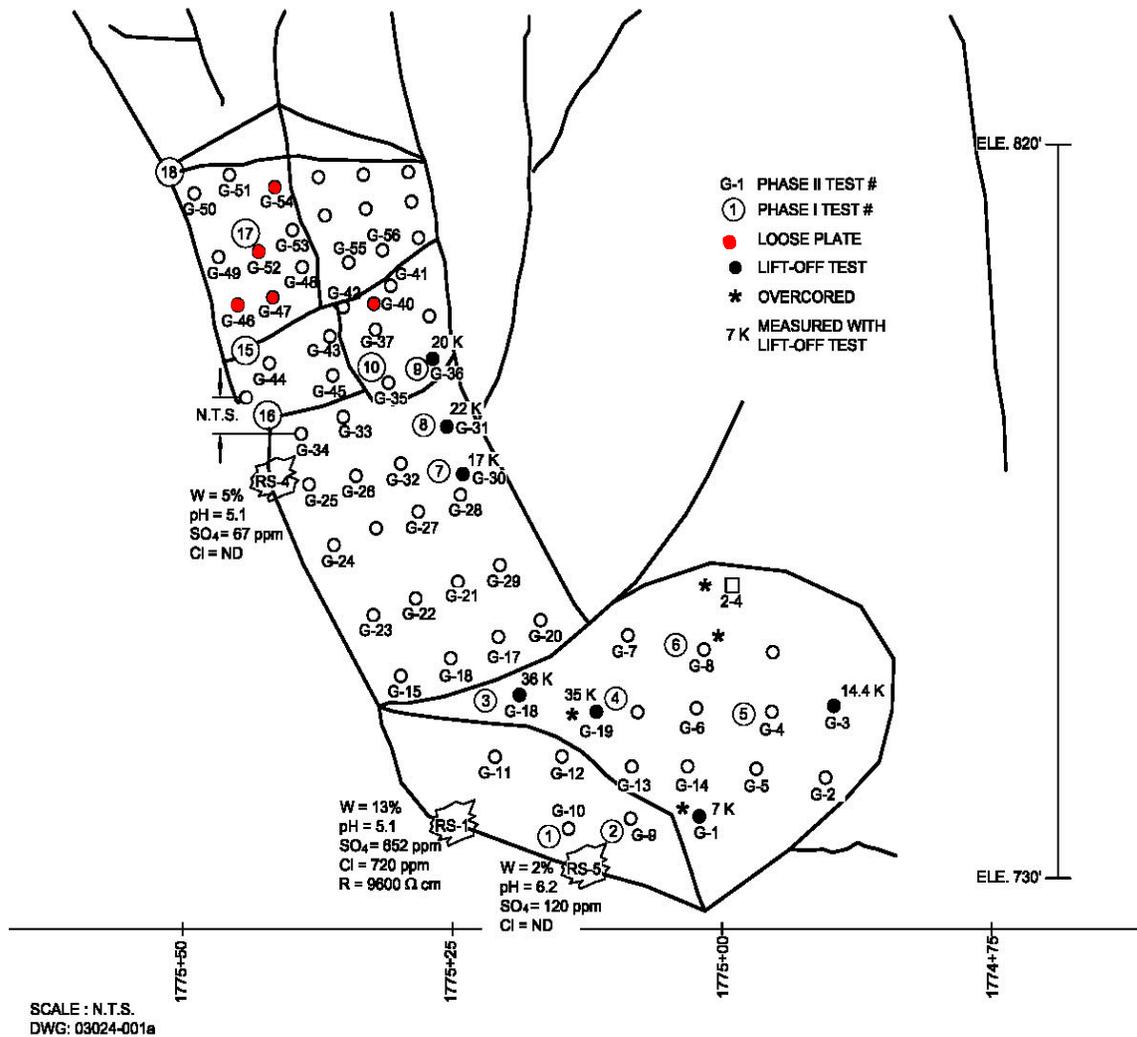
Figure 4. Rock Face Elevation View With Stationing, Reinforcement Locations, and Test Numbers for Phase I and II.

MMCE also observed loose or slack bearing plates at the anchorage for bolts G-40, G46, G-47, G-52 (MMCE #17), and G-54 (see Figure 4). Because a slack bearing plate indicates that the anchorage cannot sustain prestress, these observations contribute to five additional direct observations. Thus, Phase II includes twelve direct observations of prestress; seven lift off tests and five slack plates.

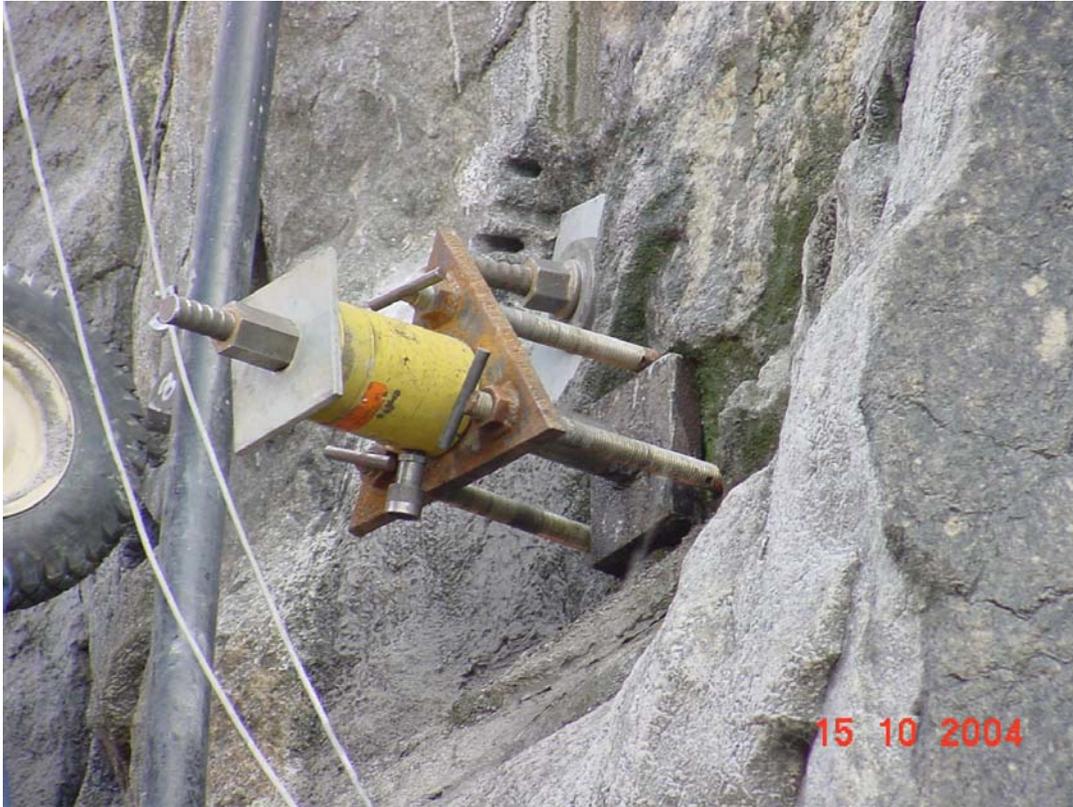
Figure 5. Lift-off Test for Prestressed Rock Bolts

MMCE observed the lift-off tests to document that they were performed using equipment and procedures recommended by PTI (1996). Load is applied to the end of the rock bolt with a center hole hydraulic jack. Figure 5 shows the load assembly including a chair to seat the hydraulic jack and facilitate load transfer at the bolt head. The preload in the rock bolt is observed when the anchor nut lifts off the bearing plate at the anchorage assembly.

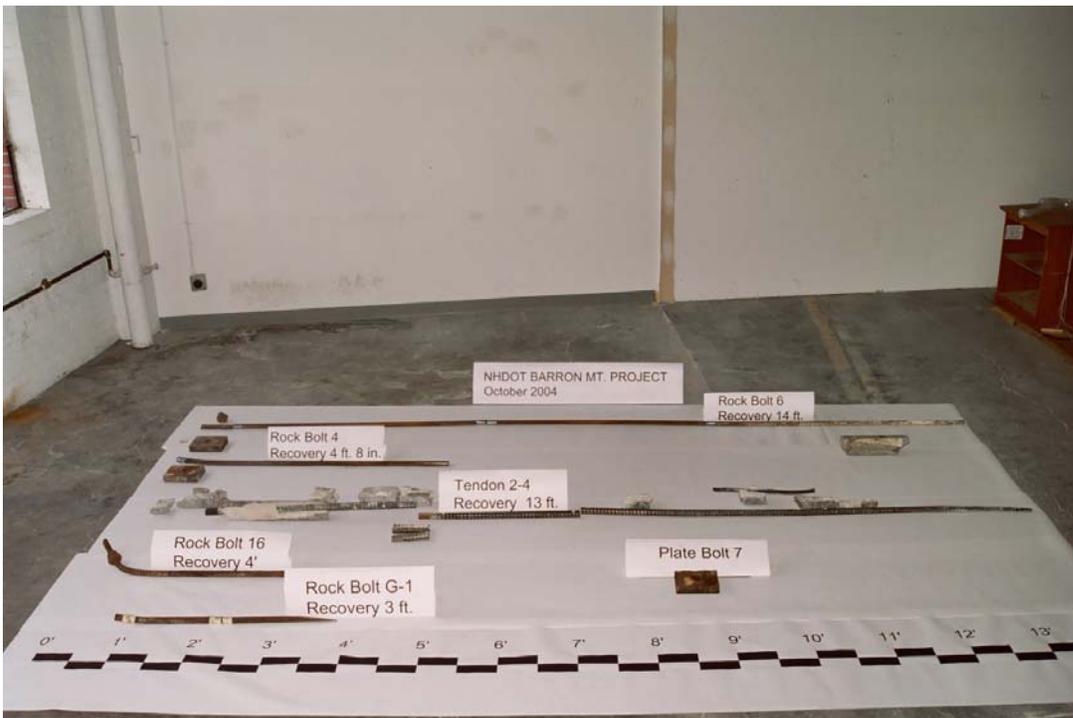
Figure 6. Recovered Rock Reinforcement

Figure 6 shows the lengths and overview of the reinforcement samples obtained from the site. Appendix VI describes detailed observations obtained for each sample including general observations, measurements of remaining diameter, observations of pitting corrosion and hardness measurements where grout samples were available.

Bolt #G-8 (MMCE # 6) was retrieved in its entirety for a sample length of approximately fourteen feet. The bolt appears to be in relatively good condition although some pitting corrosion is evident. Grout was observed at intermittent locations beginning four feet from the distal end of the bolt. The resin grout appeared to provide poor coverage to the bar, and for most of the area that had traces of grout, the thickness was not sufficient to cover the bar deformations. The best coverage was observed in an area about 4.25 inches in length, covering one side within the last foot of the bar. This poor coverage probably accounted for the bond breaking and the bolt spinning as the contractor removed the nut and bearing plate prior to overcoring. Bolt #G8 (MMCE #6) was installed at an upwards angle and slid out of the hole after over coring to a depth of approximately eight feet. Bolts #G30 (MMCE #7) and #G19 (MMCE #4) were also loosened as the nut was turned. Bolt # G30 (MMCE #7) could not be pulled from the hole with 70 kips, and the bolt was not over cored.

An approximately four feet long sample of MMCE #G19 (MMCE #4) was retrieved. The sample was terminated after a coupling was encountered. This sample exhibited more corrosion compared to # G8 (MMCE #6) and loss of cross section was observed at a location near the backside of the bearing plate. A three feet long section of Bolt # G-1 was also retrieved and similar loss of cross section was observed near the bearing plate.

Bolt – MMCE #16 was not overcored, but was recovered when JANOD fractured and removed the loose block of rock it supported with the Boulder Buster™. The Boulder Buster™ is a small charge that usually fractures the rock surrounding a rock bolt when detonated, causing the loosened rock to slide toward the base of the rock cut. In this case the rock bolt was severed and removed with the block. The fracture surface at the end of the approximately four feet long sample of bolt – MMCE #16 was sent to a metallurgy lab for analysis as described in the “Results” Section. Loss of section was also observed near the backside of the anchor plate.

Tendon – MMCE #2-4 was over cored to a depth of approximately twelve feet. The proximal end of the sample included an approximately two feet long annulus of grout adhered to the reinforcement and surrounding rock core. Cement grout was exposed on one side of the sample as the core barrel wandered slightly off track. The exposed grout measured about 5 by 20 inches in plan. Recorded observations include hardness, absorption and bulk specific gravity. The steel reinforcement appeared to be in excellent condition and the surface did not appear to have been subject to corrosion. A coupling was encountered at a depth of approximately five feet from the rock face.

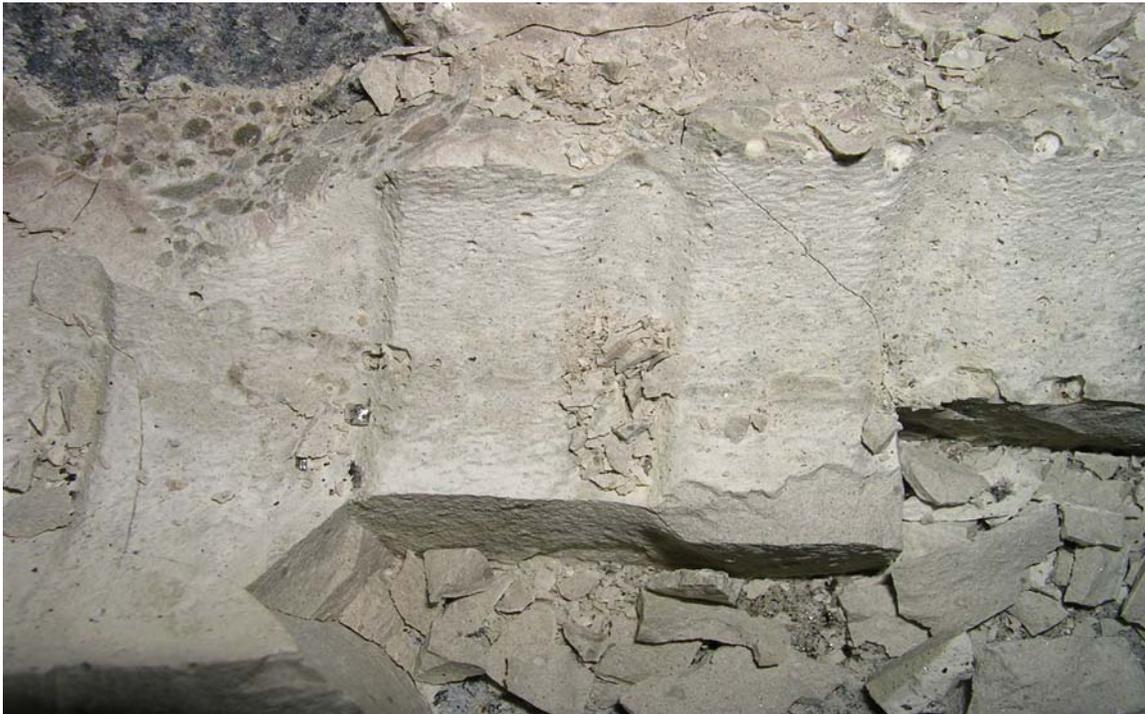
Figure 8. Pores Distributed Throughout Portland Cement Grout Sample.

The Portland cement grout was removed from the bar following completion of hardness testing. After the grout was removed, a very slight amount of corrosion was evident on sample Tendon - MMCE # 2-4, within about 2 feet of the rock face. The close-up in Figure 8 depicts numerous pore spaces distributed throughout the grout sample. To evaluate the porosity, MMCE selected five specimens for measurement of specific gravity and water absorption.

that grout condition is questionable and that corrosion is likely. The high porosity observed for the exhumed grout sample may confirm the interpretation of grout quality from the results of NDT. In general, the exhumed tendon element (Tendon – MMCE #2-4), which was protected by Portland cement grout, was in very good condition compared to the resin grouted rock bolt (Rock bolt G8- MMCE #6) and this is also consistent with observations from NDT.

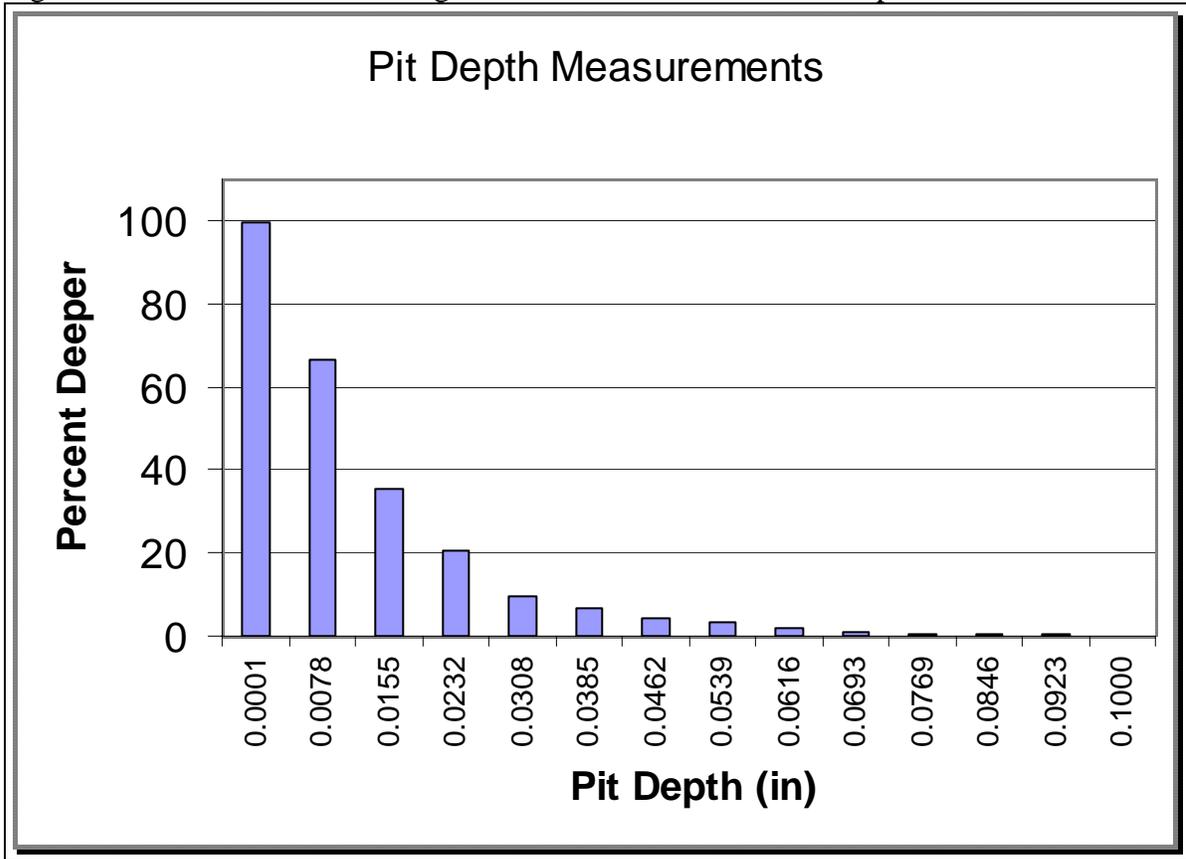
Figure 9. Cumulative Distribution of Pit Depth Measurements

Pits and craters were observed at a number of locations along the rock bolt samples, and craters appear to coalesce into areas of uniform corrosion extending for lengths of approximately four inches. One hundred and seventy-eight pit depth measurements were obtained from the surface of the rock bolt samples. Pit depths were measured with a pit depth gage having a sensitivity of 0.0001 inches. The average measured pit depth was approximately 0.015 inches with a standard deviation of 0.014. Figure 9 shows the cumulative distribution of pit depth measurements indicating that the maximum measured pit depth was 0.1 inches and 10 percent of the measured pit depths were greater than 0.031 inches. We observed that deeper pits are often associated with larger pit diameters, supporting the notion that pitted areas coalesce into areas of uniform corrosion.

Three of the rock bolt specimens exhibited a maximum loss of section corresponding to approximately 0.1 inches in diameter. This loss is consistent with existing mathematical models of service-life and with the observation from NDT that 70% of the rock bolts have experienced significant corrosion. Considering the initial diameter, level of prestress, and rate of metal-loss, we estimate that rock bolts will not become overstressed from loss of section due to corrosion for another fifteen to twenty years.
