**INTERIM INSPECTION REPORT
FOR THE
MEMORIAL BRIDGE
OVER THE PISCATAQUA RIVER**

August 2010

HDR

Part I: Interim Structural Inspection Report

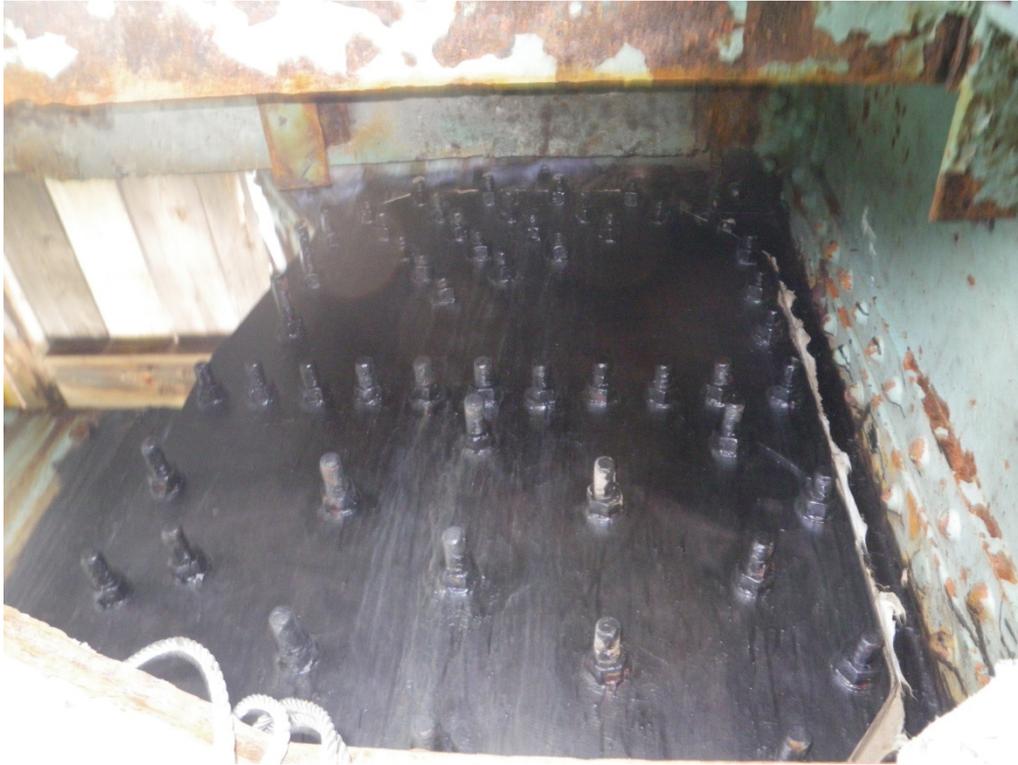
Photo 1: Span 1, Gusset Plate L2E, Interior. Gusset plate was repaired in 2009.

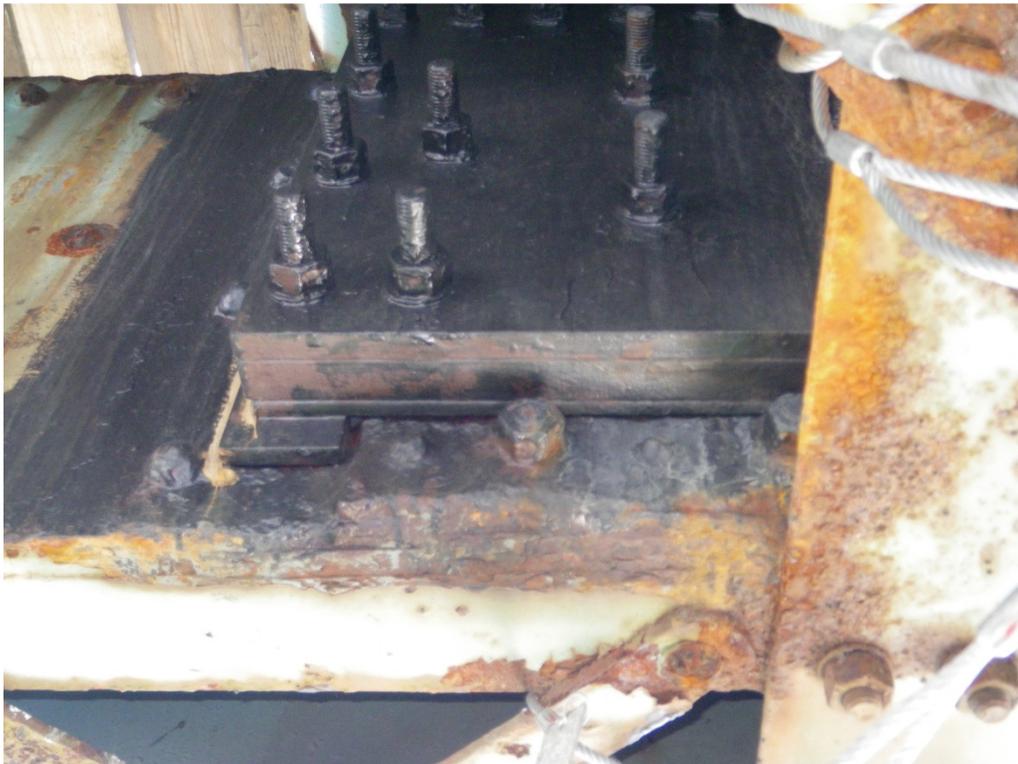
Photo 2: Span 1, Gusset Plate L2E, Interior. Paint placed in 2009 on existing steel starting to fail at edges. Rust showing through.

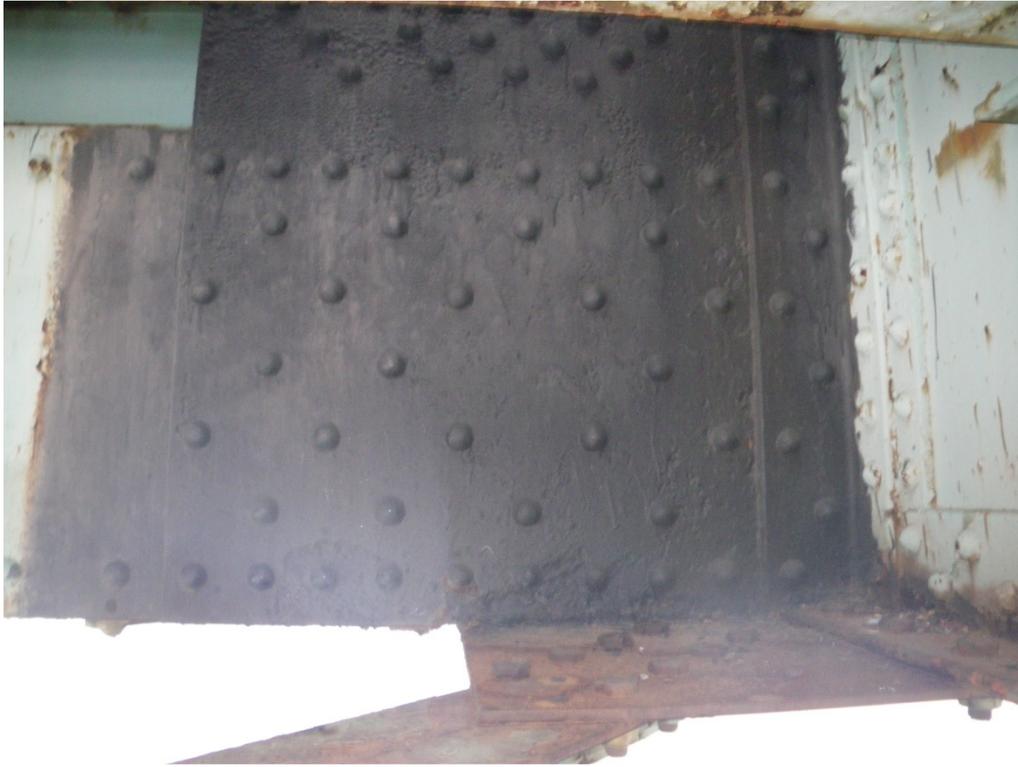
Photo 3: Span 2, Gusset Plate L8W, Interior. Painted over pitting.

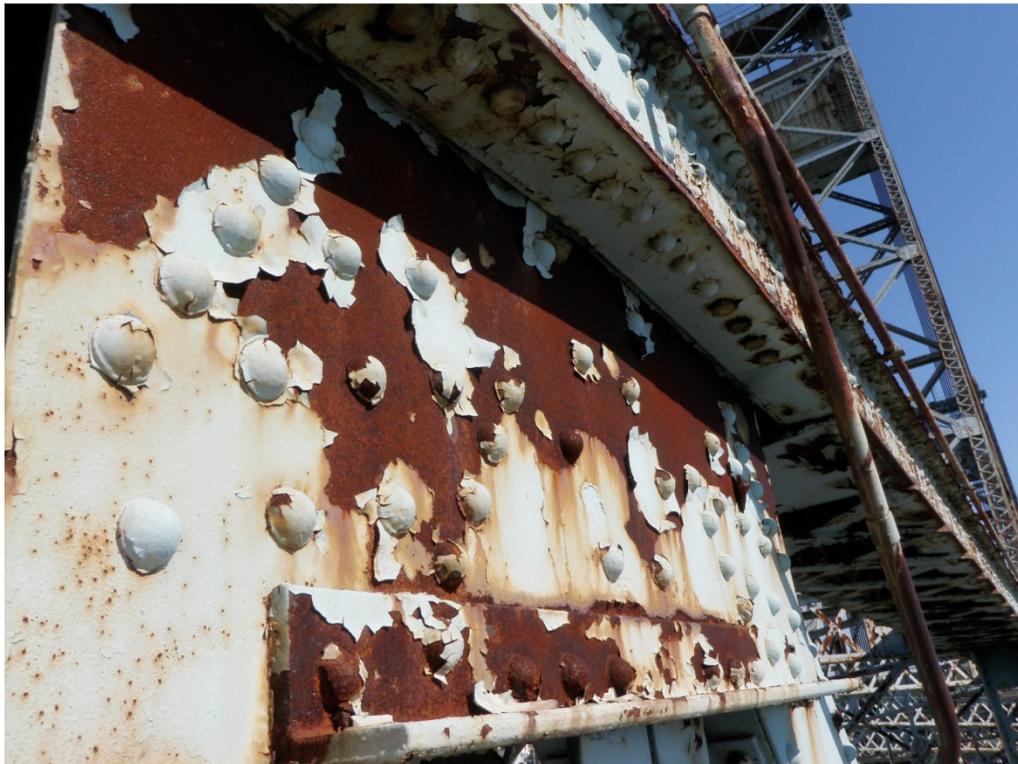
Photo 4: Span 1, Gusset Plate U5E, Exterior. Surface rust throughout plate. Pitting on plate along interface with steel angle.

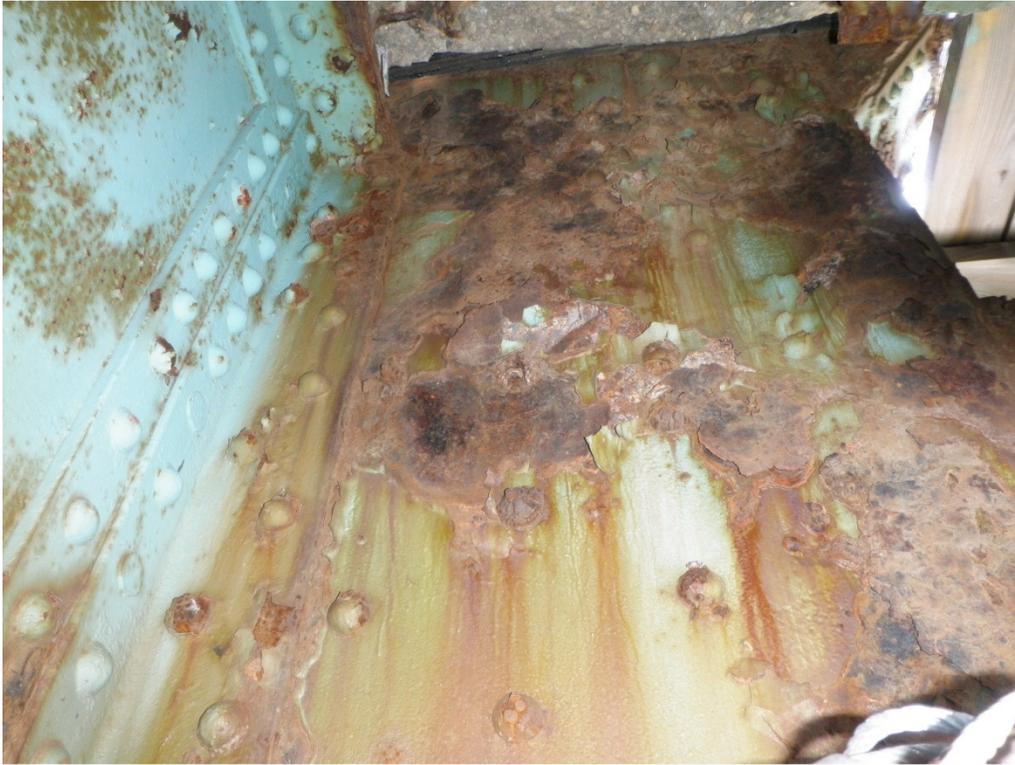
Photo 5: Span 1, Gusset Plate L8E, Interior. Heavy laminar corrosion throughout plate.

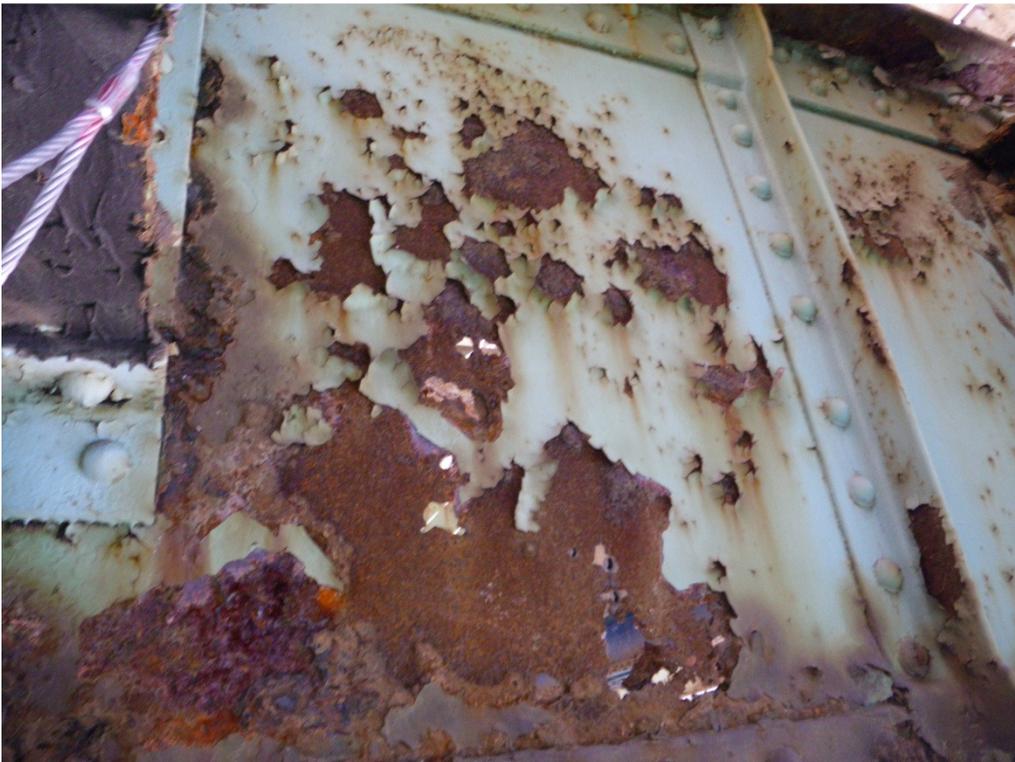
Floorbeam FB4 has several holes that have increased in size. One new hole has formed adjacent to Stringer S9, where severe section loss was found in 2009. Due to the gained inspection access as described above, a new hole was found in the floorbeam web at the top of Stringer S6. Steel between two adjacent holes located near Stringer S5 has completely deteriorated, forming one larger hole.

Photo 6: Span 2, Floorbeam FB4. South Face. Web between Stringers S4 and S5. Several web holes and heavy section loss in web. Holes occur in 17'' by 16'' area.

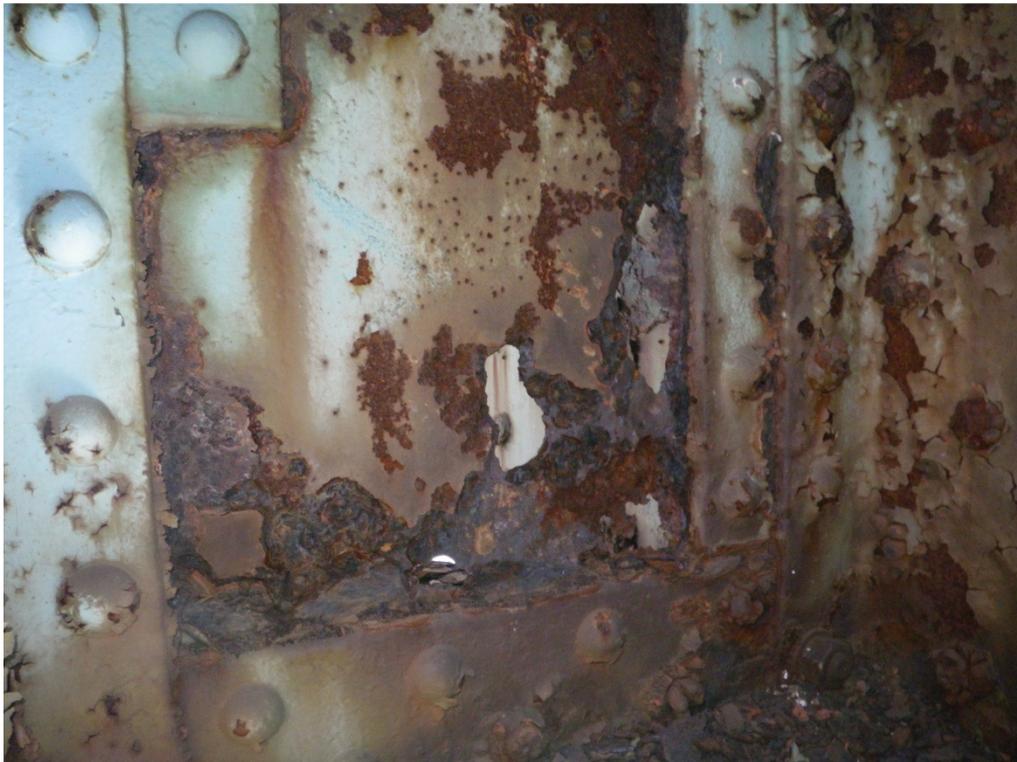
Photo 8: Span 1, Floorbeam FB4, South Face. Web at east end. Multiple holes in web.

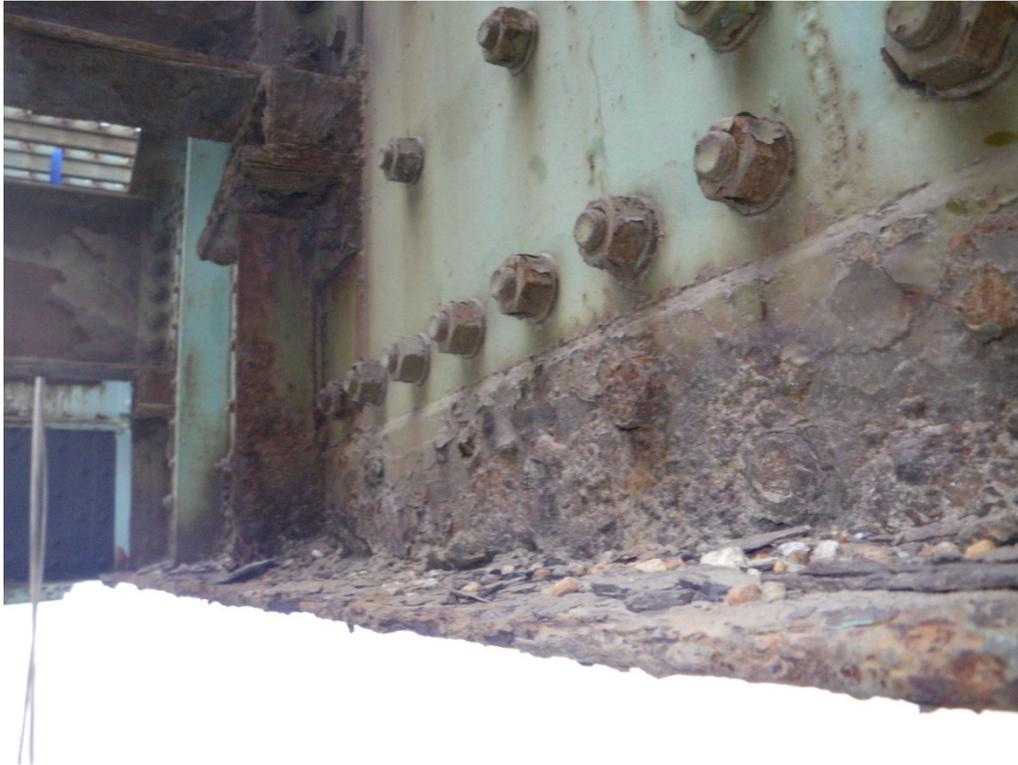
Floorbeam FB8 has a new area of pitting at the west end of the web. In areas of severe corrosion on the floorbeam web, a new 2" diameter hole was found and an existing 2" hole increased to 4" by 2".

Photo 9: Span 2, Floorbeam FB8, South Face. Laminar corrosion on bottom flange near Stringer S6.

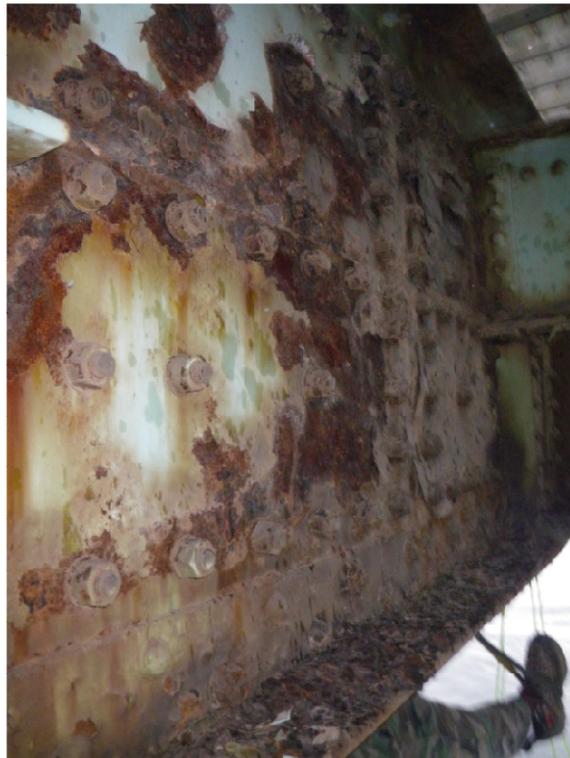
Photo 10: Span 2, Floorbeam FB8, South Face. Laminar corrosion on web at midspan.

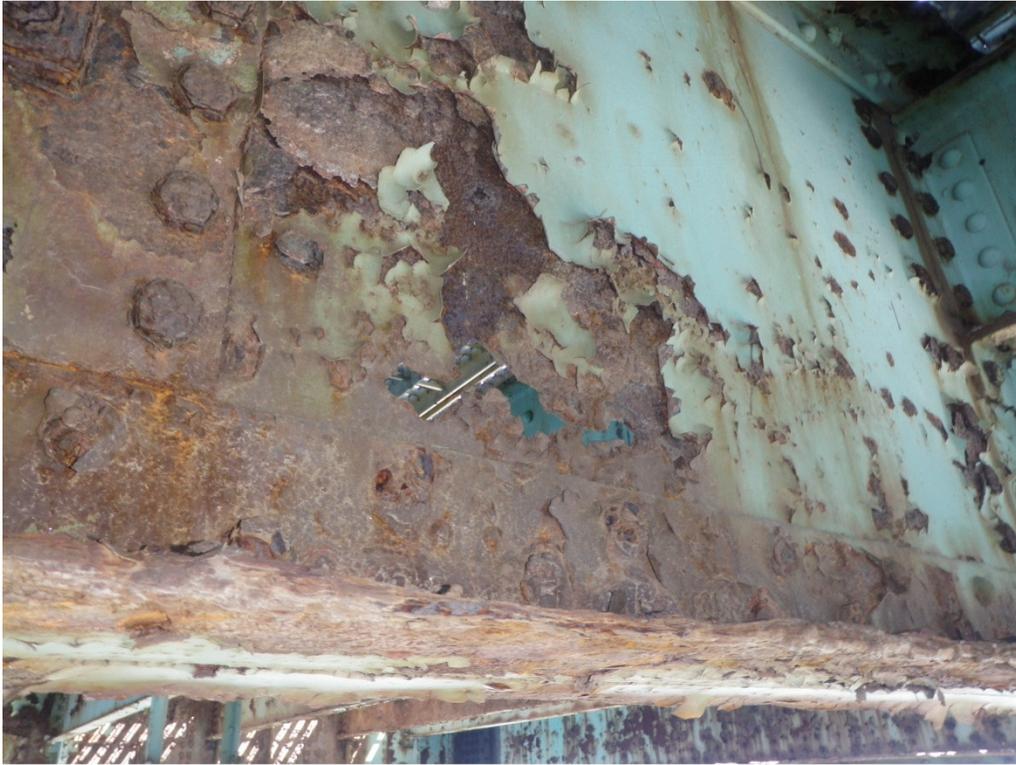
Three holes in the web of Floorbeam FB5 have increased in size. The widest point of the largest hole has increased from 13"x3.5" to 13"x4". The steel around a hole found between Stringers S8 and S9 has increased from 2" in diameter to 6" by 2"; however, it should be noted that the remaining steel around this hole was found to be severely corroded in 2009. So while the increase of section loss since 2009 is substantial, it is not a three-fold increase as the enlarged hole size would seem to indicate. An area with severe deterioration and multiple pin holes between Stringers S7 and S8 has further deteriorated to become a 4"x2" corrosion hole. There has also been increased deterioration on the bottom flange.

Photo 11: Span 2, Floorbeam FB5, North face. 13"x4" corrosion hole in web.

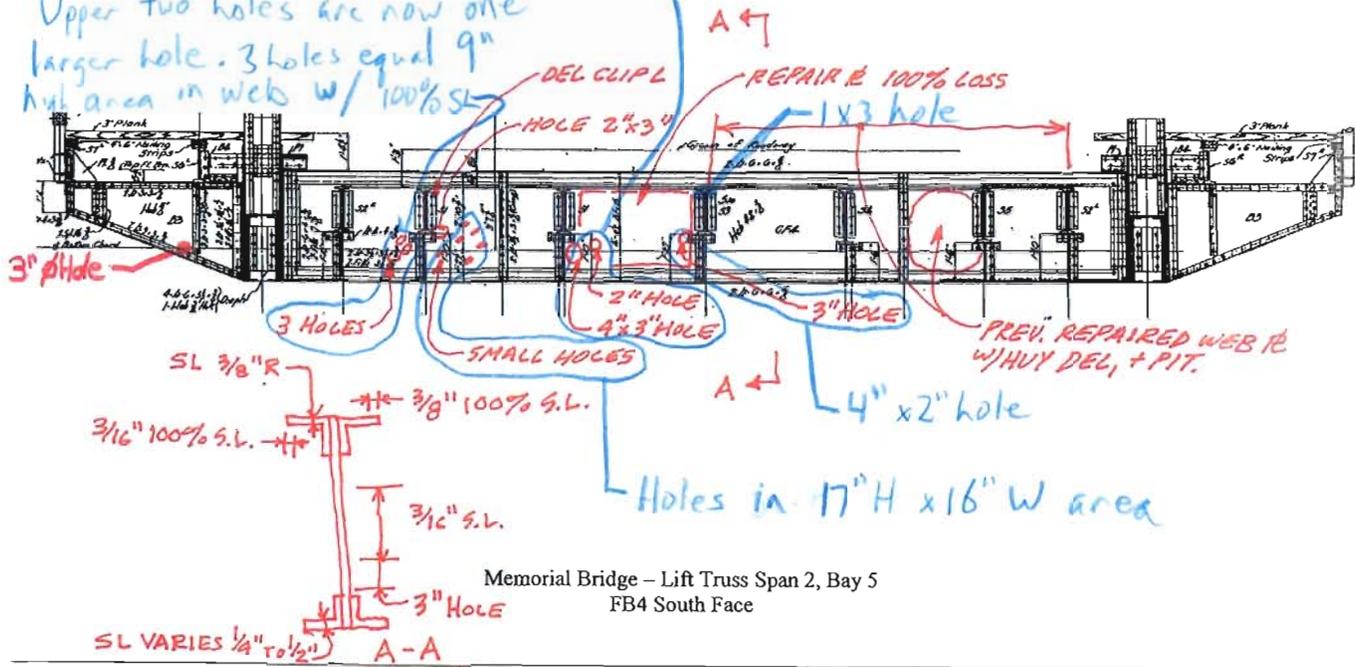
Memorial Bridge – Lift Truss Span 2, Bay 5
FB4 South Face

Holes have enlarged and have become one 4"x6" hole

Upper two holes are now one larger hole. 3 holes equal 9" net area in webs w/ 100% SL

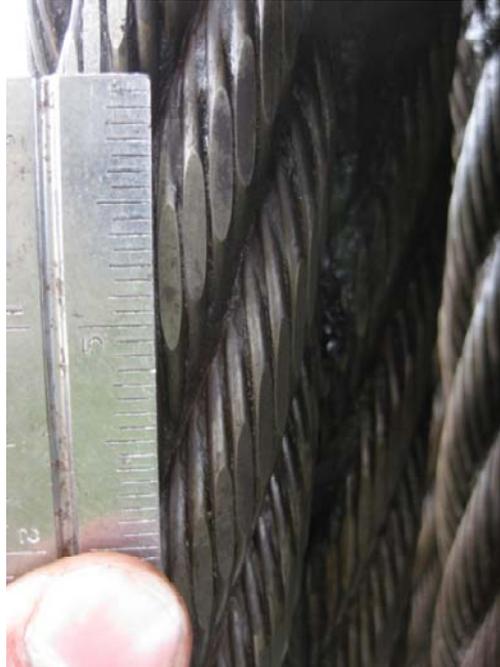
In general the wire ropes in the area inspected were found to have reduced diameters, and heavy crown wear (See Photo 2-6) ranging up to 11/16" in length (See Table 2 through Table 5 for full list of measurements). The ropes replaced in 2008 also had crown wear up to 3/8" in length. During the scoping study performed by HDR in the spring of 2009 it was found that all counterweight grooves were worn beyond the acceptable limits of the "minimum for worn groove" gauge. The Wire Rope User Manual recommends that ropes be replaced once their diameter has reached 95% of its nominal diameter (1.544" for a 1-5/8" rope). The measurements taken indicate that ropes 1, 2, and 3 on the SW corner and rope 1 on the SE corner should be replaced based on their diameter. Note that Rope 3 in the SW corner was replaced in 2008, and the diameter should be confirmed in upcoming inspections. Lubrication of the ropes was fair to poor. Lubrication was typically dry and caked (See Photo 2-7), with areas of bare wire rope, and surface rust. HDR found only one break on Rope 10 in the SE quadrant (See Photo 2-8). Due to the amount of caked grease on the ropes it is difficult to identify broken wires. It should be noted that during previous interim inspections (by others) the crown wear given in the reports indicate more crown wear than measured in this report.

Photo 2-6: SE corner rope 1 with 5/8" crown wear.

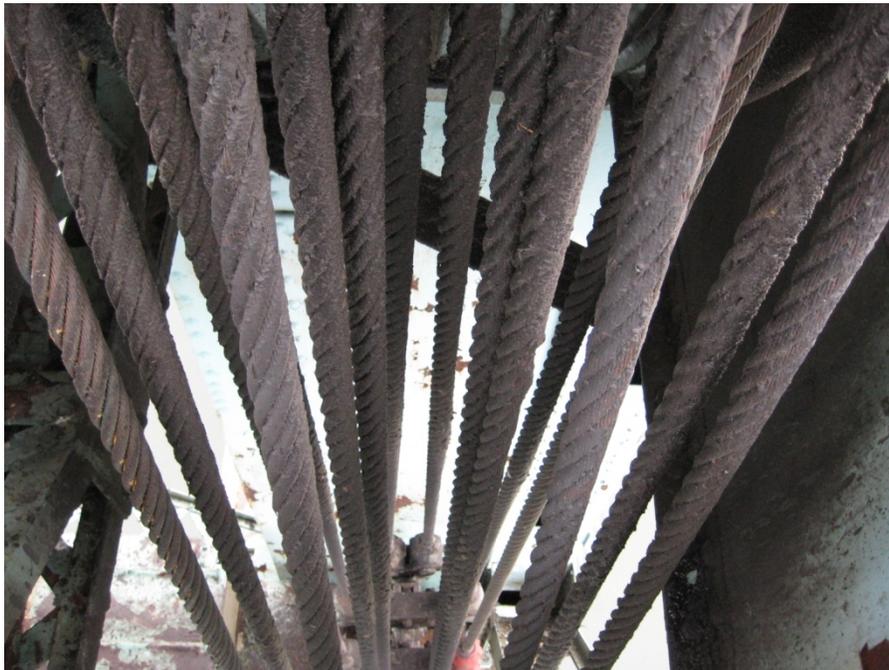
Photo 2-7: Dry, and caked lubrication of ropes; this is typical of all ropes.

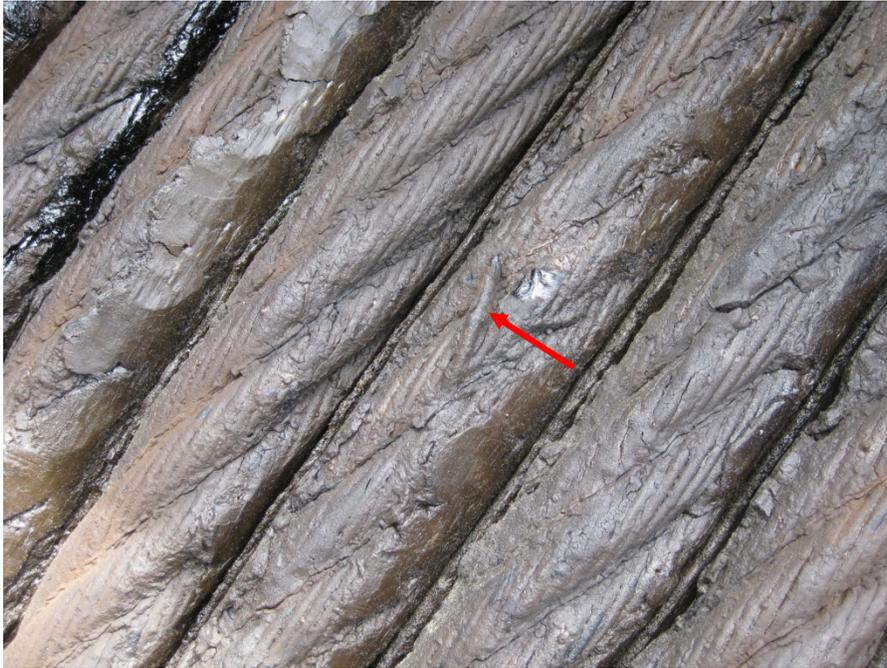
Photo 2-8: Wire break on rope 10 in the SE corner

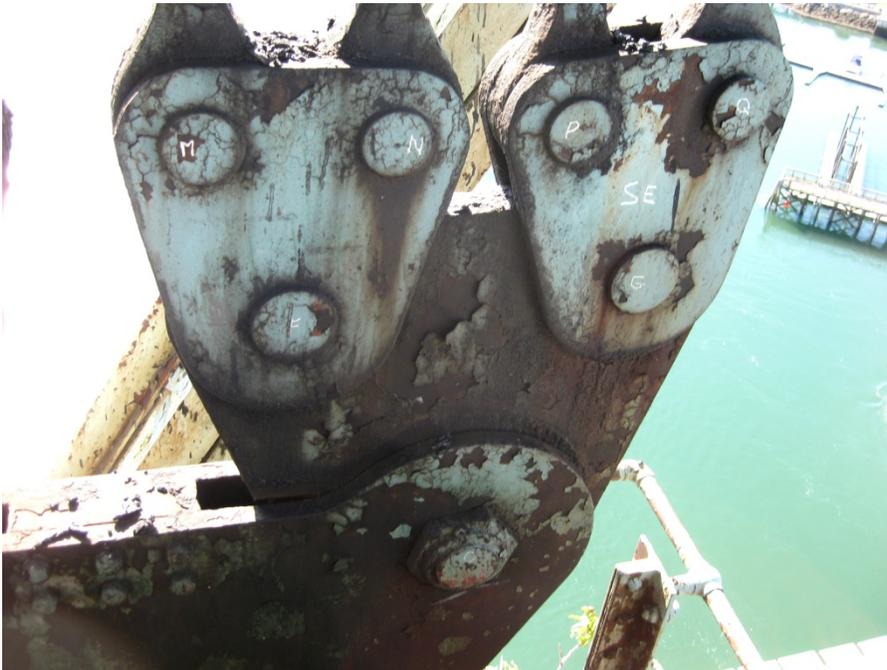
Photo 2-9: Typical general condition of equalizer plates, peeling paint, surface rust, and fretting corrosion between plates, and pins.

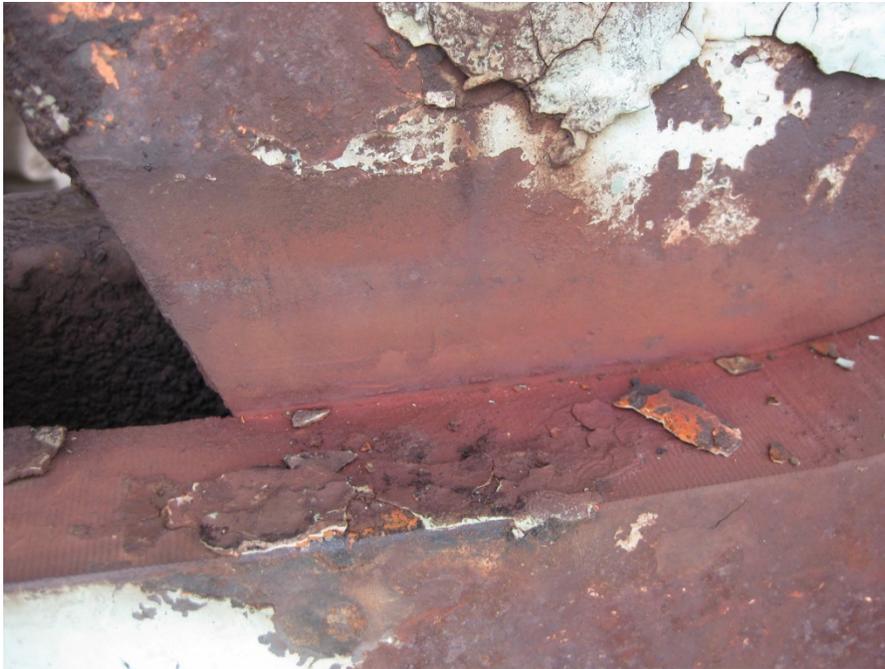
Photo 2-10: Typical fretting rust between equalizer plates. This photo is of the interface between the primary and the North secondary plates on the NE corner.

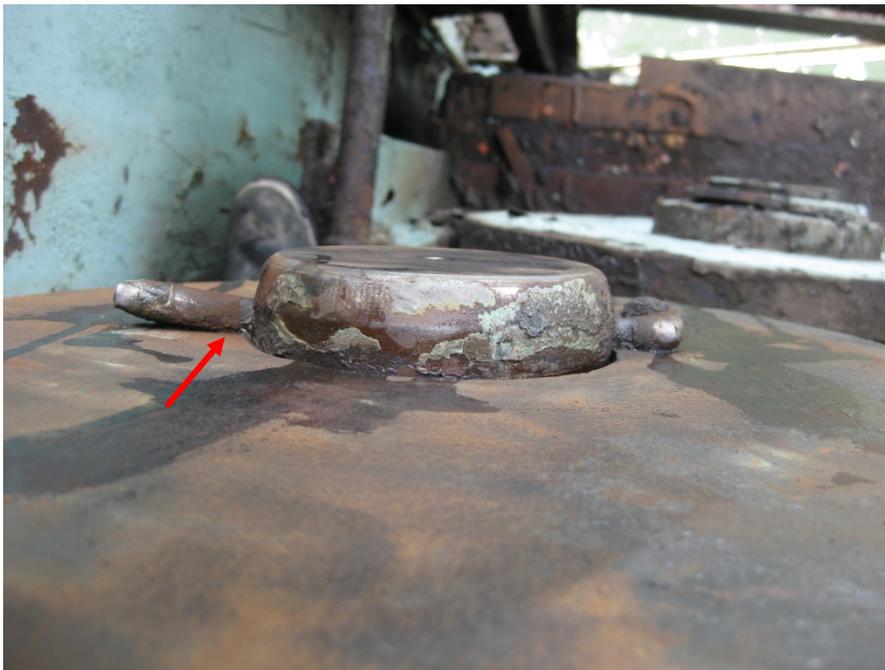
Photo 2-11: Pin D on the NW corner. Plate appears to be bearing against the cotter pin causing section loss and the pin to bend.

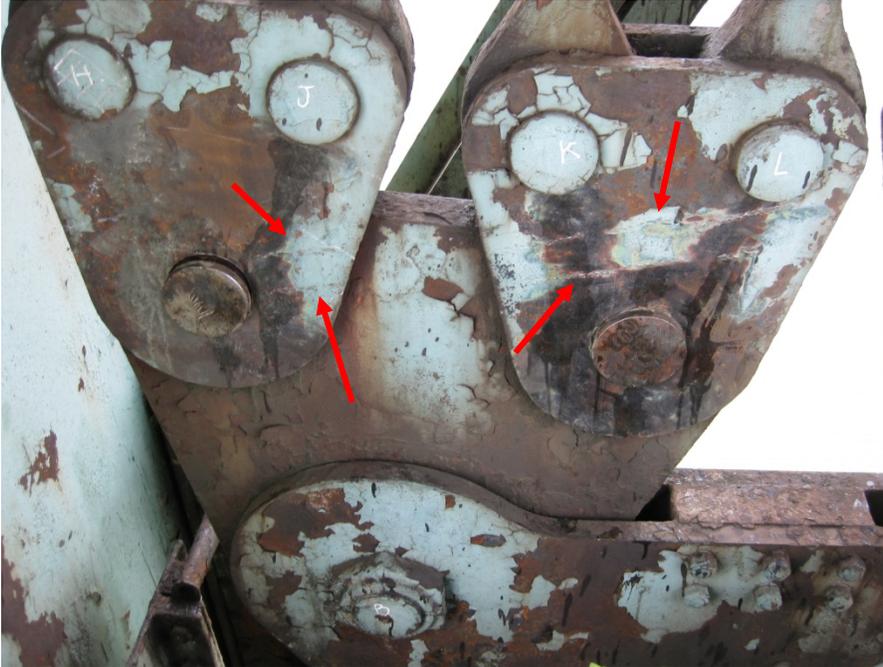
Photo 2-12: Welding on the tertiary plates on the NW corner equalizer near pin D and above pin E.

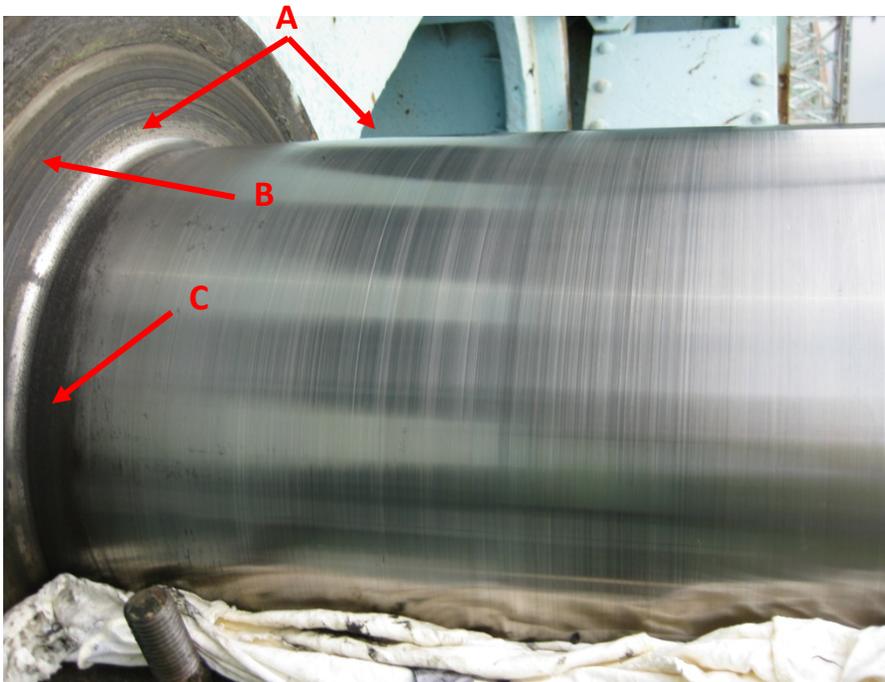
The trunnion shafts were found to have light to severe scoring, pitting, and galling (See Photo 2-13 SW Inboard Trunnion, and Photo 2-14 NE inboard Trunnion). These defects tended to be concentrated at the fillet, and thrust faces. There were no indications found with wet magnetic particle testing, or with ultrasonic testing. Bearing caps show mild to moderate scoring on the thrust faces. Table 1: Journal Conditions provides detailed conditions of the trunnions based on visual inspection. See Appendix: D NDT Testing report for details on ultrasonic and magnetic particle testing results.

Photo 2-13: SW inboard trunnion has (A) light scoring on the fillet and journal, (B) heavy scoring on the thrust face, and (C) moderate to heavy pitting on the adjacent and on the fillet.

- No action should be taken to replace the trunnion shafts, counterweight sheaves, or counterweight ropes. The ropes should be visually inspected annually, the trunnions should be ultrasonic, and wet magnetic particle tested every five years, and the counterweight sheaves should be visually inspected annually.
- Replace all tertiary plates, and pins D-G on all corners, field bore and sleeve secondary plates at location of pins D-G as required. Yearly inspections should continue to monitor the balance assembly. See Appendix: A Section 2.3.2 Repair Equalizer for further details.

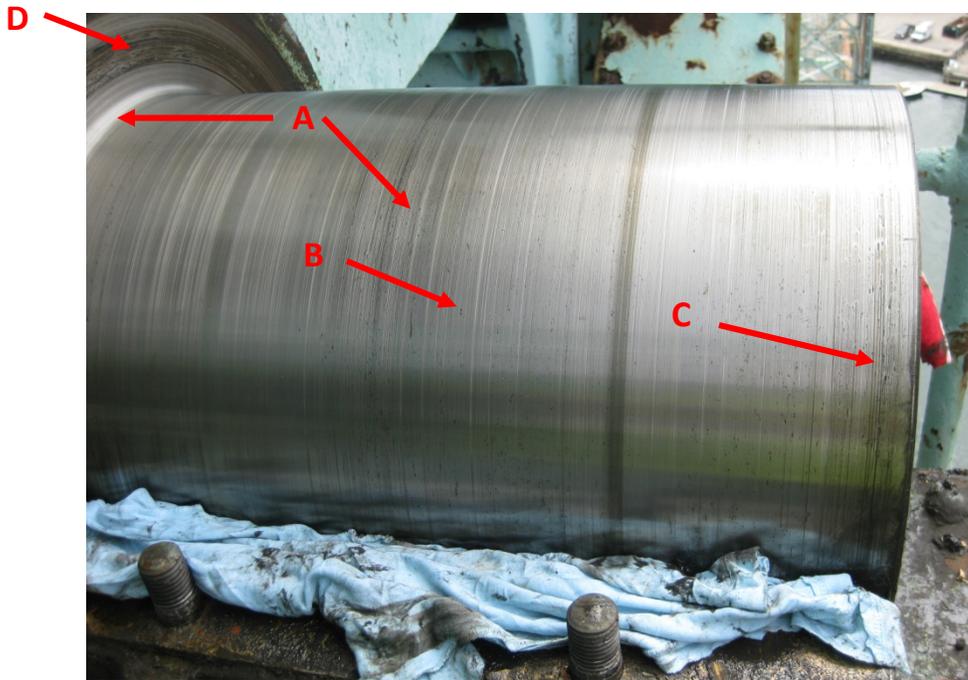
Photo 2-14: NE inboard trunnion has (A) light scoring and (B) pitting on trunnion shaft and fillet, (C) moderate galling and scoring near the end of the journal, and (D) heavy galling and scoring on thrust face.

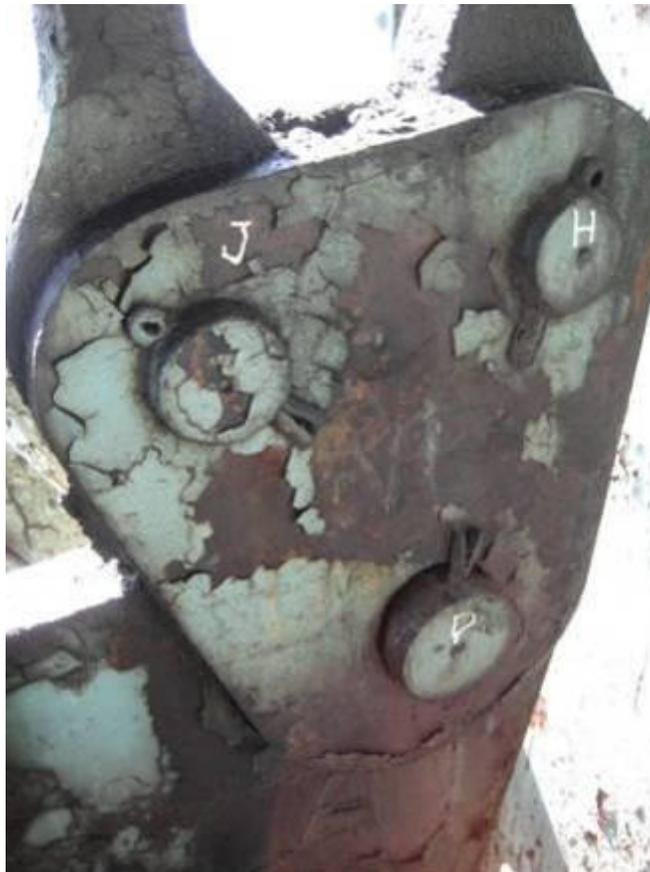
Figure 6: Equalizer plate condition

The equalizer plates had loosely adhering layers of paint and rust as Figure 6 shows. These layers were removed using a wire wheel attached to an electric grinder. Once the surface was free of paint and rust, ultrasonic couplant was applied to the face of the plates and inspection was carried out.
