**MEMORANDUM**  
**BUREAU OF RAIL & TRANSIT**  
**BICYCLE & PEDESTRIAN SECTION**

Subject: Field Review of Inactive Portions of Hampton Branch Railroad Corridor on May 29, 2009

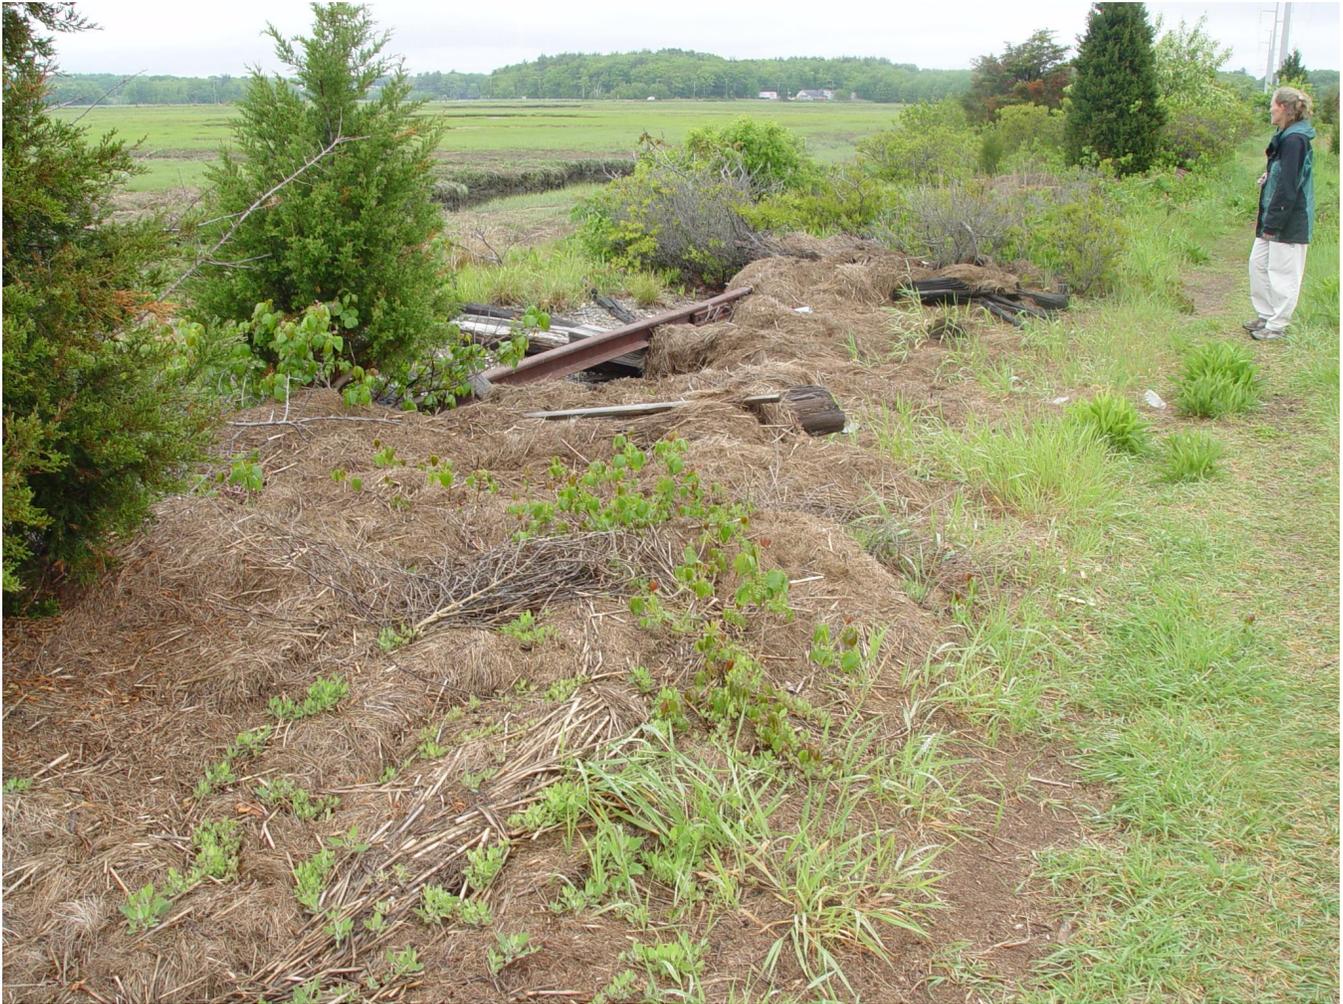
Throughout this segment of the Hampton Branch rail corridor, the rail bed was once double-tracked. Substantial portions of westerly ties and rail still remain in place. Throughout the Hampton marshes, railroad bed subsidence, surface erosion and wave rap are evident.

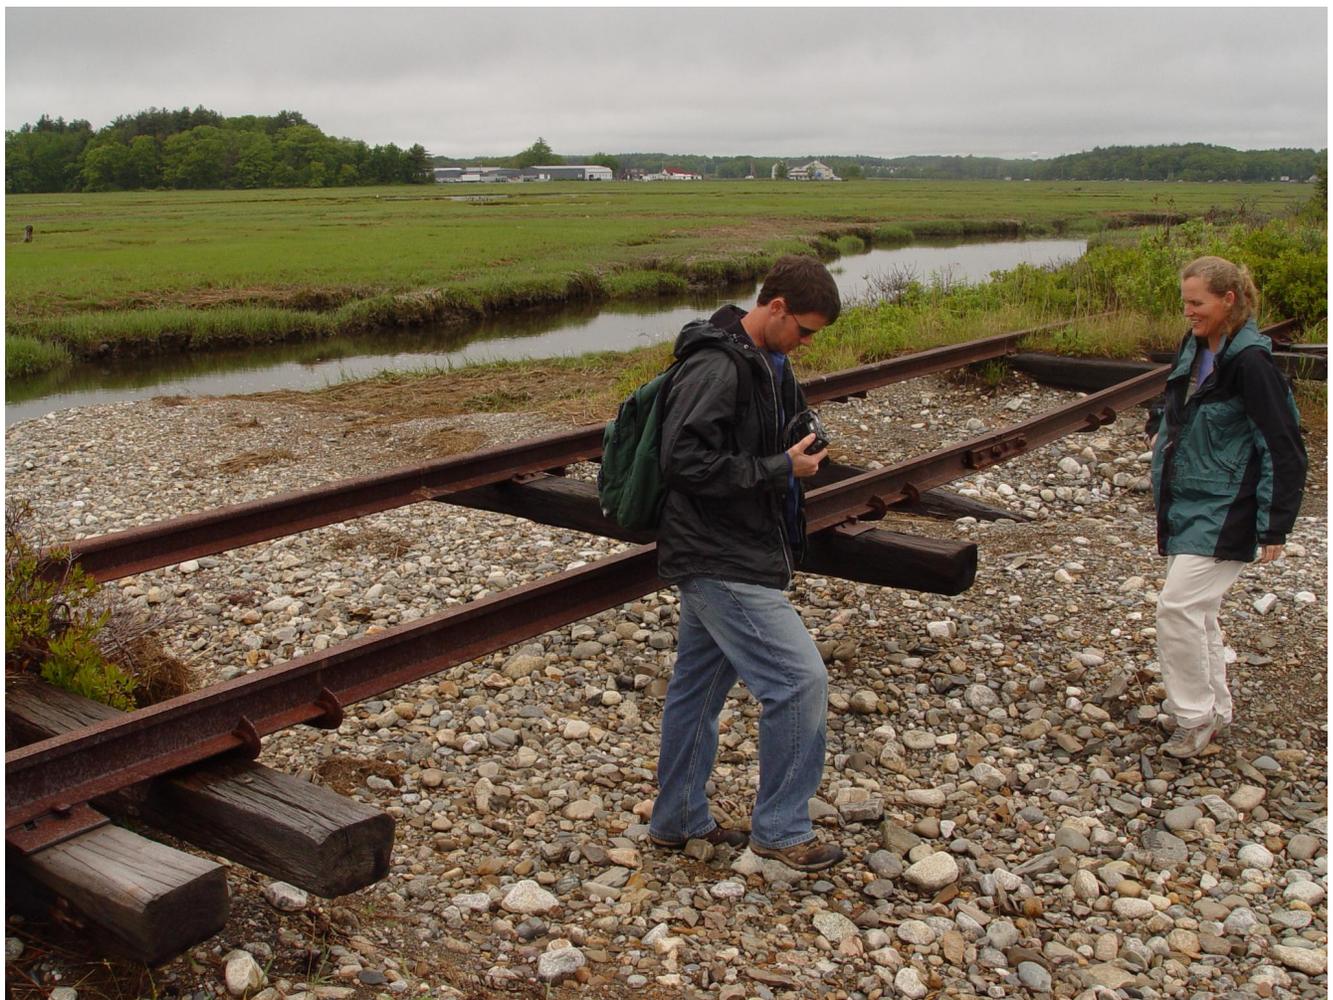
Between the Un-named Creek Bridge Crossing and the Taylor River Bridge Crossing to the north lay an additional half-mile of vulnerable rail road embankment where tidal rap and tidal breaches are evident. In the vicinity of the Taylor River Bridge, the easterly side of the railroad way has been buffered with an 18-inch high berm. This berm appears to be effective in holding back railroad way tidal breaching from normal cyclical tides. The relatively undamaged railroad bed in the area of the Taylor River Bridge makes noticeable the subsidence of the railroad bed (relative to the comparatively stable abutments) that appears to have occurred over the last 170 years.

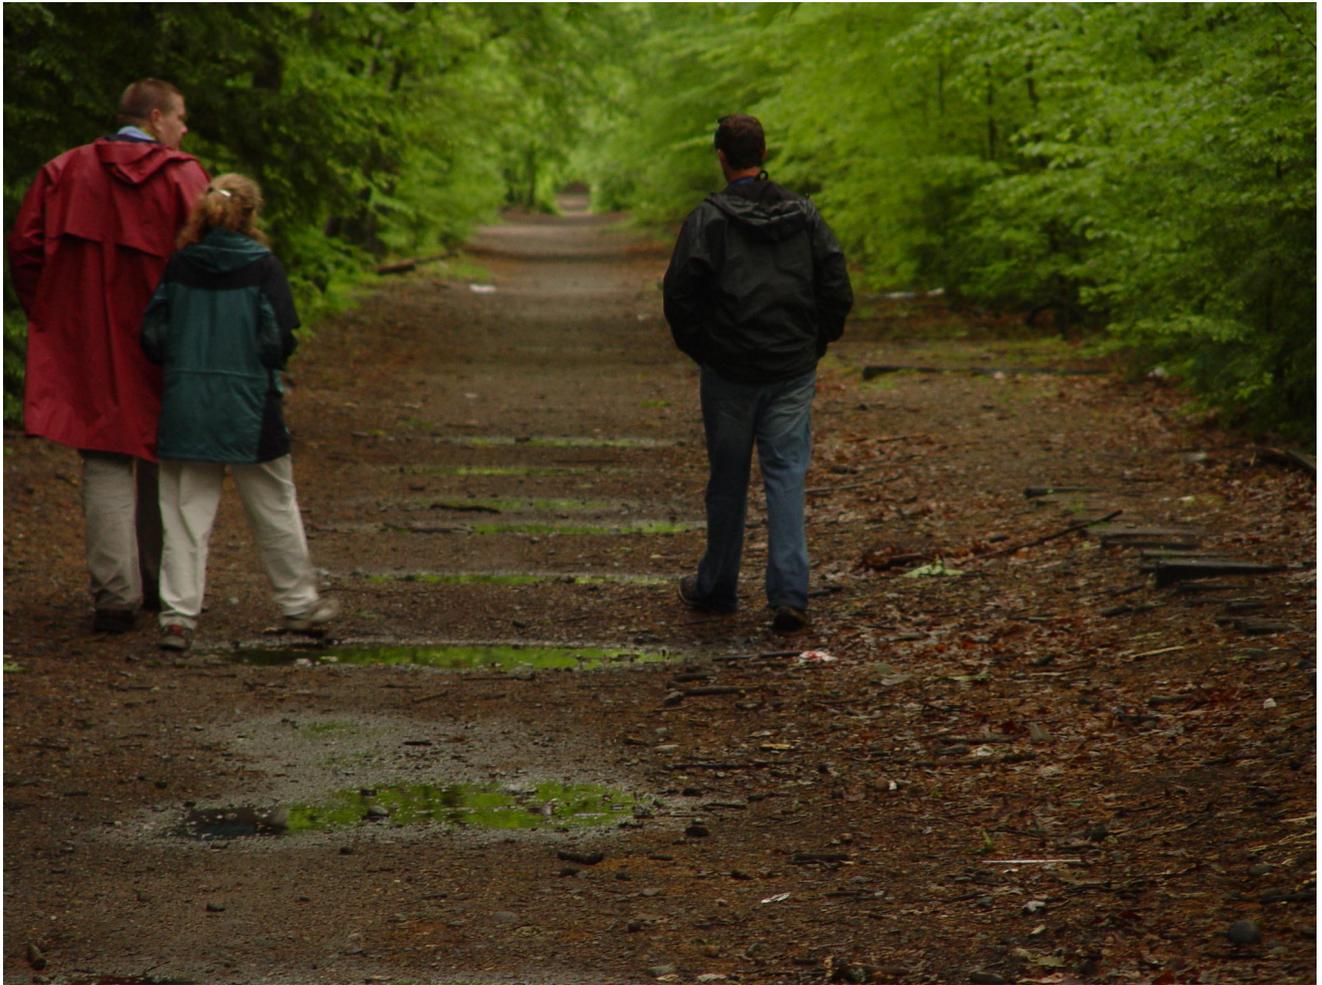
An informal crossing from the Seabrook Town complex to the behind the Wal-Mart shopping plaza is marked with an "Authorized Vehicles Only" sign. The crossing appears to have been purposefully improved relatively recently with a foot of gravel over the westerly ties and track. The gravel road crossing gets heavy and routine use. The crossing appears to be diverting many trips that would otherwise require a torturous and circuitous route along congested Route 1 and several Town roads.

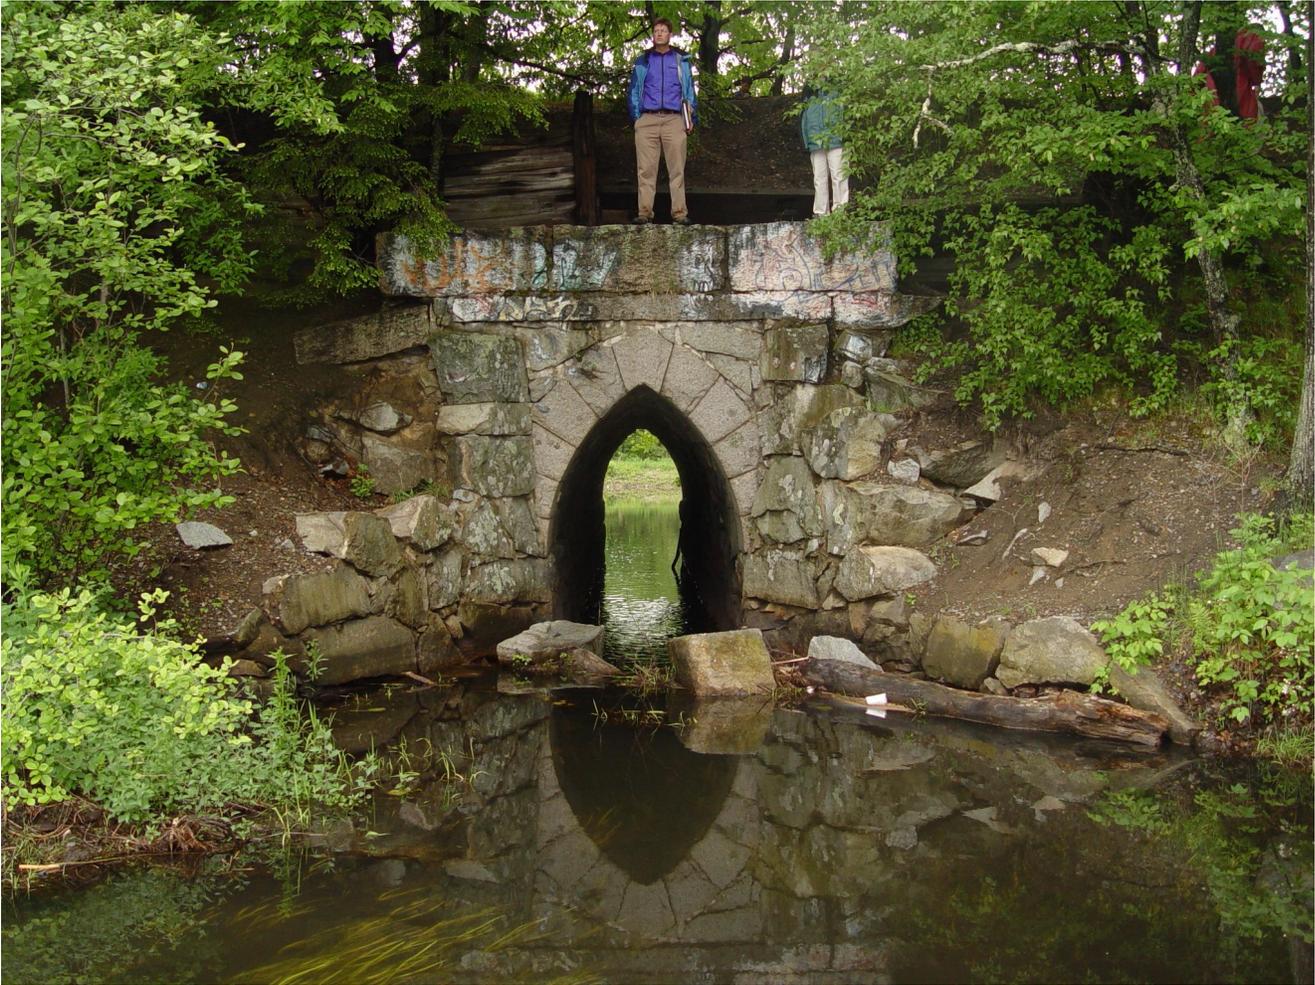
Along a 20-foot embankment fill, a finely-crafted drainage structure provides drainage relief for Caine's Mill Pond. The structure is about 10 feet high and 3 feet wide. Damage to the unique stone work is evident where vandals have levered large cut granite stones out of the head wall and wing walls. The cut stones have been levered into the drainage channel and are firmly lodged in the opening to the drainage

structure. Authorities in Seabrook should be made aware of the vandalism and perpetrators should be discouraged from continued destruction of the historical and cultural resource. The head wall, wing walls and channel opening should be restored before additional water and embankment damage result.

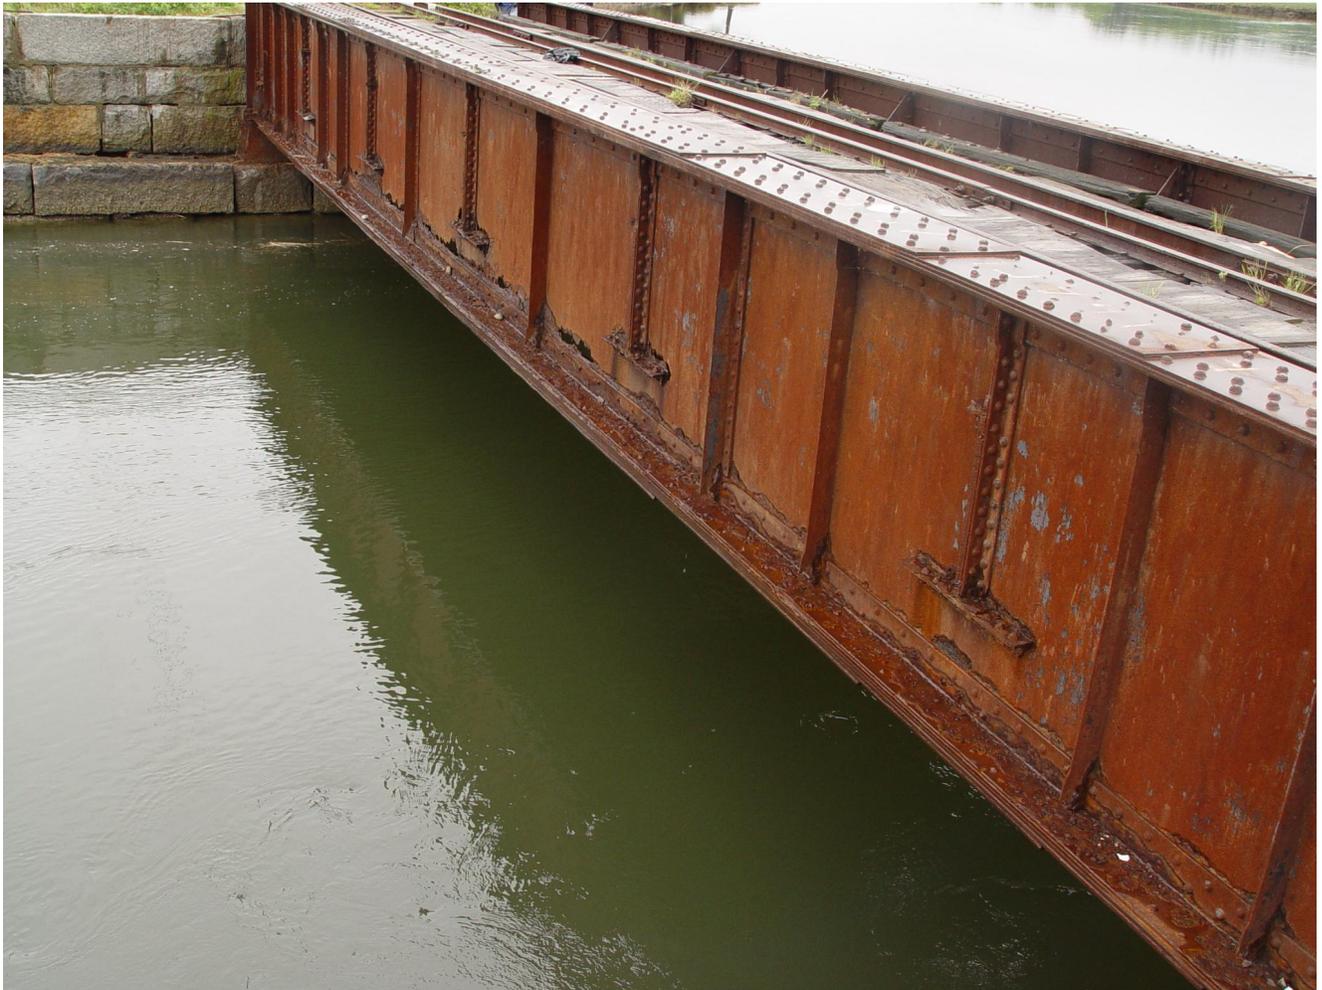
The substructures are made from carefully placed cut stones. Many of the large stones show signs of shifting. A few stones have fallen from the wing walls and/or bank protection has failed, with roadbed fill washing away behind the abutments.

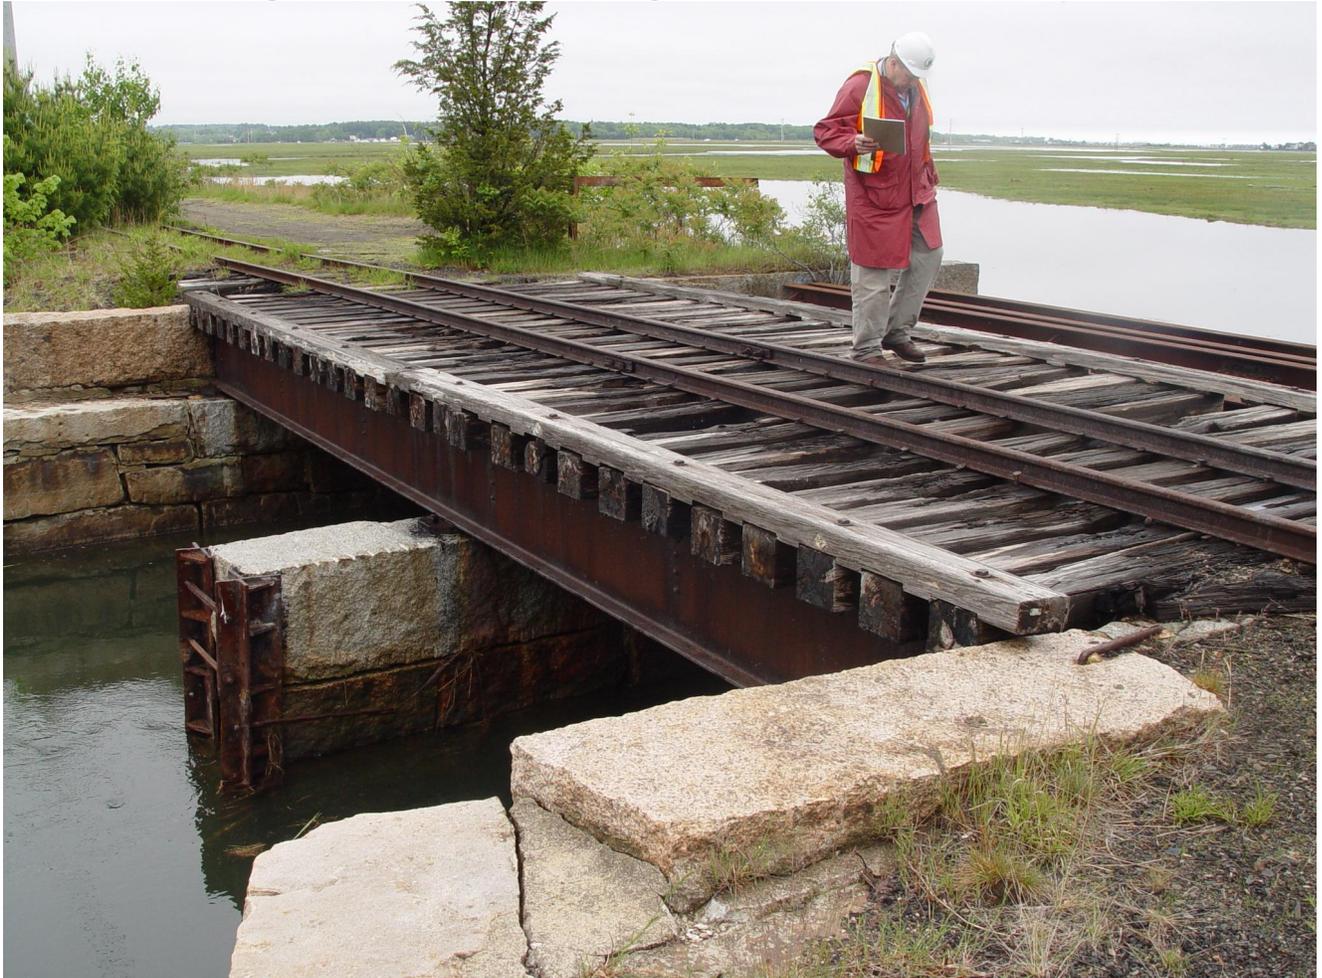
The structural steel has no paint, is close to the salt water and is partly covered in timber and debris. There is significant corrosion through many of the steel members. There are many holes rusted through including a twenty-foot hole in the plate girders of the northern most bridge. The rising tide reaches

close to the two northernmost steel superstructures. The high tide on May 29 was 8.7 feet at 4:21 pm. The tide is likely to get over ten feet several times in each month., which would put the two northern most steel structures in salt water.

The southernmost superstructure was somewhat higher above the water and is in fair condition.
