STATE OF NEW HAMPSHIRE
INTER-DEPARTMENT COMMUNICATION

SUBJECT: Taylor River Pond Dam and Taylor River Pond Dike, Hampton Falls
Dam #106.08 (Haz. Class A to B) and Dike #106.09 (Haz. Class AA)

On July 2, 2004, the State of New Hampshire Department of Environmental Services (DES) conducted a scheduled inspection of the aforementioned dam and dike. Under the provisions of RSA Chapter 482, Sections 8 through 15, DES is authorized to inspect all dams in the State, which by reason of their physical condition, height and location may be a menace to the public safety.

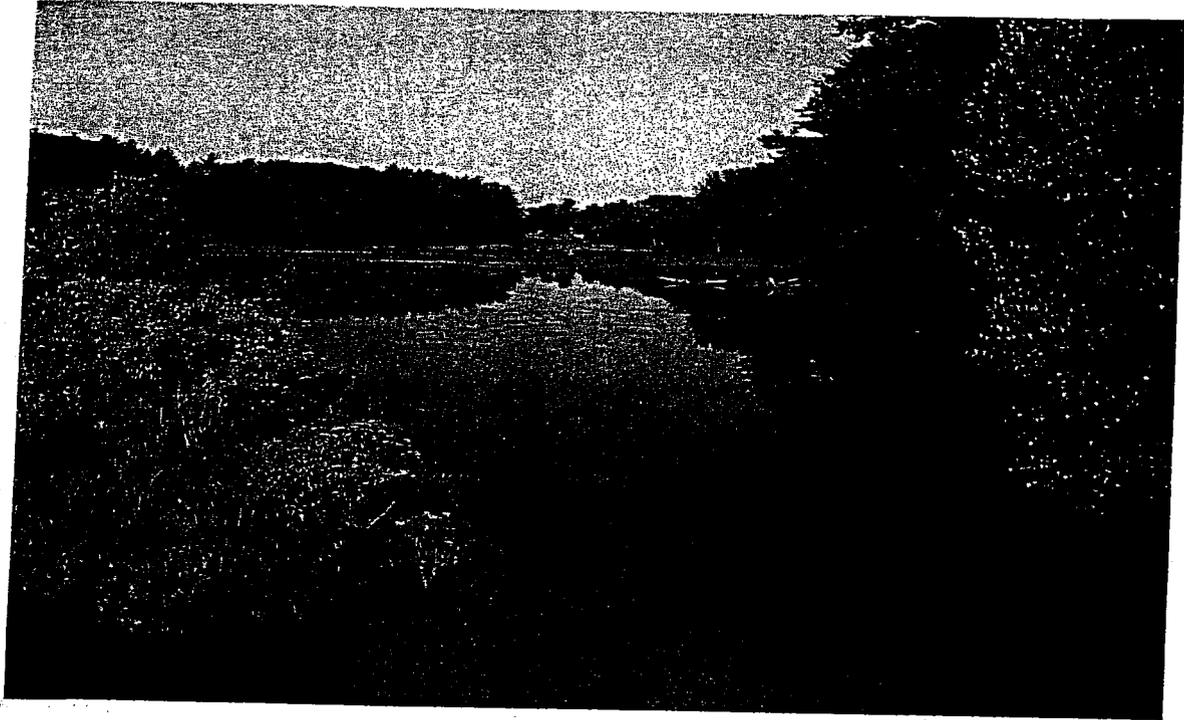
Picture 1. Taylor River impoundment – upstream of dam (west side of I95) – August 2004

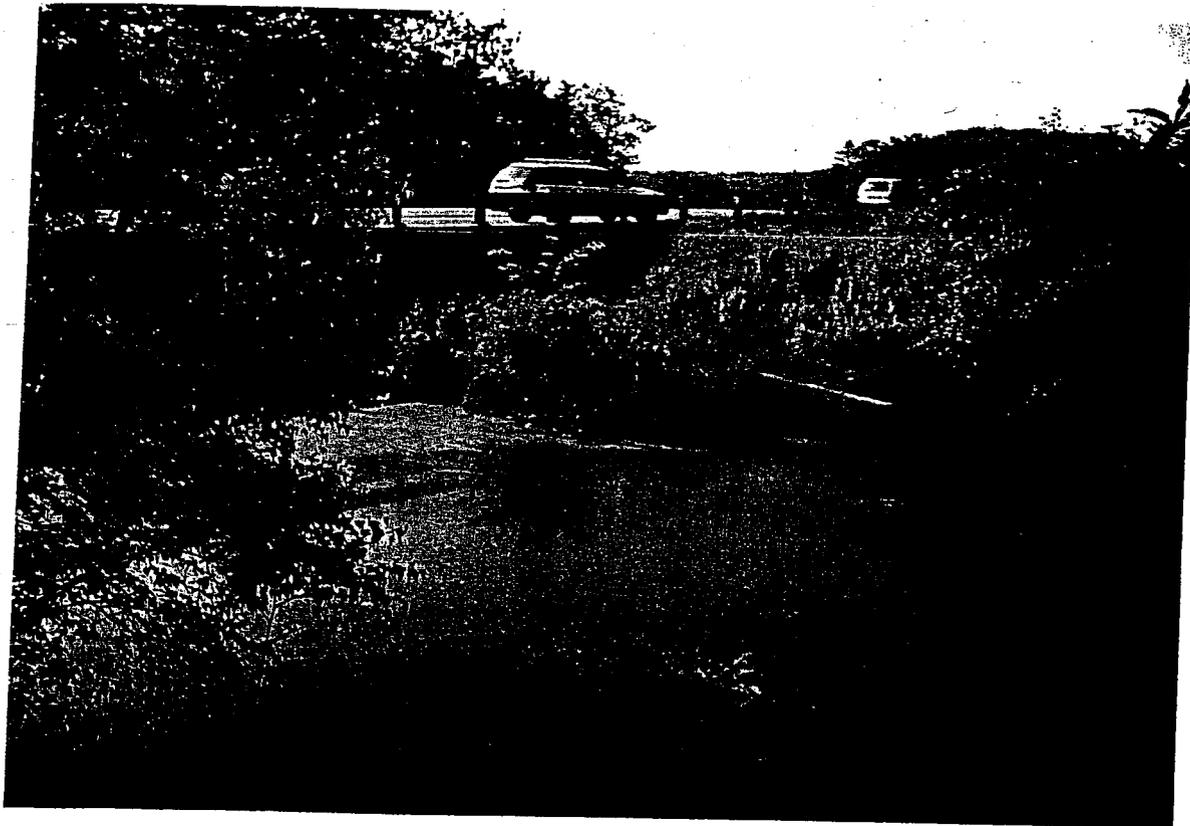
Picture 2. Taylor River fish ladder exit – West side of I95 – August 2004

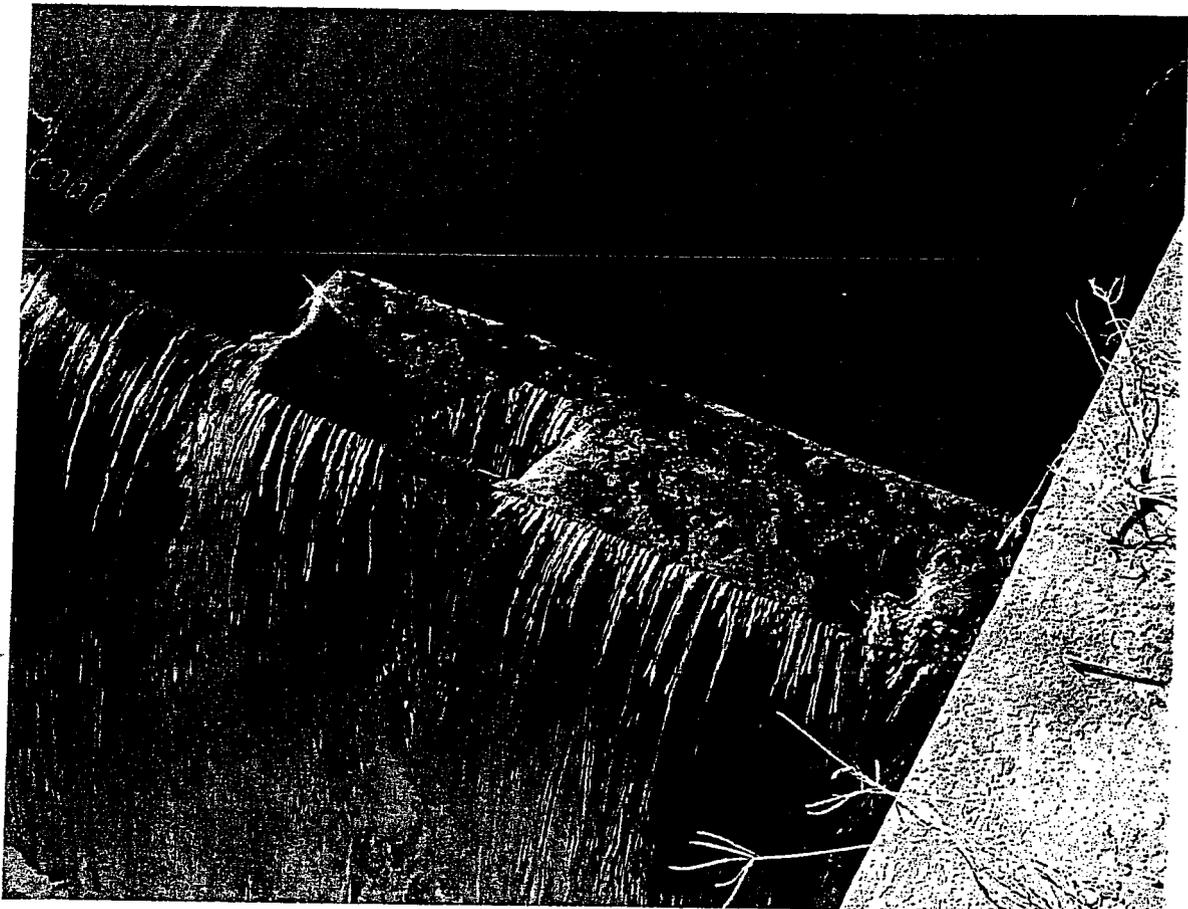
Picture 4. Taylor River dam – two holes on top lip of dam on opposite side of fish ladder entrance – November 2004.

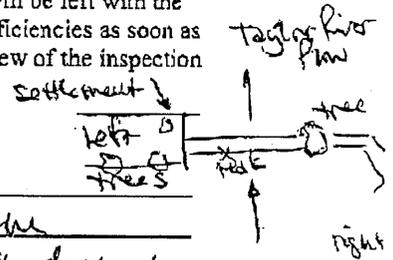
- Remove trees and brush
- ① Brush and trees on left abutment of dam
 2 trees measured greater than 12" diameter
 tree along downstream face of dam to the left of low level gate
 - ② Leakage noted in several locations along upstream spillway - water migrating beneath concrete slab through stonework - unable to maintain normal pool level in pond.
 - ③ Left abutment and earth interface has settled and eroded.
 - ④ Concrete cap on spillway is cracked and deteriorated
 - ⑤ Please complete an operation and maintenance plan and submit to DES - refer to guidelines.
 - ⑥ Exercise low level gate (in fall)
 - ⑦ Sediment - blockage in impoundment.
 - ⑧ In place of repairs consider dam removal - contact Stephanie Lindloff at #271-3406 funding may be available.
