**IN-DEPTH INSPECTION AND CONDITION REPORT
FOR THE
PORTSMOUTH MEMORIAL BRIDGE
OVER THE PISCATAQUA RIVER**

October 2009

VOLUME 2 OF 2

Underwater Inspection Report

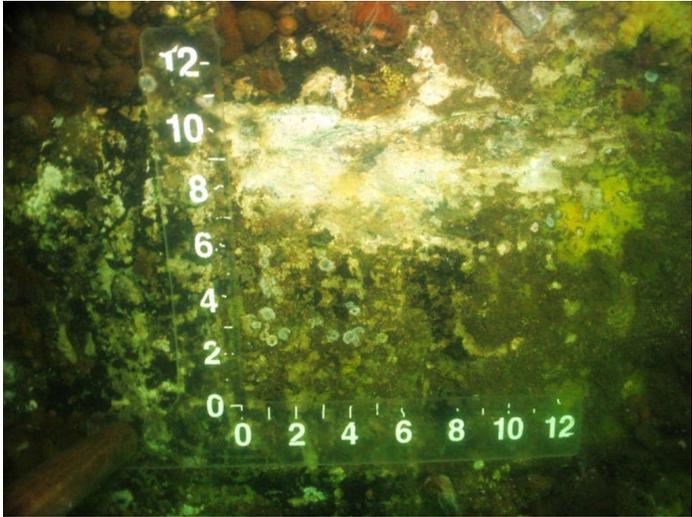
An underwater photograph showing a concrete surface with significant green and brownish discoloration and pitting. A ruler is placed vertically on the left side of the frame, with markings from 0 to 12 inches. The ruler is positioned against the concrete to provide a scale for the extent of the deterioration.	<p>Photo 1: Typical concrete deterioration around low water. Limited to ½-inch in depth.</p>

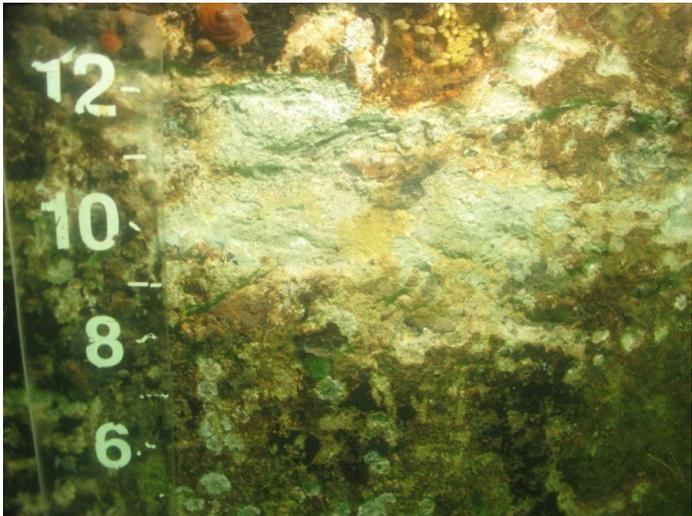
A close-up underwater photograph of a concrete surface. The surface is heavily eroded and covered in a thick layer of green and brownish material. A ruler is placed vertically on the left side of the frame, with markings from 6 to 12 inches. The ruler is positioned against the concrete to provide a scale for the extent of the deterioration.	<p>Photo 2: Close view of deterioration after hammer removal of deteriorated concrete.</p>

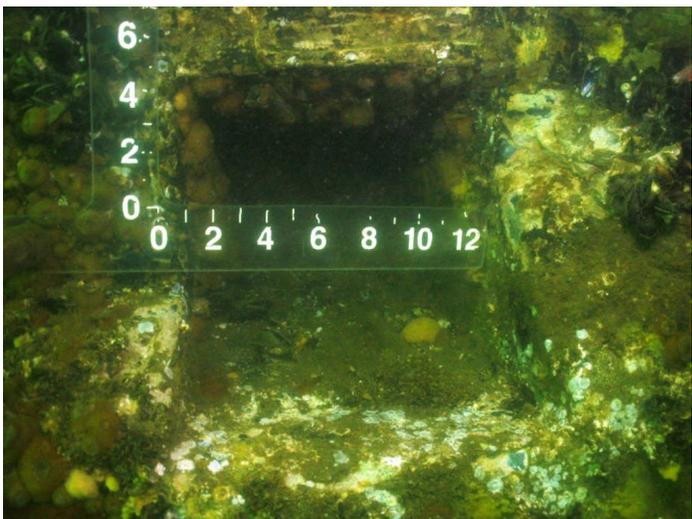
The concrete is generally in overall sound condition with limited areas of minor deterioration. The deterioration is generally more concentrated around low water. In the low water zone hammer soundings identified that the outer ½-inch of concrete is soft (Photo 1&2). Once the deteriorated concrete was removed, the underlying concrete was sound. The structure also has 12-inch by 12-inch block outs in the concrete from timber members that were originally cast into the piers and marine borers subsequently deteriorated the timber. These voids extend approximately 12-inches into the structure and have had no deleterious effect on the concrete pier (Photo 3).

An underwater photograph showing a concrete surface with a large, dark, rectangular blockout. The blockout is surrounded by green and brownish discoloration and pitting. A ruler is placed horizontally at the top of the blockout, with markings from 0 to 12 inches. The ruler is positioned against the concrete to provide a scale for the size of the blockout.	<p>Photo 3: Typical blockout in the concrete piers where timber elements were once connected. Concrete is sound at these locations.</p>

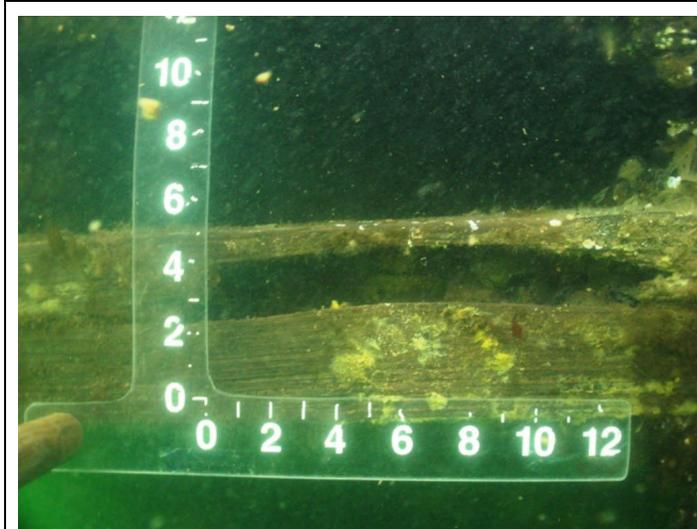
The timber fender systems have moderate marine borer deterioration throughout (Photo 4). The deterioration has progressed since the 2003 inspection and estimated to have affected approximately

10% - 20% of the timber members. It is important to note that marine borer deterioration is difficult to detect and could be more prevalent within the interior of the timber members.

Photo 4:
Marine borer deterioration to the
fender system.

The fender system is progressively deteriorating and recommended it be replaced in the short term (0-10 years). Our estimate of the probable cost of construction is depicted in Table 1 and is based on in-kind replacement.

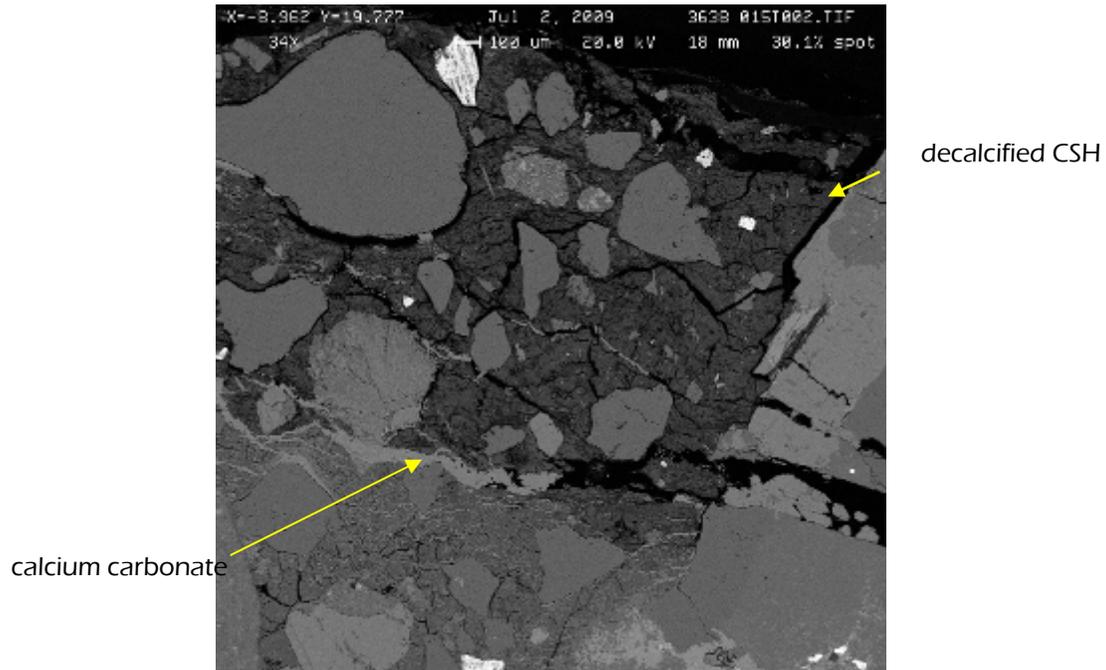
Figure 3 - North Pier of Memorial Bridge, core #1-1 (RJLG ID 3638015T). SEM image showing many cracks parallel to the exposed surface due to external sulfate attack. Near the surface, decalcified CSH has been converted to magnesium silicate with aluminum, which has no strength. Calcium carbonate is seen in the crack. The area below the crack is rich in magnesium.

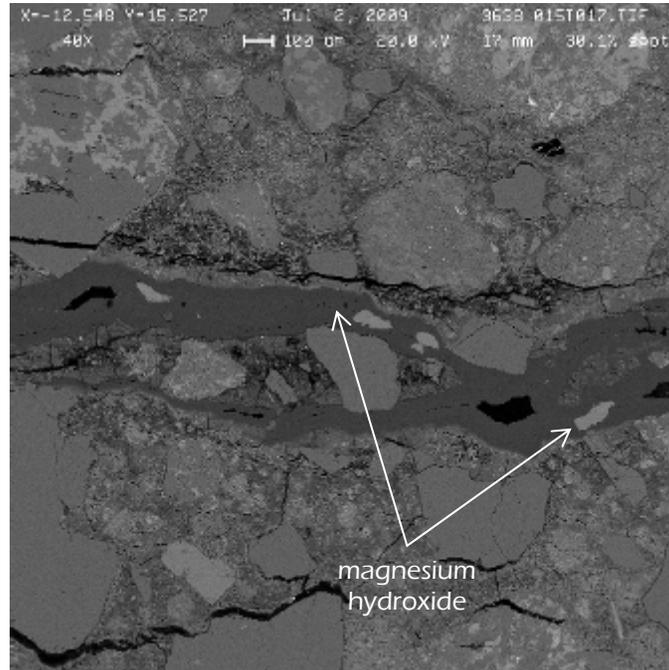
Figure 4 - North Pier of Memorial Bridge, core #1-1 (RJLG ID 3638015T). SEM image showing crystalline magnesium hydroxide (Brucite) in a crack.

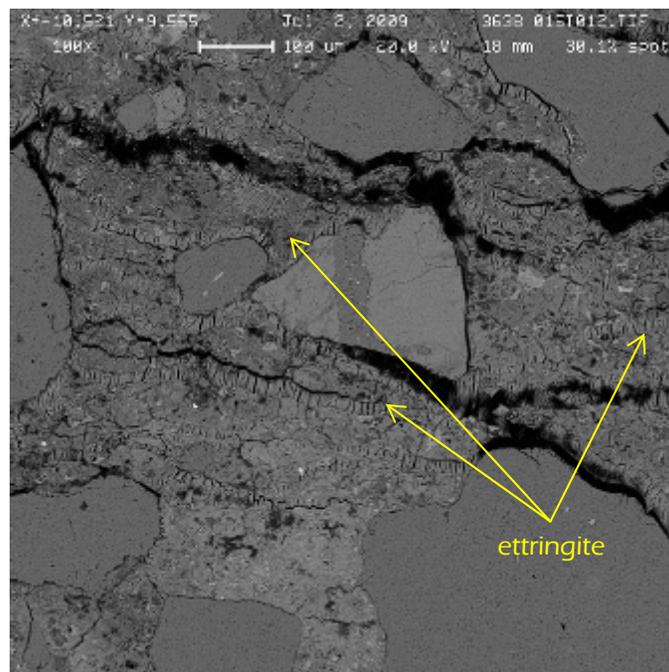
Figure 5 - North Pier of Memorial Bridge, core #1-1 (RJLG ID 3638015T). SEM image showing ettringite filling multiple cracks.

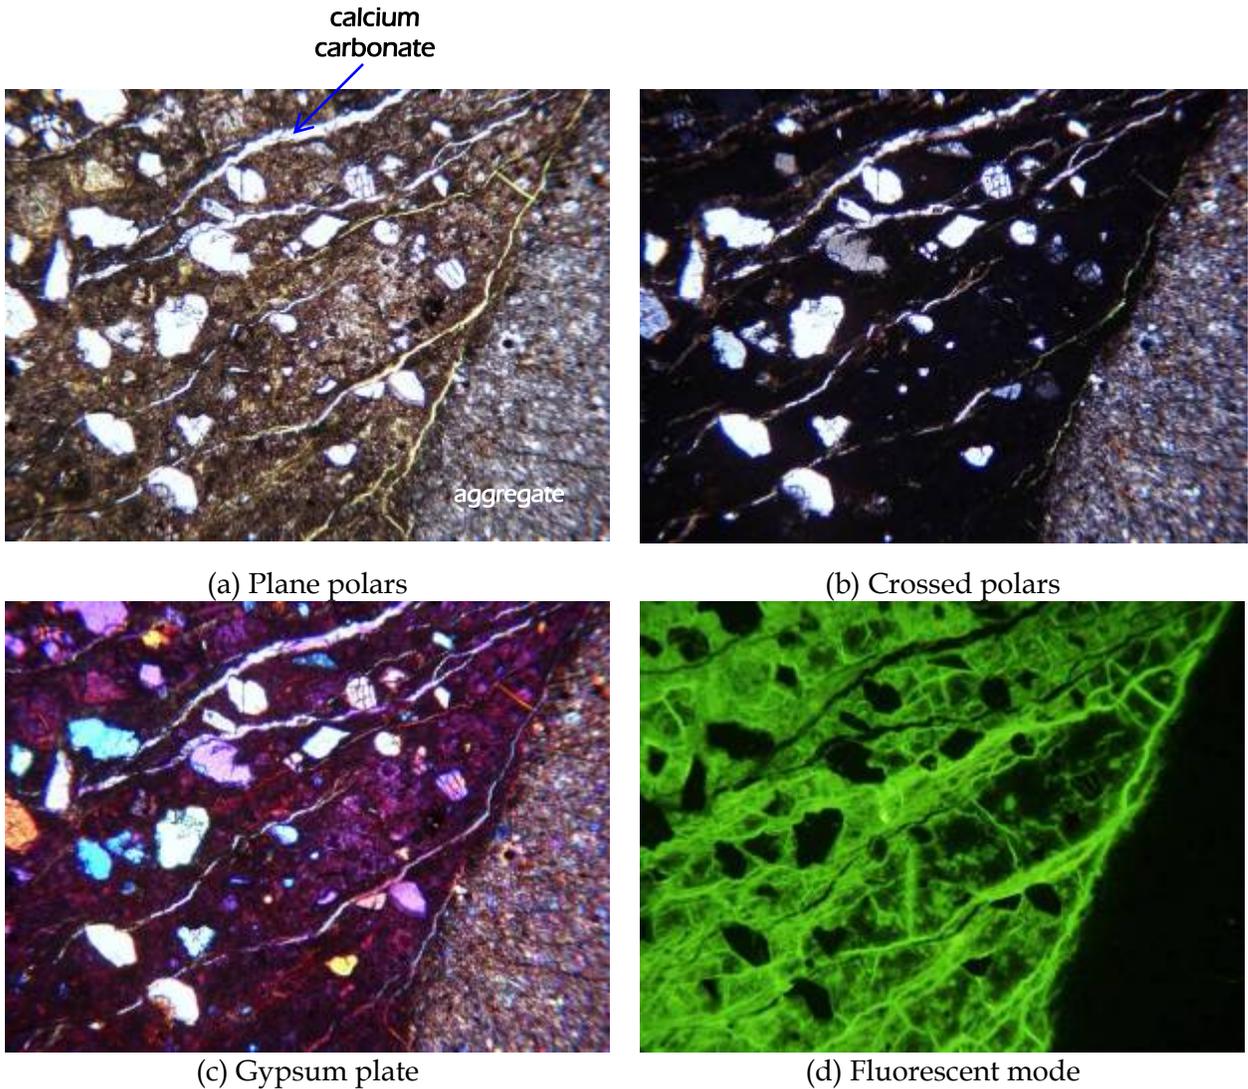
Figure B3 - North Pier of Memorial Bridge, 1-1, RJLG ID 3638015T. Optical images in different light modes showing cracks parallel to exposed surface in carbonated paste. Some cracks are filled with calcium carbonate which appears white in plane polarized light. Image area is 2.6 mm wide.

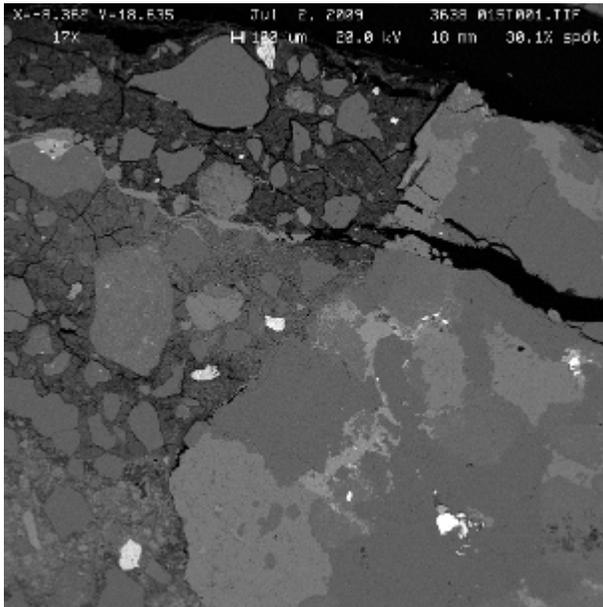
Figure B9 - North Pier of Memorial Bridge, 1-1, RJLG ID 3638015T. SEM image showing top exposed surface with parallel cracks.

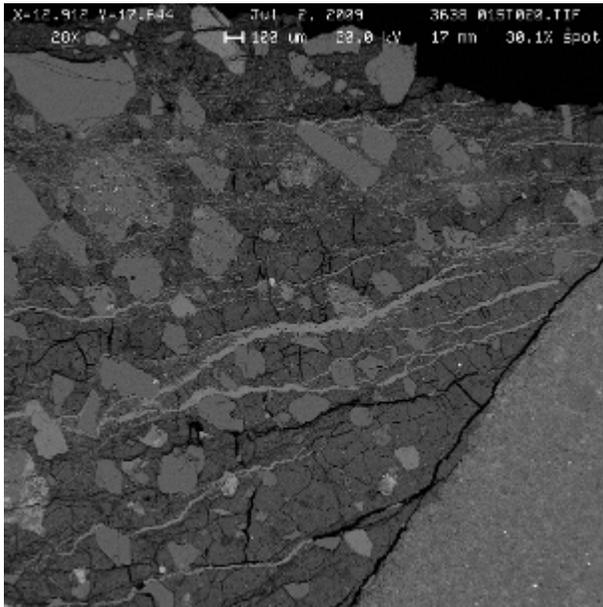
Figure B25 - North Pier of Memorial Bridge, 1-1, RJLG ID 3638015T. SEM image showing parallel cracks at top exposed surface.

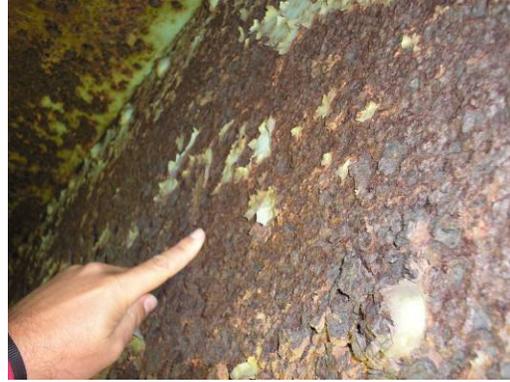
Photograph 6 – Corrosion on interior portion

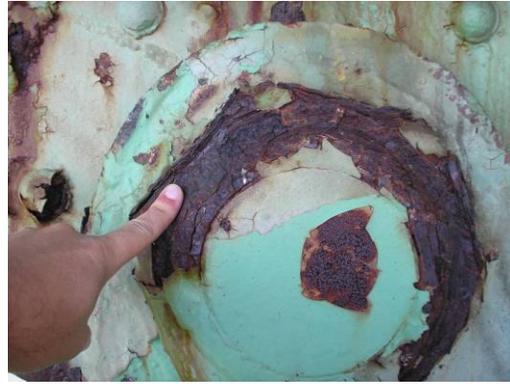
Photograph 12 – Section loss on bearing pin nut

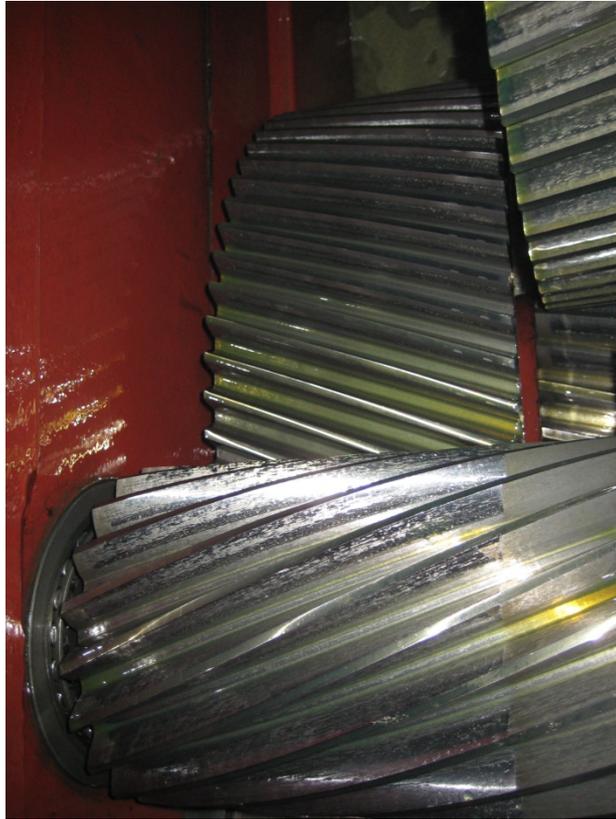
Photo M-3: Both reducers suffer from moisture intrusion into the interior of the housing.

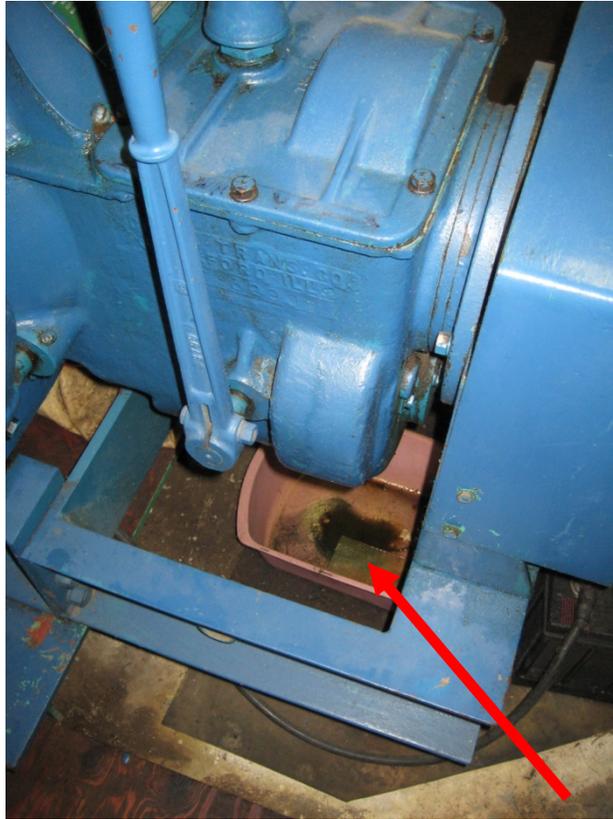
Photo M-4: The LPG back-up motor transmission leaks oil.

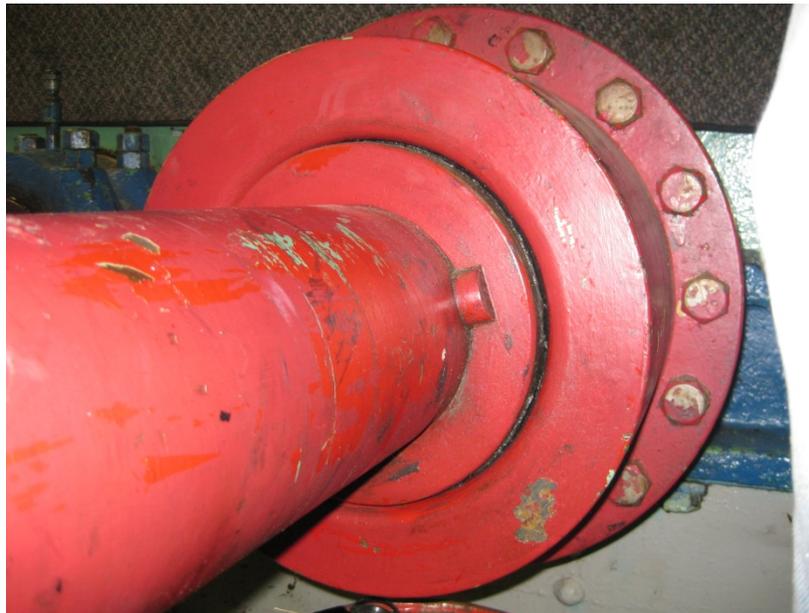
Photo M-5: Most shafts and couplings have paint related deficiencies.

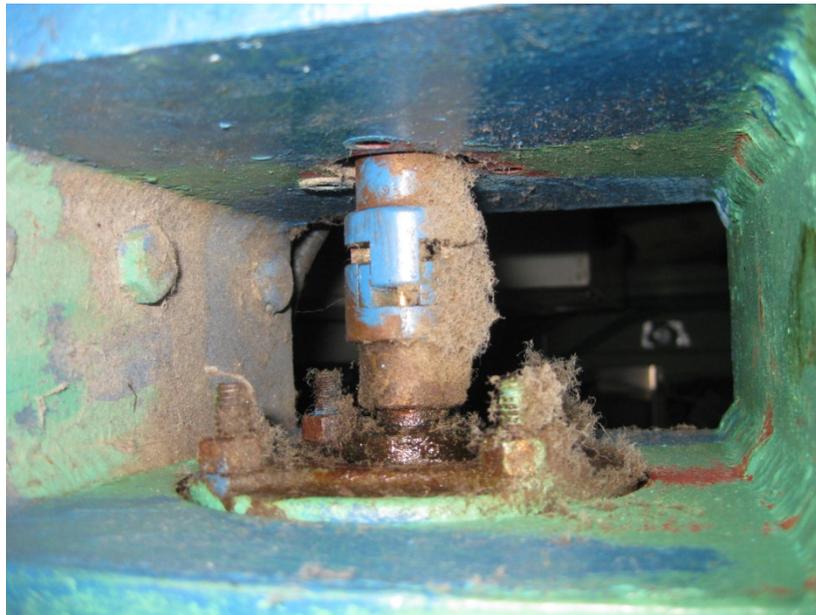
Photo M-7: Coupling C-11 may have a loose hub which does not fully engage the center spider of the coupling.

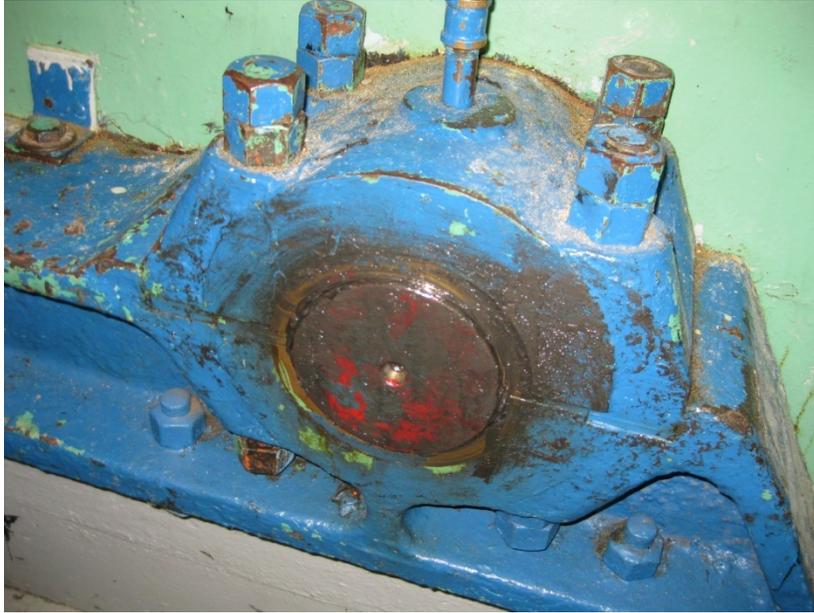
Photo M-8: The machinery bearings have minor maintenance related deficiencies and in most cases have wear beyond the standards for clearance.

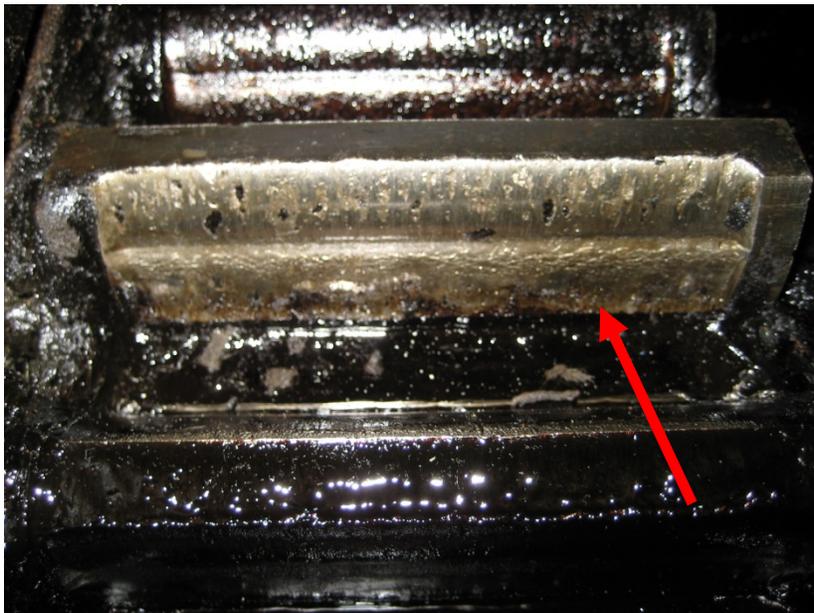
Photo M-9: The gear teeth show significant wear in all the open gear sets of the movable span, Southeast drum gear raise face shown.

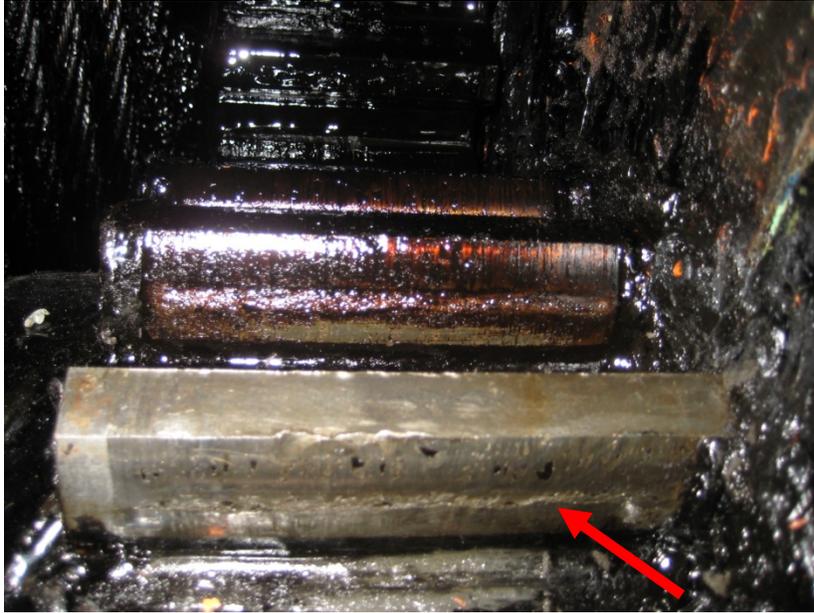
Photo M-10: The gear teeth show significant wear in all the open gear sets of the movable span, West pinion gear raise face shown.

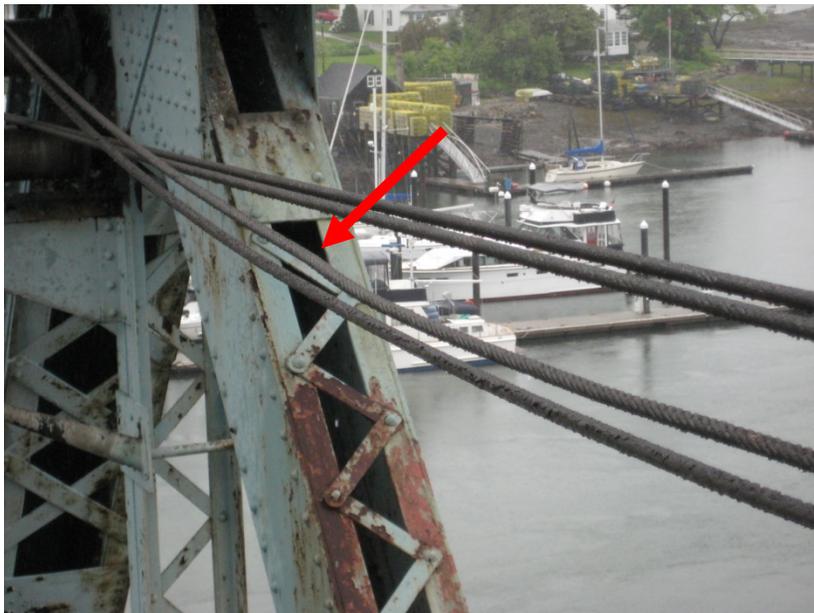
Photo M-11: There is a kink in the East, northeast uphaul rope at about the just before the double rollers when the span was approximately 1/3 open position. The kink in the rope was visible when the load on the rope was relieved and the rope went slack.

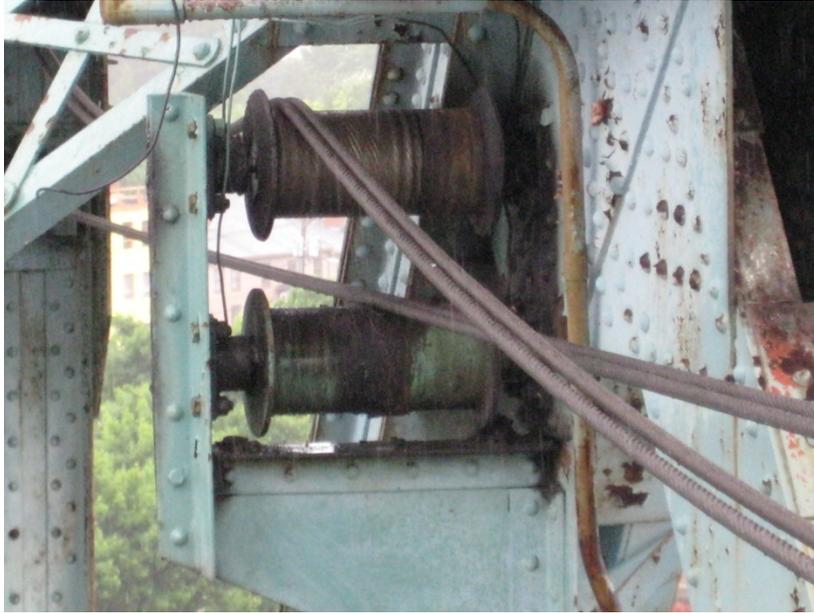
Photo M-12: These rollers show evidence of groves and scoring over the outer diameter of the rollers caused by contact with the operating ropes.

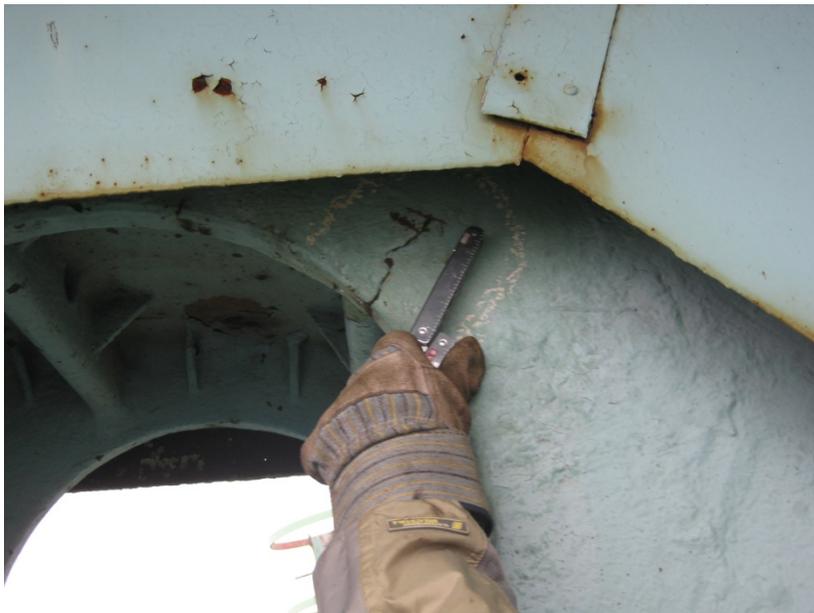
Photo M-13: The crack in the outboard web of the NE sheave was confirmed and showed no additional growth since the previous inspection.

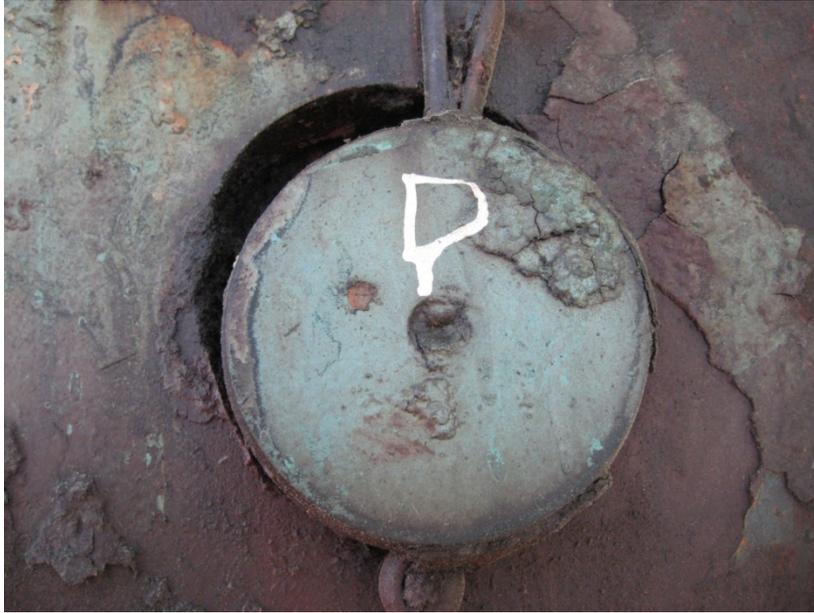
Photo M-14: The worn clearance between the pins and bars of the counterweight equalizing device have not increased since the previous inspection.

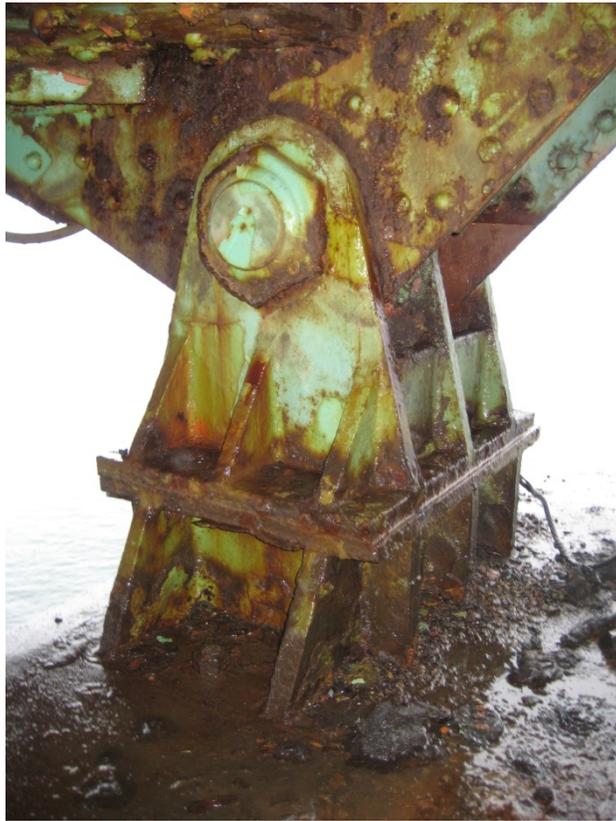
Photo M-15: All of the live load bearings were found to have only minor deficiencies, with no visible, significant wear.

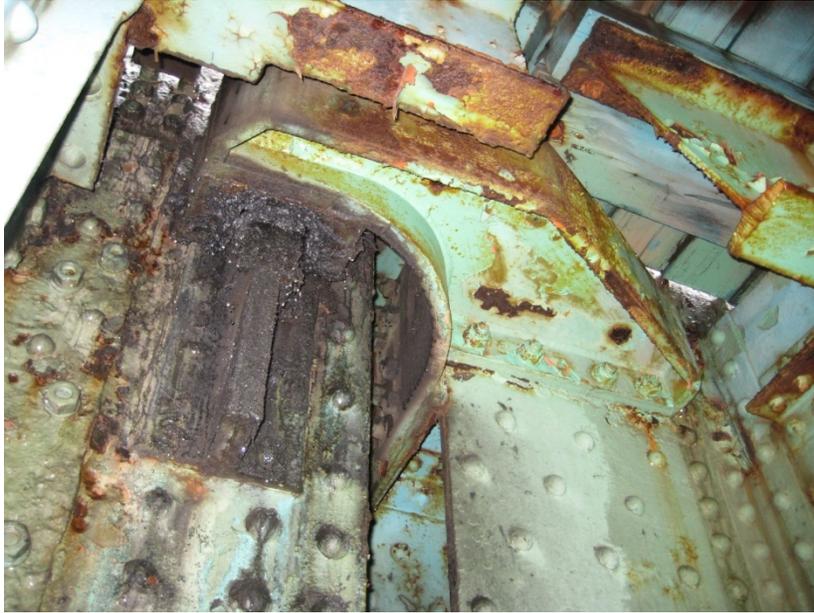
Photo M-16: All of the span guides were found to have only minor deficiencies such as paint failure and corrosion.

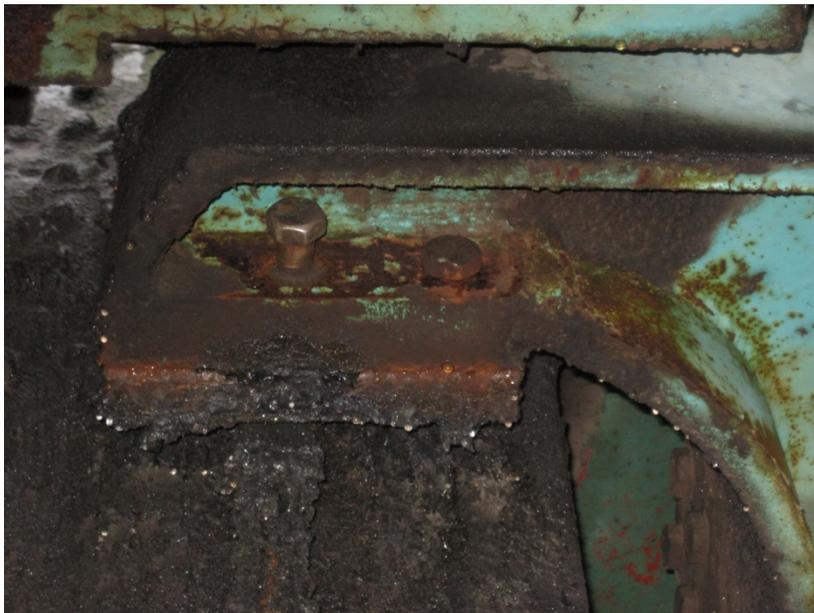
Photo M-17: During inspection it was noted that the bolts for the wear plate on the Northwest lower span guide were loose.

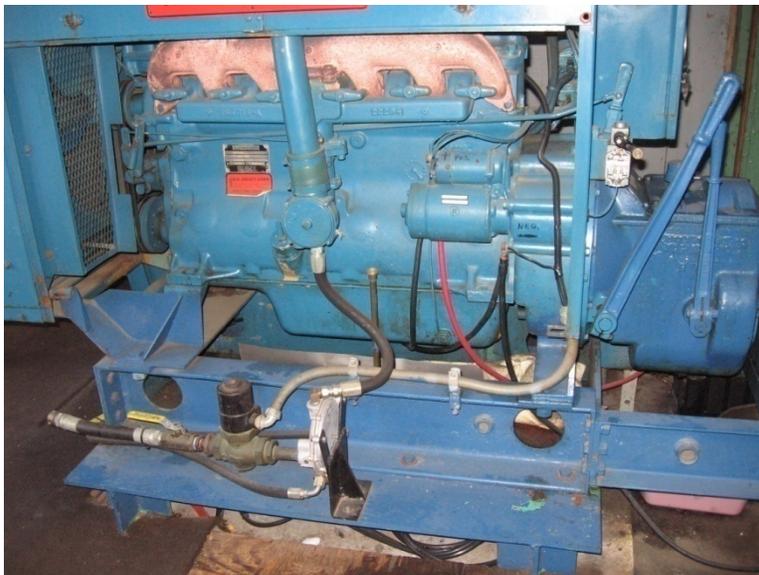
Photo E-2: The use of propane fired emergency engine in the machinery and control room requires the installation of carbon monoxide detectors to alert the operator of any exhaust or plenum leaks

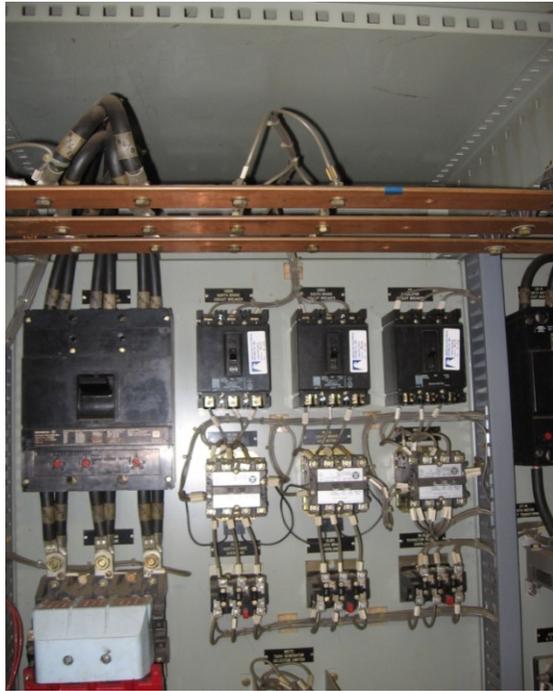
Photo E-3: The MCC is of obsolete design with exposed bare copper bus which exposes the switch person to the arcing that might occur during the switching process

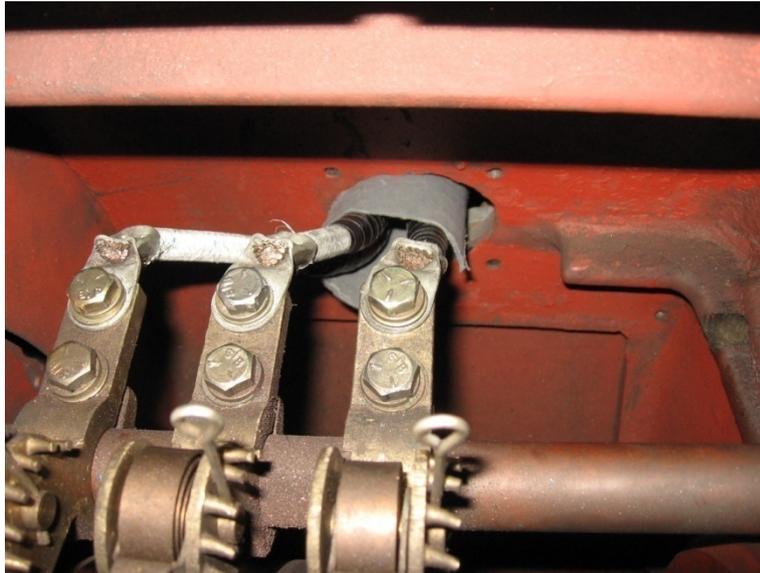
Photo E-4: Temporary measures were taken to minimize the potential for the insulation on the rotor leads to wear through and short out as they leave the motor rotor housing

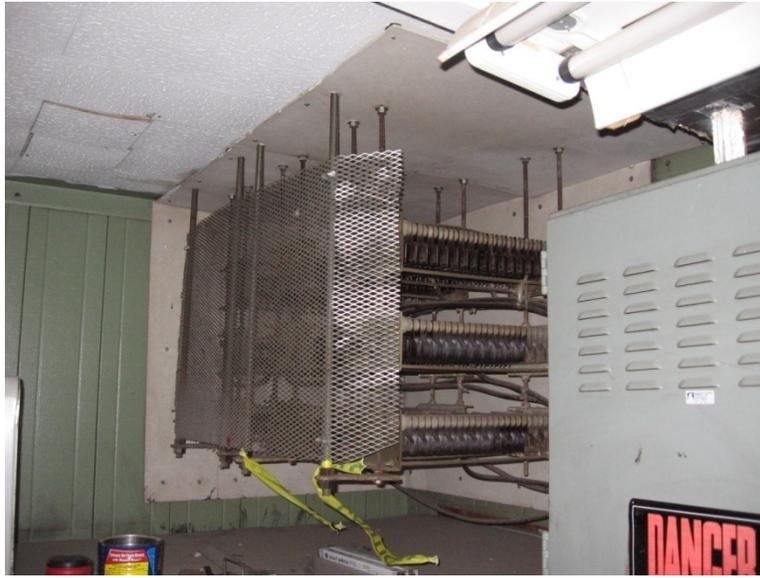
Photo E-5: The secondary resistors have exposed energized elements and conductors and the existing guard does not fully encompass for the hazard

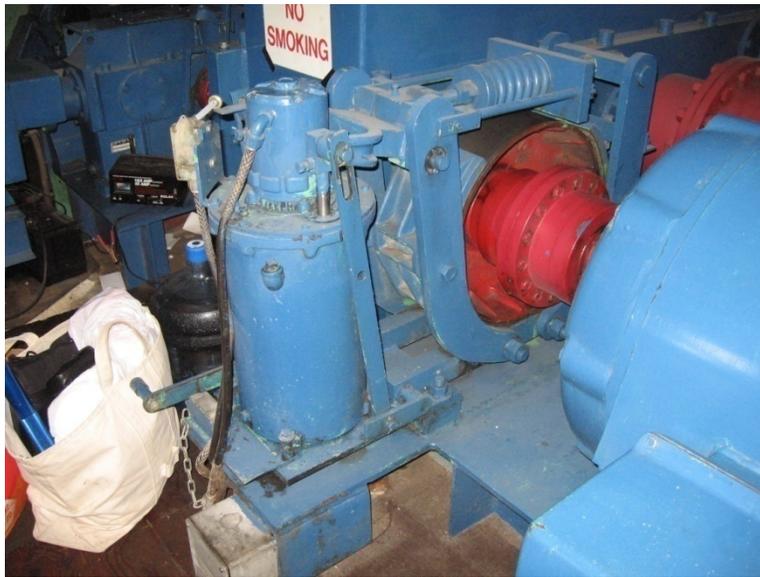
Photo E-6: Even though the thruster brakes appeared to be in a good condition, they are an obsolete GE model and no spare parts, such as seals, are available

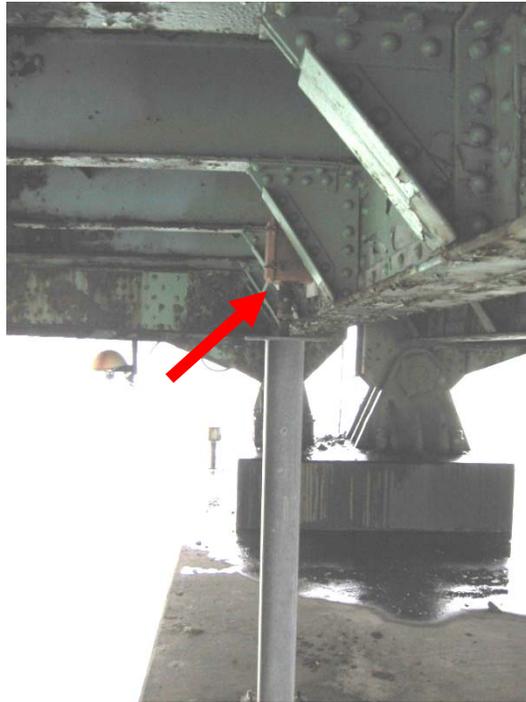
Photo E-7: From field experience the plunger switches for the span seated indication are problematic. If they are not adjusted properly, they get damaged easily.

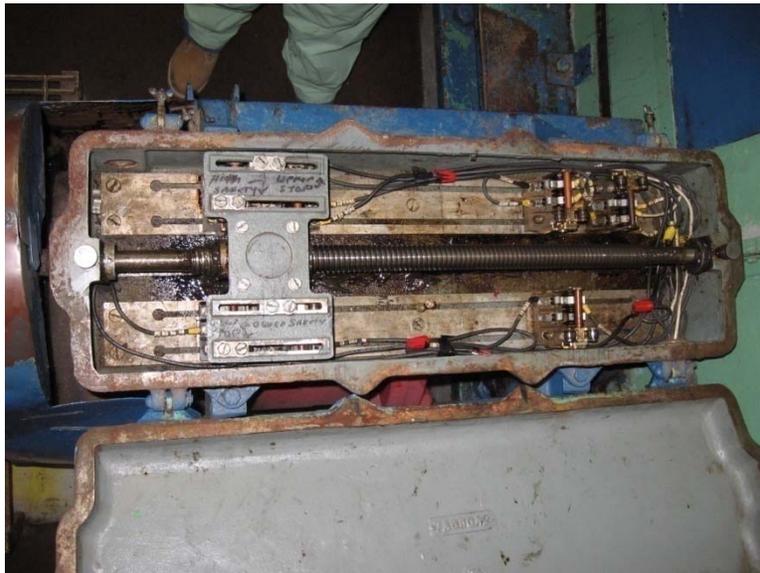
Photo E-8: The lead screw rotary cam limit switch is an obsolete model and it is very difficult to adjust

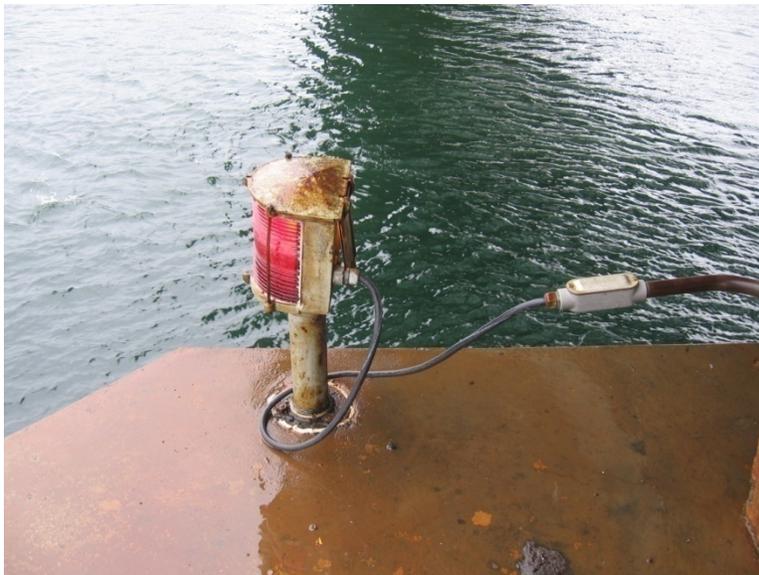
Photo E-10: Several access doors on the navigation lights are open due to missing or defective closing hardware
