Paint Evaluation Report

**COATING CONDITION ASSESSMENT
OF PORTSMOUTH-KITTERY
MEMORIAL BRIDGE
PROJECT NO. 13678-E**

November 20, 2009

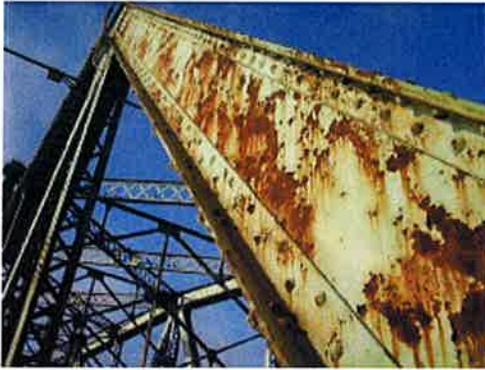
The coating system applied to the bridge steel was in poor condition. Approximately 50% corrosion was observed over the surfaces of the steel members. The above deck portions on the truss spans were in poor condition. Corrosion was observed in the splash zone as well as the upper truss members.

Photograph 1 – Top chord portal

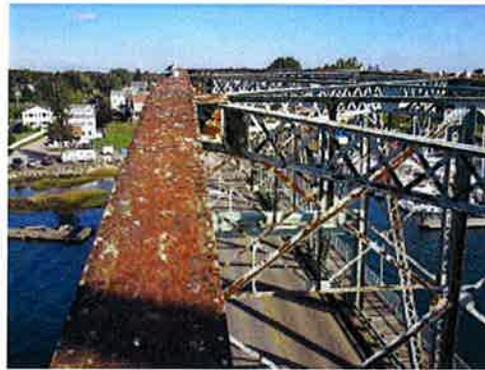
Photograph 2 – Top surface of top chord

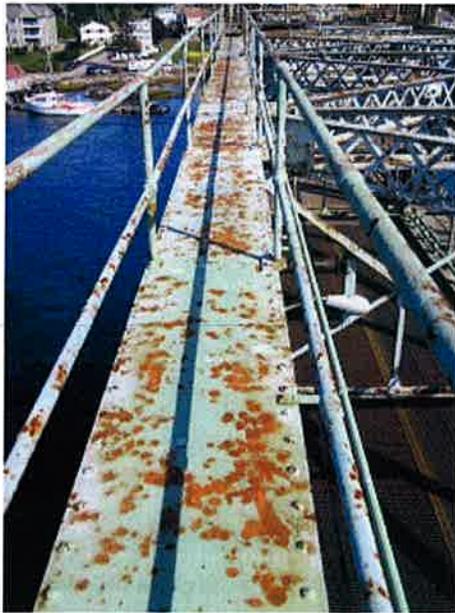
Photograph 3 – Top surface on top chord

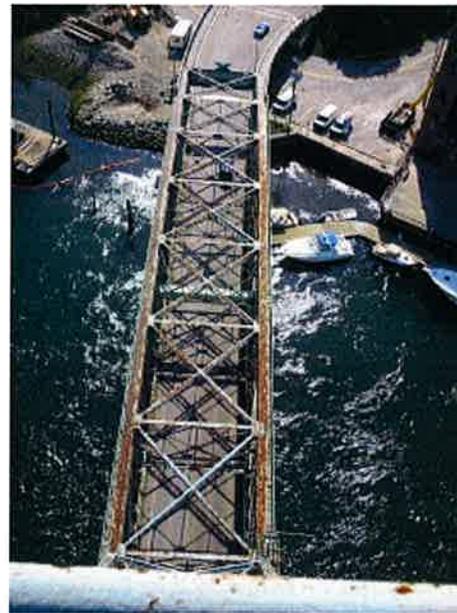
Photograph 4 – Fixed truss portion

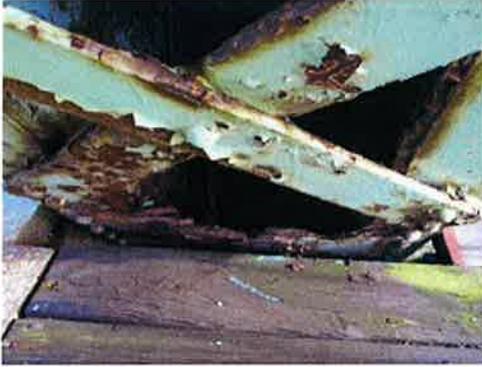
The interior portions of the box members were in poor condition, with the amount of corrosion similar to the exterior portions. Pack rust was observed at the lattice bar connections. Section loss was observed on some of the rivet heads.

Photograph 5 – Corrosion on lattice

Caulking should be considered for crevice areas, particularly those where pack rust has already formed. The caulking can be applied prior to the finish coat or after the finish coat. If applied before the finish coat, productivity can be affected as the caulking may take a few days to cure prior to painting. If applied after the finish coat, it will be visible and can pick up and retain dirt. A compromise is to apply the caulking after the finish coat and follow up with a brush coat of finish on the caulking a few days later to conceal it and to prevent dirt pick-up.

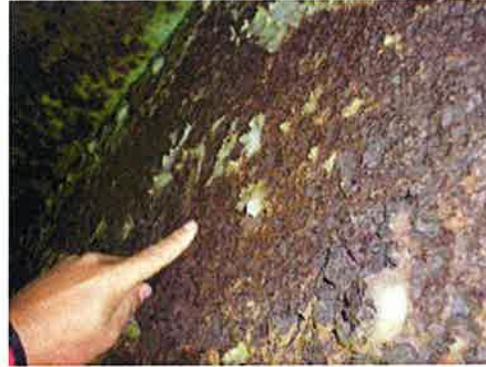
Photograph 6 – Corrosion on interior portion

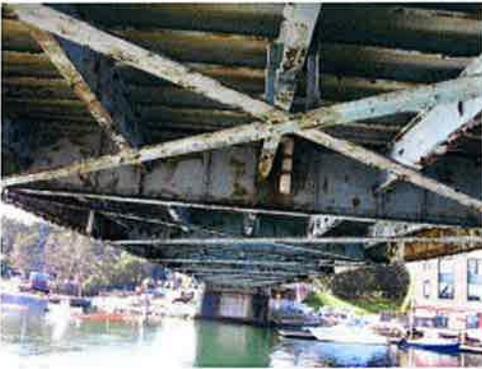
The coating on the below deck members was in poor condition. Increased corrosion levels were observed under the open grating deck portions of the lift span. Areas of pack rust, pitting, and section loss were observed on the stringers and floor beams. Section loss was observed on some of the rivet heads and stratified corrosion was noted on the bearing pin nuts.

Photograph 7 – Below deck on fixed truss

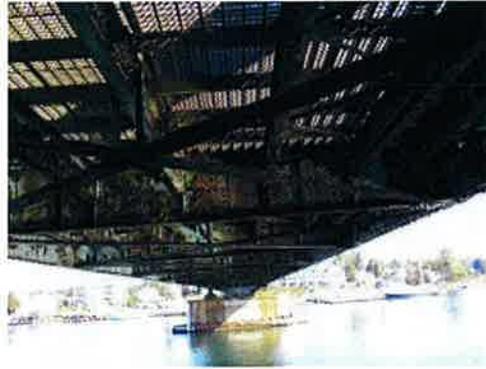
Photograph 8 – Below deck on lift span

The existing open steel bridge decking is in good condition overall. When blasting and painting members adjacent to and below the bridge decking, the preferred method is to remove the bridge decking while blasting and painting the support steel and reinstall the bridge decking when painting is complete. This allows blasting and painting for the portions of steel that would be below the bridge decking and since the bridge decking itself is in good condition it would not need to be painted. If the bridge decking remains in place, the edges will get blasted while blasting the support steel. These areas along the edges would require coating. Due to the good condition of the bridge decking, full blasting and painting of all of it would not be required.

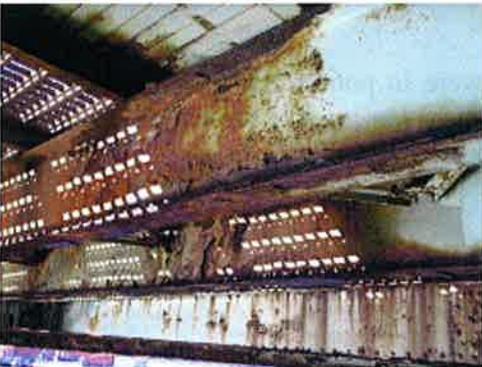
Photograph 9 – Corrosion on stringer

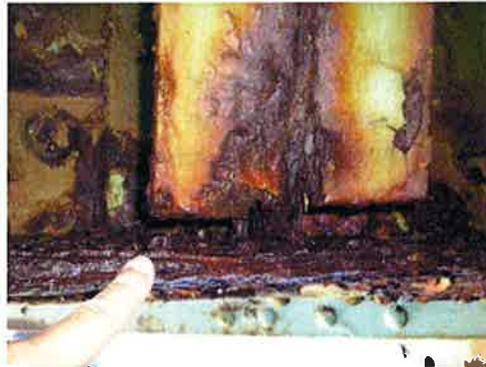
Photograph 10 – Section loss at floor beam

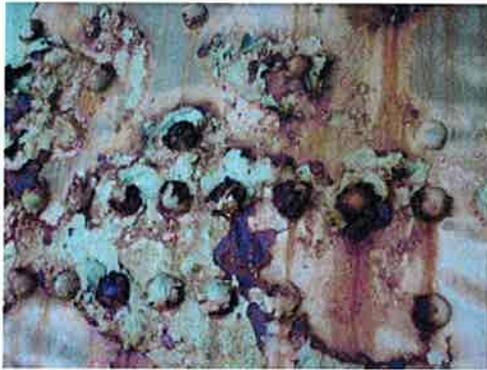
Photograph 11 – Section loss on rivets

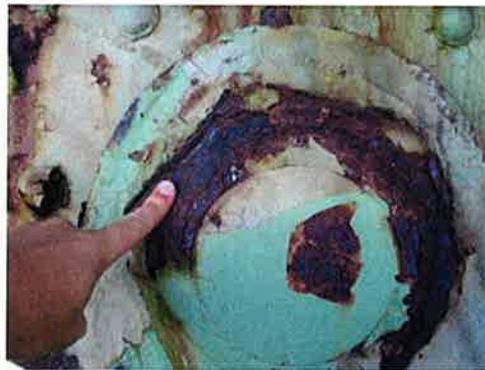
Photograph 12 – Section loss on bearing pin nut

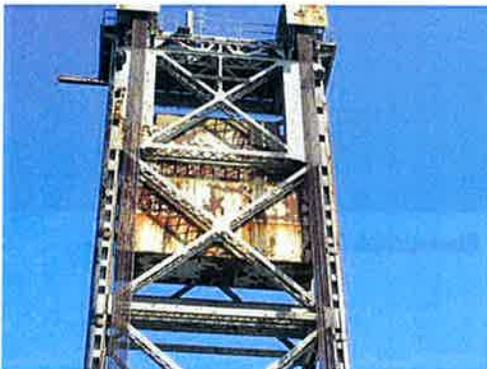
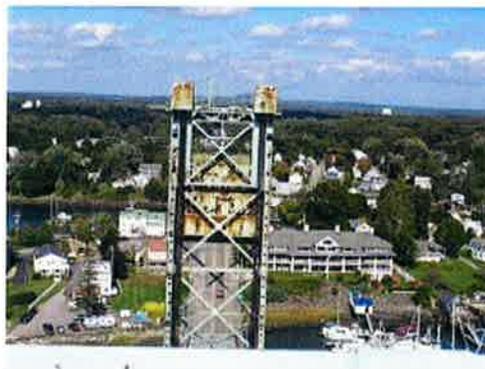
The lift span towers were in poor condition overall. Corrosion was observed on the tower members as well as the mechanical portions located on top of the towers.

Photograph 13 – Tower and counterweight

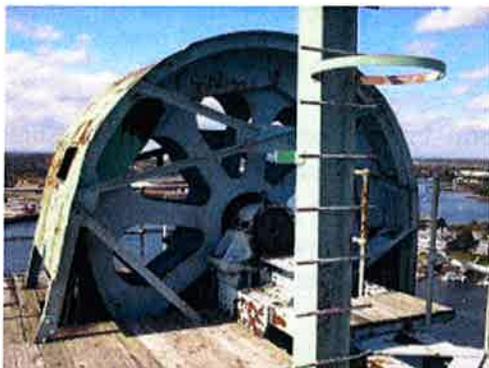
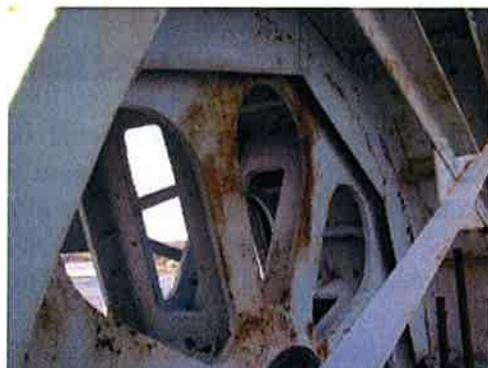
Photograph 15 – Cable sheave

The lift span operates using a cable system. Measures to protect the cables during cleaning and painting must be taken, such as wrapping cables in a sheet rubber sleeve. A non-metallic abrasive may be preferred in these areas to prevent corrosion of any stray abrasive on the cables that may work its way under the protective shield. Any inaccessible areas where abrasive blasting can not be performed should be coated with a more surface tolerant system such as epoxy mastic or calcium sulfonate alkyd.

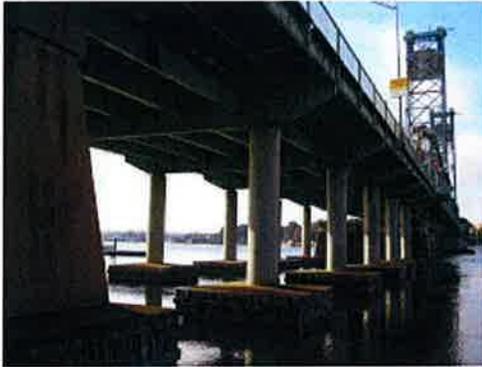
The Kittery approach spans were in poor condition overall. Corrosion was observed to be increased on the fascia members and on the steel members adjacent to the deck drains.

Photograph 17 – Kittery approach

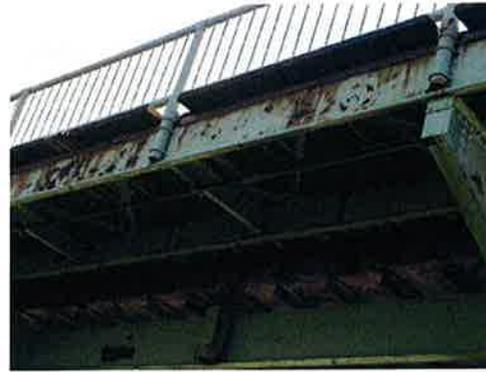
Photograph 18 – Fascia corrosion

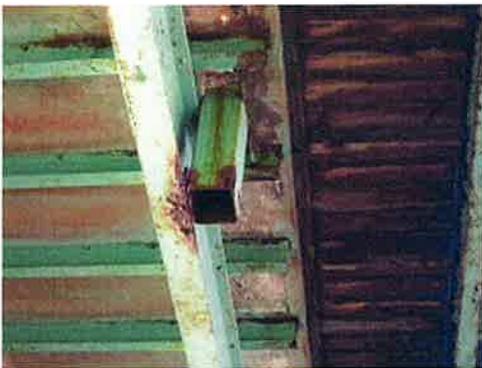
Photograph 19 – Deck drain
