### NOTES ON THE CARTLAND HOUSE LEE, NEW HAMPSHIRE

JAMES L. GARVIN

JULY 24, 2007

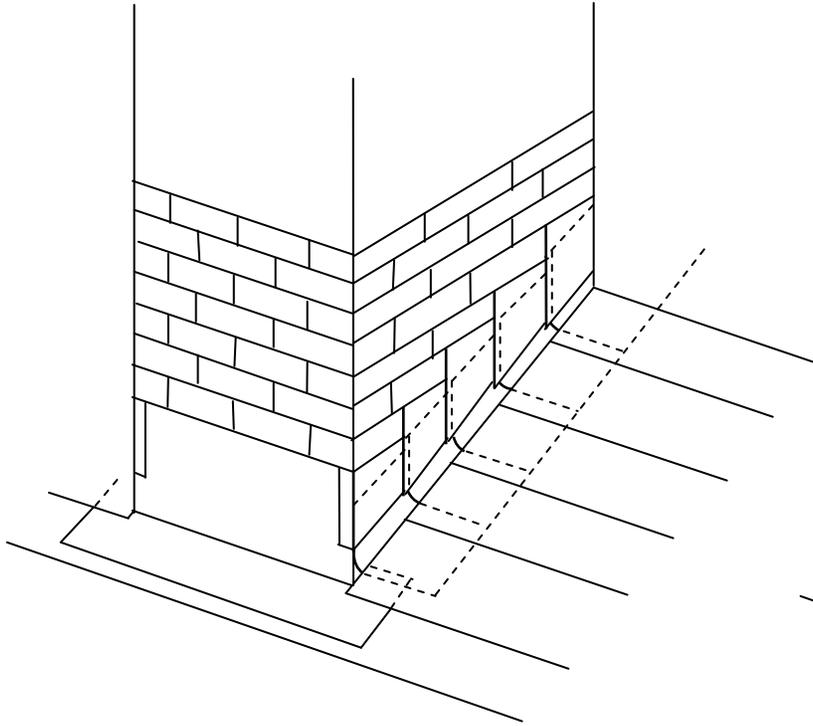
Cap and base flashing  
(good method)

The recommended method of flashing a projection through a roof is shown on the following drawing at the left. This method uses two entirely independent systems of lead flashing sheets: cap flashing and base flashing. The base flashing is placed under each course of shingles, projecting well out onto the roof, and is folded up against the side of the chimney stack. The cap flashing, mortared into the joints of the chimney, is folded down over the base flashing, covering the vertical portions of the base flashing. This method prevents water from penetrating the juncture of roof and chimney even in torrential rains. The metal that is traditionally used in such flashing is sheet lead, which is soft, pliable, long-lived, and poses no health hazard in its metallic form. Copper or lead-coated copper may be substituted, but are stiffer and somewhat harder to use.

An advantage of this double system of flashing is that it permits the wooden frame of the roof to shrink, swell, and flex independently of the almost immovable chimney without straining the flashing metal. This provides longer life for the flashing and makes the reinstallation of the flashing system easier and more resistant to leakage during periodic re-roofing of the house.

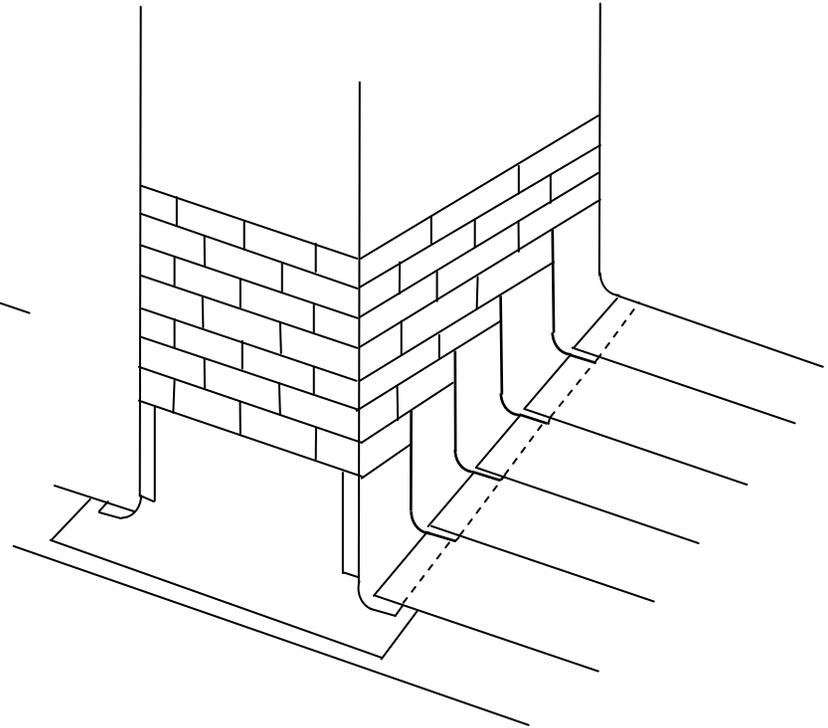
When the chimney was rebuilt above the roof, the lead flashing that is mortared into the joints of the chimney appears to have been simply turned down, folded out onto the roof, and interlaced with the shingles, as shown on the following drawing at the right. This method of flashing, although common, is often a cause of leaks around the sides of a chimney.

Flashing tucked under shingles  
(poorer method)

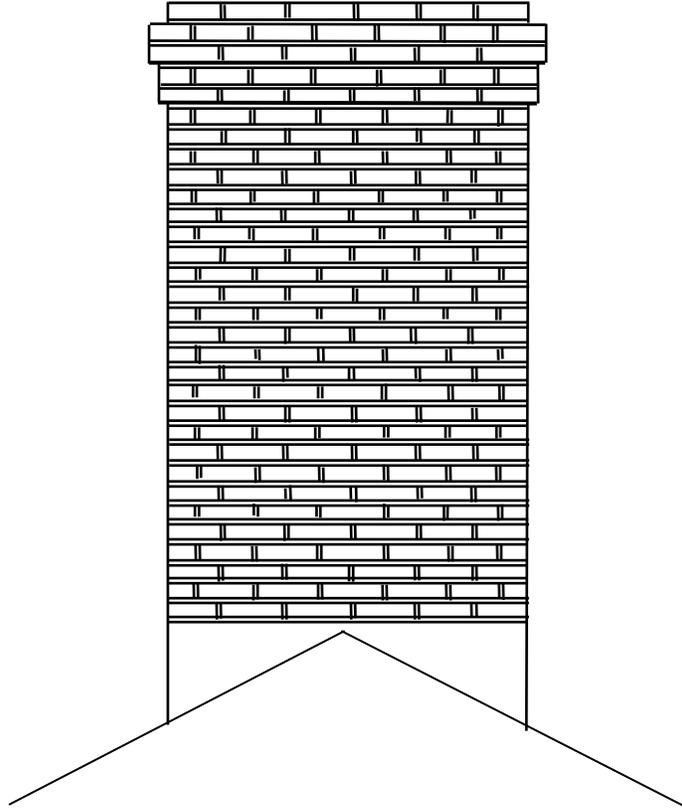
Typical chimney cap:  
two courses corbeled out about  $\frac{1}{2}$  inch,  
two more courses corbeled out  $\frac{1}{2}$  inch beyond that,  
and one cap course brought back into  
alignment with the main stack,  
usually covered with a "wash" of  
mortar or cement to shed water.

Both the northern and southern chimneys currently terminate with no corbelled brick cap. While such caps are purely ornamental and serve no functional purpose, the rebuilding of the northern chimney above the roof would provide an opportunity to consider recreating the type of cap that would probably have been employed. Such a cap may be documented in older photographs. A typical cap of this type is shown in the second drawing, below.
