REPORT ON THE LOCOMOTIVE ROUNDHOUSES WEST LEBANON (WESTBORO), NEW HAMPSHIRE

JAMES L. GARVIN

APRIL 12, 2000

This report records an inspection of the engine houses, sand house, bunk house, and other structures made on April 7, 2000. Present were James L. Garvin of the New Hampshire Division of Historical Resources and Joyce McKay of the Bureau of Environment, New Hampshire Department of Transportation. The purpose of the inspection was to develop initial familiarity with the railroad structures owned by the State of New Hampshire at the West Lebanon (Westboro) railroad yards, and especially to assess the structural system and general condition of the locomotive roundhouses.

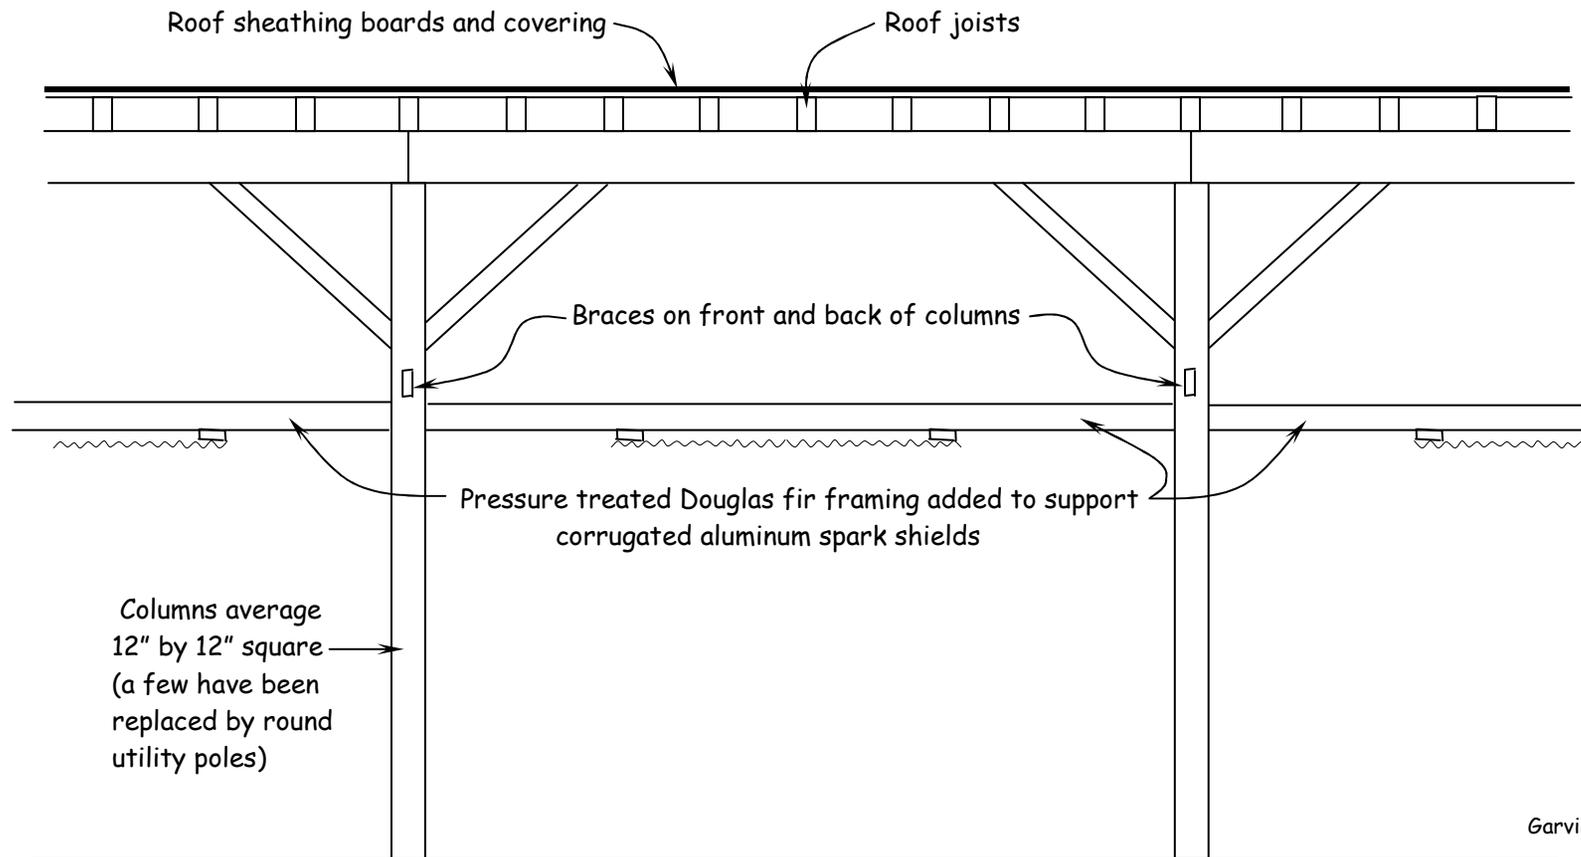
Lateral Section through Roundhouse Bays, Showing Structural Bents (Not to Scale)

In both buildings, the roof membranes are supported by a series of wooden bents. These are composed of columns, measuring about twelve inches square and supported on concrete footings, which are arranged at the intersections of concentric circles and radii, both having their centers on the pivot of the former turntable (see attached floor plan). The tops of the columns support wooden beams that follow the lines of the concentric circles. These beams are further supported by diagonal wooden braces that rise from the four sides of the columns (see lateral section drawing, attached). The beams support wooden roof joists that follow the lines of radii. The joists are covered with wooden sheathing boards. The roof covering was not examined, but may be presumed to be some form of asphalt-impregnated roll roofing.
