REPORT ON THE OLD PARSONAGE NEWINGTON, NEW HAMPSHIRE

JAMES L. GARVIN
OCTOBER 22, 1999

This report is based on an inspection of the Old Parsonage on the afternoon of October 19, 1999. The purpose of the inspection was to evaluate the general condition of the building, with particular reference to moisture conditions and exterior paint failure.

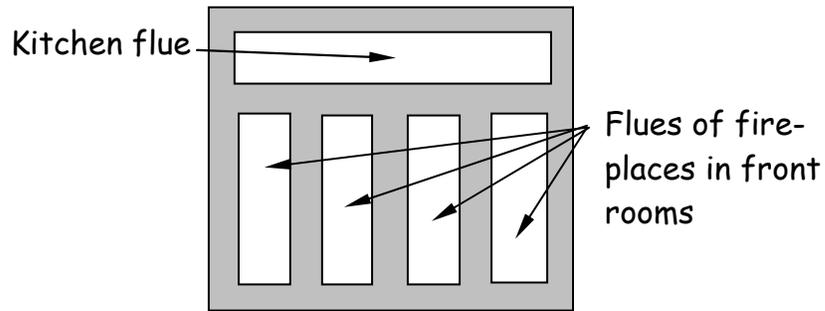
Most of the moisture that is saturating much of the chimney stack is almost certainly entering the chimney through the open flues that are exposed to rain. As seen from the top, the flue arrangement of a central chimney like that of the parsonage looks like this:

Exposed to the sky, these open flues absorb a great deal of water. When the chimney is inactive, as at the parsonage, this moisture saturates much of the masonry. The only means by which the chimney rids itself of the water is through evaporation in warm, dry weather. This evaporation is aided by convection currents that naturally rise through the chimney flues and help to carry off the moisture.

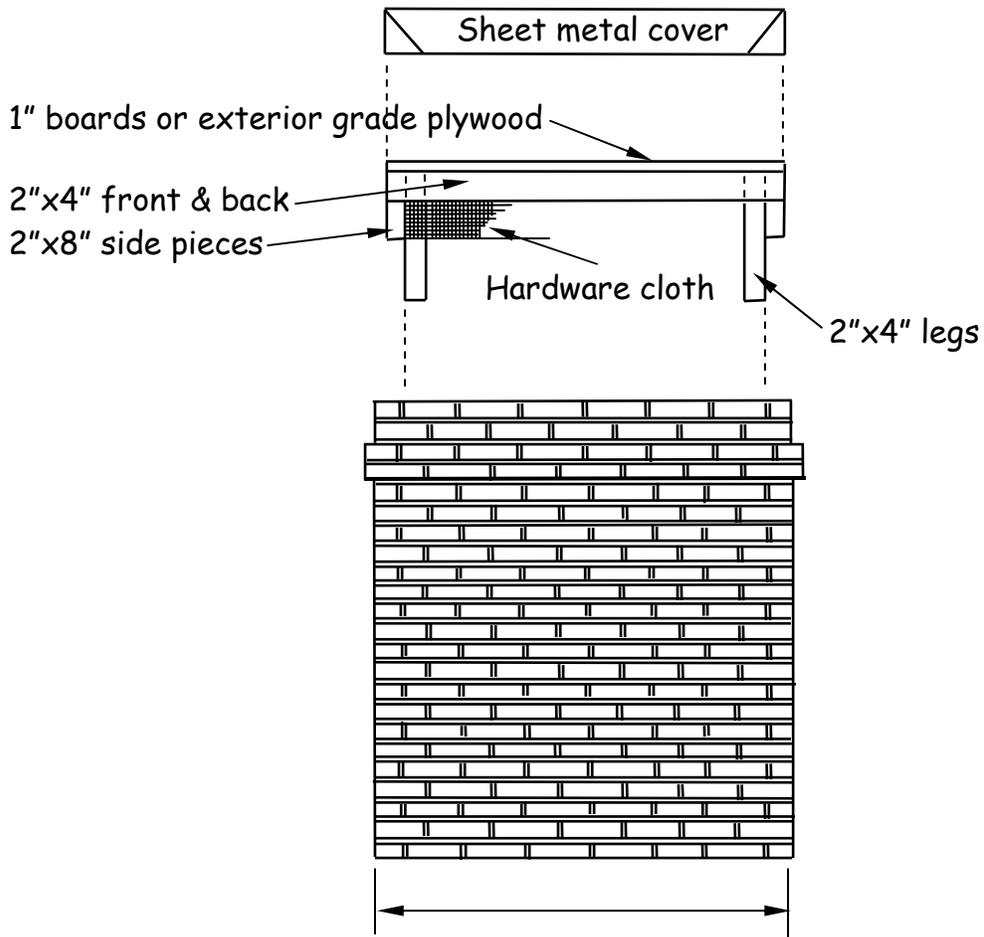
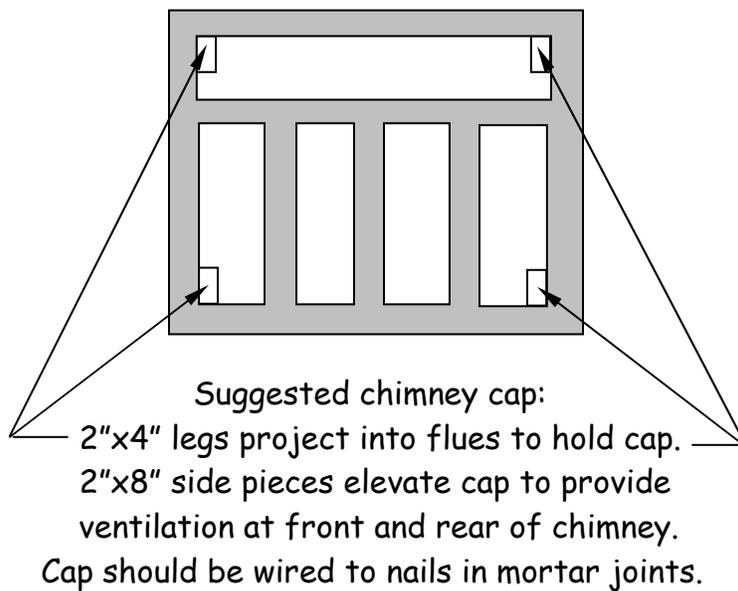
Chimney measures approximately
5'-0" wide by 4'-0" deep

The drawing on the following page offers one suggestion (of many that might be devised) for a low-profile wooden cap that would exclude rain and snow from the flues while permitting some degree of air flow upward through the chimney flues.

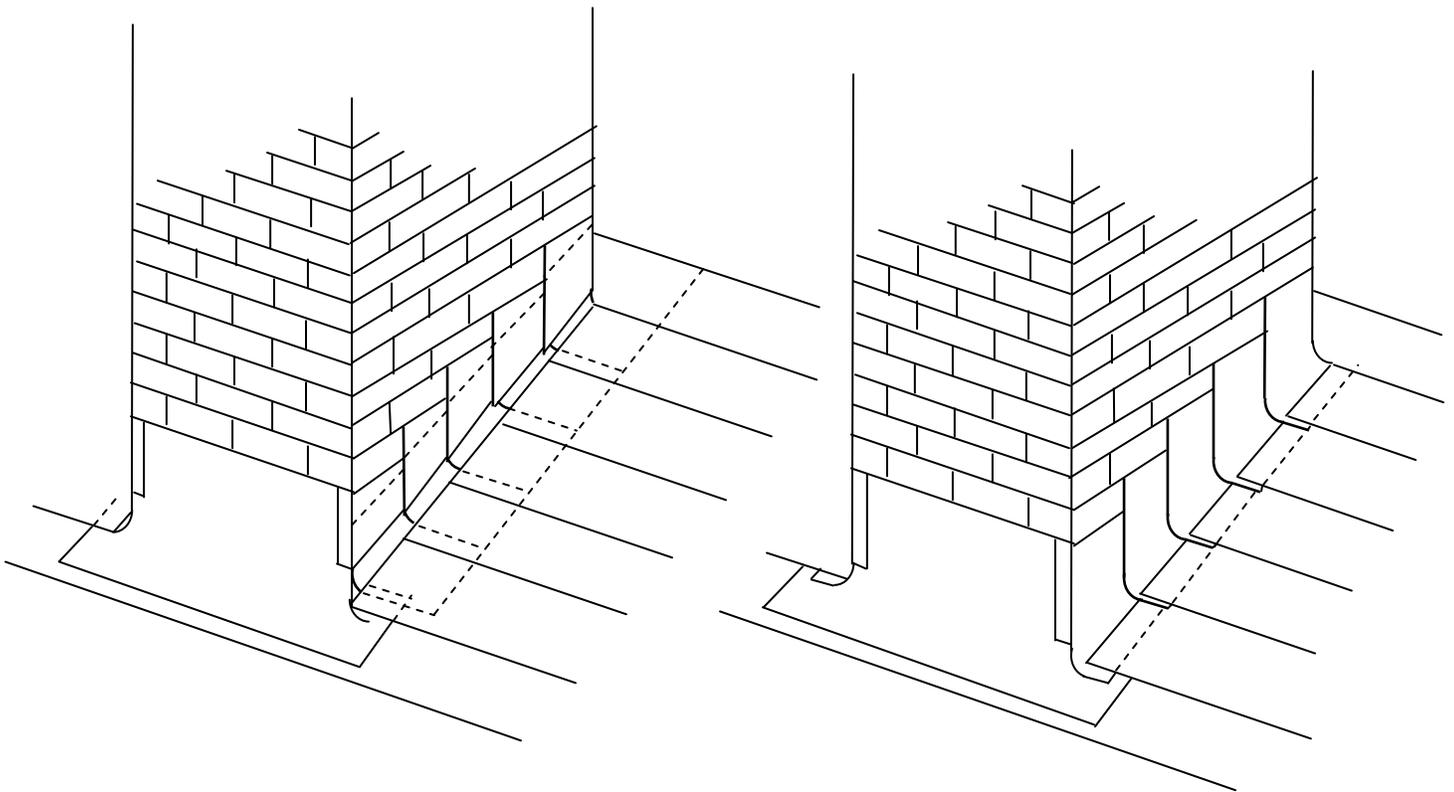
Another possible means by which water may be saturating the chimney is through the flashing at the juncture of the chimney and roof. When the present roof of asphalt shingles was installed, the lead flashing that is mortared into the joints of the chimney was simply turned down, folded out onto the roof, and interlaced with the shingles, as shown below at the right. This method of flashing, although common, is often a cause of leaks around the sides of a chimney.

Cap and base flashing
The best practice

Flashing tucked under shingles
Common but poor practice

The recommended method of flashing a projection through a roof is shown below at the left. This method uses two entirely independent systems of lead flashing sheets: cap flashing and base flashing. The base flashing is placed under each course of shingles, projecting well out onto the roof, and is folded up against the side of the chimney stack. The cap flashing, mortared into the joints of the chimney, is folded down over the base flashing, covering the vertical portions of the base flashing. This method prevents water from penetrating the juncture of roof and chimney even in torrential rains.

be prudent to require a double system of cap and base flashing when the roof is re-shingled in the future.
