**New Hampshire Bureau of Turnpikes
Renewal and Replacement Program Assessment**

May 16, 2017

Re: 2017 Renewal and Replacement Program Assessment

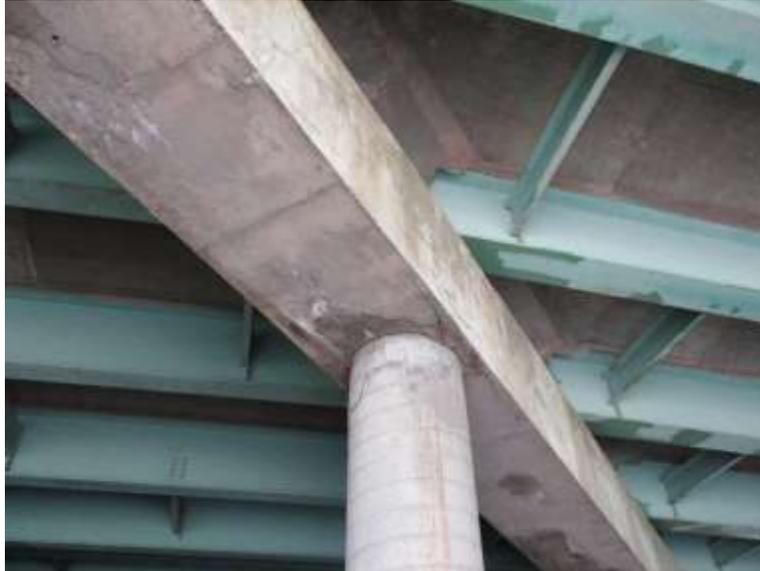
The preceding observations show the direct correlation between the condition of bridge deck to the condition of the remaining structure below and generally the condition of the bridge relative to its age. In most cases, leaking bridge joint and deteriorated concrete bridge decks result in deterioration to the portions of the girders, bearings and substructure below the joints and deteriorated concrete decks respectively. Figure 2 shows an example of pier cracking, and Figure 3 displays abutment spalling.

Figure 2: Central Turnpike SB over Hall Street 201/096 – S. Pier Cracking on Cap and Column

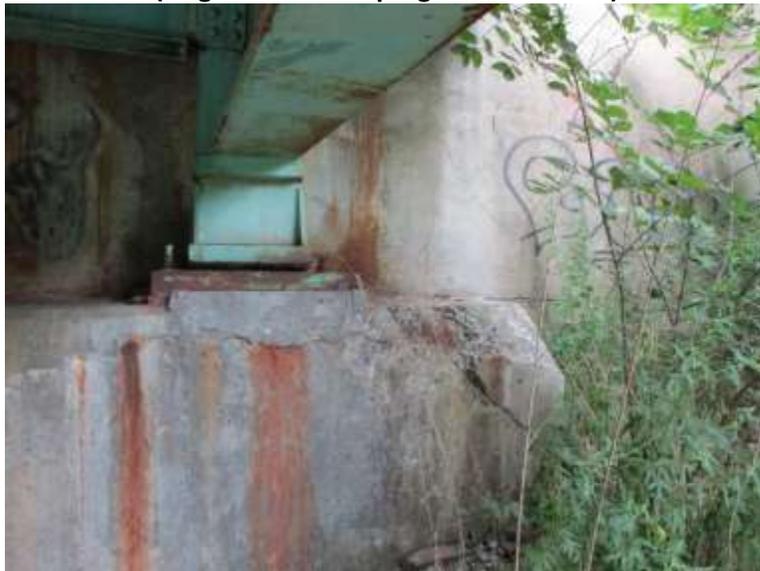
Figure 3: Spaulding Turnpike SB over Cocheco River 105/133 – North Abutment Spalling (targeted for R&R program in FY 2021)

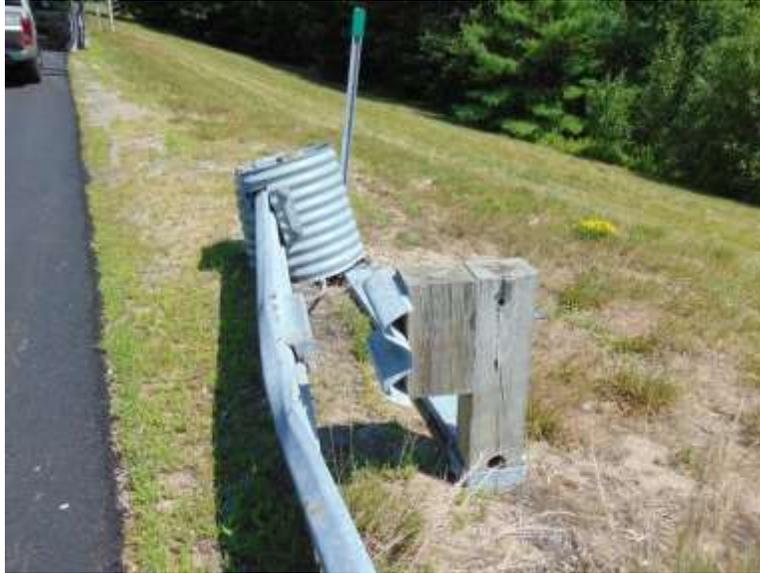
Figure 4: Spaulding Turnpike – Post Sheared

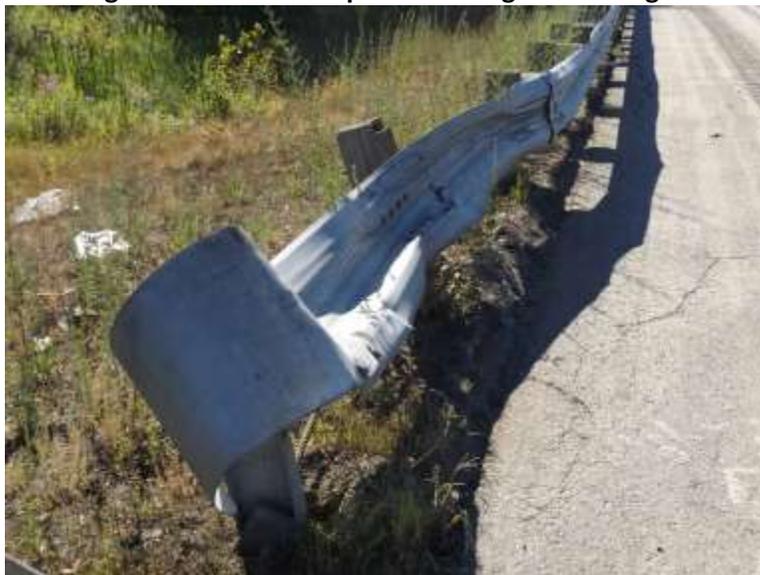
Figure 5: Central Turnpike – Trailing End Damaged

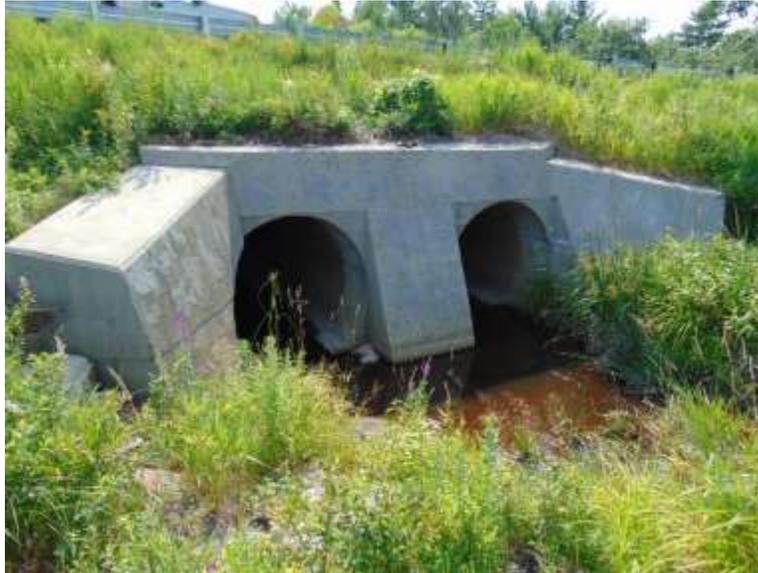
The culverts that are over 36" in diameter are in good condition, and the Bureau has done well in maintaining them through previous projects. The Bureau performed drainage repair along the Central Turnpike in FY 2015. The Bureau intends to repair additional drainage on the turnpike system in FY 2022, and the future focus will be on culverts that are less than 36".

Figure 6: Spaulding Turnpike – Twin Pipes

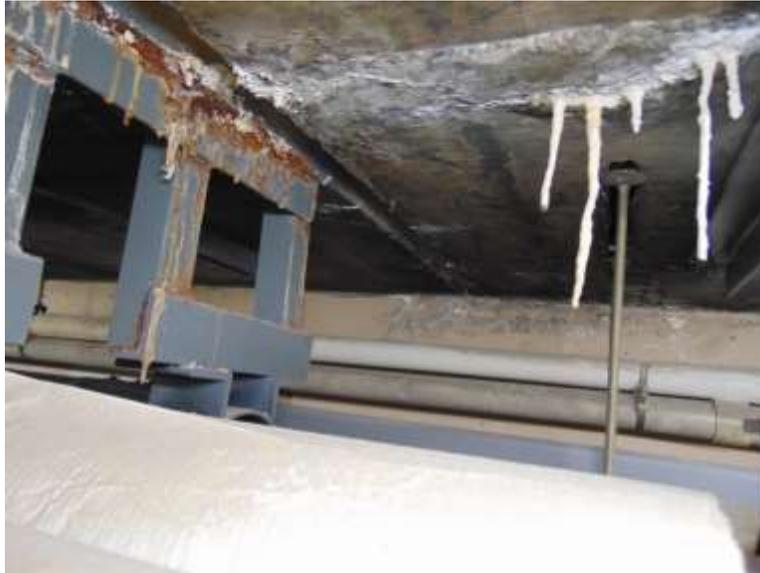
At the Hampton mainline plaza, tunnel leakage and salt penetration was observed at most of the pipe joints and at the duct openings for the toll booths. Most of the calcium hydroxide deposits have been removed but the cracks in the tunnel ceiling need to be addressed.

Figure 7: Hampton Mainline Toll – Tunnel Ceiling Leak

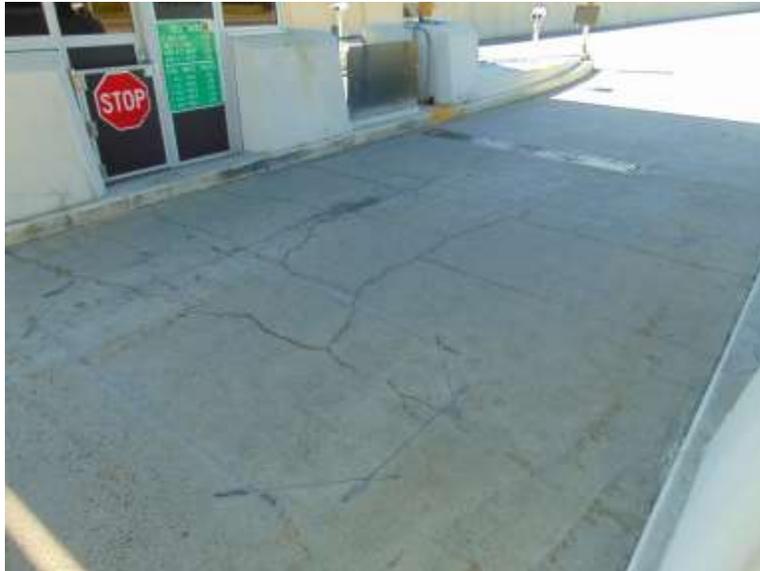
Figure 8: Hampton Mainline Toll – Cracked Lane with Differential Settlement

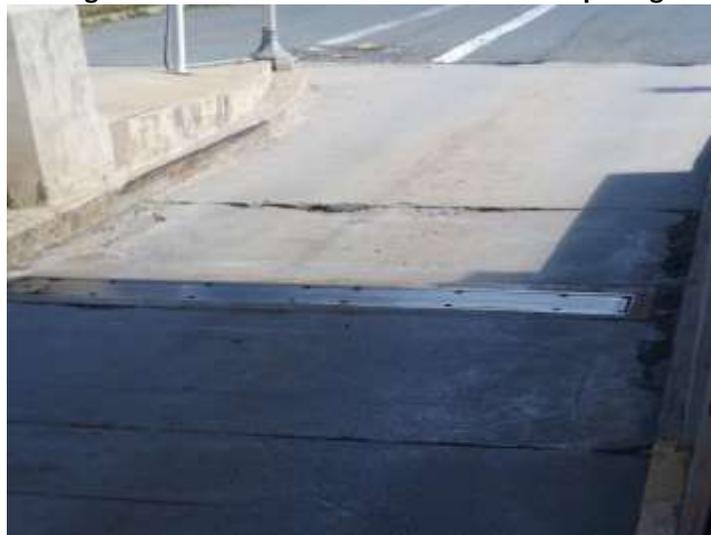
Figure 9: Exit 10 NB Merrimack Side Toll - Spalling

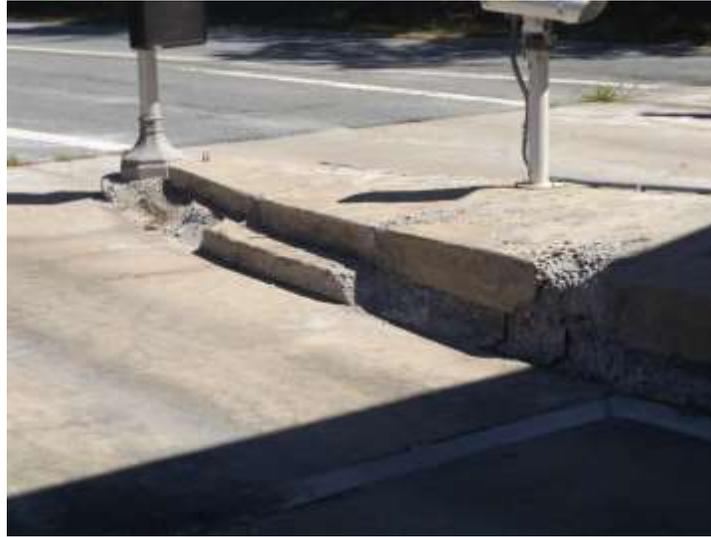
The Southbound Ramp Plaza at Exit 11 is in generally good condition. The coin lane is in fair condition, and the bumpers have heavy spalling with exposed reinforcement. This plaza slab was repaired in 2015 by Bridge Maintenance, however more repairs are needed to the plaza as a whole. This toll plaza should be targeted as an early FY 2022 repair. Traffic congestion is another issue during peak periods and should be addressed if possible under a Capital Program project.

Figure 10: Exit 11 NB Merrimack Side Toll – Spalling with Exposed Rebar

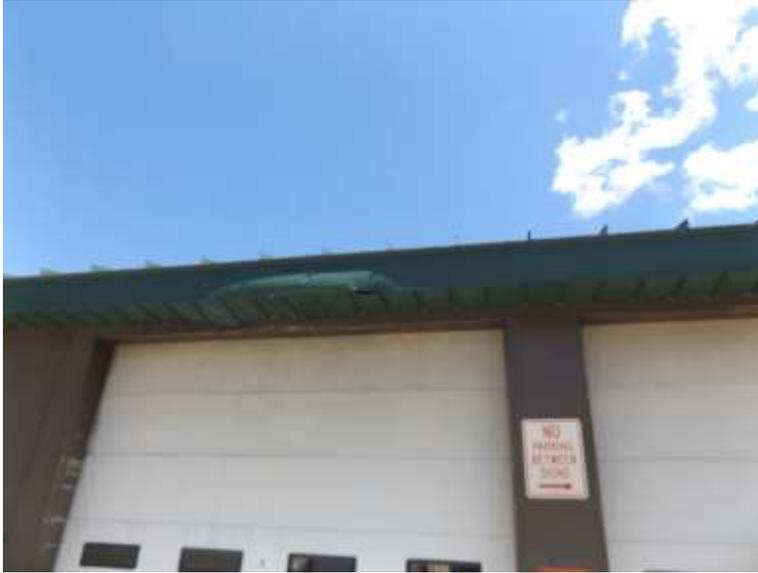
Figure 11: Nashua Maintenance Facility – Minor Soffit Damage

A new metal roof is being installed to replace the existing shingle roof installed in 1999 under this R&R program. The Nashua DMV/E-ZPass WIC facility is also getting a roof replacement. The existing shingle roof installed in 1999 is proposed to be replaced with a metal roof.

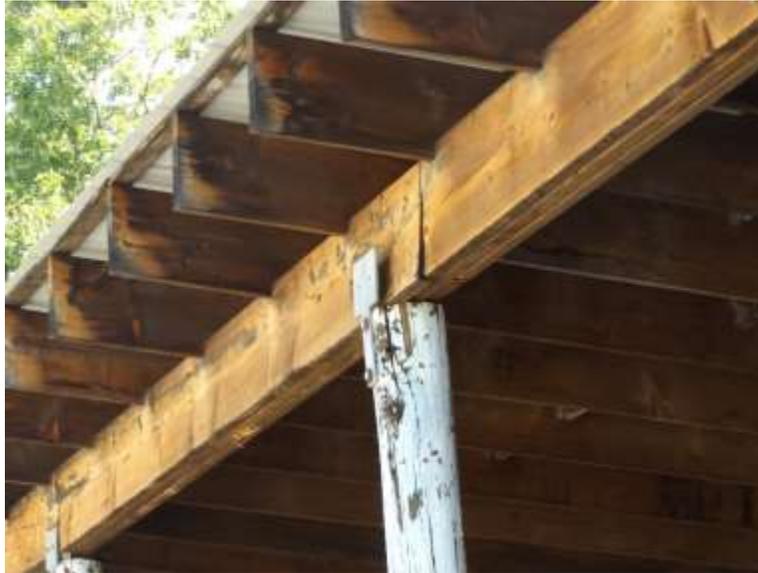
The Hookset facility is in generally good condition. The site pavement is in generally good condition but has some cracking and delamination, and the access road has some transverse cracks. The main garage is in generally good condition but there is minor cracking in the interior floors, the exterior door frame is cracking and has minor deterioration and rust at the base, and the exterior walls require caulking in spot locations. The 9-bay lean-to roof requires repair as a header beam post connector has failed (see Figure 12). The 5-bay storage building exterior door and walls are in fair condition, and the drainage is flowing against the building. The 7-bay exterior walls exhibit minor siding rot at the base and the end panels need to be secured; the exterior door is in fair condition. The exterior of the 40' x 80' storage building and 2-bay garage with lean-to were in generally good to very good condition. The 2-bay garage with lean-to, the 7-bay, and the 40' x 80' storage building were locked, and therefore their interiors were not inspected.

Figure 12: Hooksett Maintenance Facility – Nine Bay Lean-To – Failed Connection
