Barron Mountain
Rock Reinforcement Evaluation – Phase II
I-93, Woodstock, New Hampshire
Validation of NDT Results for Condition Assessment of
Rock Reinforcements

1. Report No. FHWA-NH-RD-14282C		2. Gov. Acc. No.	3. Recipient's Catalog No.
4. Title and Subtitle PHASE II: CONDITION ASSESSMENT AND EVALUATION OF ROCK REINFORCEMENT ALONG I-93 BARRON MOUNTAIN ROCK CUT, WOODSTOCK, NH Validation of NDT Results for Condition Assessment of Rock Reinforcements		5. Report Date SEPTEMBER, 2005

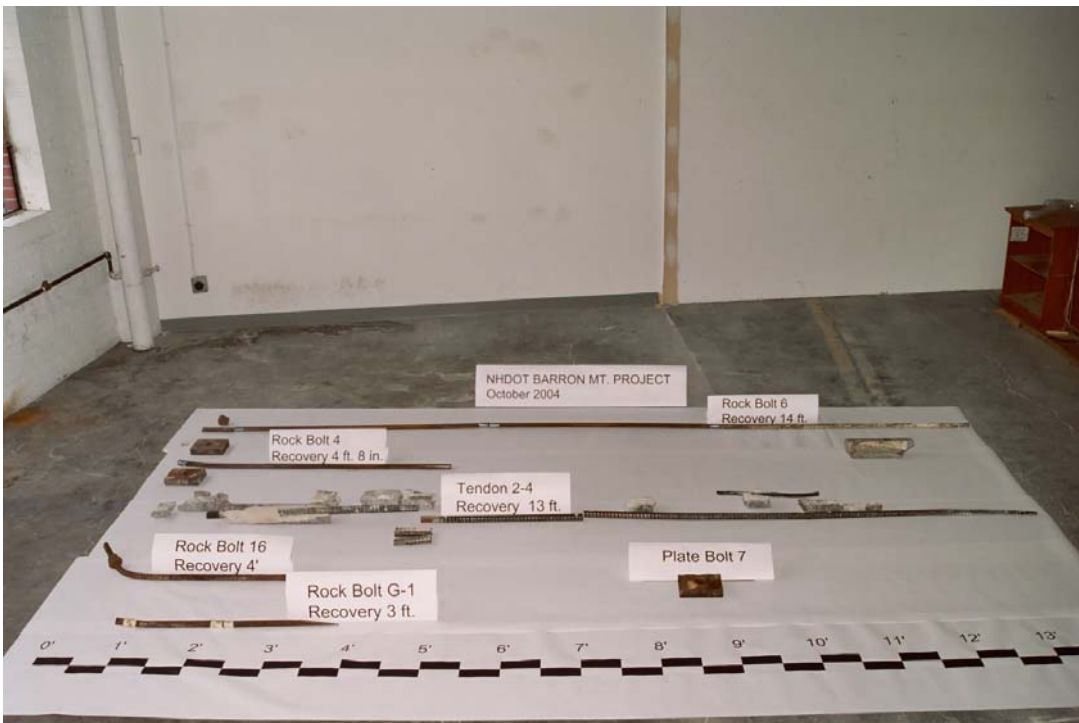
Figure 6. Recovered Rock Reinforcement

Figure 6 shows the lengths and overview of the reinforcement samples obtained from the site. Appendix VI describes detailed observations obtained for each sample including general observations, measurements of remaining diameter, observations of pitting corrosion and hardness measurements where grout samples were available.

Bolt #G-8 (MMCE # 6) was retrieved in its entirety for a sample length of approximately fourteen feet. The bolt appears to be in relatively good condition although some pitting corrosion is evident. Grout was observed at intermittent locations beginning four feet from the distal end of the bolt. The resin grout appeared to provide poor coverage to the bar, and for most of the area that had traces of grout, the thickness was not sufficient to cover the bar deformations. The best coverage was observed in an area about 4.25 inches in length, covering one side within the last foot of the bar. This poor coverage probably accounted for the bond breaking and the bolt spinning as the contractor removed the nut and bearing plate prior to overcoring. Bolt #G8 (MMCE #6) was installed at an upwards angle and slid out of the hole after over coring to a depth of approximately eight feet. Bolts #G30 (MMCE #7) and #G19 (MMCE #4) were also loosened as the nut was turned. Bolt # G30 (MMCE #7) could not be pulled from the hole with 70 kips, and the bolt was not over cored.

An approximately four feet long sample of MMCE #G19 (MMCE #4) was retrieved. The sample was terminated after a coupling was encountered. This sample exhibited more corrosion compared to # G8 (MMCE #6) and loss of cross section was observed at a location near the backside of the bearing plate. A three feet long section of Bolt # G-1 was also retrieved and similar loss of cross section was observed near the bearing plate.

Bolt – MMCE #16 was not overcored, but was recovered when JANOD fractured and removed the loose block of rock it supported with the Boulder Buster™. The Boulder Buster™ is a small charge that usually fractures the rock surrounding a rock bolt when detonated, causing the loosened rock to slide toward the base of the rock cut. In this case the rock bolt was severed and removed with the block. The fracture surface at the end of the approximately four feet long sample of bolt – MMCE #16 was sent to a metallurgy lab for analysis as described in the “Results” Section. Loss of section was also observed near the backside of the anchor plate.

Tendon – MMCE #2-4 was over cored to a depth of approximately twelve feet. The proximal end of the sample included an approximately two feet long annulus of grout adhered to the reinforcement and surrounding rock core. Cement grout was exposed on one side of the sample as the core barrel wandered slightly off track. The exposed grout measured about 5 by 20 inches in plan. Recorded observations include hardness, absorption and bulk specific gravity. The steel reinforcement appeared to be in excellent condition and the surface did not appear to have been subject to corrosion. A coupling was encountered at a depth of approximately five feet from the rock face.

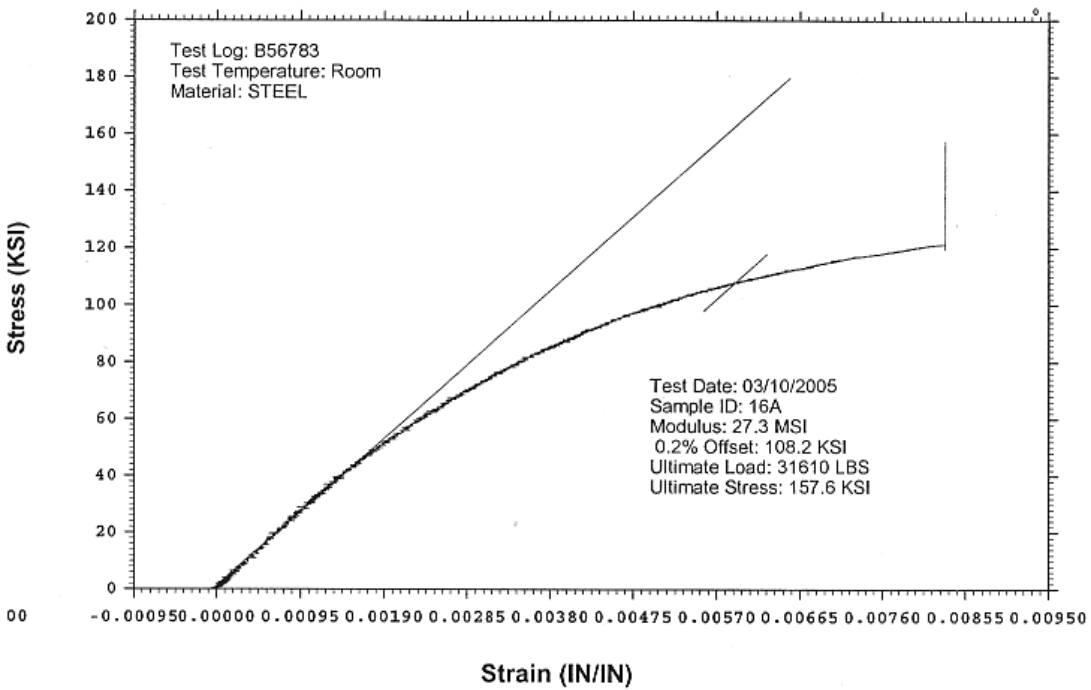
(b) Response of Specimen from Sample MMCE #16

The fracture initiation site is identified near the perimeter of the cross section. Inclusions, one high in chlorine, were found near the fracture initiation site; and, in another area of the fracture surface, intergranular separation cracks were found. Inclusions with higher concentrations of silicon, aluminum, with lesser amounts of sodium, potassium and calcium were also observed in areas away from the fracture initiation site.

A corrosive environment, e.g. one high in chlorine may have been the cause of the intergranular separation cracks. We postulate that fracture initiated at the inclusions, and propagated by fast fracture through the structure, which was already weakened by intergranular corrosion.
