BUREAU OF MATERIALS & RESEARCH

EXPERIMENTAL FEATURE 2004-2 and 2005-2 Poly-Carb Flexogrid Bridge Deck Overlay System and Stirling Lloyd SafeTrack HW

Interim Report

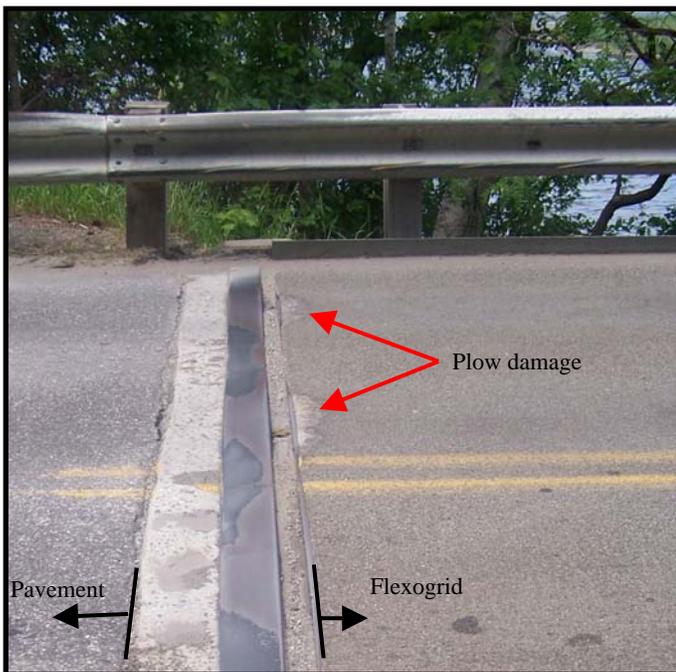
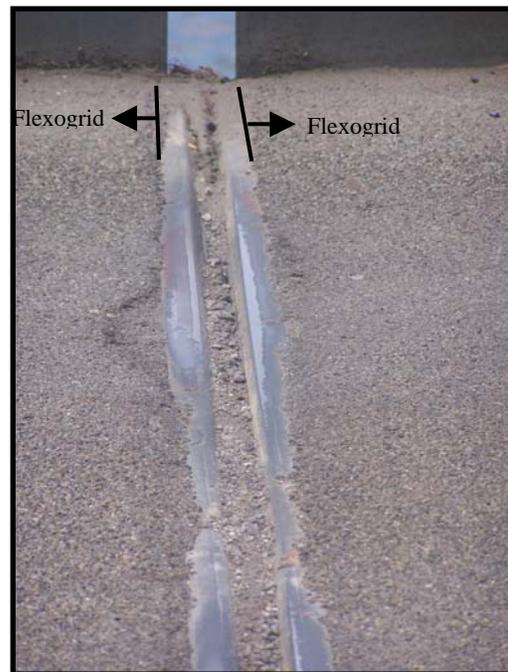
Although it appears that the majority of the Poly-Carb product is still in good condition, there has been some snowplow damage at expansion joints (see Figures 6 and 7). This loss is most likely due to the fact that the overlay was not inset at the joint but rather was applied over the existing deck surface and onto the top surface of the expansion joint as shown in Figure 8. Efforts were made to prevent the overlay material from running into the opening of the expansion joint. This left an unprotected edge of overlay material that could be snagged by snowplows.

Figure 6 – Flexogrid snowplow damage

Figure 7 – Flexogrid snowplow damage

Visual inspection of the Poly-Carb Mark-163 Flexogrid Bridge Deck Overlay system revealed that the overlay has been damaged by snowplows at the expansion joints. The overlay was placed over the edge of the expansion joint as shown in Figure 8, and it is expected that this type of damage could be avoided by inseting the overlay at the expansion joint to obtain a flush finish.

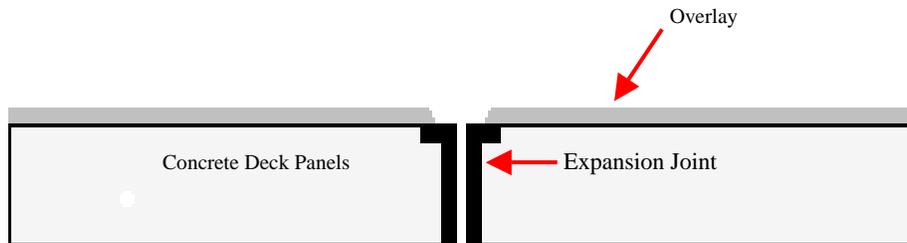
Figure 8 – Overlay at expansion joint

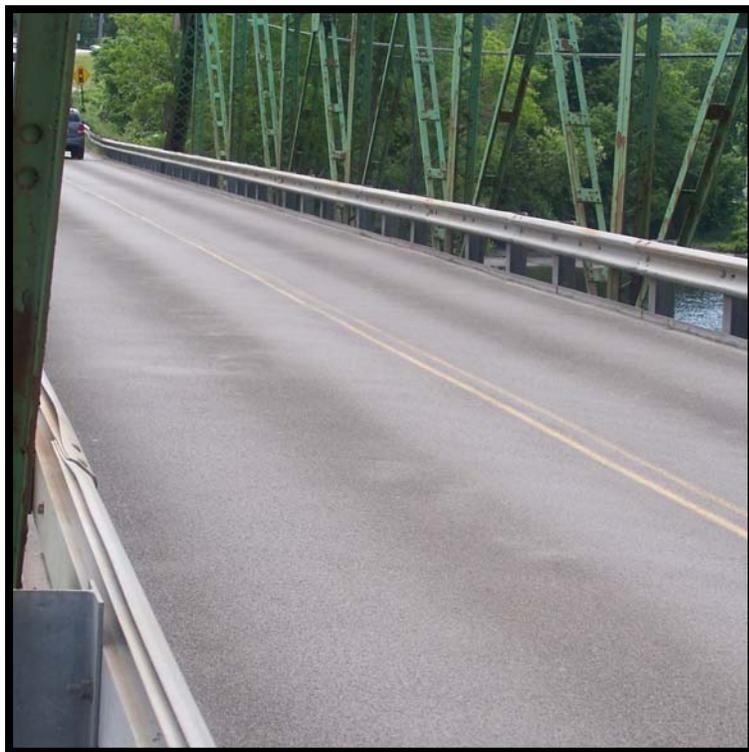
Between expansion joints, the overlay aggregate shows some signs of wear in that the surface appears to be discolored in the wheel paths (see Figure 9). Although this wear may indicate some loss of skid resistance, it did not seem to be slippery under foot or when subjected to normal driving actions.

Figure 9 – Flexogrid aggregate wear in wheel path

The surface of the Poly-Carb overlay shows some wear in the wheel paths, but no apparent loss of traction.

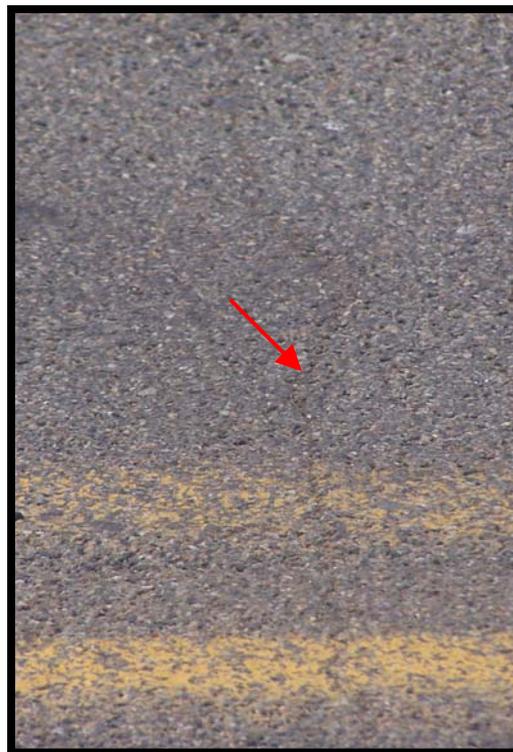
Figure 10 – Flexogrid cracking

There are several fine cracks in the overlay as shown in Figure 10. It is not clear if these cracks are reflective cracks over the joints in the bridge deck system, but this may be the case. The cracks are tight and there does not appear to be any loss of overlay material at these locations.

Fine, widely spaced cracks were observed in the overlay. These cracks may have reflected up from the joints between precast deck slabs. An underside inspection is recommended to determine if the cracks align with the panel joints or if any leakage is occurring in these areas.

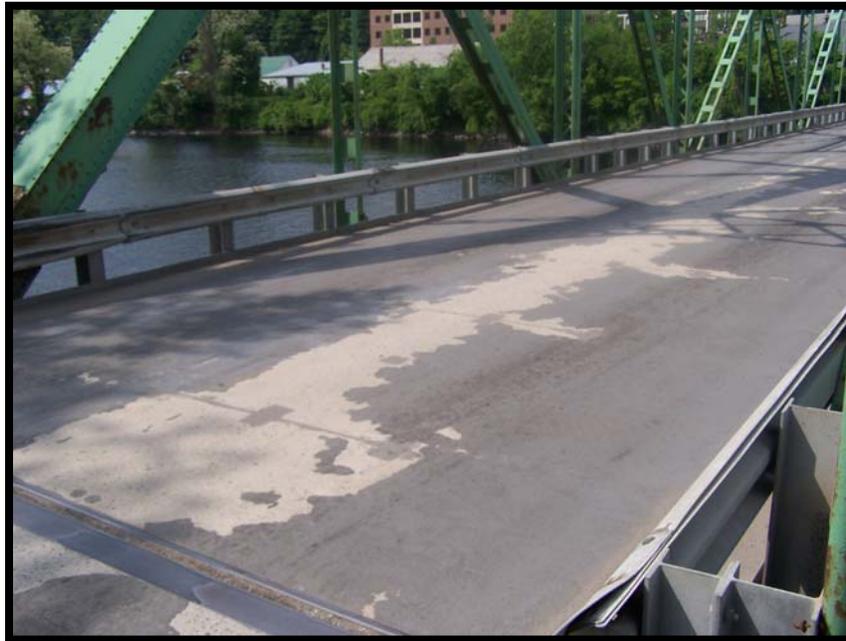
The Stirling Lloyd product has experienced significant areas of bond failure. Areas of missing overlay material can be seen in Figure 11. Pieces of separated overlay were lying in the roadway as seen in Figure 12.

Figure 11 - Failed Stirling Lloyd overlay

It is readily apparent that the Stirling Lloyd Safe Track HW overlay has suffered significant loss of bond with the underlying deck surface. Significant areas of overlay are missing and loose pieces of overlay material are evident.

As this product has not fared well over the 2-year evaluation period, further use is not recommended.

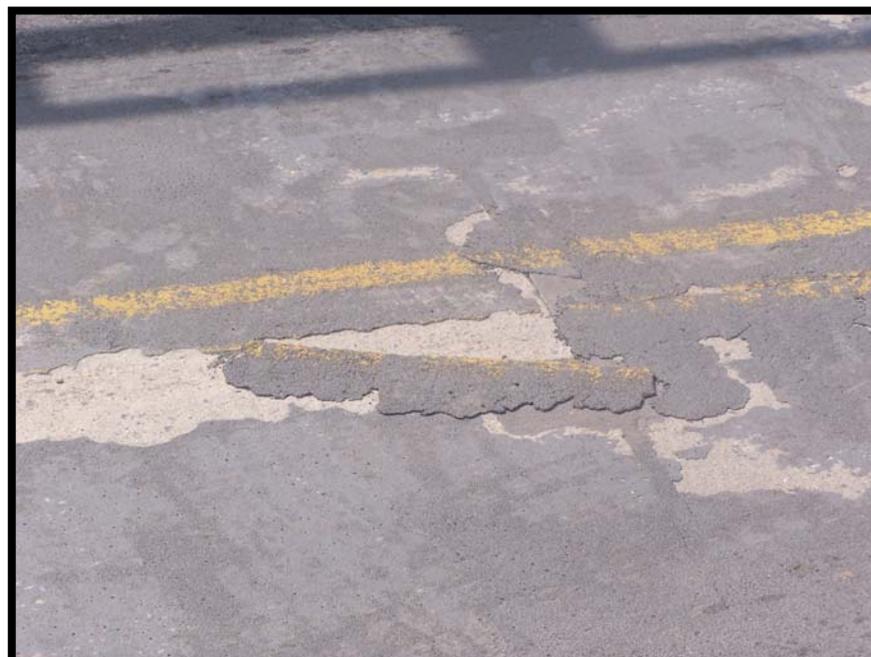
In addition, it appears that the remaining overlay material has suffered damage from wear. There are areas where aggregate and binder appear to have been scraped off as indicated by the light colored areas of the overlay surface in Figure 12.

Figure 12 – Separated pieces of Stirling Lloyd

Areas of the remaining overlay have experienced significant wear, presumably from traffic and/or snowplows. These areas appear to have lost aggregate and a portion of the binder material.
