US Route 2 (Rogers' Rangers) Bridge -Lancaster, NH – Guildhall, VT
NHDOT Bridge No. 111/129 – Project No. 16155
Inspection Photos

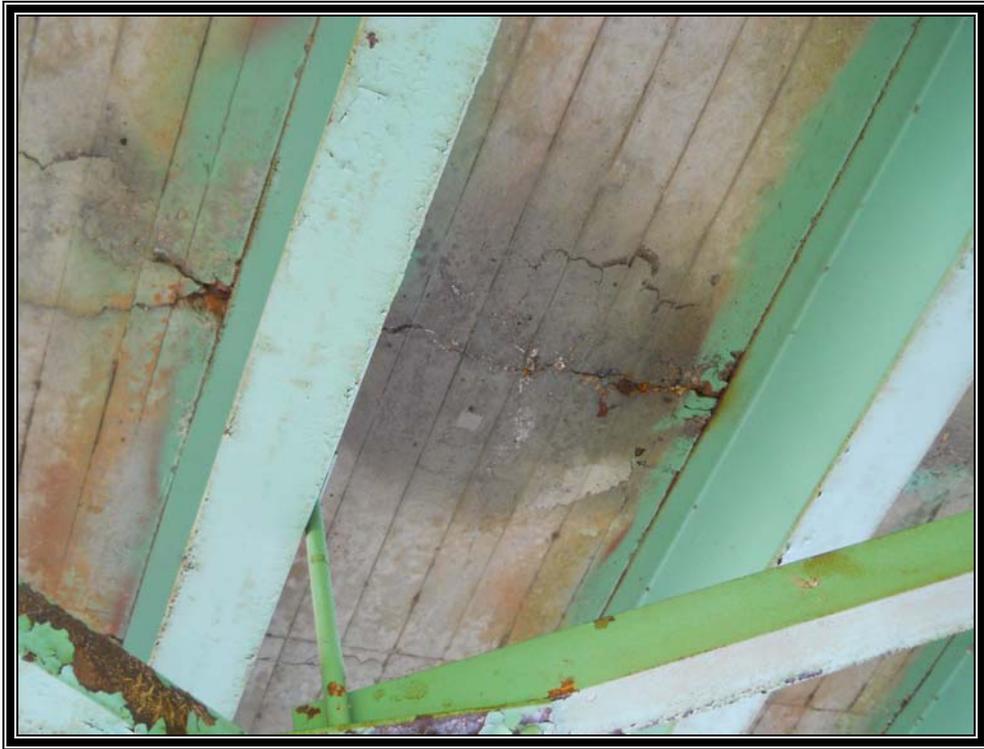
Photo 1: Deck Soffit Transverse Cracking

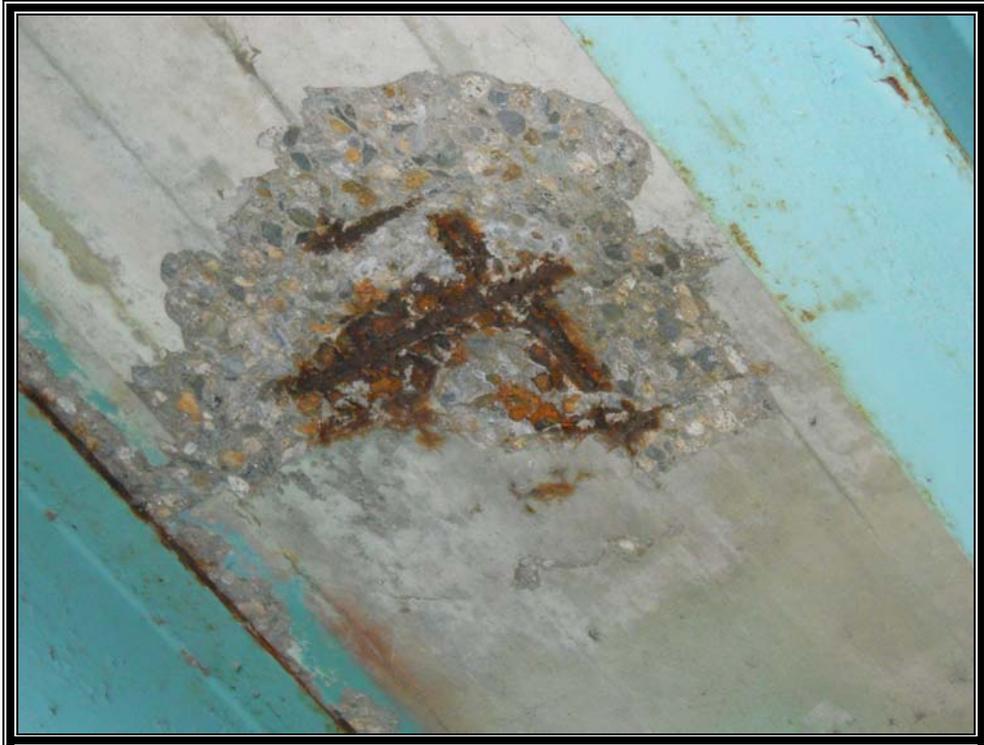
Photo 2: Typical Deck Soffit Concrete Spall

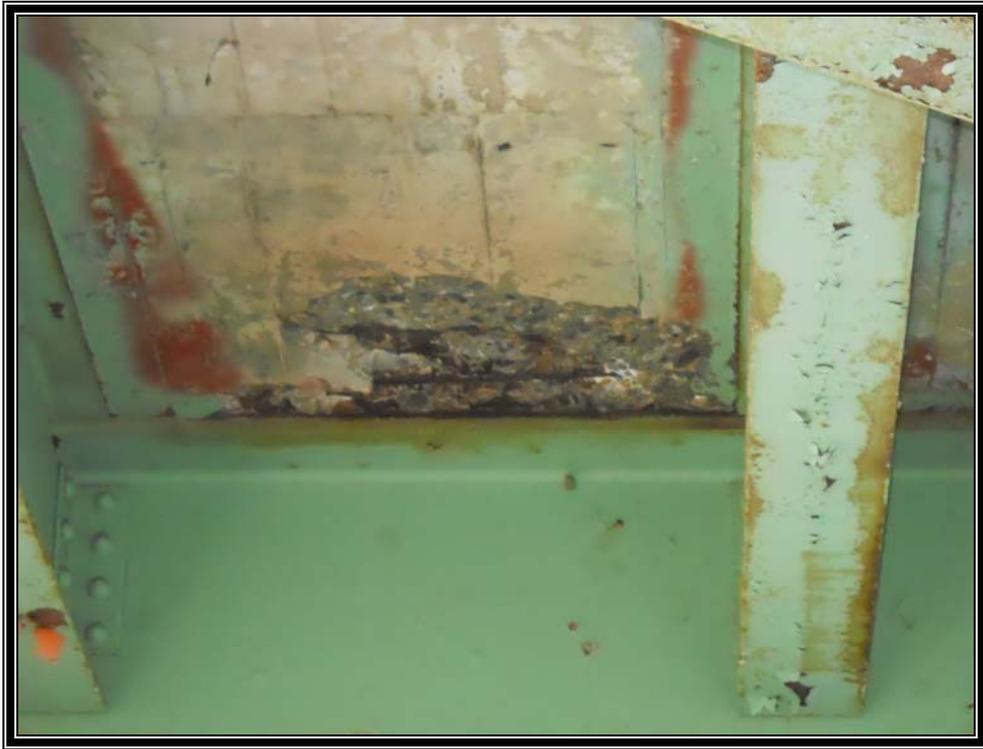
Photo 3: Deck Concrete Spall at Intermediate Floorbeam

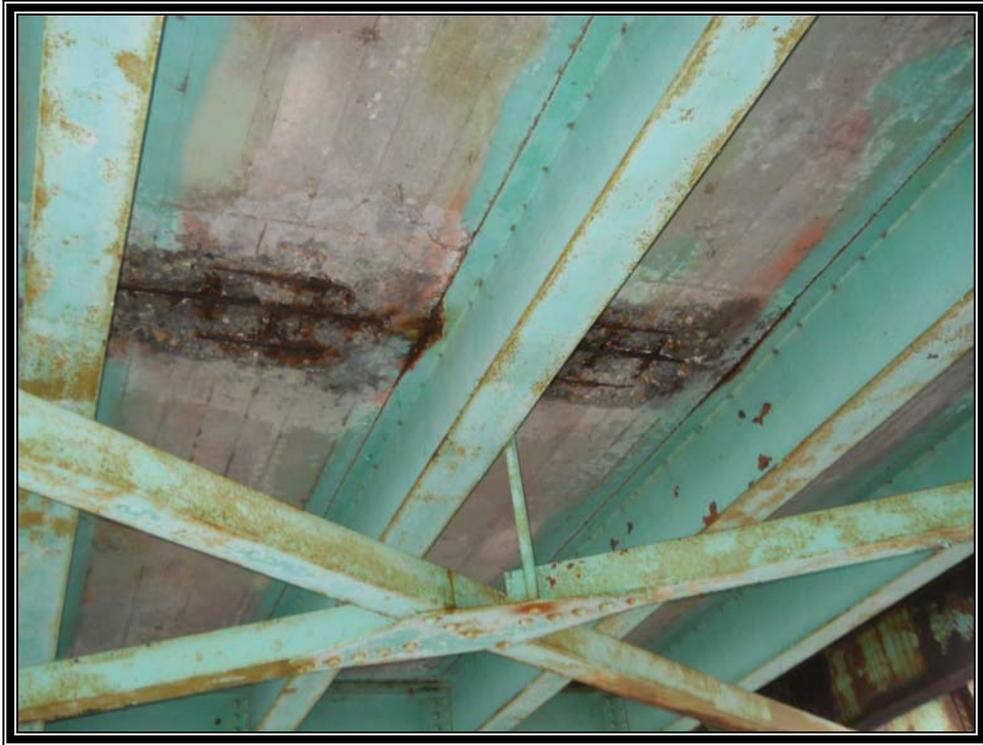
Photo 4: Deck Concrete Spall with Exposed Reinforcement and Moisture

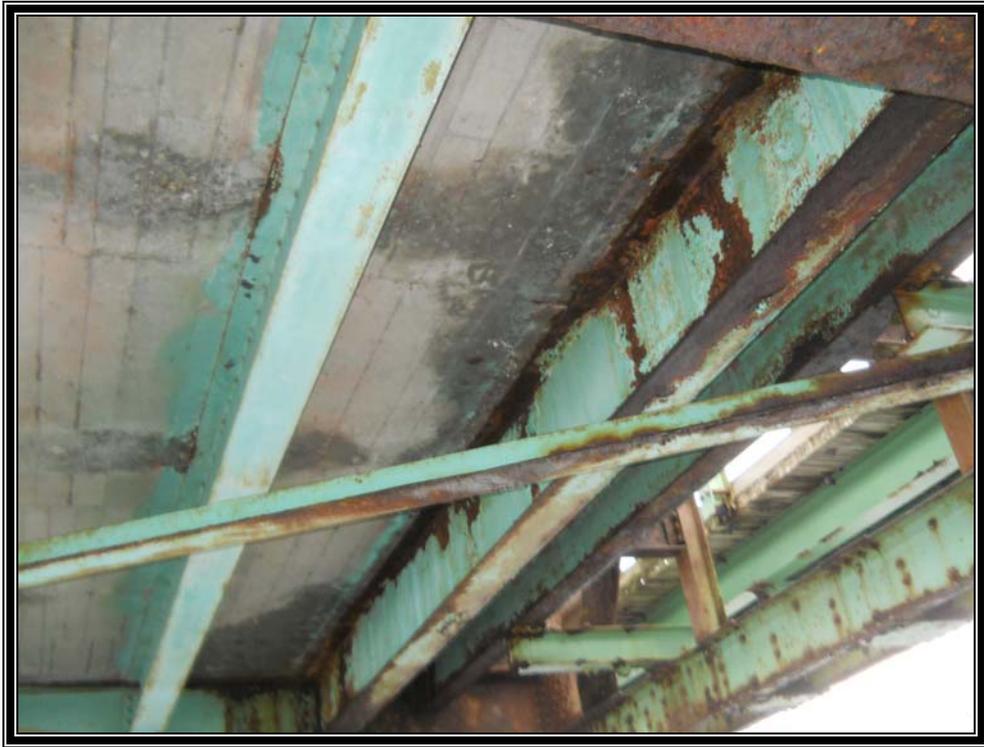
Photo 5: Wet Deck Soffit

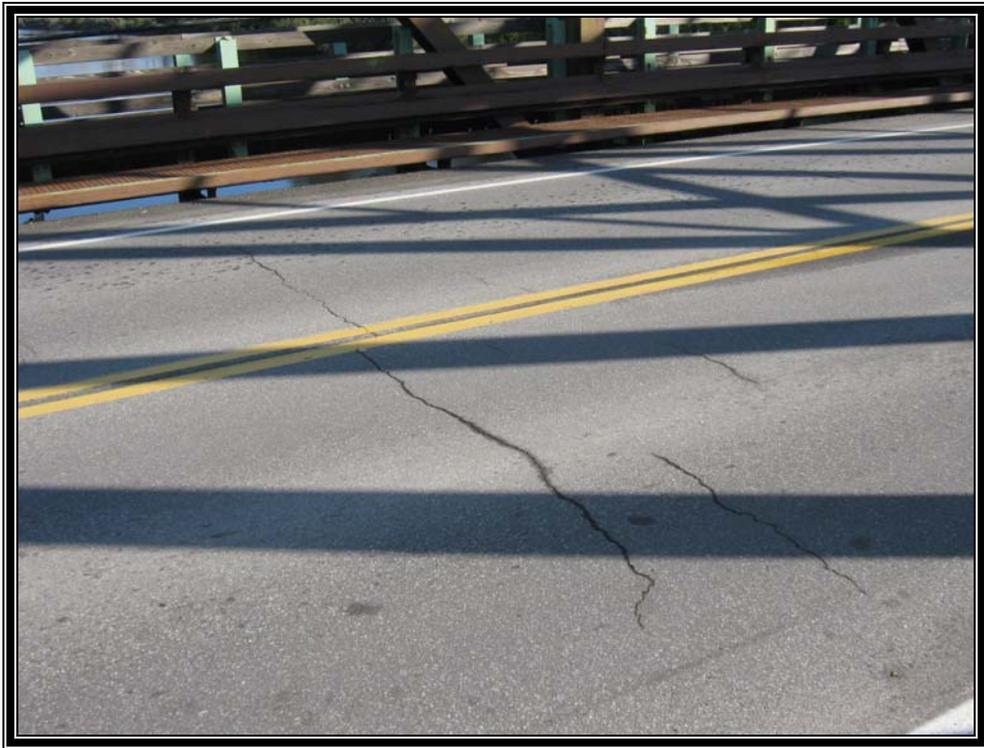
Photo 6: Typical Wearing Surface Transverse Cracking

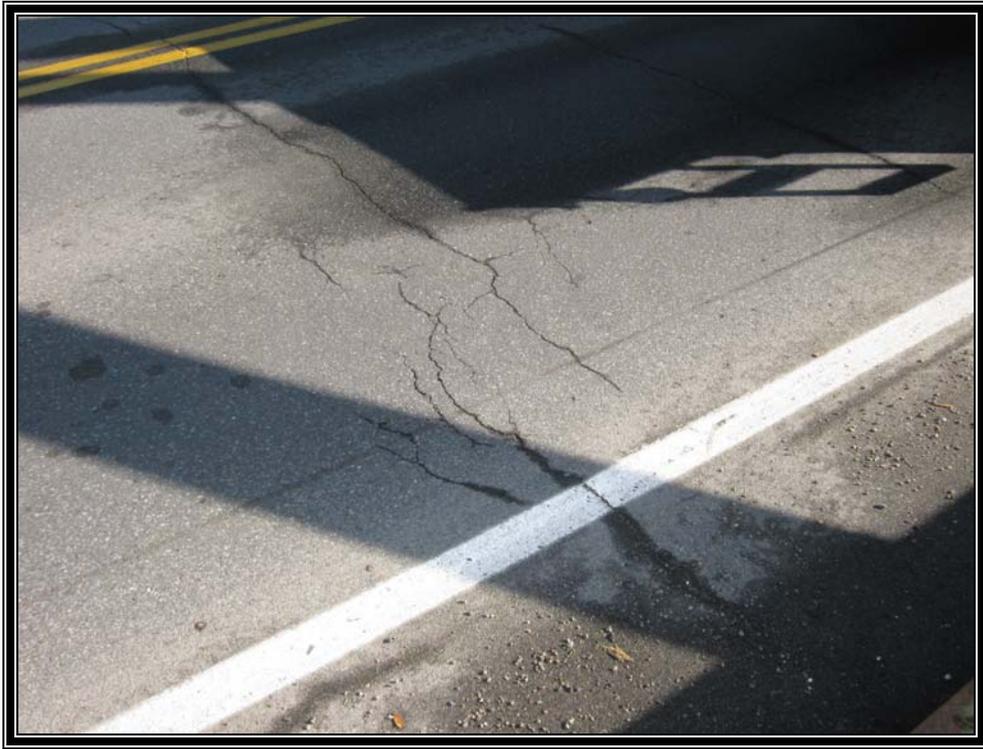
Photo 7: Wearing Surface Cracking

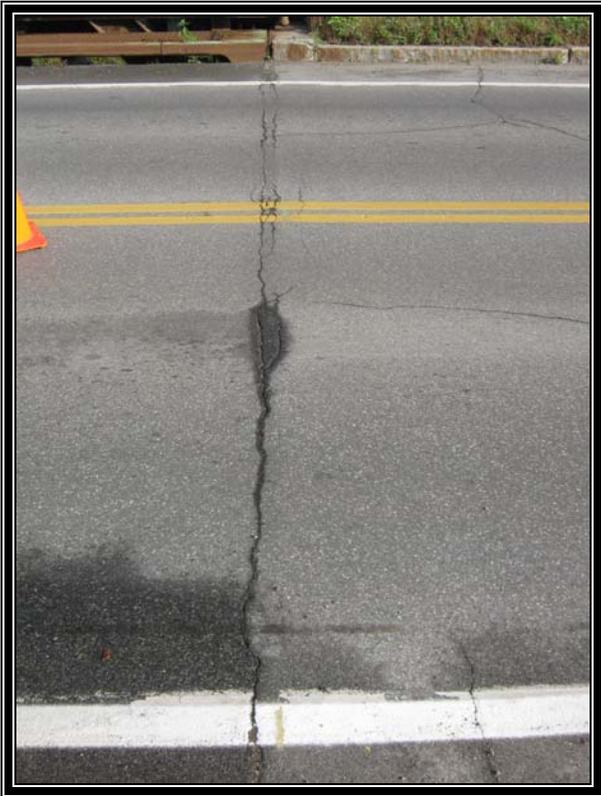
Photo 8: Wearing Surface Cracking at End of Deck (New Hampshire Abutment)

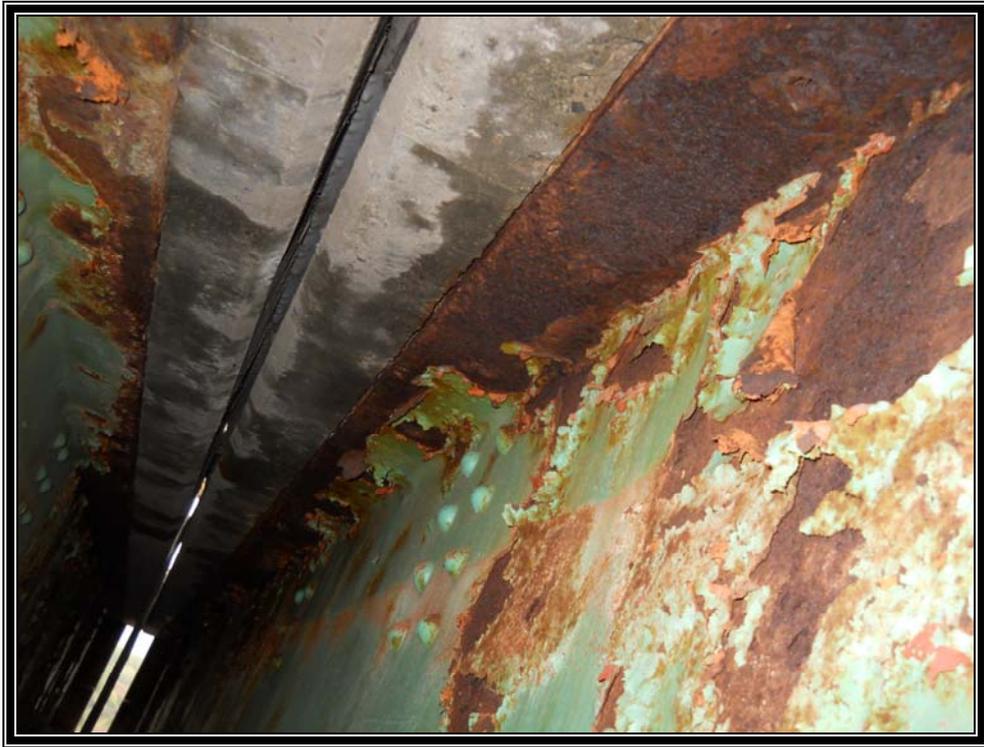
Photo 9: Failed Compression Seal Hanging Below the Deck

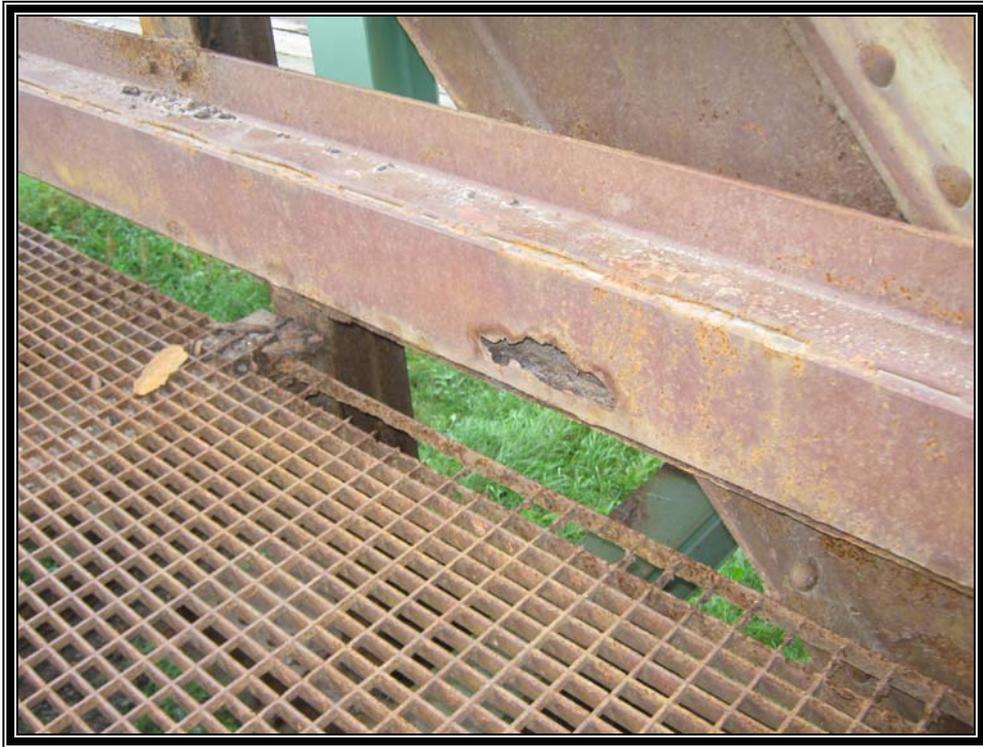
Photo 11: Open Grid Safety Curb Distribution Bar Deterioration

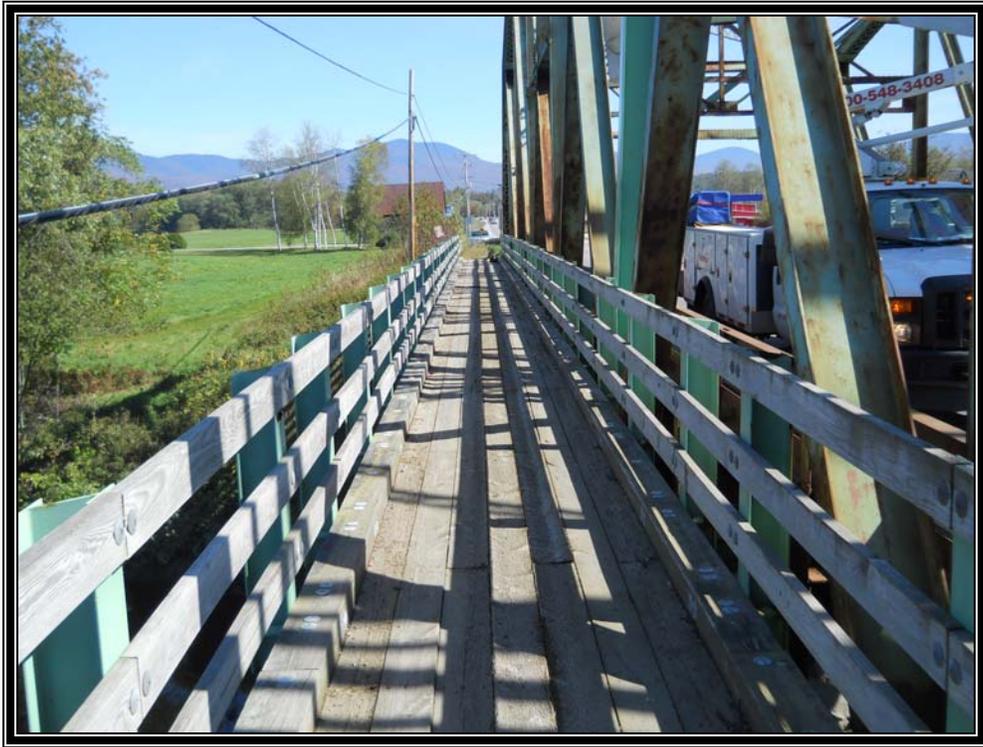
Photo 12: Cantilevered Sidewalk Weathered Running Boards

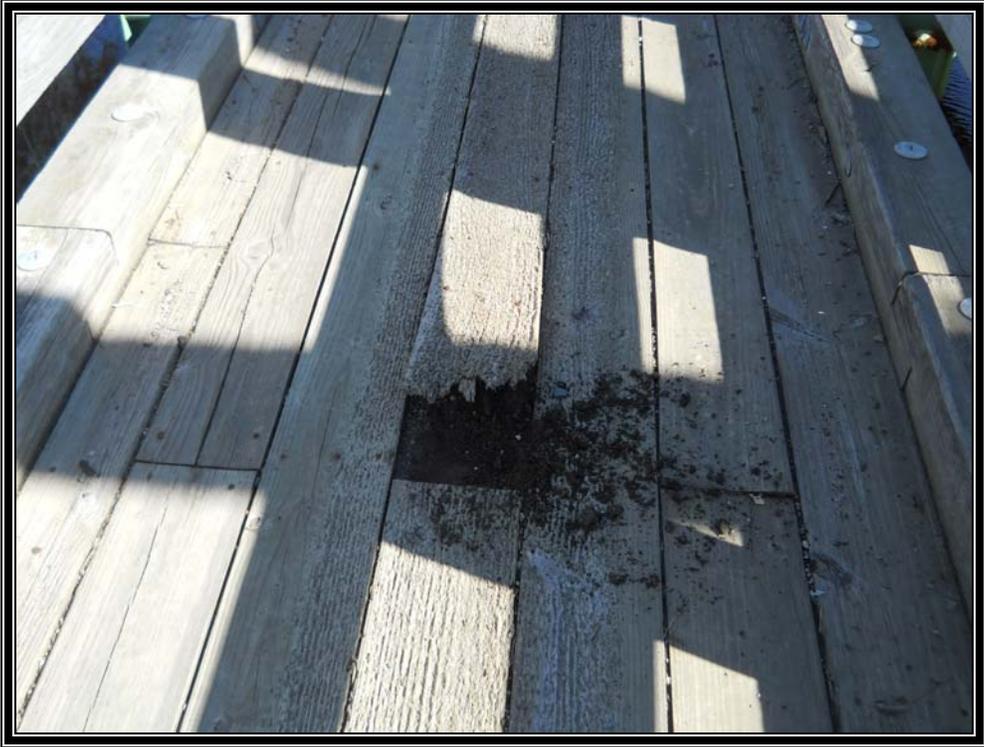
Photo 13: Cantilevered Sidewalk Running Board Rot

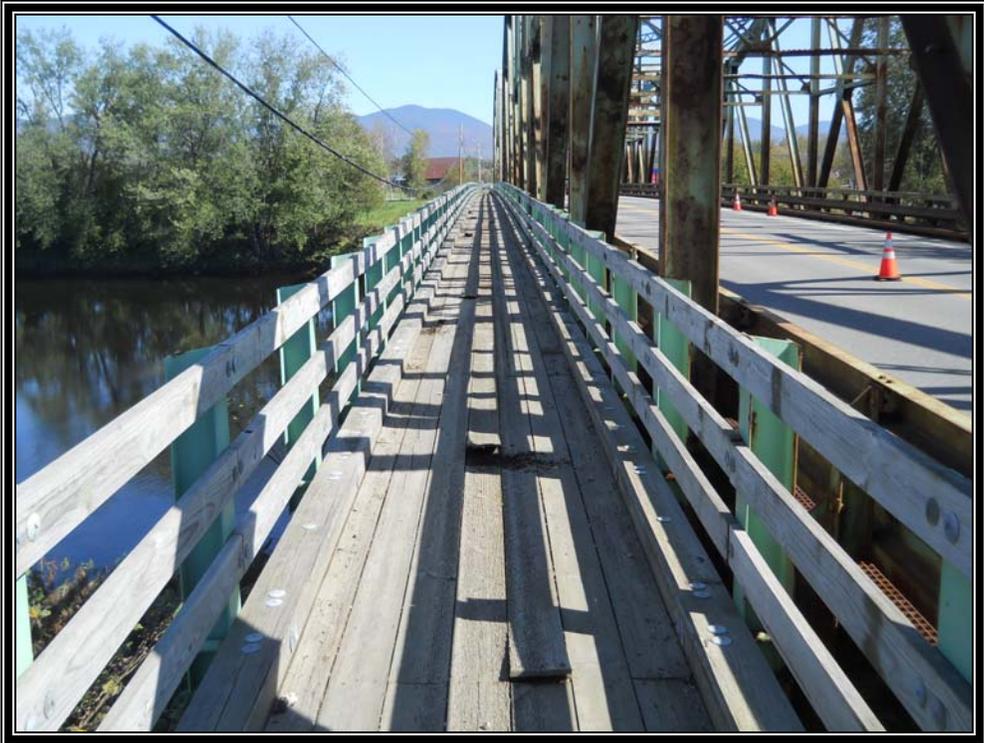
Photo 14: Cantilevered Sidewalk Curled Running Boards

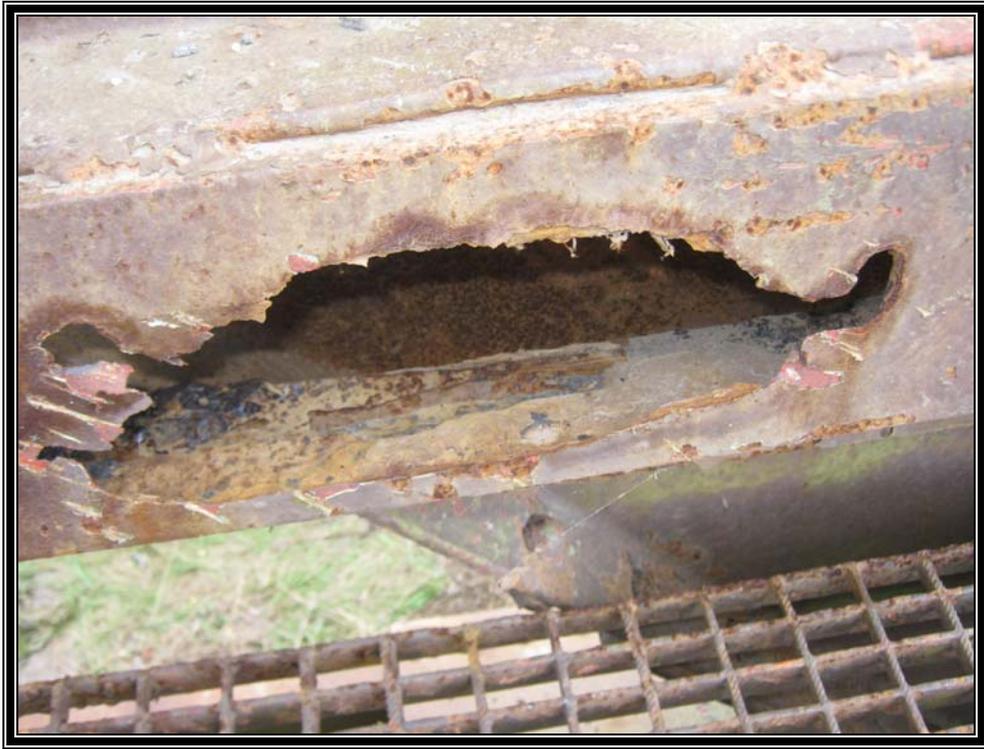
Photo 15: Typical Bridge Rail Lower Railing Corrosion Holes

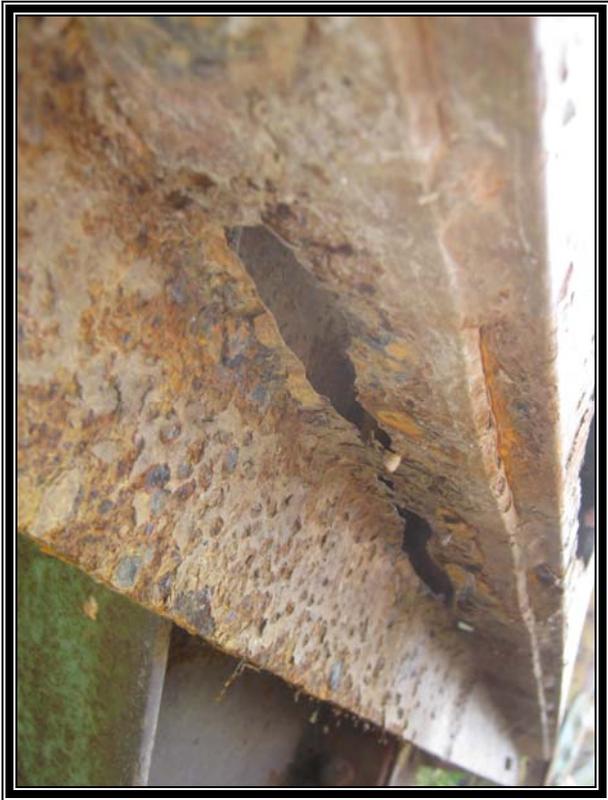
Photo 16: Typical Bridge Rail Lower Railing Corrosion Holes

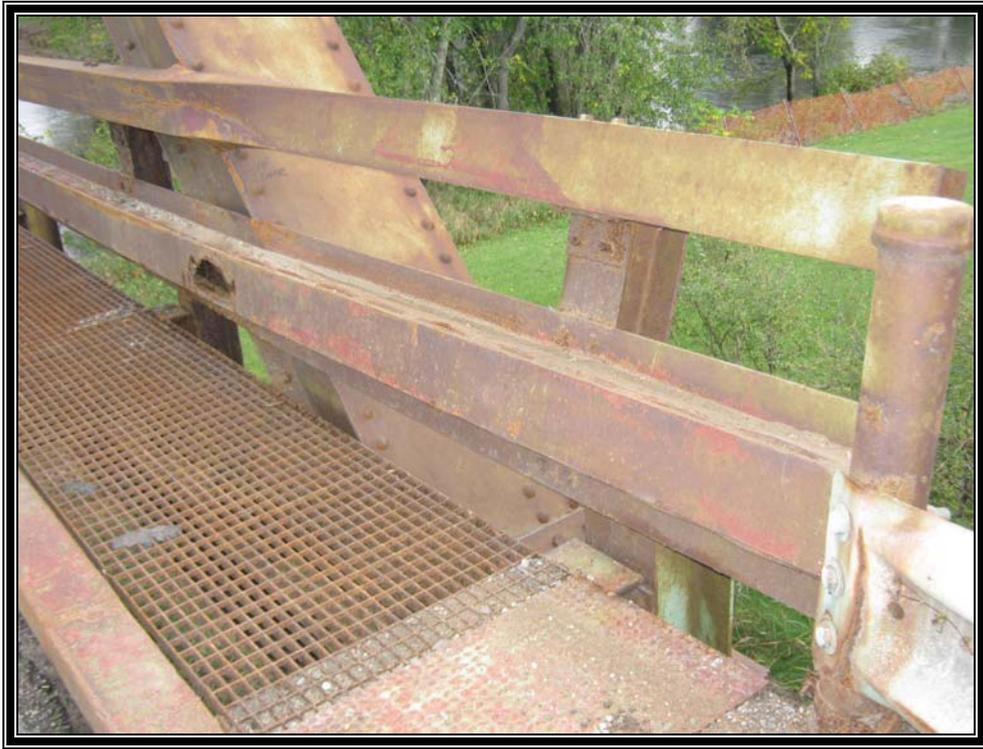
Photo 17: Span 1 Eastbound Approach – Bridge Rail Vehicular Impact Damage

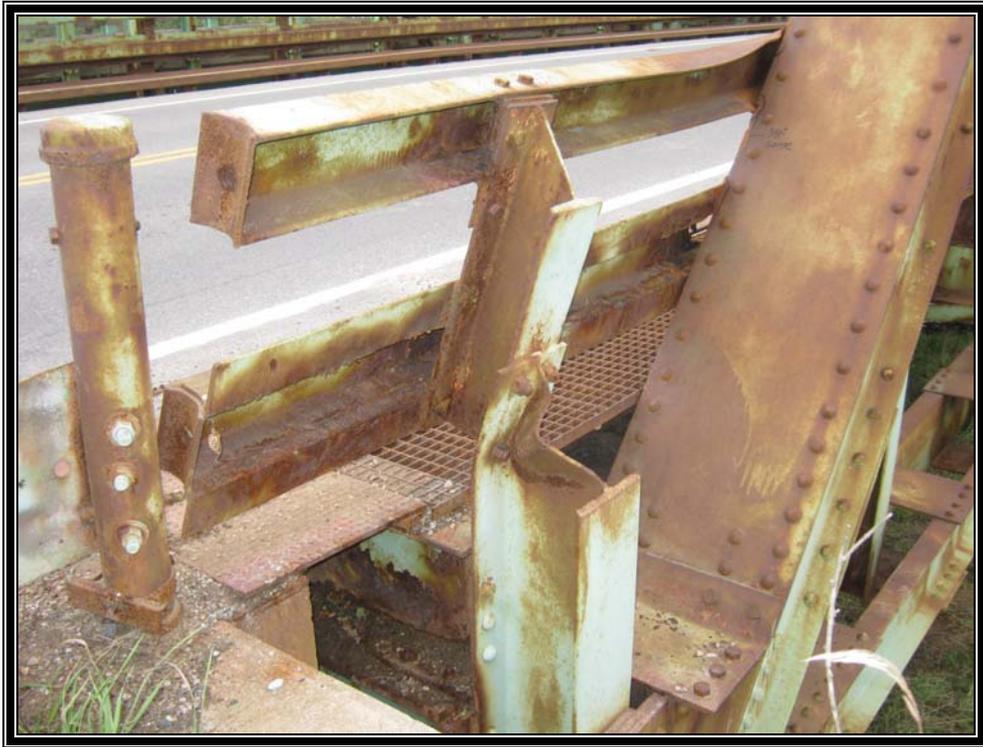
Photo 18: Span 1 Eastbound Approach – Bridge Rail Vehicular Impact Damage

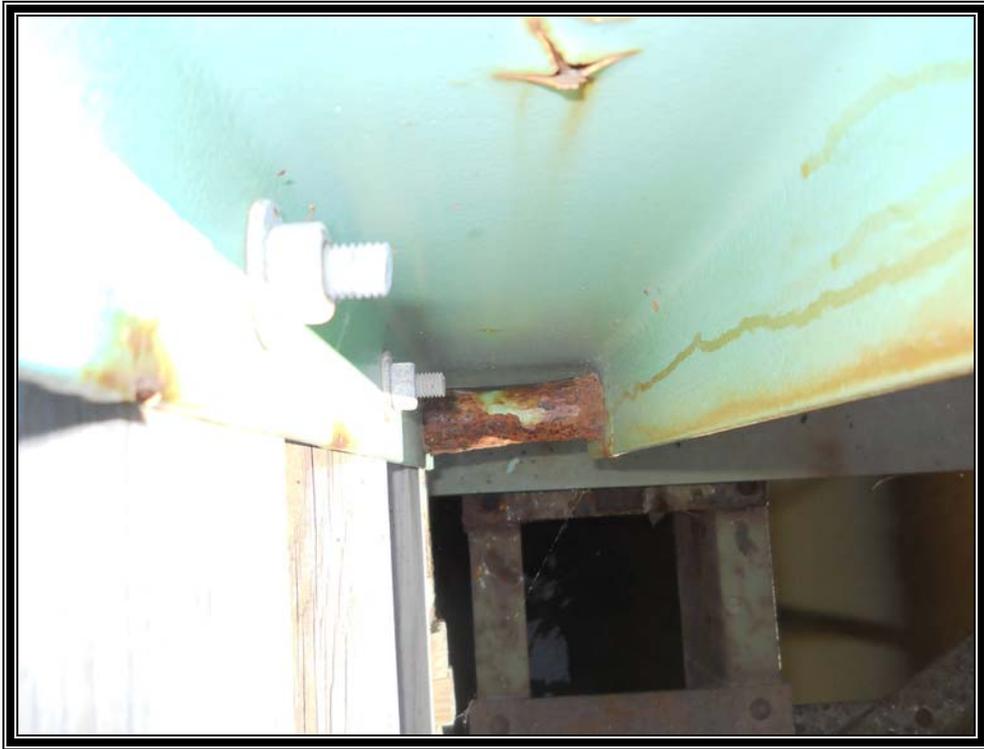
Photo 19: Sidewalk Railing Bolt Sleeve – Typical Paint Peeling and Corrosion

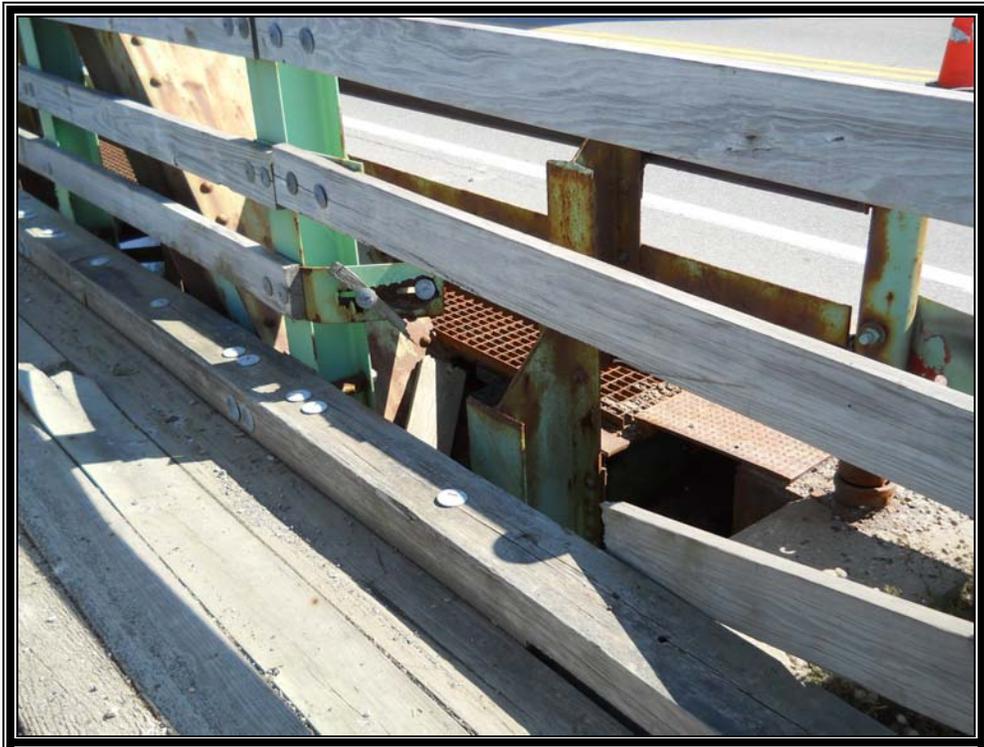
Photo 20: Sidewalk Railing Damage at Vermont Abutment

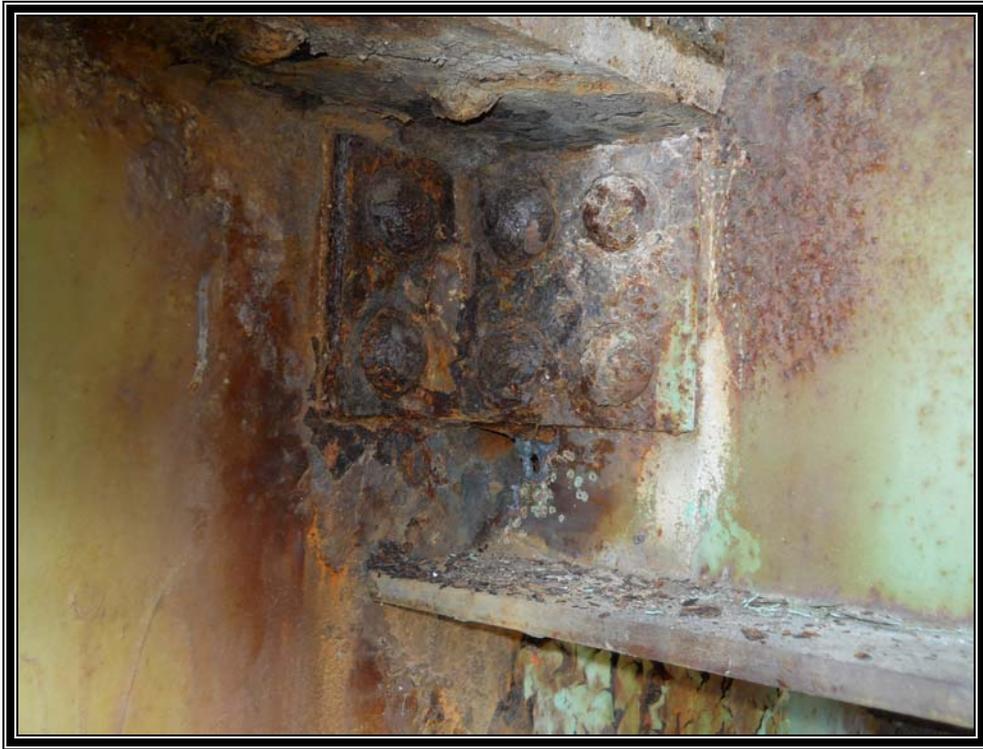
Photo 21: Span 1, Stringer 71 Web Section Loss and Connection Deterioration

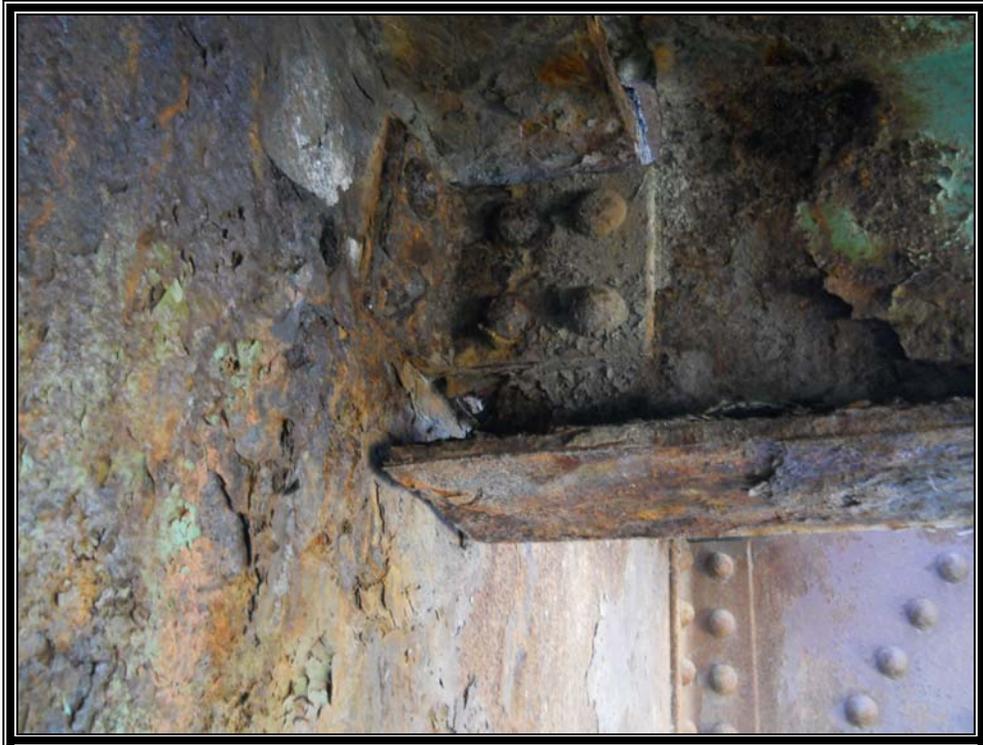
Photo 22: Span 1, Stringer 79 Web Section Loss and Connection Deterioration

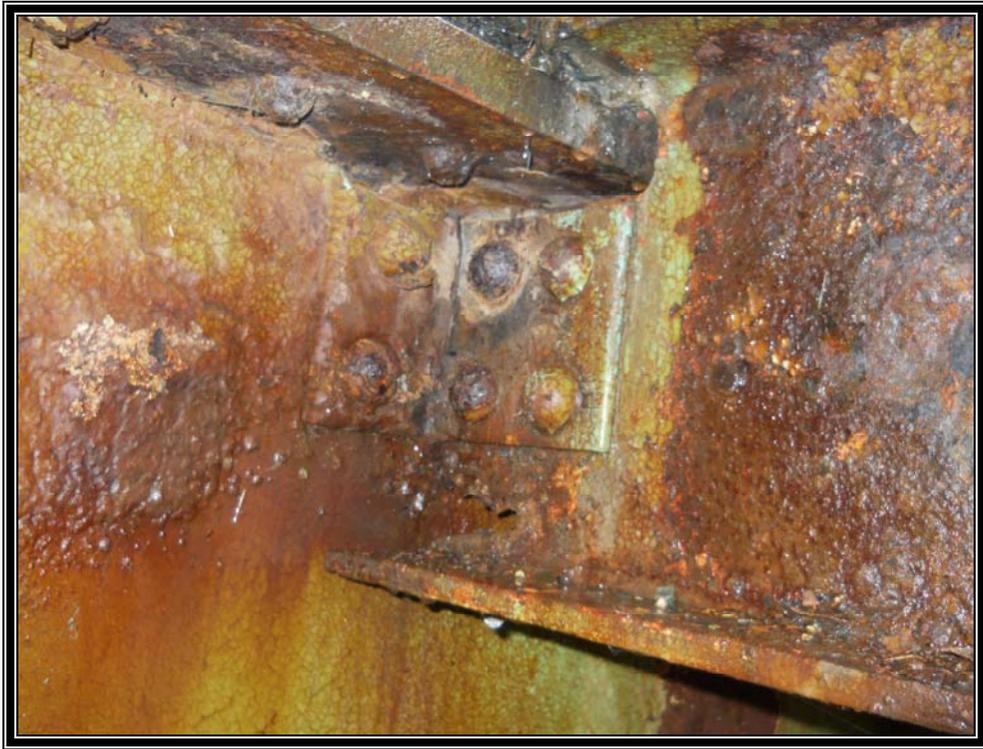
Photo 23: Span 2, Stringer 91 Web Section Loss and Connection Deterioration

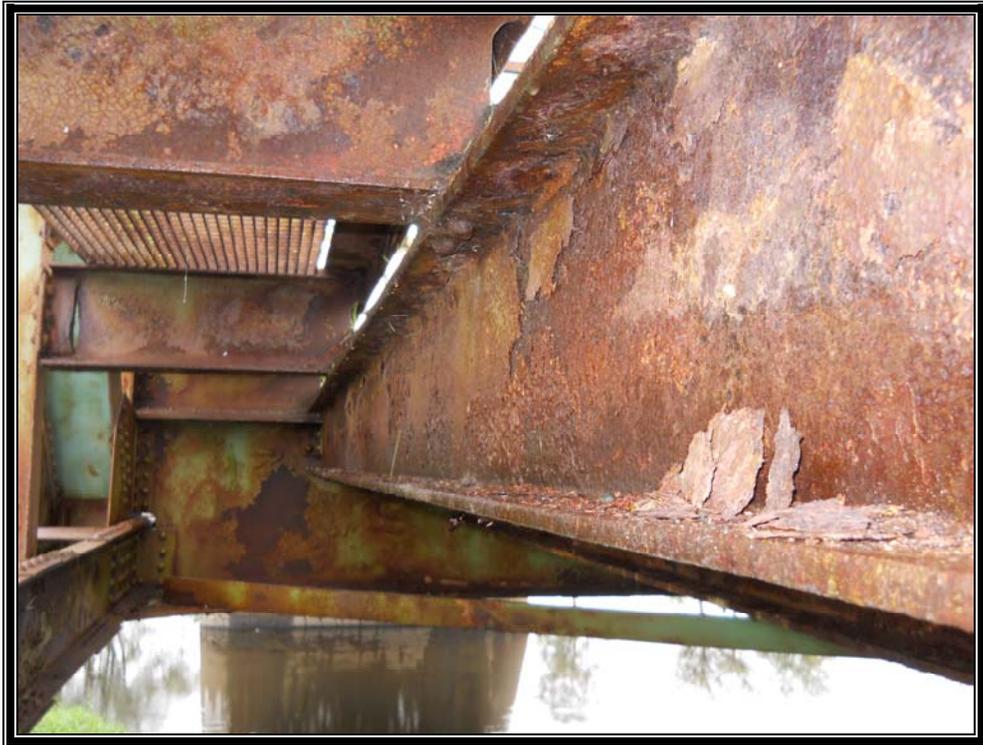
Photo 24: Span 2, Stringer 81 Rusting and Corrosion

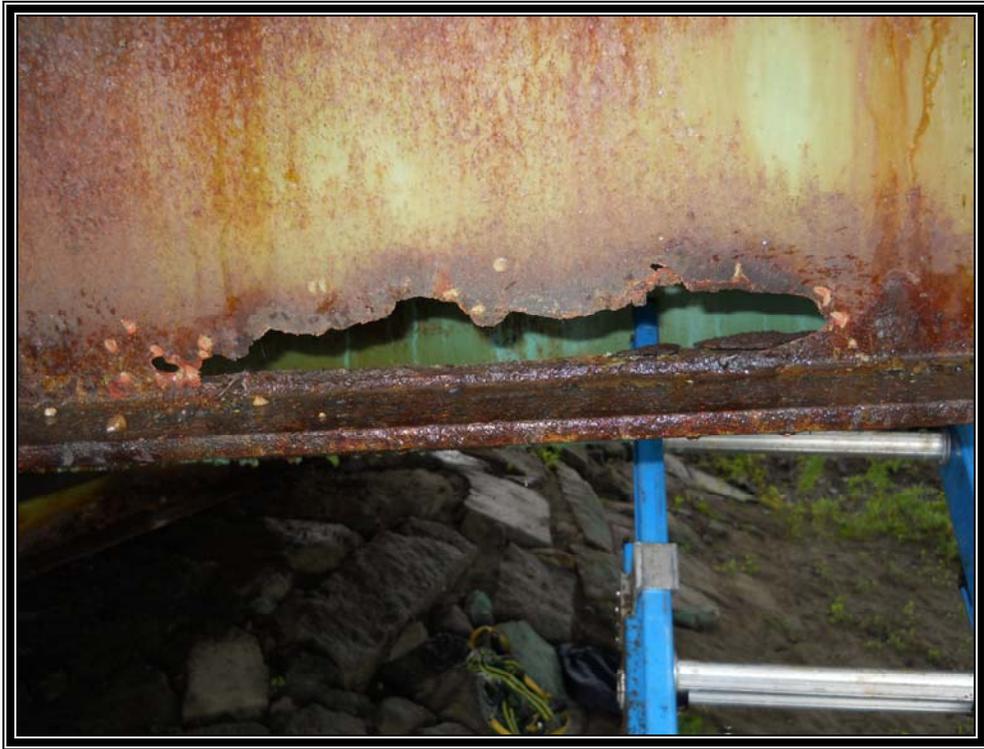
Photo 25: Span 1, Stringer 11 Holed Web

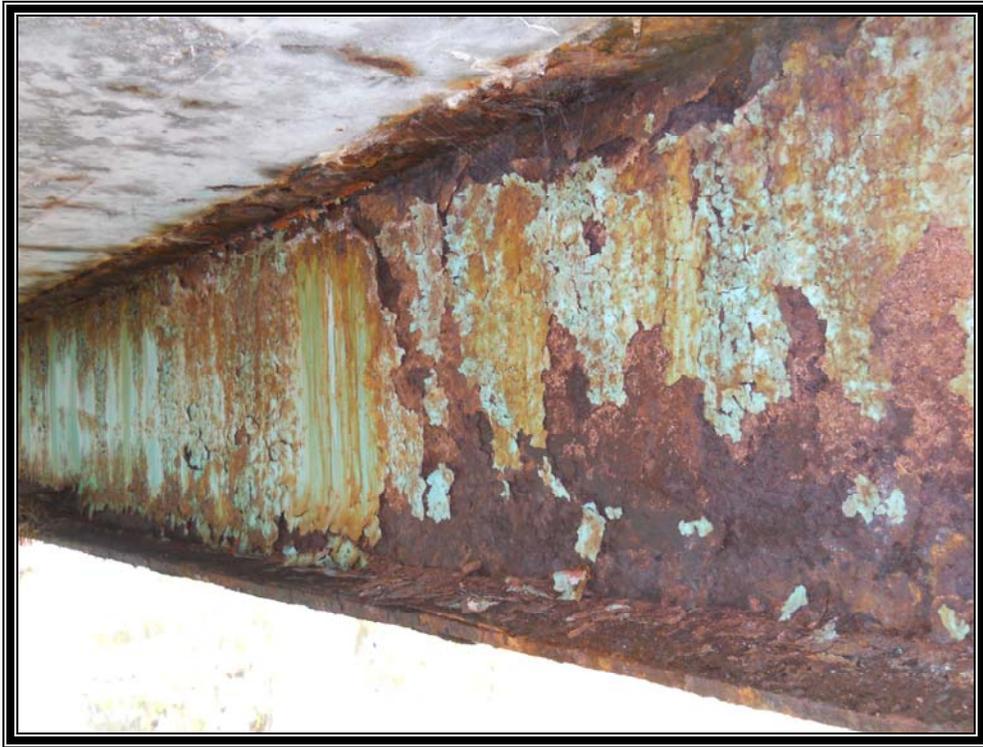
Photo 27: Typical Stringer "X2" Deterioration (Span 1, Stringer 22 Shown)

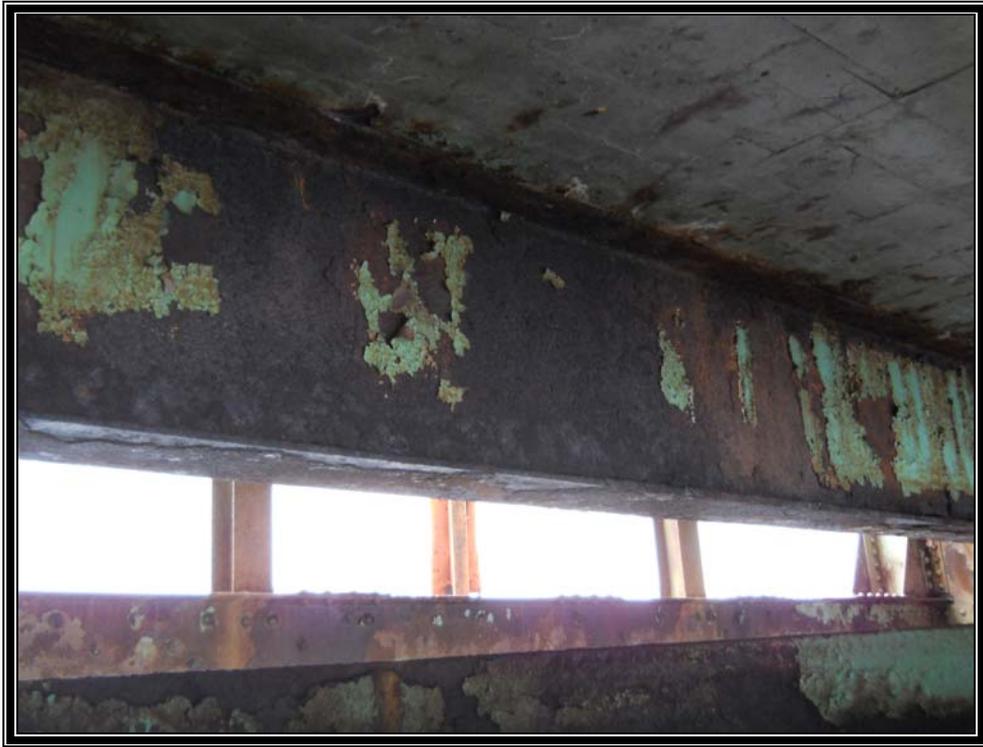
Photo 28: Span 2, Stringer 32 Bottom Flange Section Loss

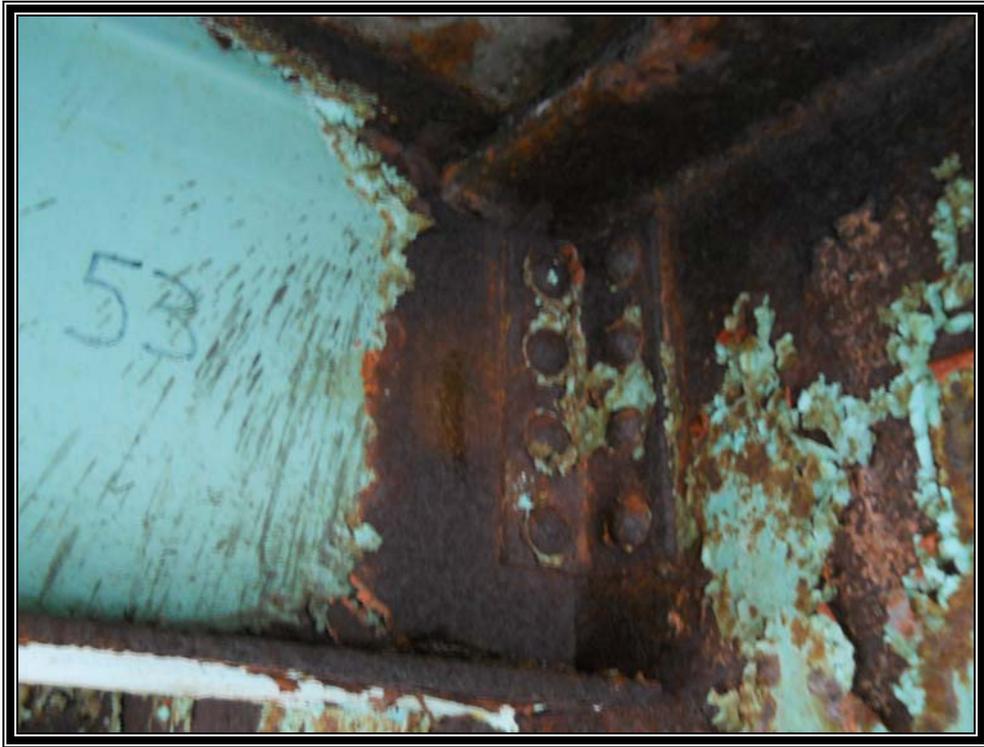
Photo 30: Span 1, Stringer 53 Web and Connection Deterioration

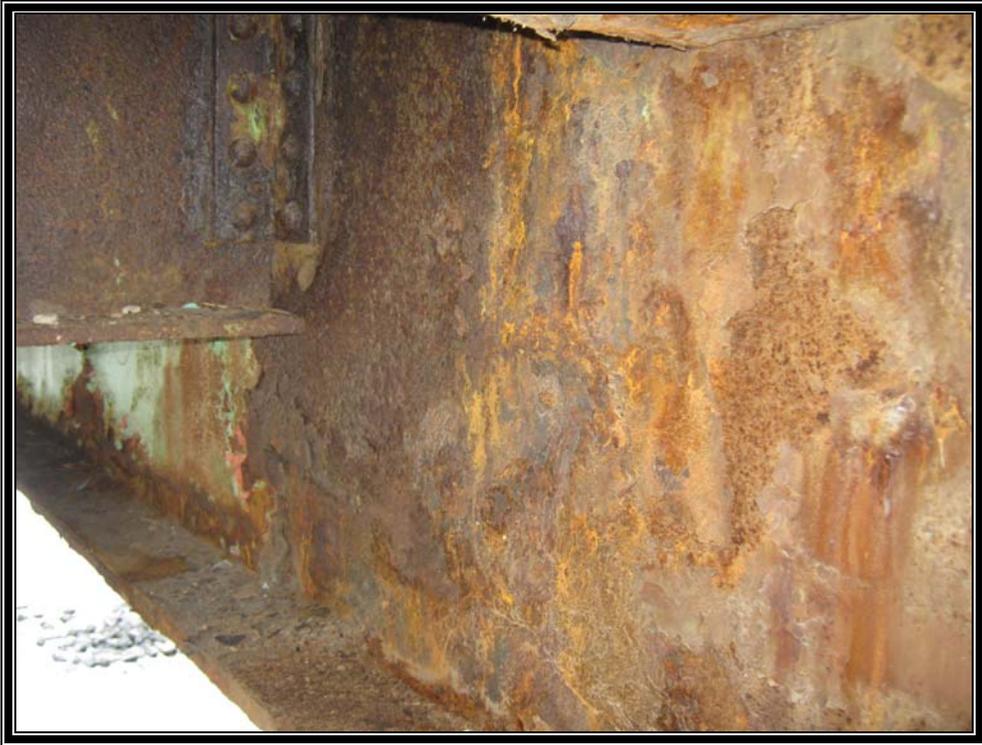
Photo 34: Typical Intermediate Floorbeam Deterioration
(Span 1, Floorbeam FB7 Shown)

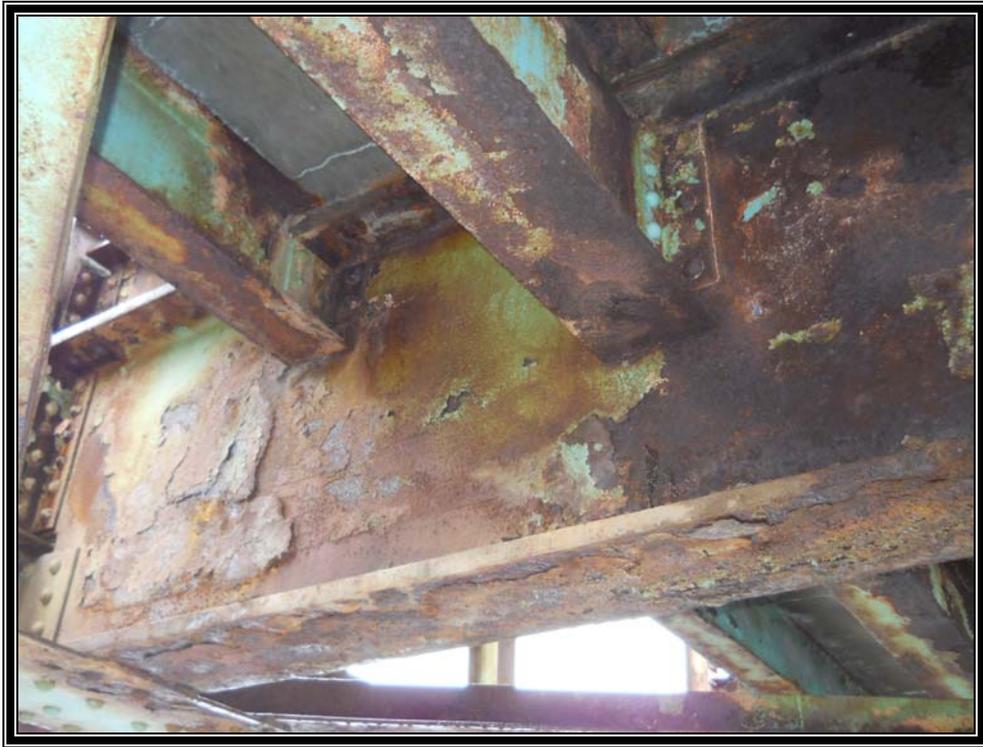
Photo 35: Typical Intermediate Floorbeam Deterioration
(Span 2, Floorbeam FB2 Shown)

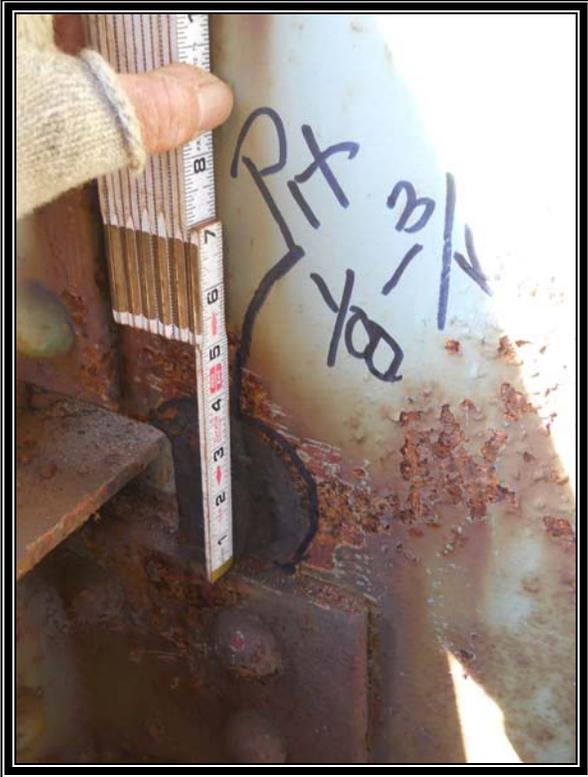
Photo 36: Span 1 Floorbeam FB8 Web Pit at FB to Truss Connection

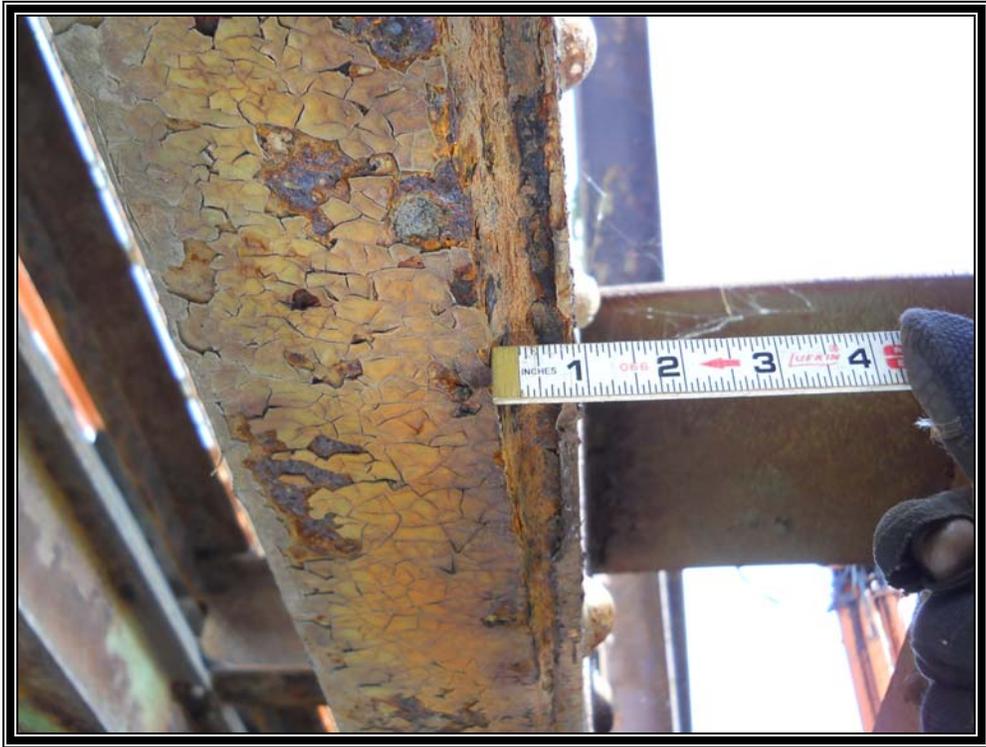
Photo 39: Typical Bottom Chord Pack Rust Between Channel Web and Interior Side Plate

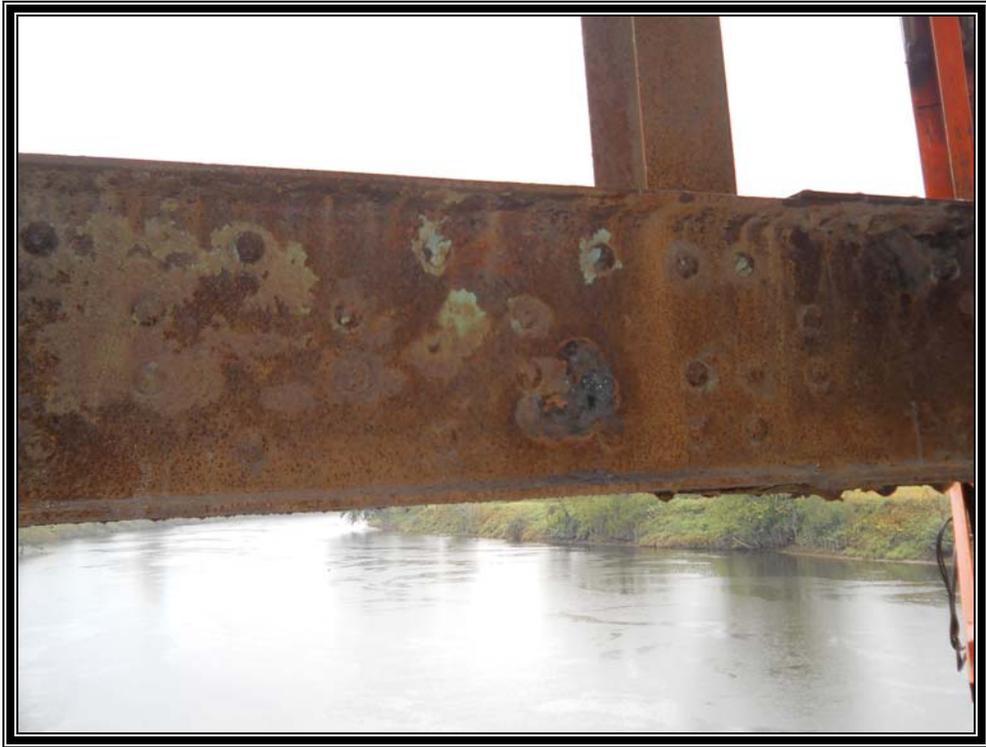
Photo 40: Bottom Chord Laminar Corrosion and Section Loss
