US Route 2 (Rogers' Rangers) Bridge -Lancaster, NH – Guildhall, VT
NHDOT Bridge No. 111/129 – Project No. 16155
Inspection Photos

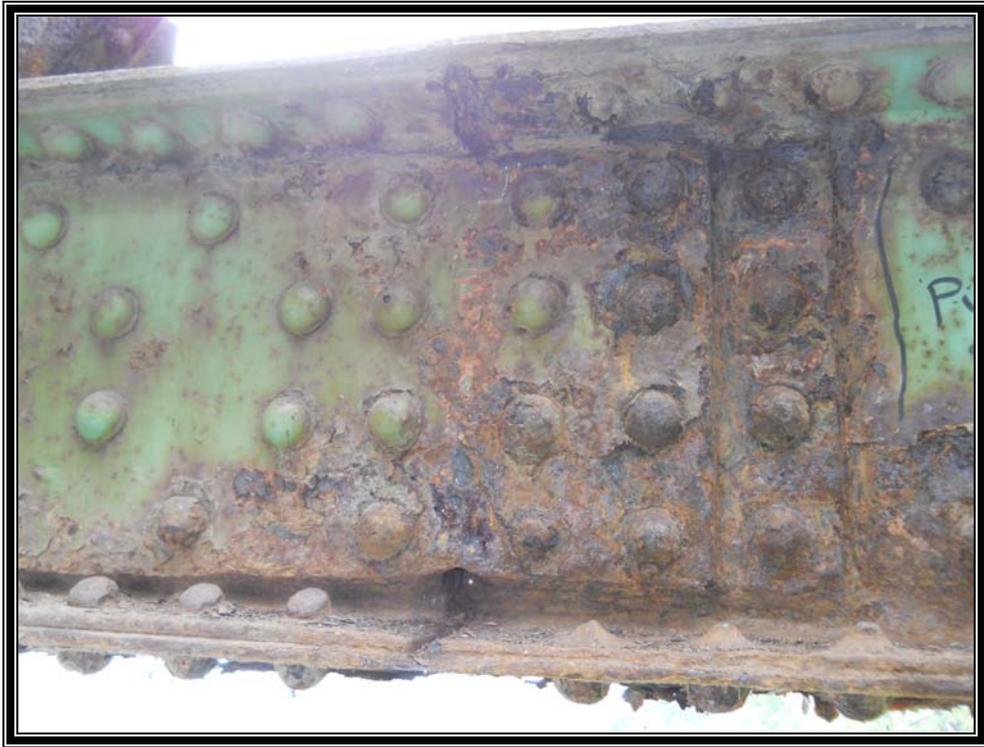
Photo 41: Bottom Chord Web Pitting at End of Splice Filler Plate
(Span 1 South Truss Bottom Chord Member L3-L4 Shown)

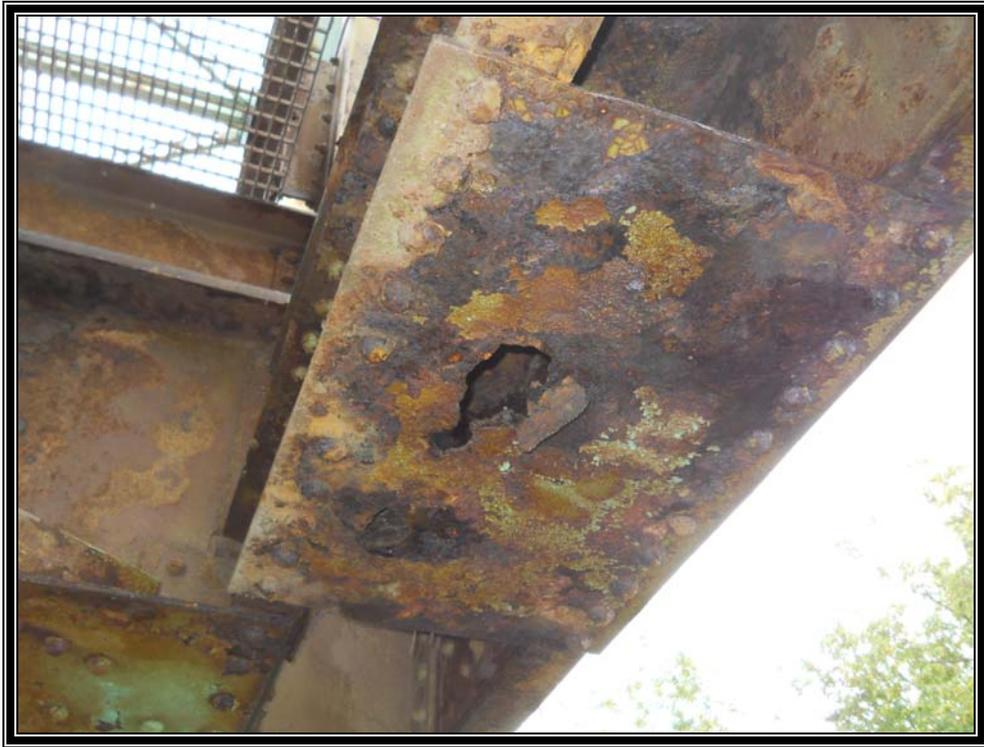
Photo 43: Span 2 South Truss Bottom Chord Member L3-L4
Flange Splice Plate Corrosion Holes

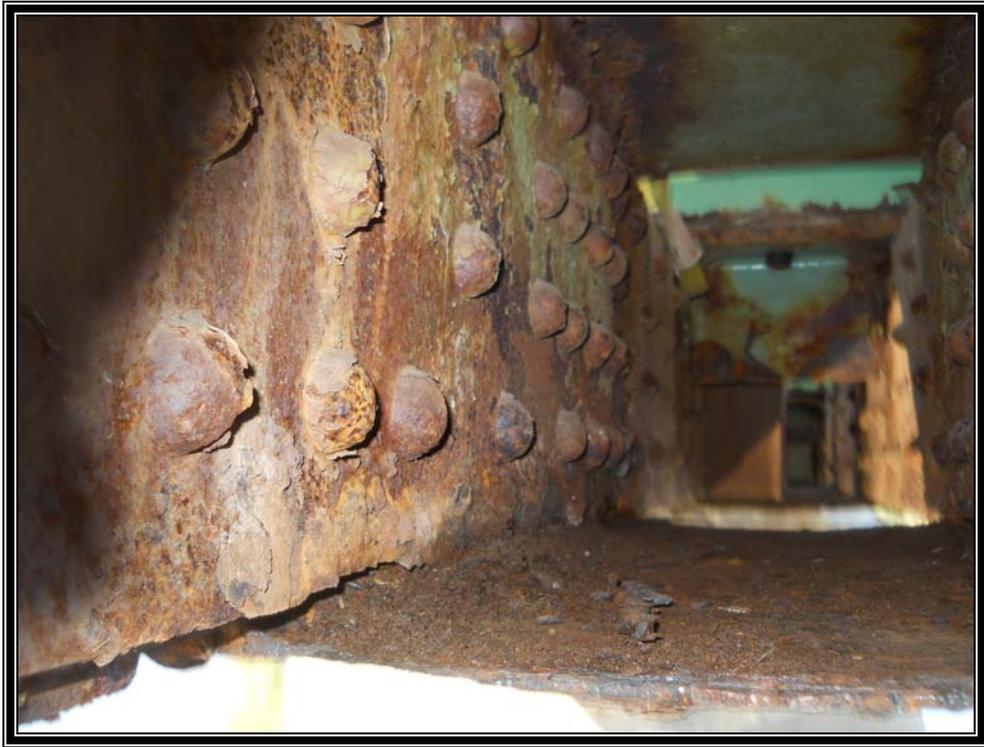
Photo 44: Span 2 North Truss Bottom Chord Member L3-L4
Flange Splice Plate Deterioration and Section Loss

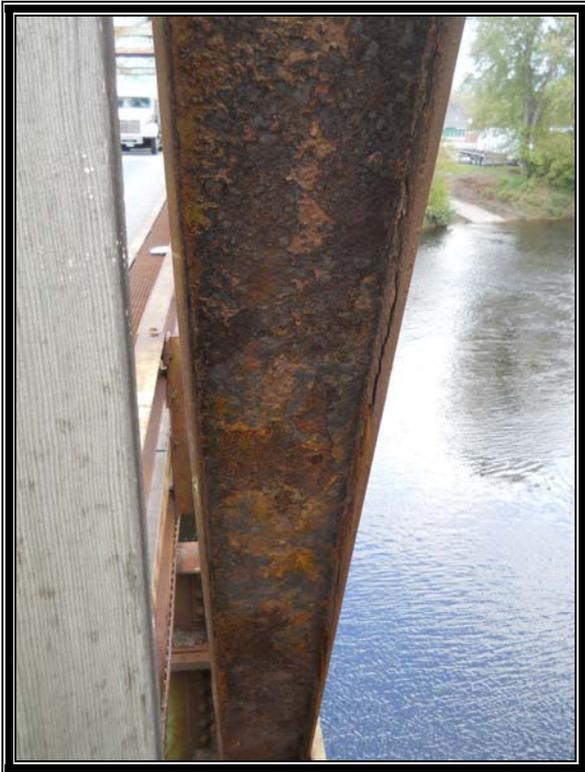
Photo 45: Typical Truss Diagonal Member Deterioration
(Face Exposed to Snow and Salt Spray from Plowing Operations)

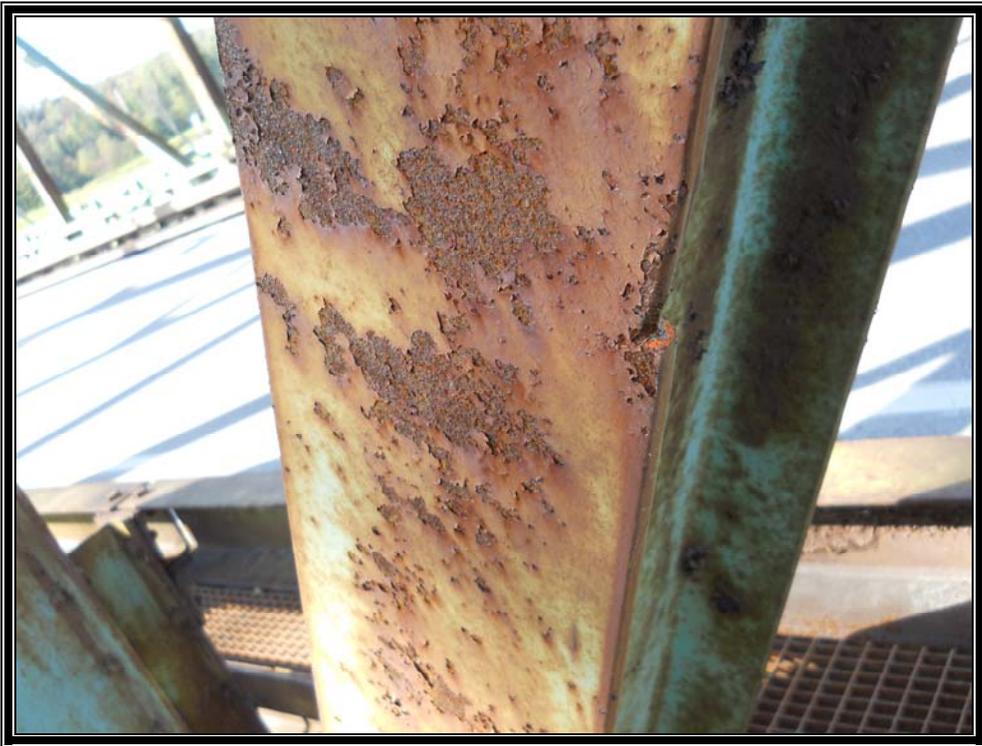
Photo 46: Span 1 South Truss Diagonal Member L4-U5 Damaged Flange

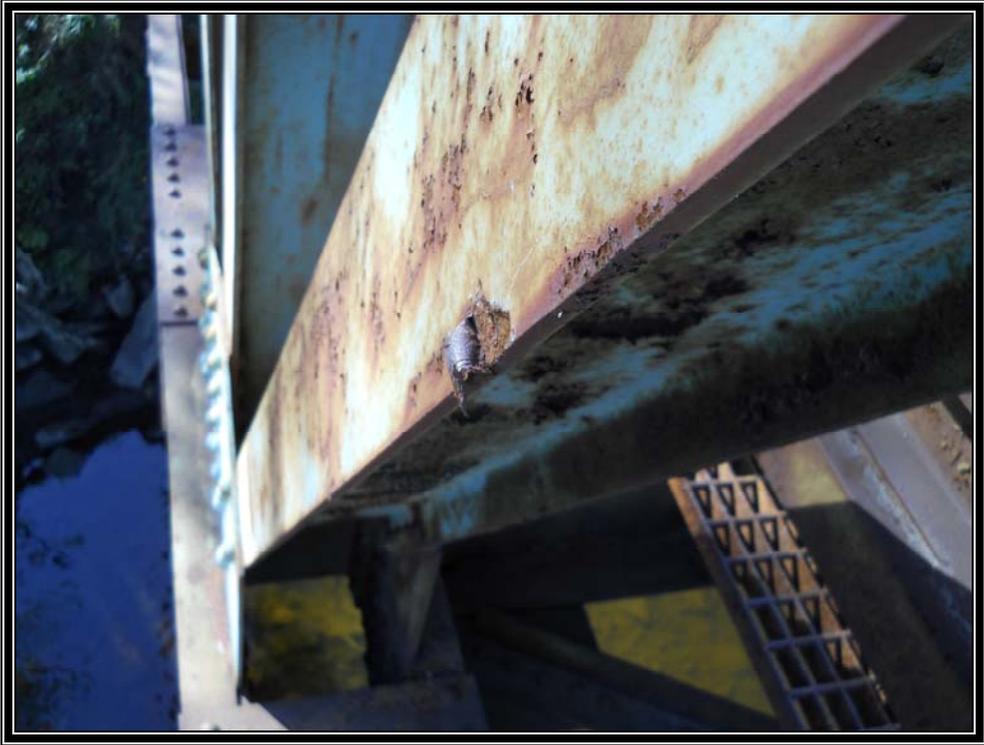
Photo 47: Span 1 South Truss Diagonal Member L4-U5 Flange Gouge

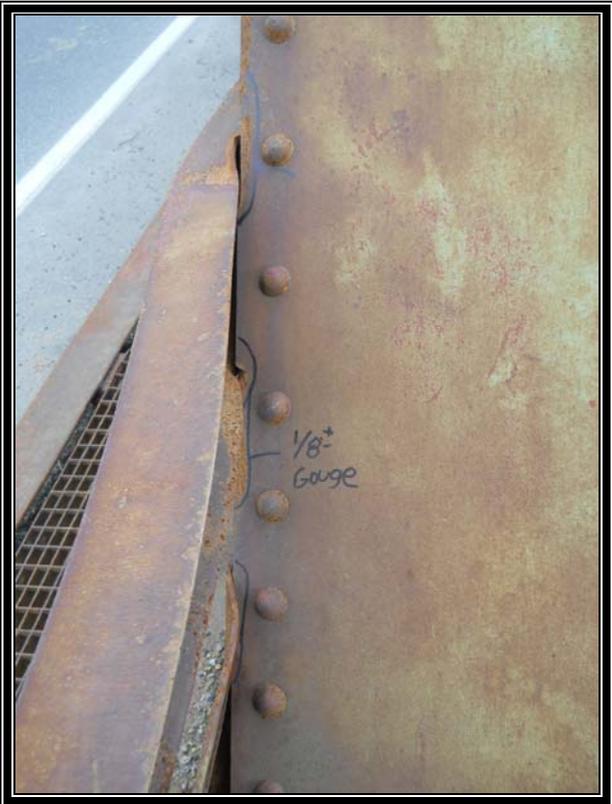
Photo 48: Span 1 South Truss End Diagonal Member L0-U1 Vehicular Impact Damage

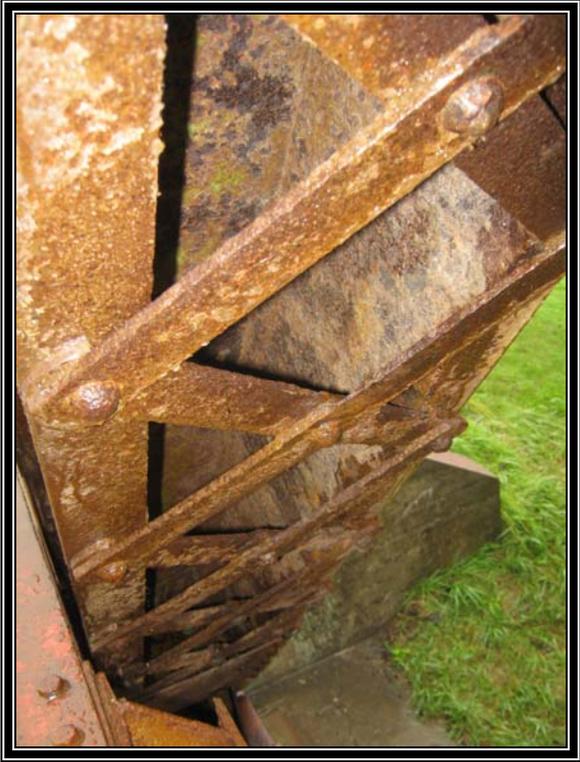
Photo 49: Span 2 South Truss End Diagonal Member U8-L9
(Side Exposed to Snow and Salt Spray)

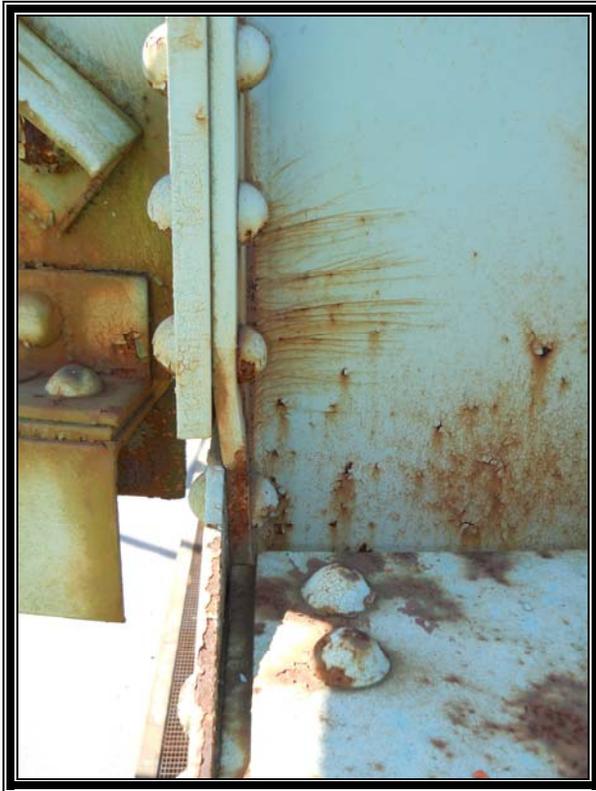
Photo 51: Span 2 North Truss Vertical Member U3-L3 Flange Damage

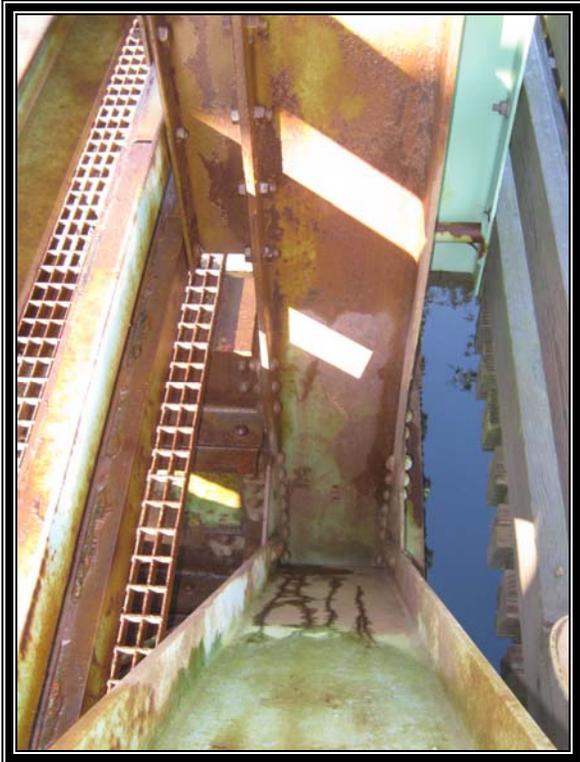
Photo 52: Span 1 North Truss Vertical Member U4-L4 is Bent Near L4

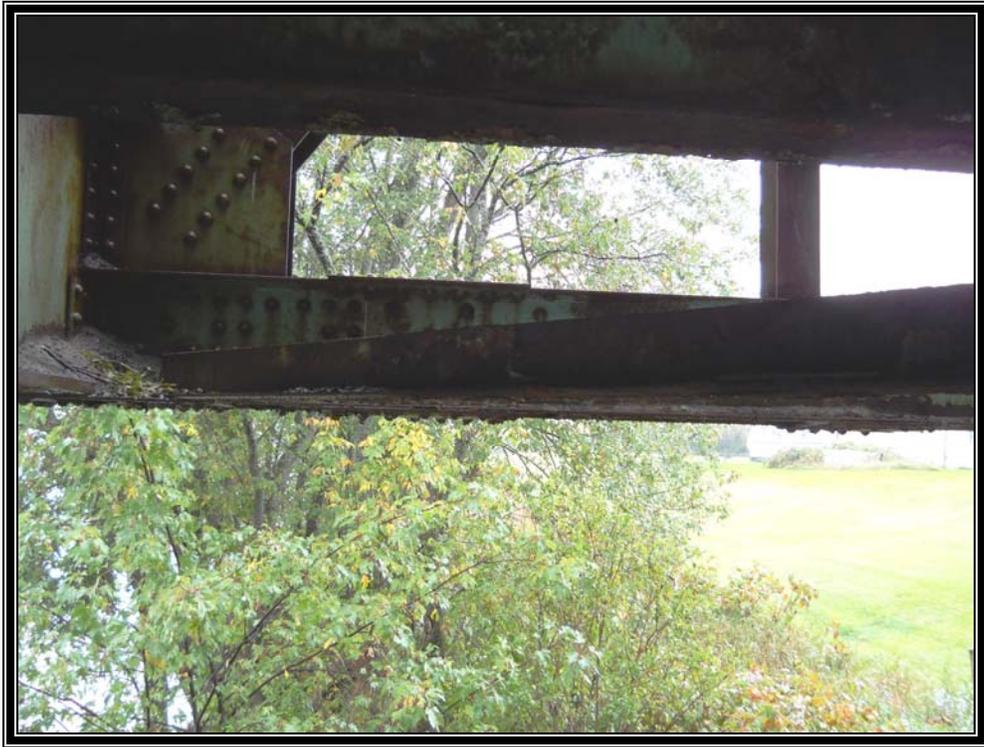
Photo 55: Lower Lateral Bracing Typical Rusting With Scaling at Ends
(Photo Also Shows Typical Debris Build-up on Connection)

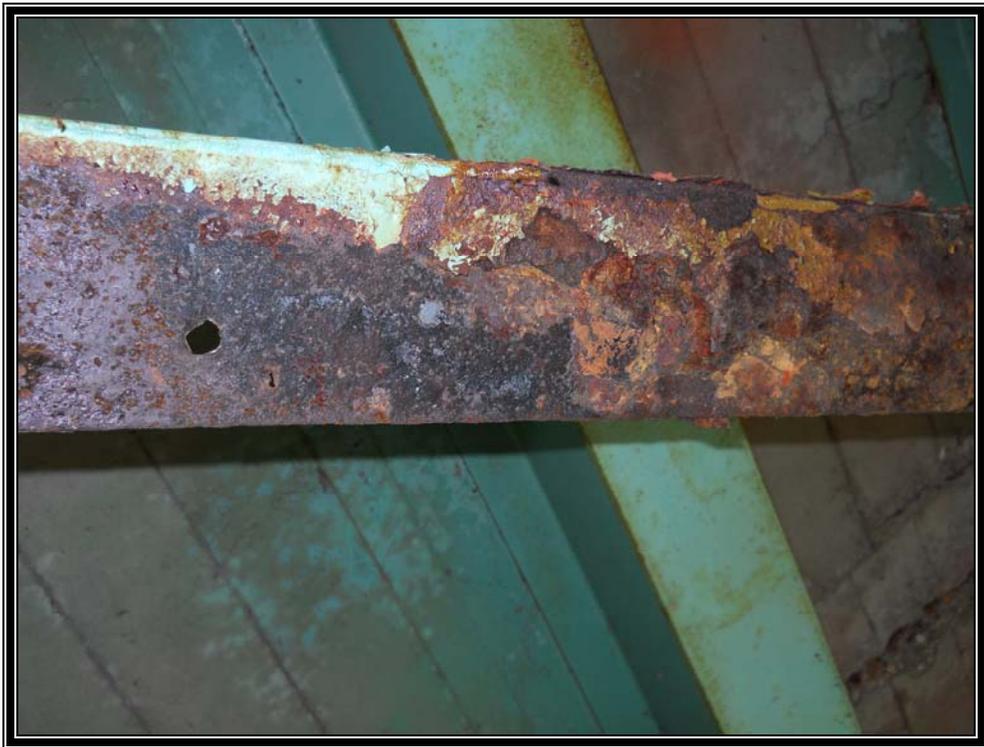
Photo 56: Span 1 Lower Lateral Bracing Member L0N-L1S Corrosion Holes

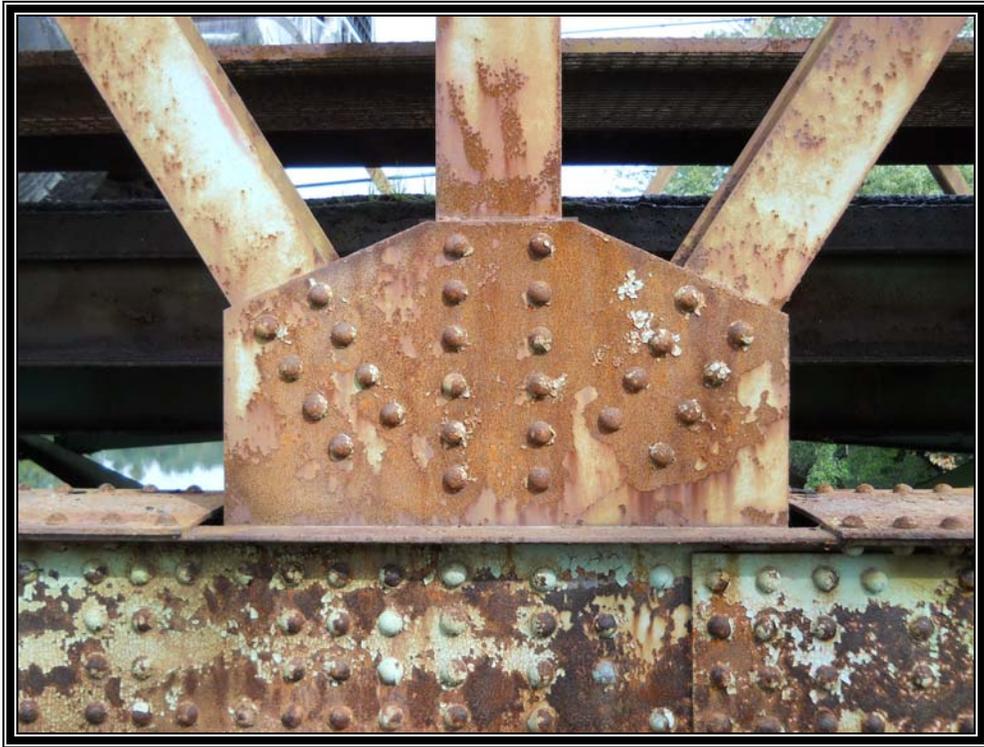
Photo 61: Lower Gusset Plate Typical Surface Rusting

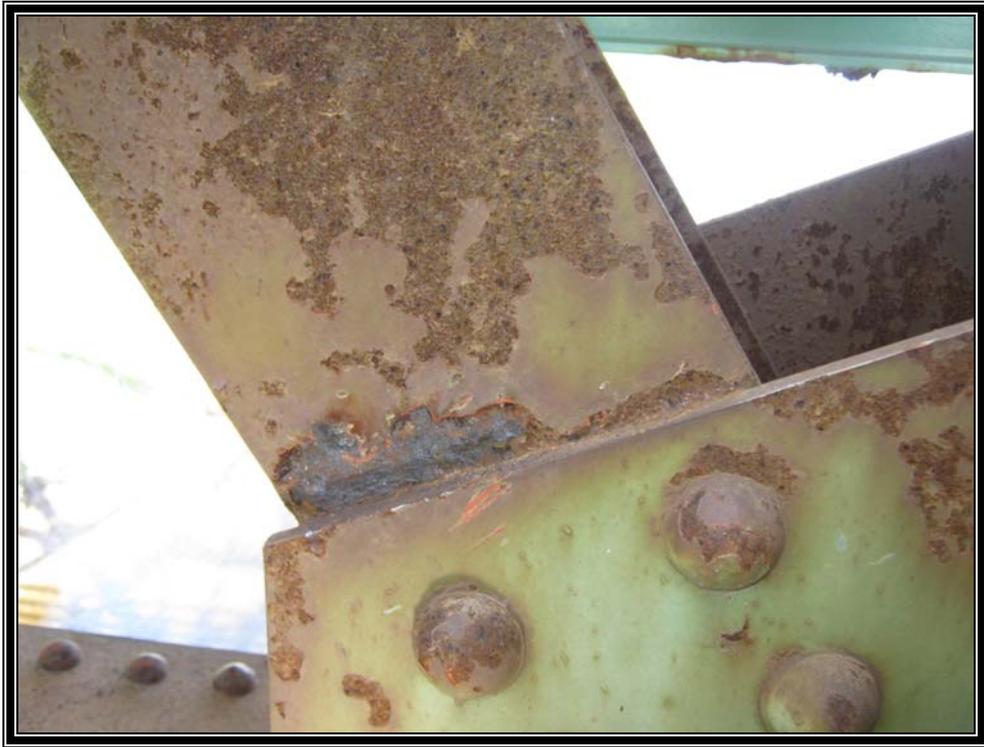
Photo 62: Typical Pitting and Pack Rust at Lower Gusset Plate / Truss Member Interface

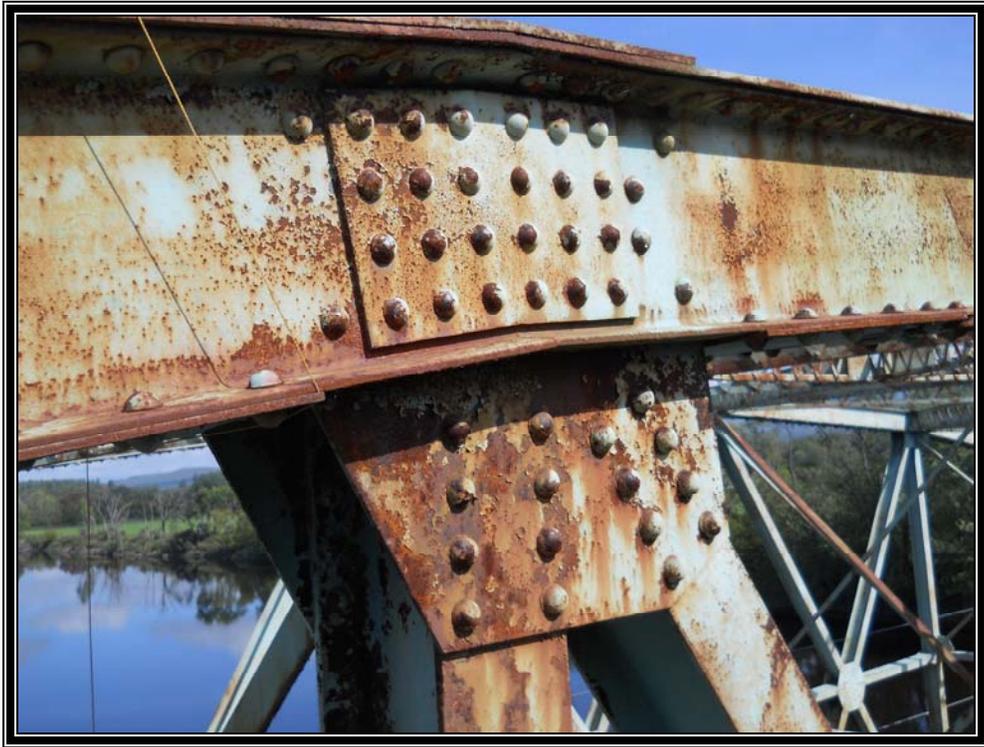
Photo 63: Span 1 South Truss Gusset Plate at U3 Paint Peeling and Rusting

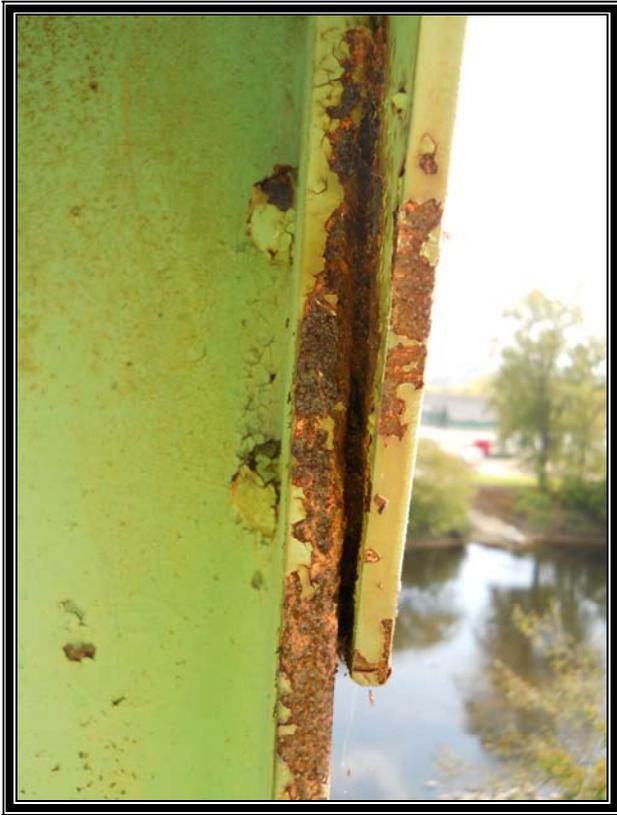
Photo 64: Pack Rust at Span 1 South Truss Gusset Plate U2

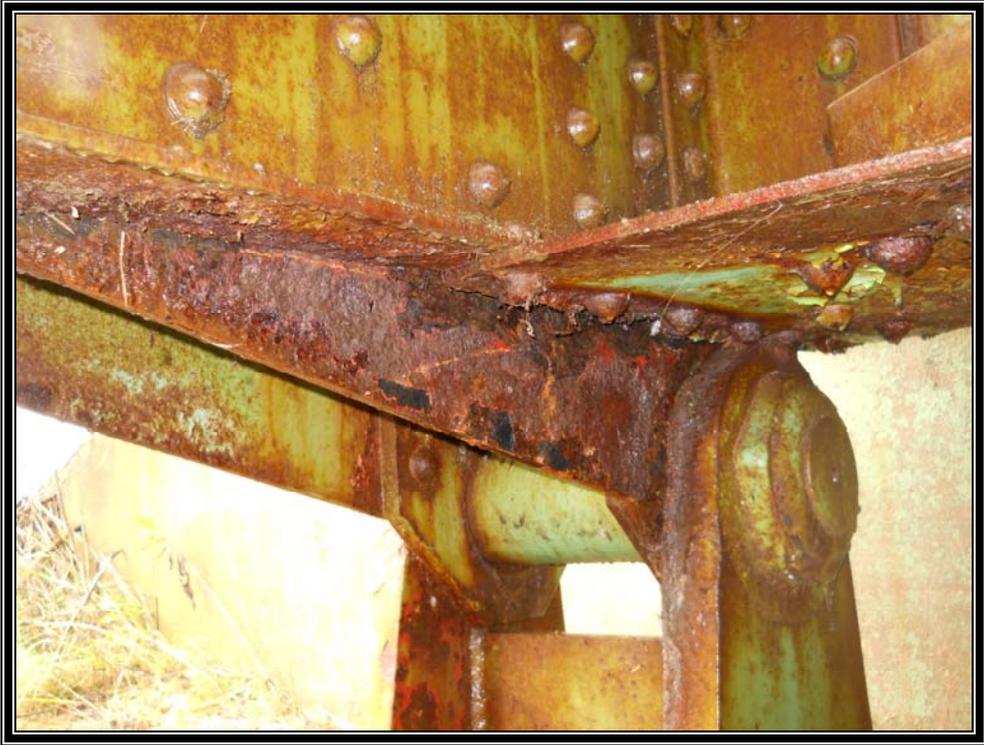
Photo 65: Span 1 South Truss L0 Gusset Plate Rusting / Pitting

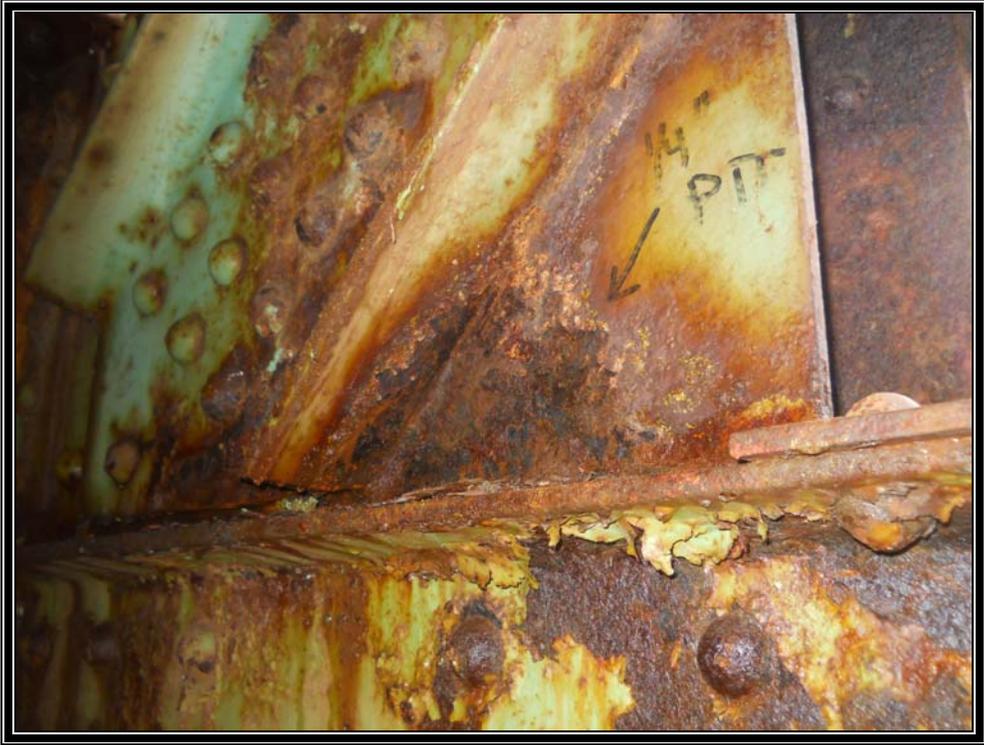
Photo 66: Span 1 South Truss L9 Gusset Plate Pitting

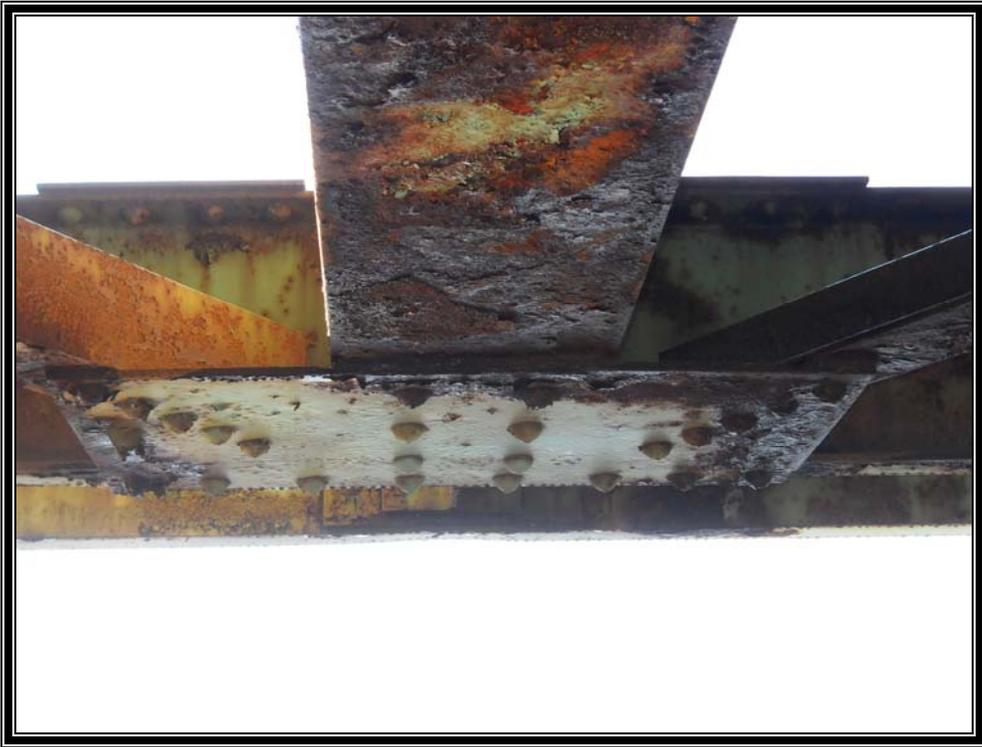
Photo 70: Typical Lower Lateral Bracing Gusset Plate Pack Rust with Prying at Floorbeam

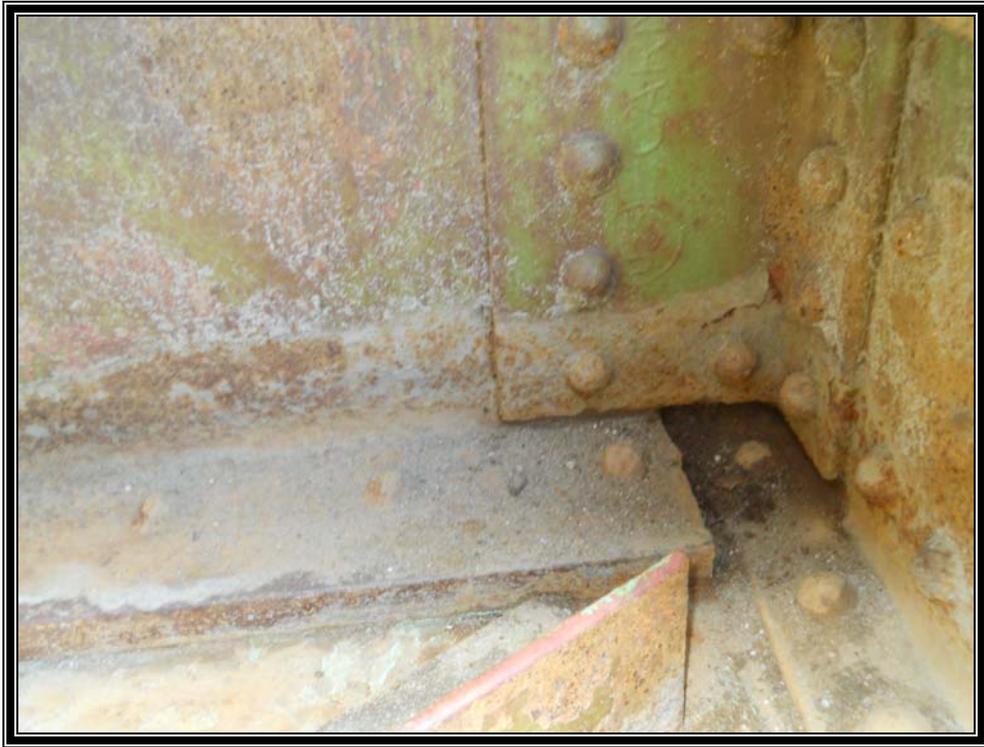
Photo 71: Lower Lateral Bracing Gusset Plate to Floorbeam Rivet Head Loss
(Span 1 South Truss L6 Shown)

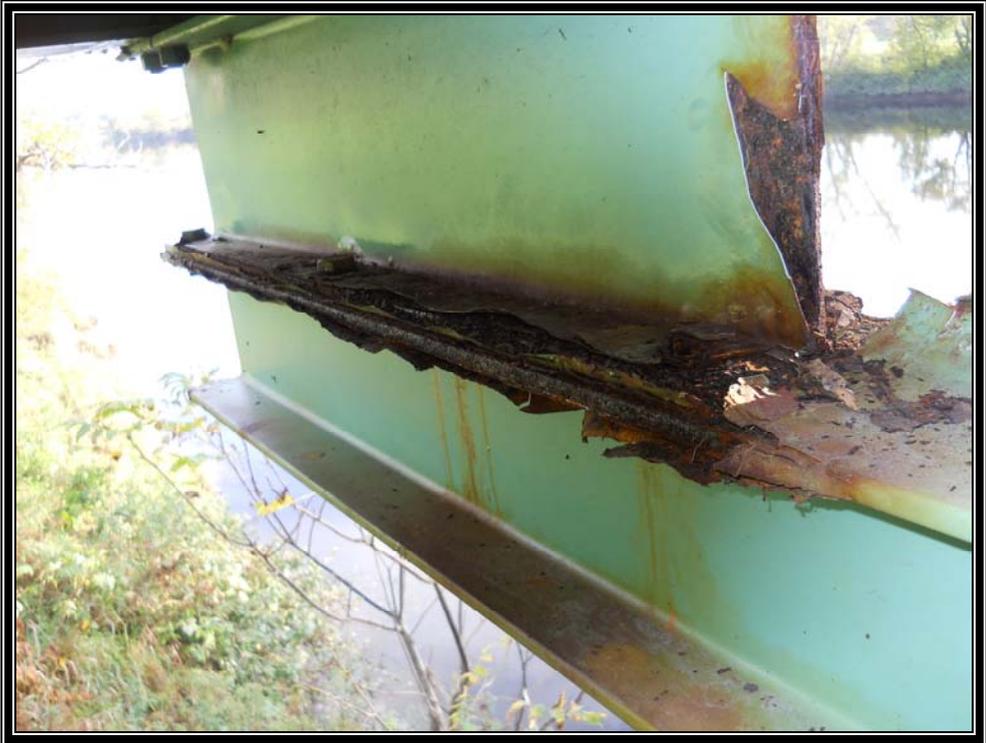
Photo 74: Cantilevered Sidewalk Support – Typical Rusting with Section Loss

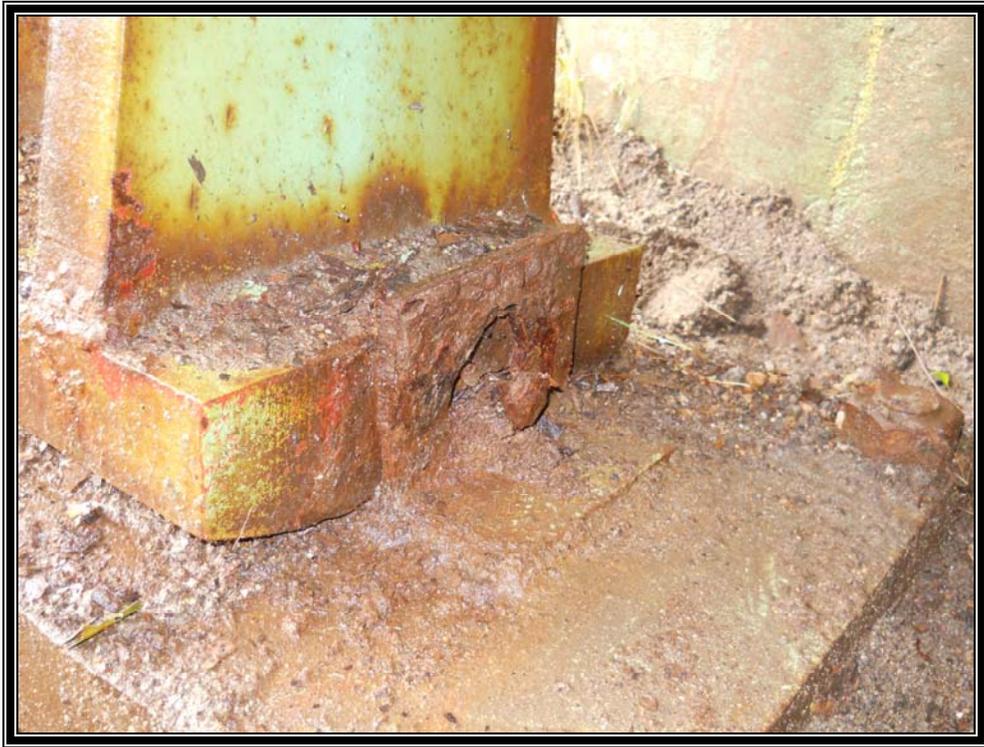
Photo 75: Span 1 South Truss Rocker Bearing Keeper Plate and Bolt Deterioration

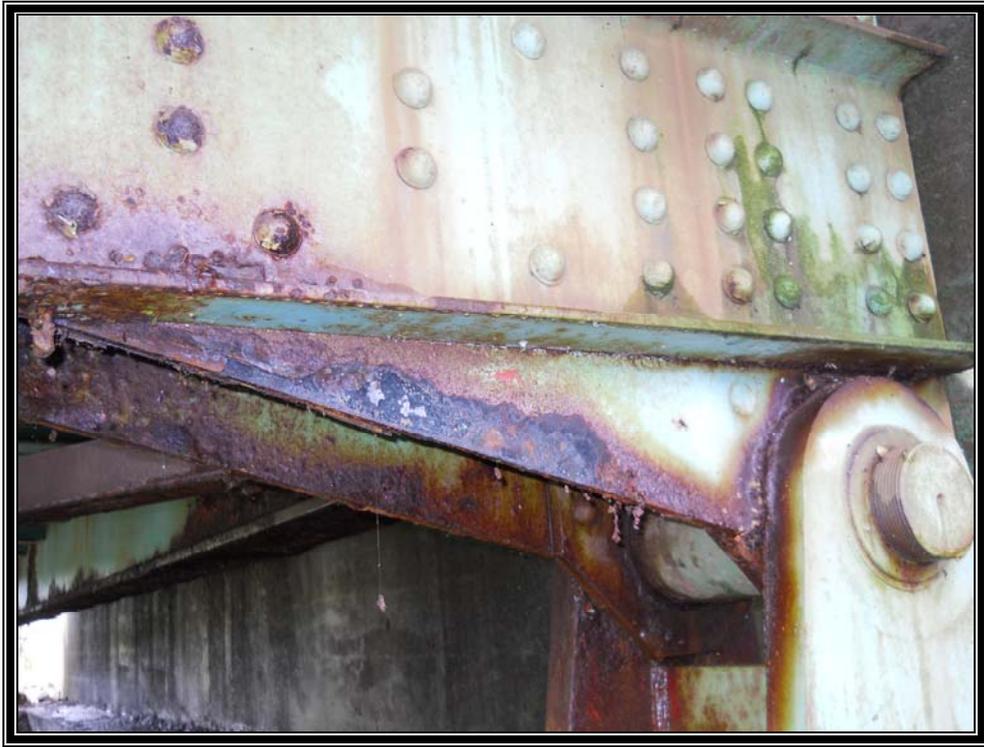
Photo 76: Span 1 North Truss Rocker Bearing with Missing Pin Cap

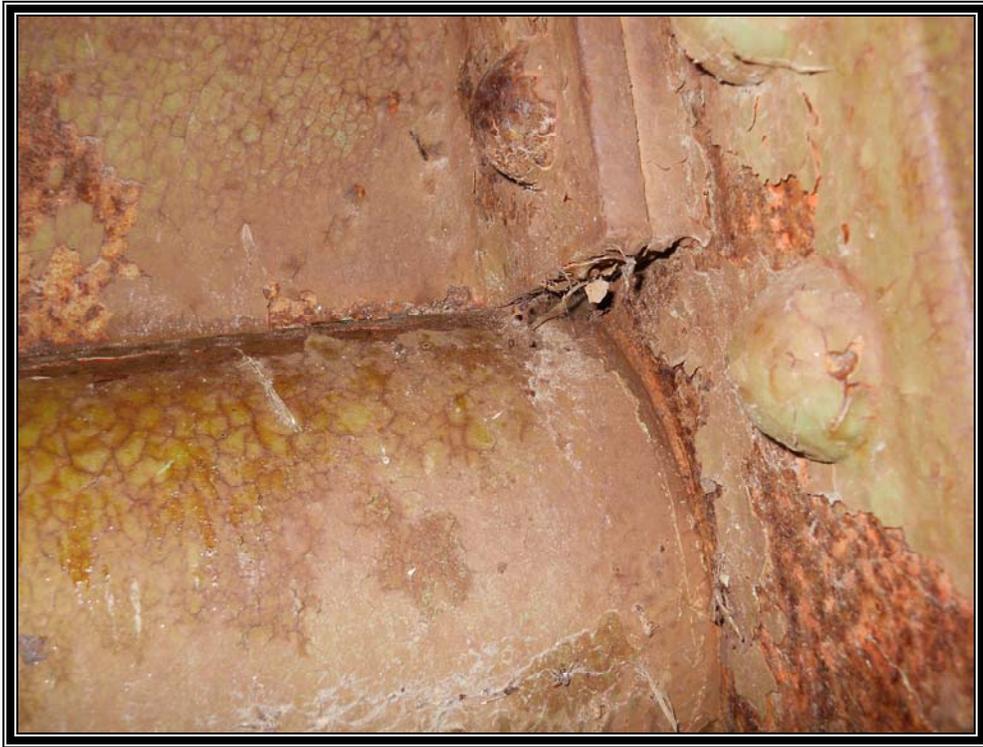
Photo 77: Span 2 North Truss Rocker Bearing Deformation (Shoulder)

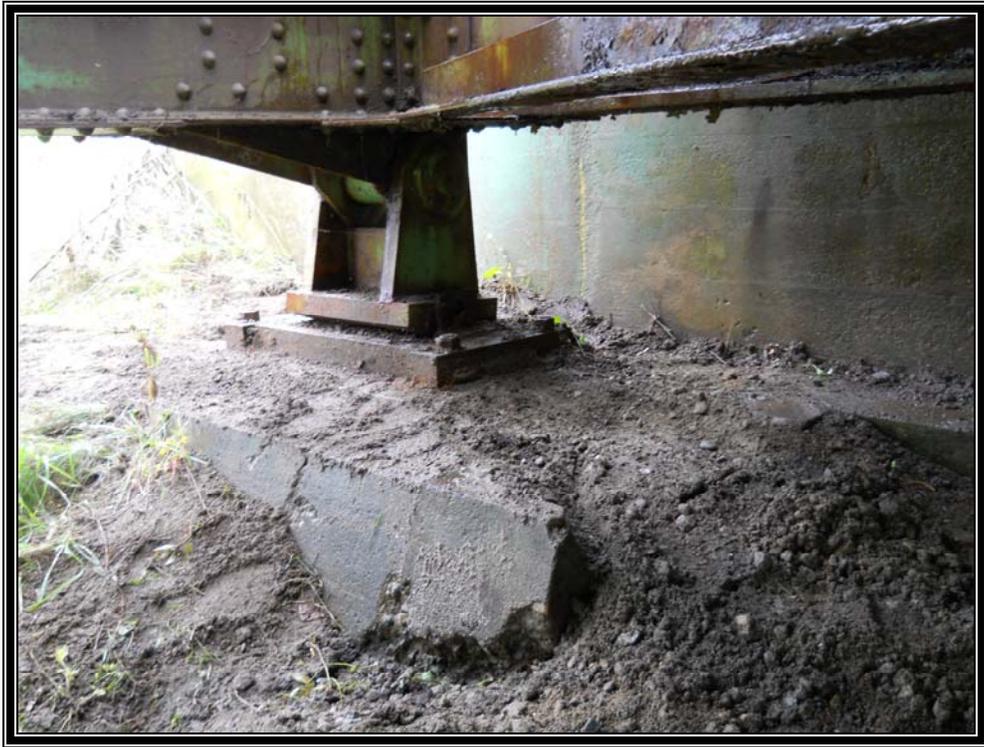
Photo 81: Vermont Abutment South Truss Bearing Seat Deterioration

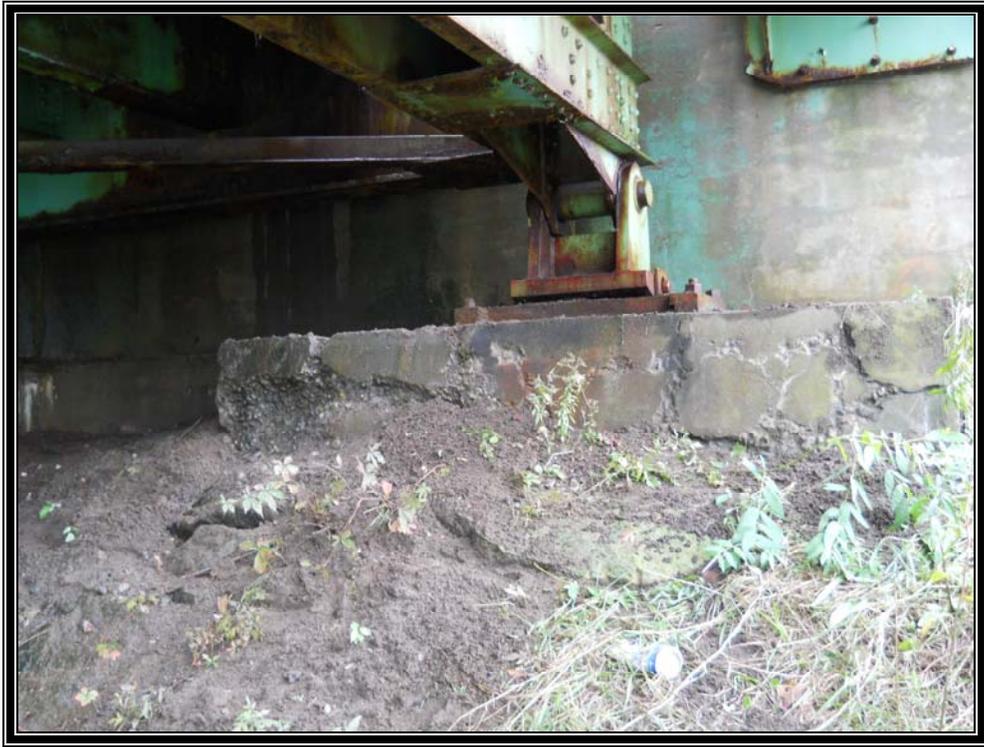
Photo 82: Vermont Abutment North Truss Bearing Seat Deterioration

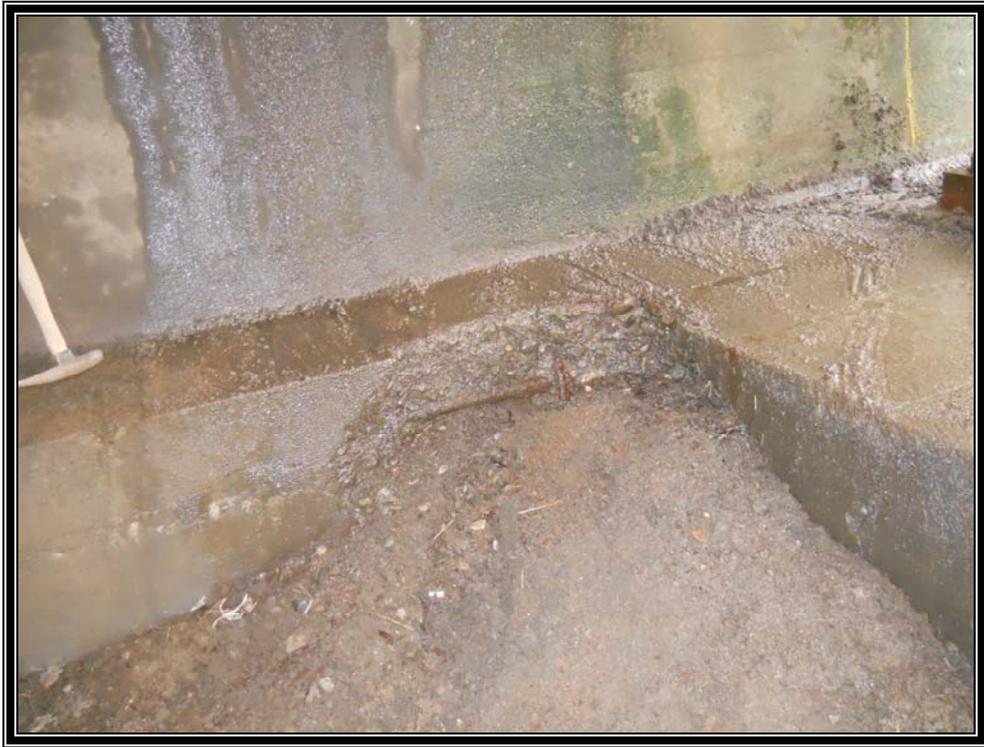
Photo 83: Vermont Abutment Concrete Spall with Exposed Reinforcement

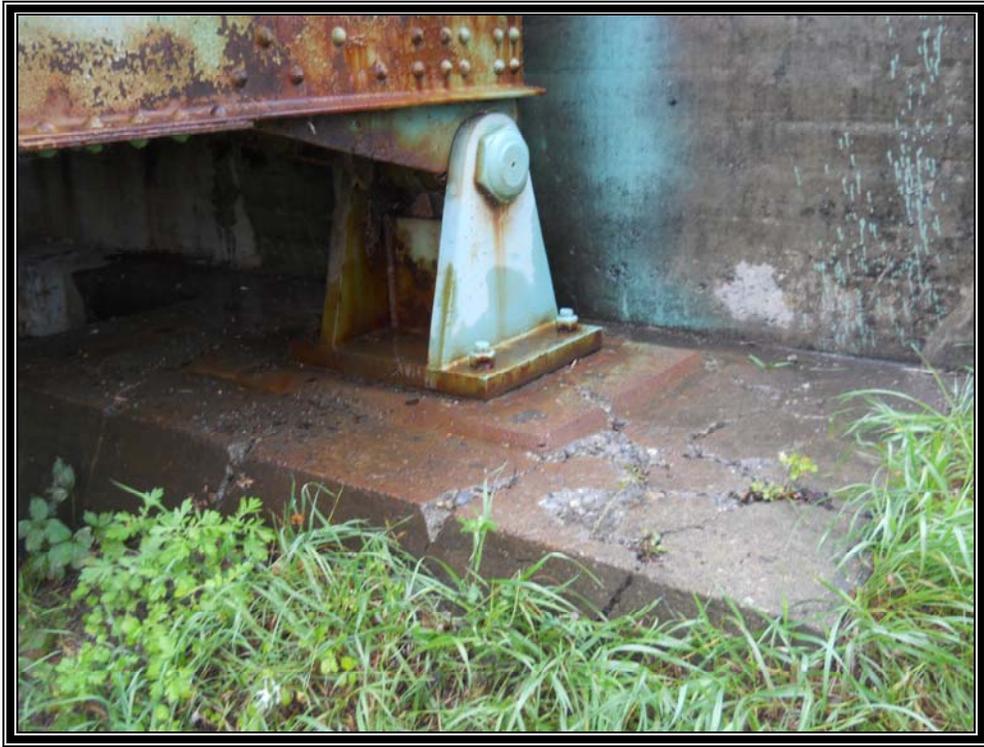
Photo 84: New Hampshire Abutment South Truss Bearing Seat Cracking and Spalling

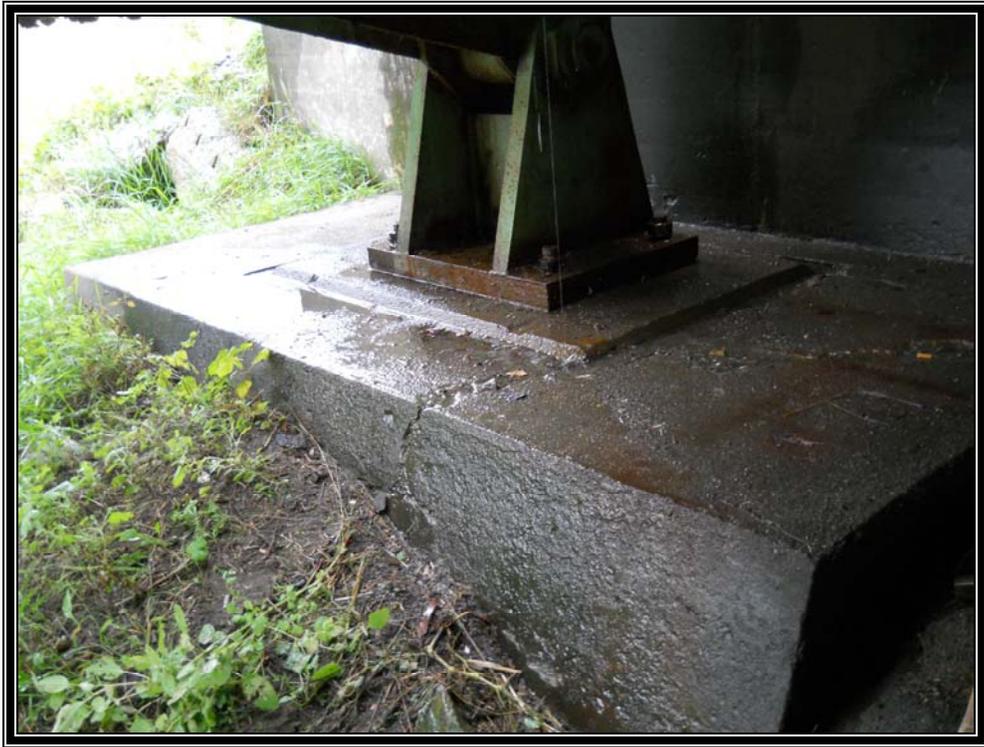
Photo 85: New Hampshire Abutment North Truss Bearing Seat Cracking and Spalling

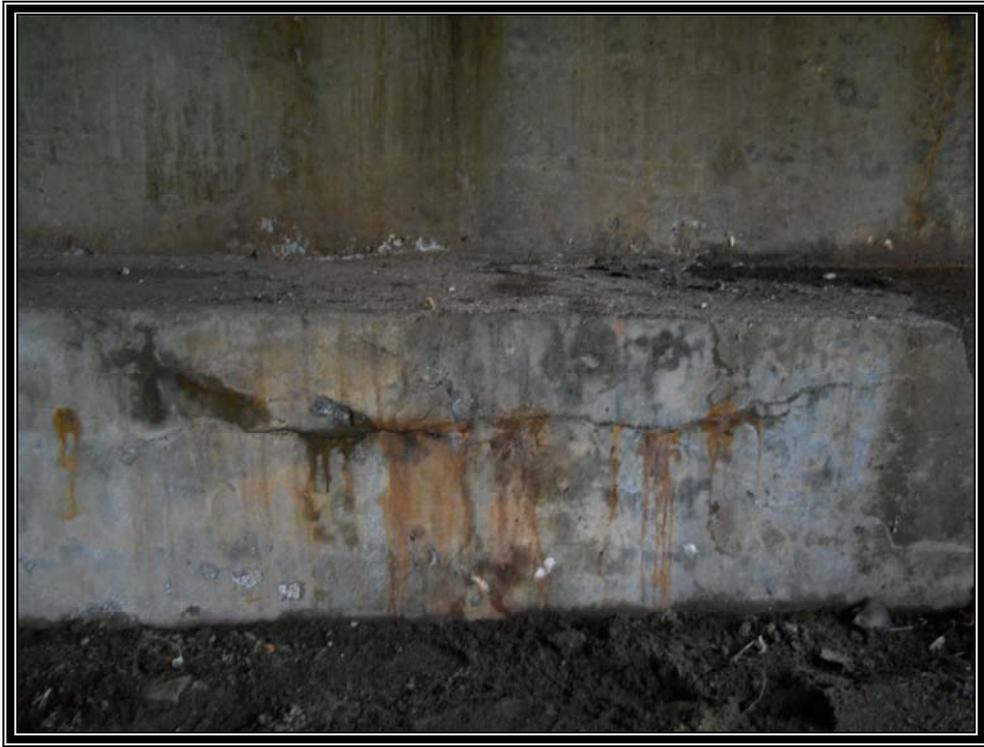
Photo 86: New Hampshire Abutment Concrete Cracking

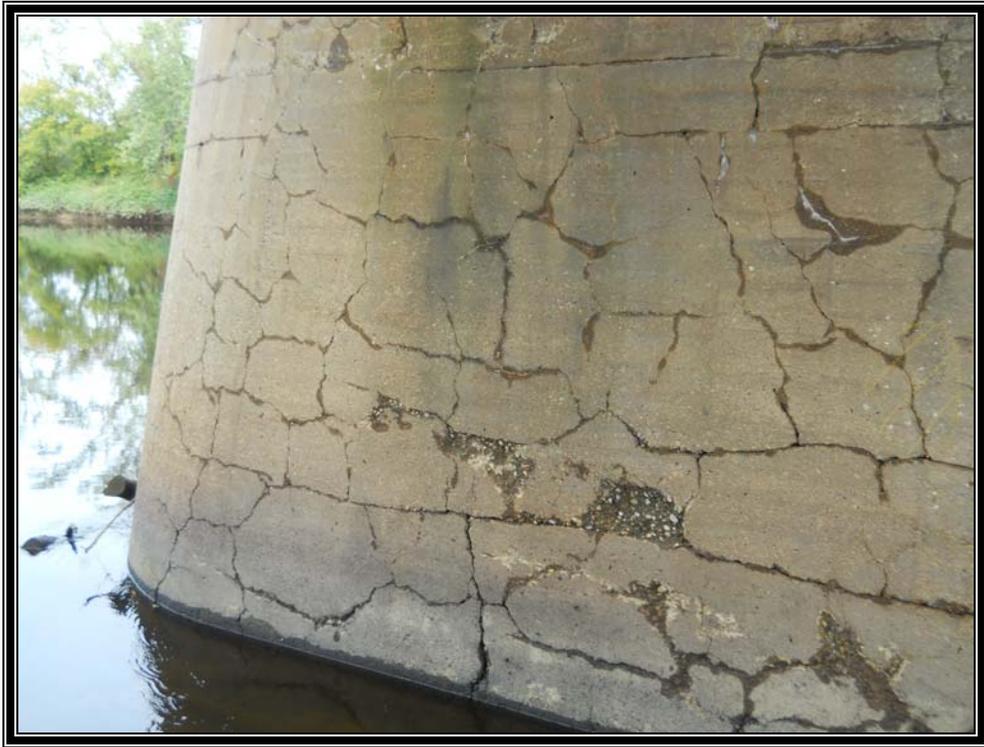
Photo 87: Typical Pier Map Cracking (West Face Looking East)

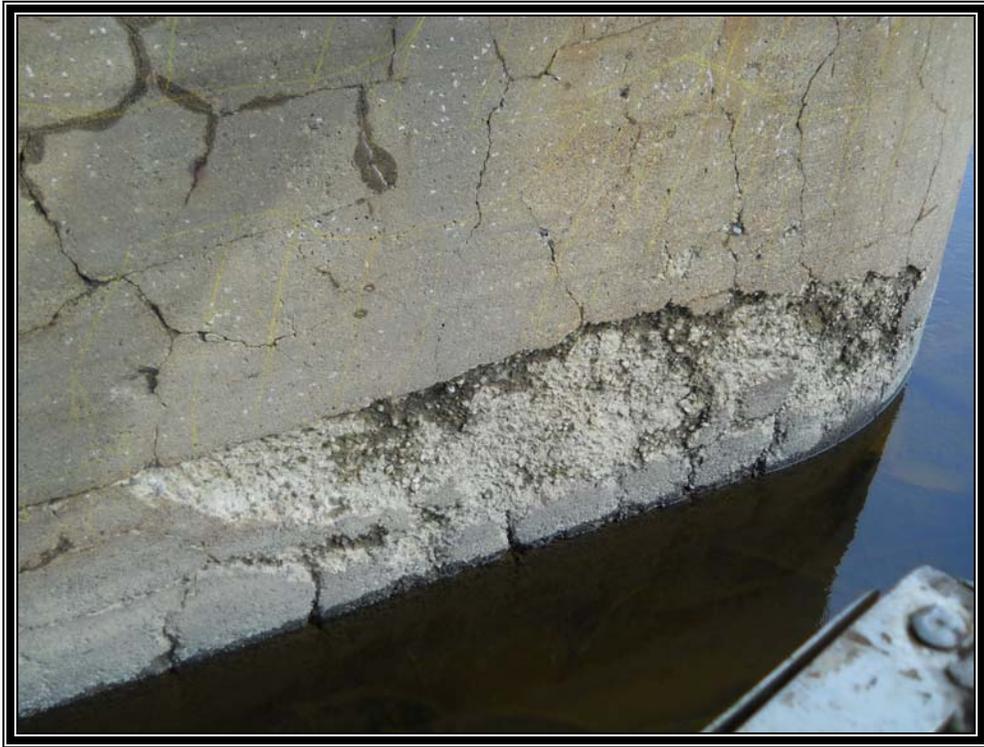
Photo 88: Large Concrete Spall on Pier West Face

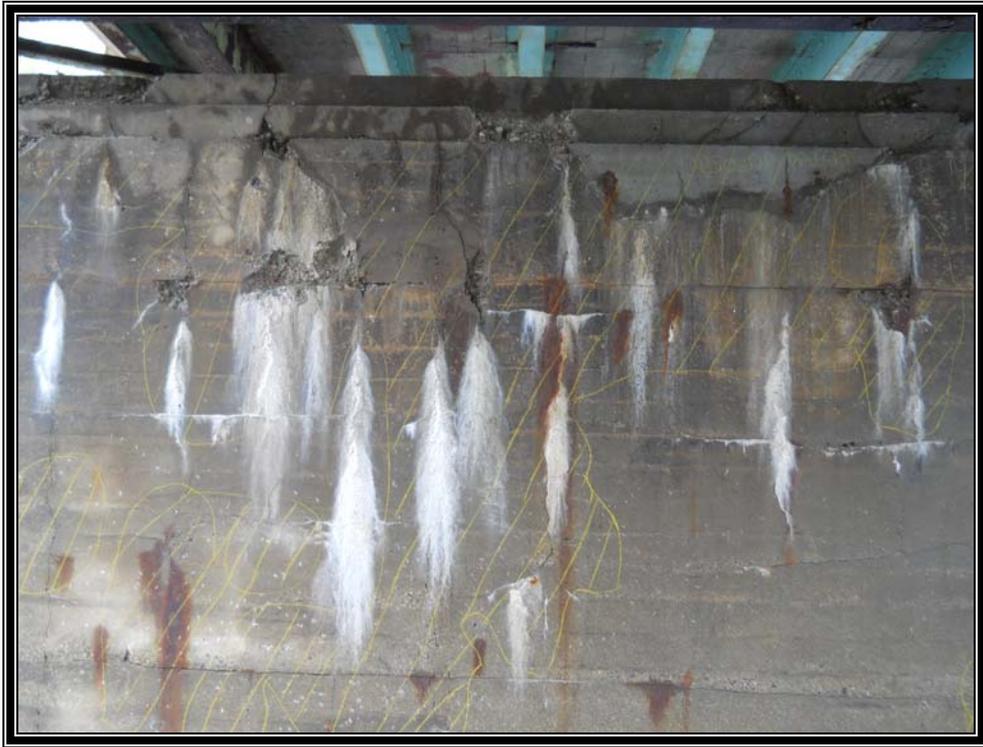
Photo 89: Pier East Face Looking West – Concrete Cracking, Spalling, Efflorescence and Mapped Areas of Delamination
