US Route 2 (Rogers' Rangers) Bridge -Lancaster, NH – Guildhall, VT
NHDOT Bridge No. 111/129 – Project No. 16155
Inspection Photos

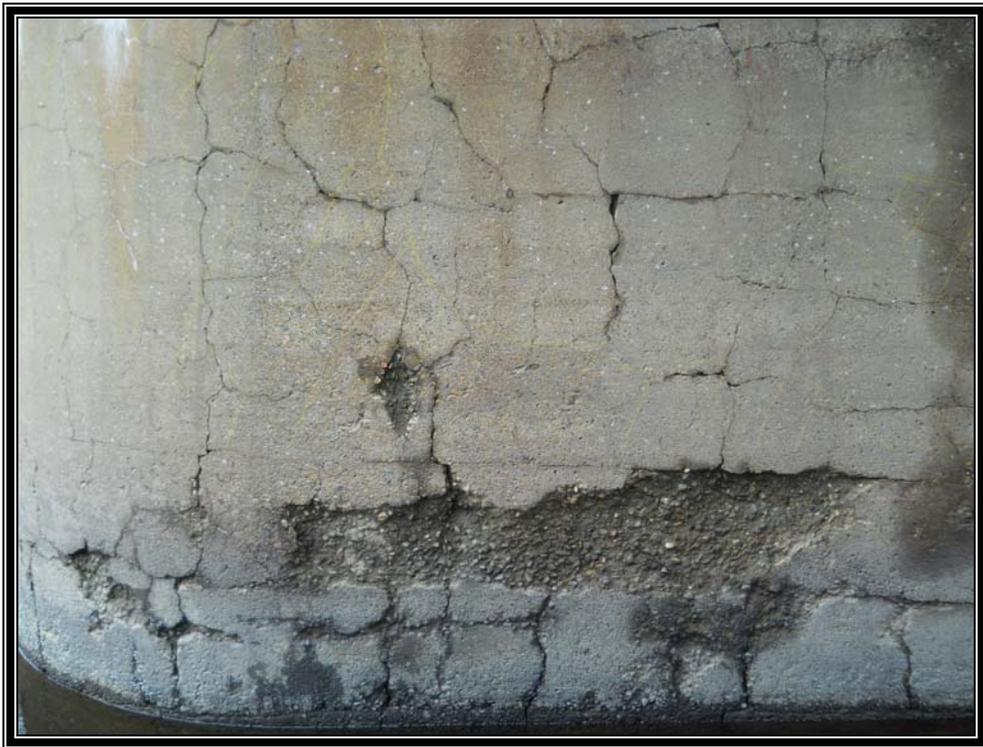
Photo 90: Large Concrete Spall on Pier East Face
