## Underwater Inspection Report

## **MEMORIAL BRIDGE**

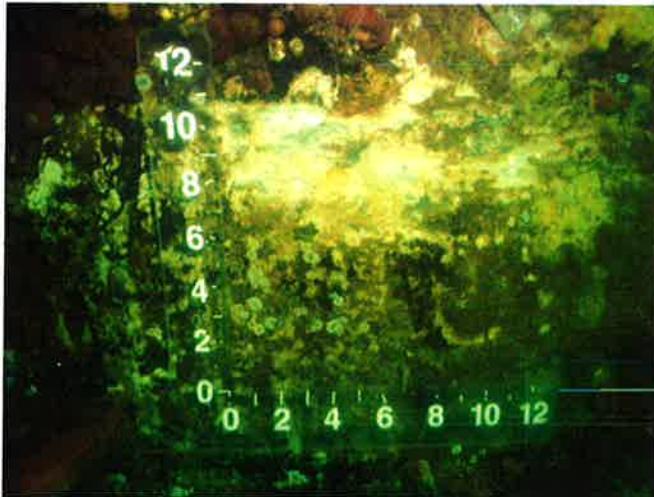
The concrete is generally in overall sound condition with limited areas of minor deterioration. The deterioration is generally more concentrated around low water. In the low water zone hammer soundings identified that the outer ½-inch of concrete is soft (Photo 1&2). Once the deteriorated concrete was removed, the underlying concrete was sound. The structure also has 12-inch by 12-inch block outs in the concrete from timber members that were originally cast into the piers and marine borers subsequently deteriorated the timber. These voids extend approximately 12-inches into the structure and have had no deleterious effect on the concrete pier (Photo 3).

Photo 1:  
Typical concrete deterioration  
around low water. Limited to ½-inch  
in depth.

No repairs are recommended to the underwater portions of the concrete piers.

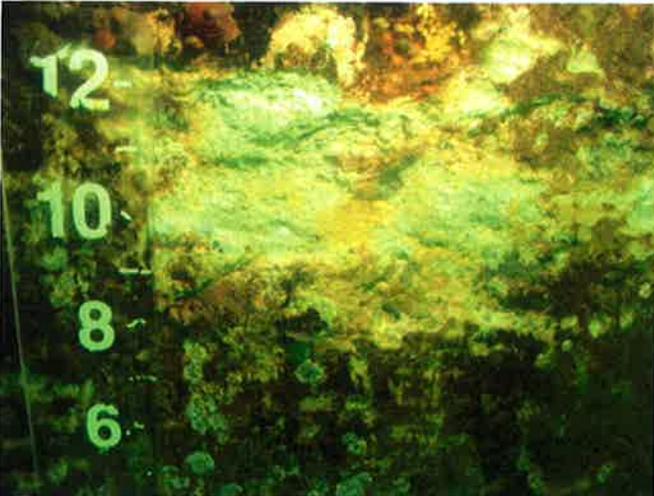
Photo 2:  
Close view of deterioration after  
hammer removal of deteriorated  
concrete.

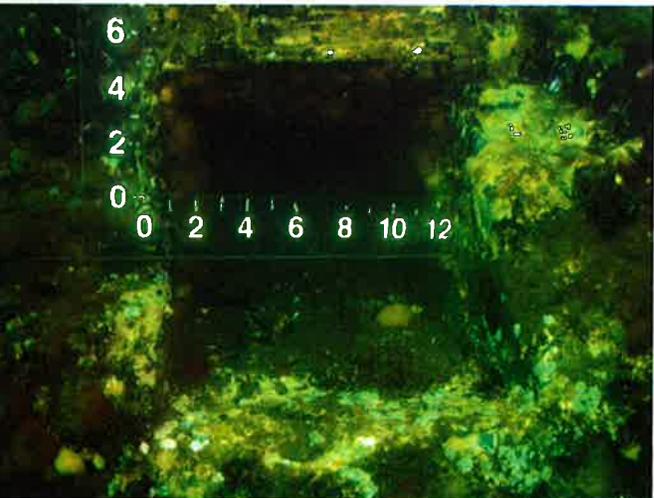
Photo 3:  
Typical blockout in the concrete piers  
where timber elements were once  
connected. Concrete is sound at  
these locations.

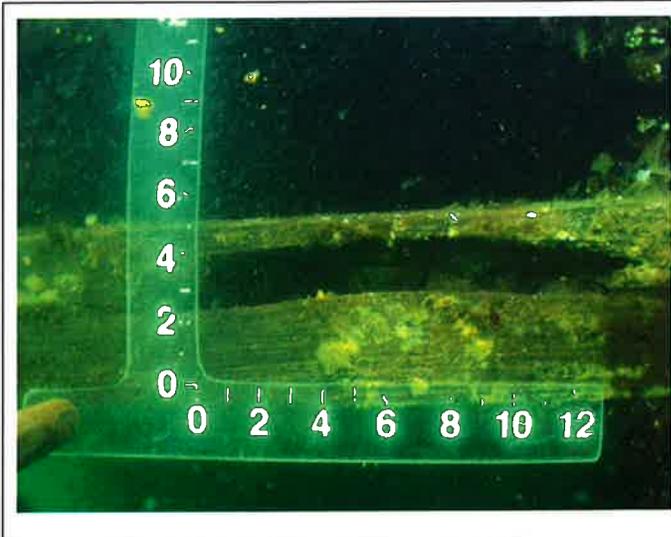
The timber fender systems have moderate marine borer deterioration throughout (Photo 4). The deterioration has progressed since the 2003 inspection and estimated to have affected approximately

10% - 20% of the timber members. It is important to note that marine borer deterioration is difficult to detect and could be more prevalent within the interior of the timber members.

Photo 4:  
Marine borer deterioration to the  
fender system.

The fender system is progressively deteriorating and recommended it be replaced in the short term (0-10 years). Our estimate of the probable cost of construction is depicted in Table 1 and is based on in-kind replacement.
