**Conditions Assessment of the  
Old State House  
Concord, New Hampshire**

**CONDITIONS ASSESSMENT REPORT**

Christine Miller

January 2008

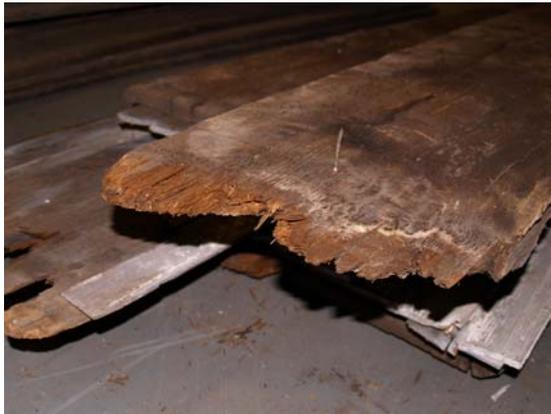
Rot: Areas of rot show signs of discoloration and a weakened wood structure. The rotted wood can range in appearance from a slightly lighter color to a reddish color. Sometimes the wood has been severely damaged and retains no structural integrity, whereas at other times the rot is scarcely visible. See Figures 3 and 4 for examples of wood rot.

Figure 3 - View of an element that has rotted, resulting in partial loss

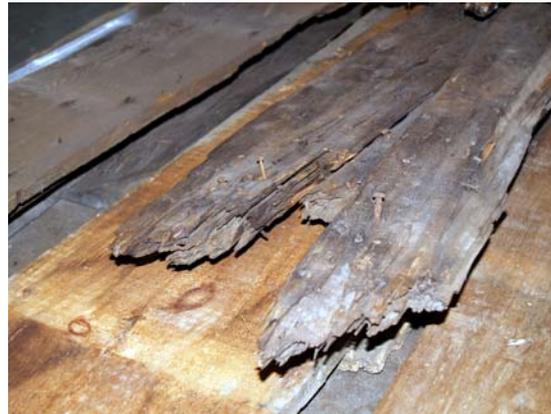
Figure 4 - View of an element that has severely rotted, resulting in cracking and partial loss

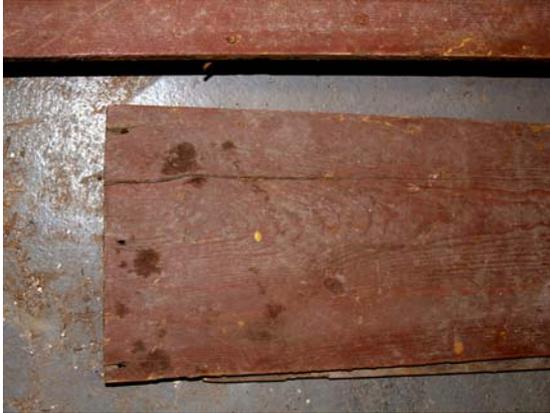
Cracking: For purposes of this assessment, any time a wood element had a through-body crack, it was recorded as cracked. See Figures 5 and 6 for examples of cracking.

Figure 5 - View of an element that has cracked

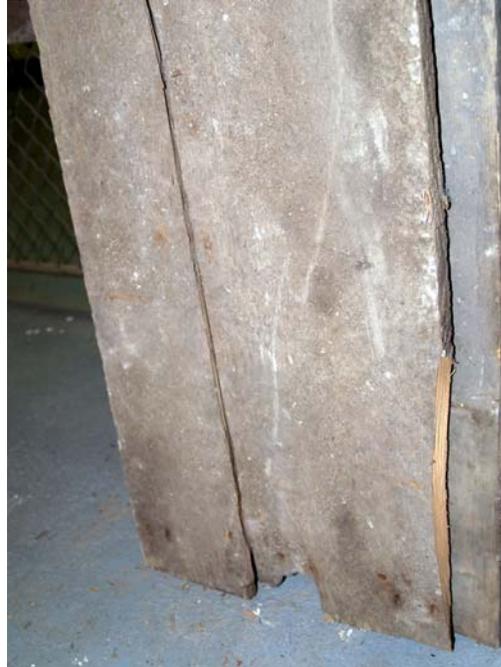
Figure 6 - View of an element that has cracked

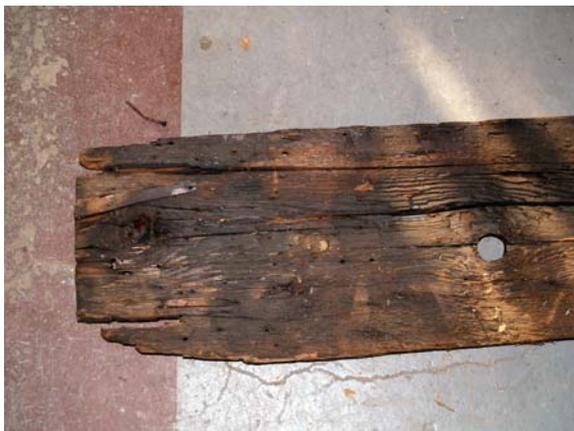
Splintering: The wood elements were recorded as splintered if they had extremely minor cracking of the wood that did not result in a through-body crack of the wood element. See Figure 7 for an example of splintering.

Figure 7 - View of an element that has splintered

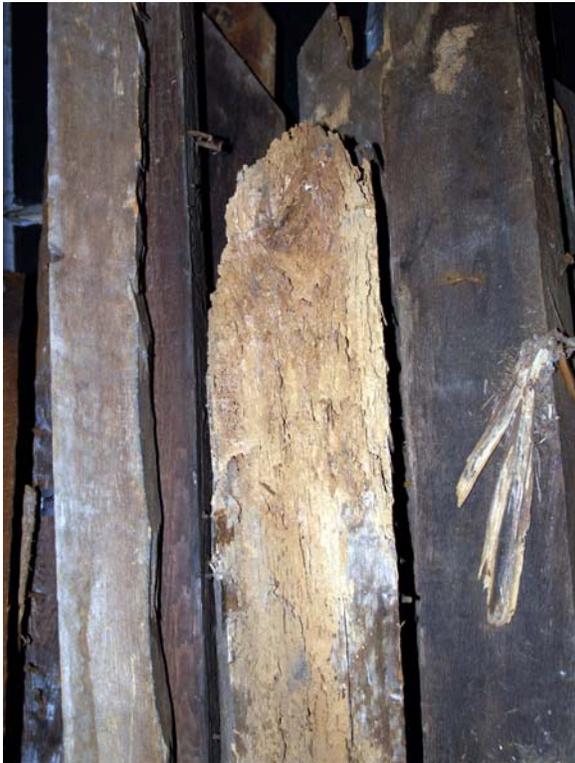
be accompanied by frass, which resembles sawdust, depending on the type of insect damage. Insect damage can result in a severe weakening of the wood's structural integrity. See Figures 8 and 9 for examples of insect damage.

Figure 8 - View of an element that has suffered from insect damage

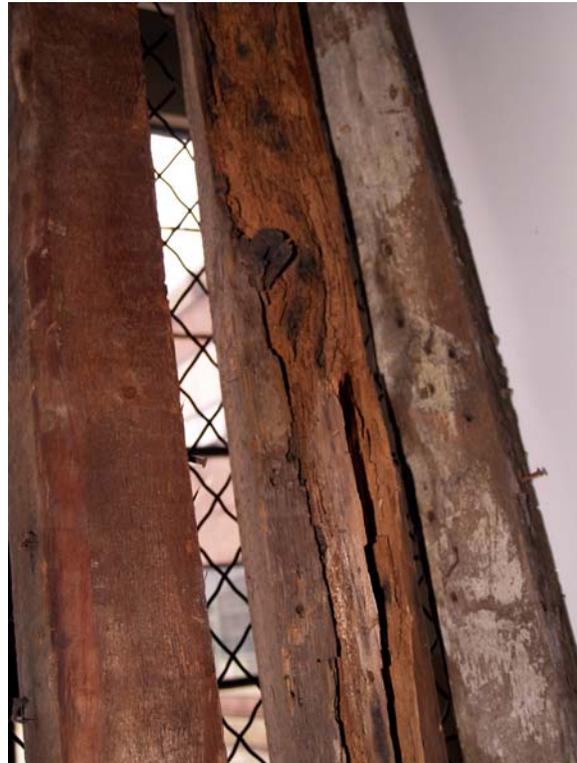
Figure 9 - View of an element that has suffered from insect damage
