JAMES L. GARVIN

**REPORT ON THE FOGG-ROLLINS BARN
44 HAMPTON ROAD, EXETER, NEW HAMPSHIRE**

JANUARY 26, 2012

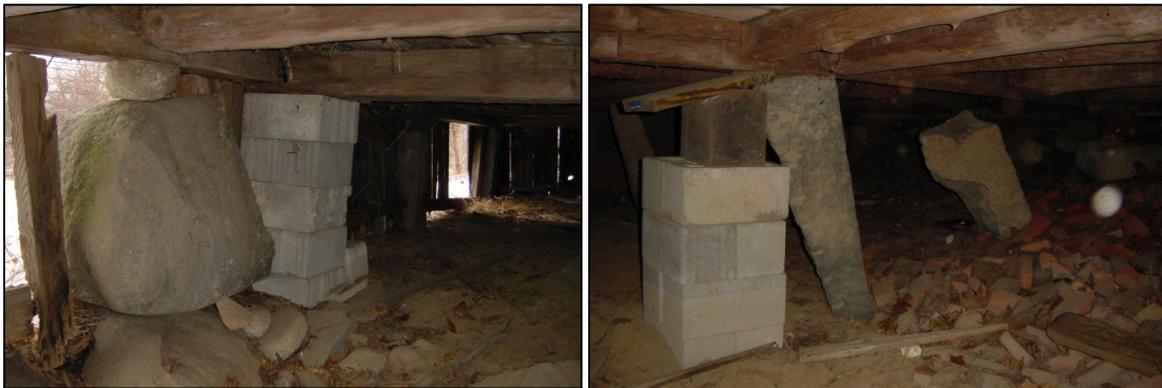
Substructure. The barn is supported on perimeter foundation walls of irregularly placed dry-laid fieldstone and boulders, and on interior piers that for the most part are posts of split granite. The splitting technology of the granite posts denotes a date after circa 1830, so it may be theorized that most of the split granite piers under the barn were added when the barn was enlarged in the mid-1800s.

In many if not most cases, these supports have shifted or subsided, often having tipped as a result of uneven freeze-thaw cycles in the soil around their feet. A number of supplementary piers of timber and/or concrete blocks have been inserted at points of lost support, as seen above. In many cases, the barn frame above these points of support had deformed and settled before supplementary piers were added. The frame of the barn, especially the newer or western portion, thus remains in distorted condition, as described below.

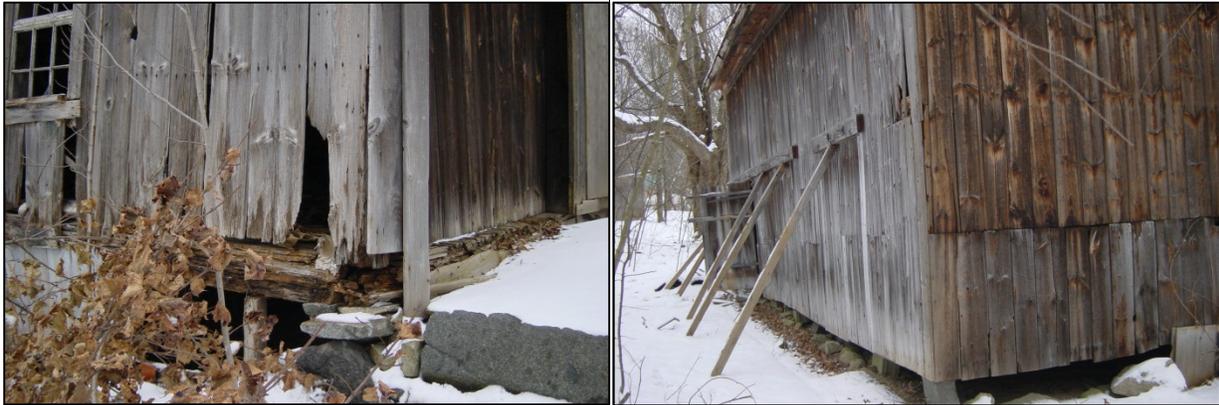
As might be expected, the perimeter sills of the barn, being close to the ground and affected by rainwater falling from the eaves of the roof, have suffered varying degrees of decay. This is especially true on the south side of the barn, facing Hampton Road. Here, as is usual with wooden buildings, the eroding effect of ultraviolet light from the sun has accelerated the deterioration of the vertical sheathing boards, leaving the southern sill of the structure especially exposed to rainwater from the roof, as seen in the photograph below, left.

The sills on the northern and western sides of the barn, though nearer to the ground, have been better protected by relatively intact sheathing, and appear to be in acceptable condition, as seen above, right.

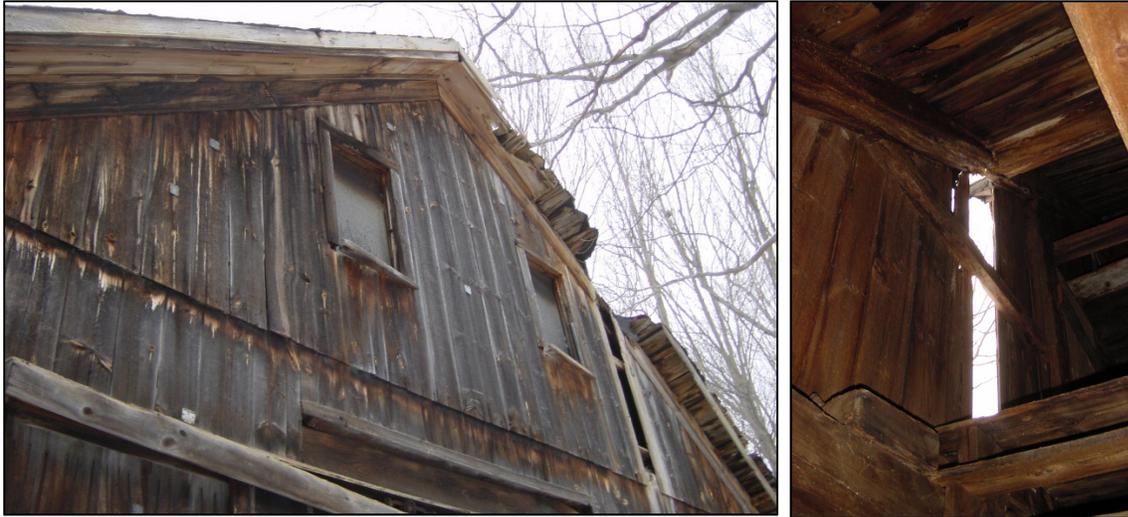
More serious than these older leaks is an active leak near the northeastern corner of the barn, shown in the photograph on page 9, left. This leak reportedly began with roof damage from a falling branch of a large sugar maple that stands just east of the barn. The branch damaged the

rake of the roof and penetrated the sheathing above the outer principal rafter, at a critical point just above the joint between the rafter and the purlin, as shown below, right. The leak was never repaired, and water penetration has progressively rotted the rafter at its center point, and the end of the purlin, threatening the integrity of a substantial portion of the northern roof plane. Continued water penetration here also threatens the original wall plate of the English barn, seen at the lower left corner of the photograph below, right.

This point of structural weakness can be temporarily supported by props extending up from the tie beam to the undersides of the rafter and purlin.

Short-term treatments must start with repair of the damage and leak near the northeast corner of the roof. Because of the crucial function of the principal rafters and purlins in this roof, and because this leak is precisely above the juncture of two such members, the leak threatens the entire slope of the roof. After the leak is repaired, it would be advisable to extend wooden props from the beam below the leak to the decaying rafter and purlin to ensure their support until the rafter can be replaced. At present, it is possible that the decayed front rafter is being supported and prevented from breaking largely by the vertical sheathing boards that are nailed to its side.

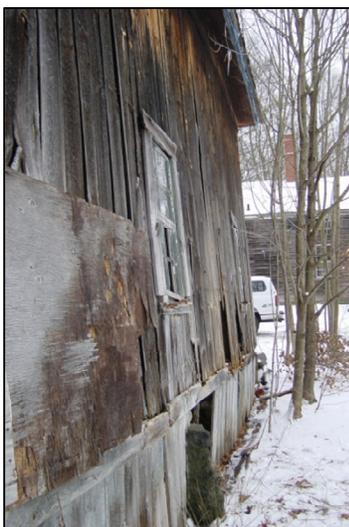
A more pervasive threat to the barn is the severe racking and twisting of the entire structural fabric, caused by the subsidence of the underpinning and piers, described on page 7. This movement has caused both localized and generalized distress, and now threatens the stability of the entire structure. Readings taken by Fred Emanuel on January 23, 2012, indicate that the barn is out of plumb by 4 inches in 48 inches from north to south, and 1¼ inches in 48 inches from east to west. As seen on page 8, an attempt has been made to prop the barn on its north side.

The degree to which the barn leans to the north can be seen by sighting along its southern wall toward the plumb walls of the dwelling beyond, as shown in the photograph at the left.

Because the modern ties of two-inch planking that were added to the roof frame do not extend continuously across the entire building, they have limited effectiveness in restraining the structure in its leaning condition. Pending the jacking of the building and its return to plumb and level condition, consideration might be given to cabling the structure from within to prevent its continued distortion, especially in the north-south direction.

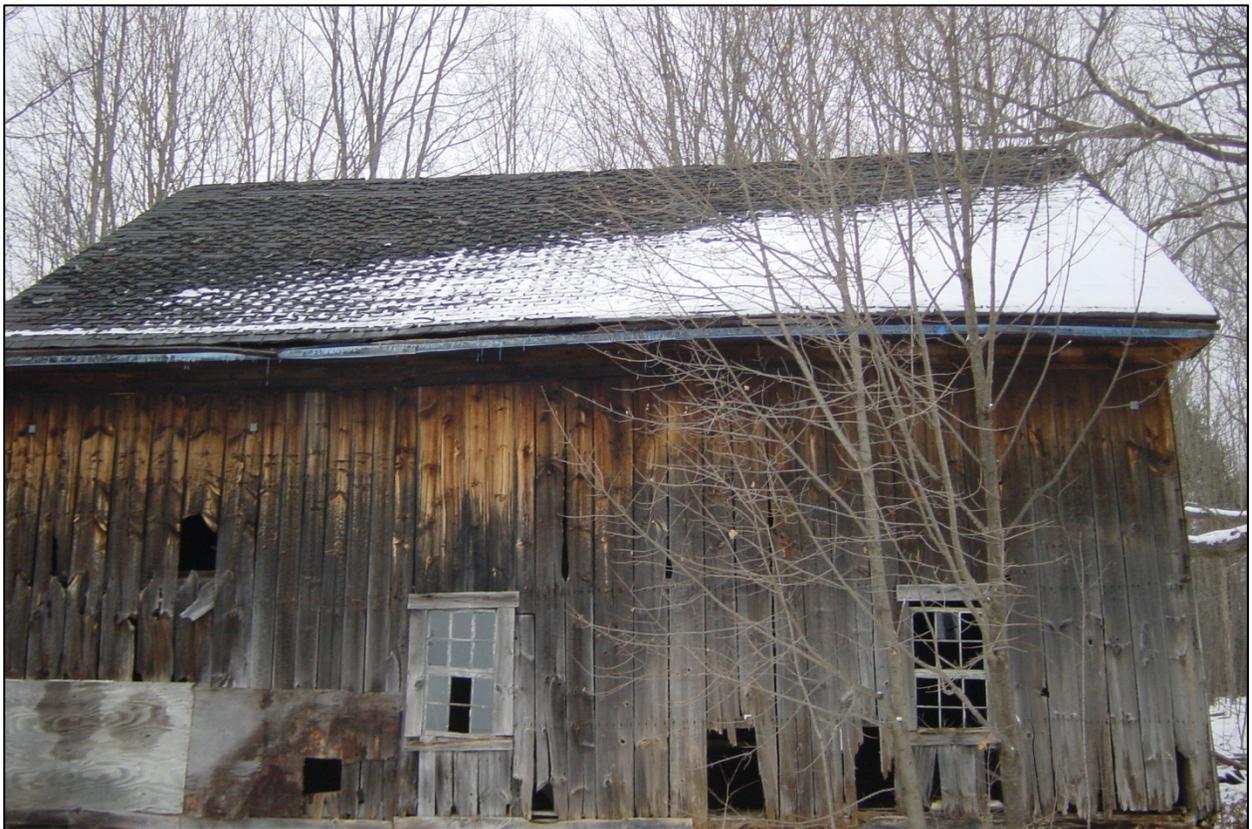
The considerable distortion of the frame through subsidence, tipping, and racking is visible on the southern elevation of the structure, as seen below. Particularly noticeable is the depression in the southwestern quadrant of the roof. This is caused by the subsidence of the former rear wall post of the English barn, mentioned above, which has telegraphed its movement to the rafter and purlin above. As seen in the diagram on page 6, the structure of the roof of the enlarged barn is not exceptionally heavy, and subsidence of a principal rafter and a purlin will be followed by subsidence of the lighter common rafters, and of the entire roof plane, as seen below.

The sheathing on the north side of the barn survives in generally good condition. The sheathing on the south elevation is badly eroded and decayed, especially at its lower ends, as seen in the photograph on page 10. The quality of sheathing on the old English barn is superior to that of the mid-nineteenth-century extension, both in width of boards and freedom from knots.

As seen in the photograph on page 10, there is severe deterioration at mid-height in the newer boarding at the western end of the south elevation. The fracture of the boards suggests failure in compression, apparently caused by subsidence of the upper frame. (The area covered by plywood is a row of window sashes that were apparently salvaged from the dwelling when it was remodeled in 1854 and now light a former hennery in this part of the barn.)

Roofing. The roof shingles of the barn are in failing condition, at least on the southern slope, as shown in the photograph on page 10. This slope was formerly covered with a polyethylene tarpaulin, which has rotted and blown away, suggesting that the roof was actively leaking, yet no sign of water or ice was noted inside the building during the inspection on January 23.

For the protection of the underlying framing elements cited in the preservation easement, it will be necessary to replace much of the sheathing on the south elevation of the barn. It may be possible to preserve the upper portions of boards that remain in acceptable condition, re-covering the lower zones of the wall. This has been done on portions of the north and west sides of the building, as seen in the right-hand photograph on page 8.

Because the roof shingles are in failing condition, they will require quick replacement. Even if it is not yet leaking, a roof in this condition can deteriorate very rapidly under certain weather conditions and develop pervasive leakage in a matter of weeks. Because the south roof plane is distorted and will need to be returned to its proper geometry through repairs to the frame, it may be advisable to strip the roof and cover the sheathing temporarily with roll roofing, pending the straightening of the frame. If the roof covering should be torn during straightening of the building, the monetary loss will be considerably less with a papered roof than with a shingled roof.

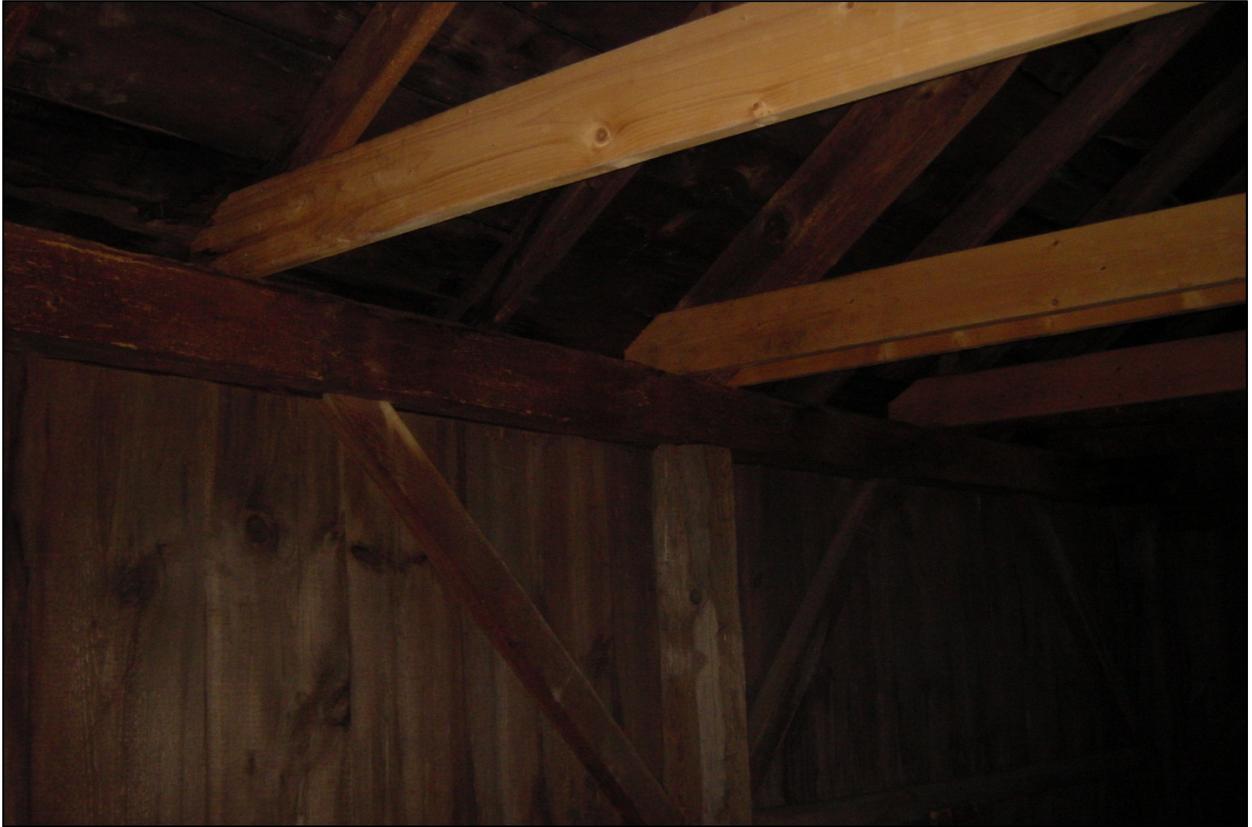
There have been attempts to restrain the movement of the upper frame of the barn. There was apparently a perception in recent years that the upper walls were spreading and the roof was flattening, probably due to snow loading. For this reason, considerable effort was made to tie the north and south walls of the structure together through the insertion of sistered ties through the barn at the level of the wall plates, as seen in the photograph on page 11. Similarly, a number of collar ties were nailed to the sides of both principal and common rafters at about the midpoint of the height of the roof frame. These new members are all two-inch planking.
