**REPORT ON THE OLD HAVERHILL ACADEMY BUILDING
(PEARSON HALL)
HAVERHILL CORNER, NEW HAMPSHIRE**

**JAMES L. GARVIN
NOVEMBER 30, 2008**

REPORT ON THE OLD HAVERHILL ACADEMY BUILDING (PEARSON HALL) HAVERHILL CORNER, NEW HAMPSHIRE

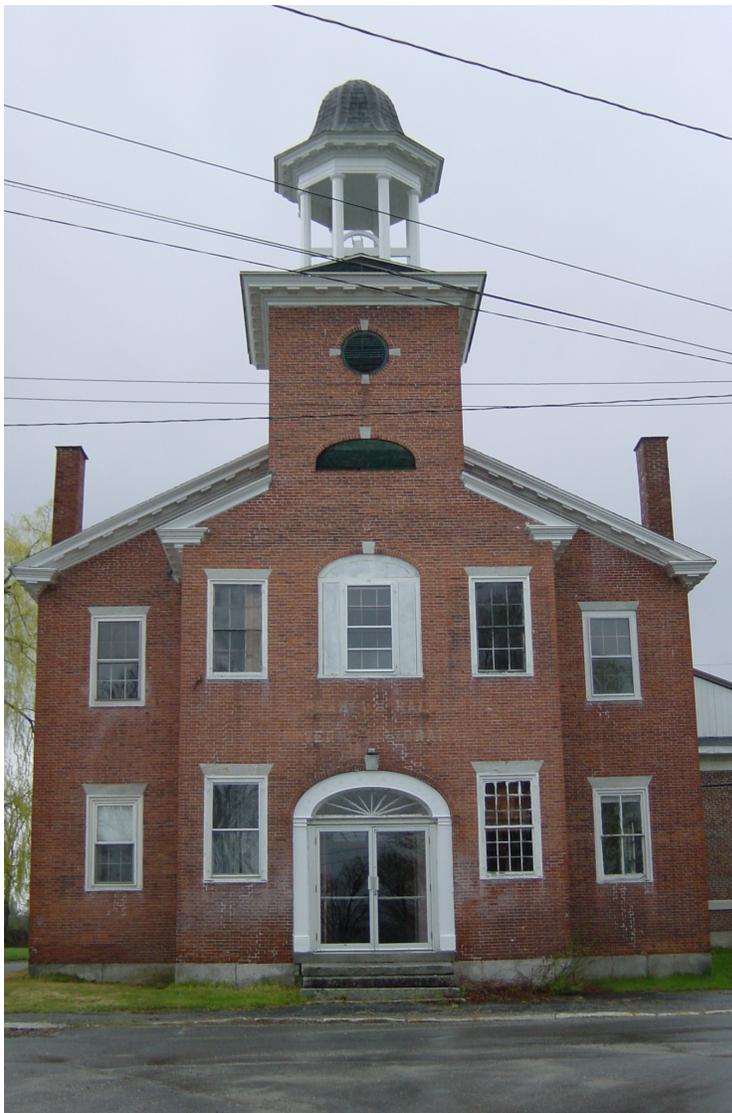
Front (west) elevation, Haverhill Academy Building (Pearson Hall), built in 1816. Photograph: April 2008.

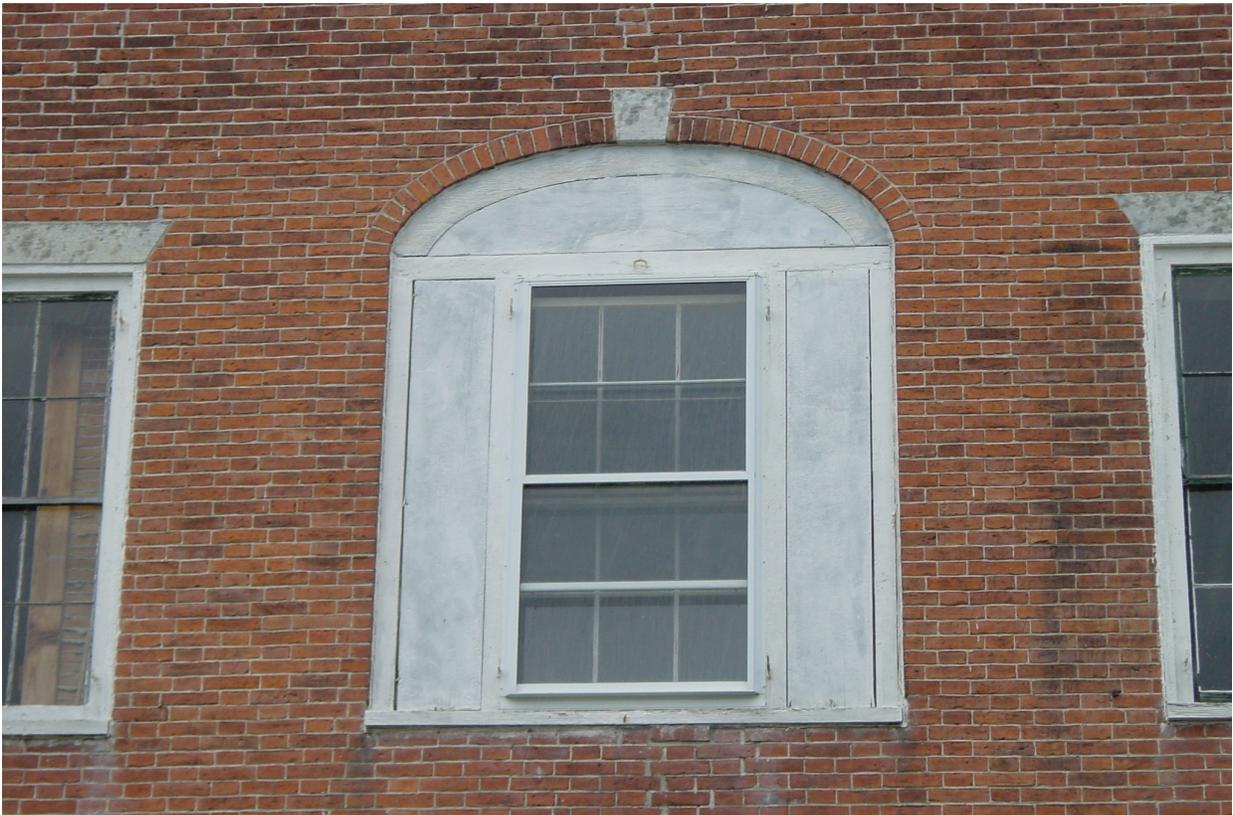
In the case of the Haverhill Academy building, the masons employed Flemish bond for the façade, but only to the height of the keystone of the arched opening on the second story. Above that elevation, well above eye level, they switched to common bond, as seen in the photograph below.

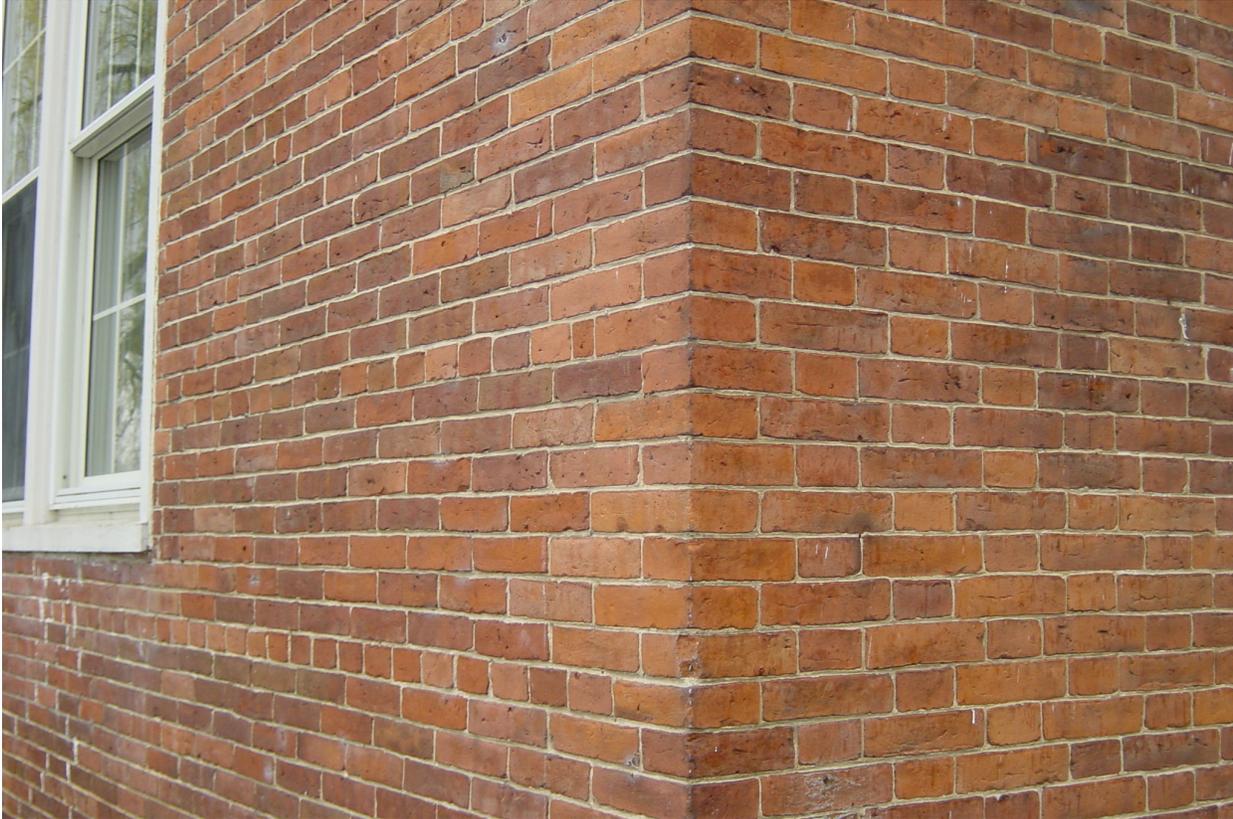
Similarly, the bricklayers used common bond for the side and rear elevations of the building, a transition that is not unusual in buildings of the early 1800s.

Front (right) and north side elevations of Haverhill Academy building, showing the transition from Flemish bond on the façade to common bond on the side walls.

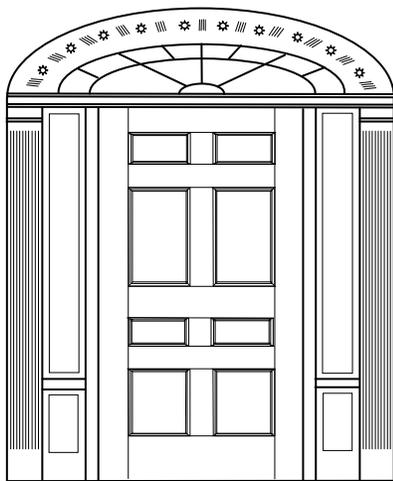
Solid board infill
on sides of door

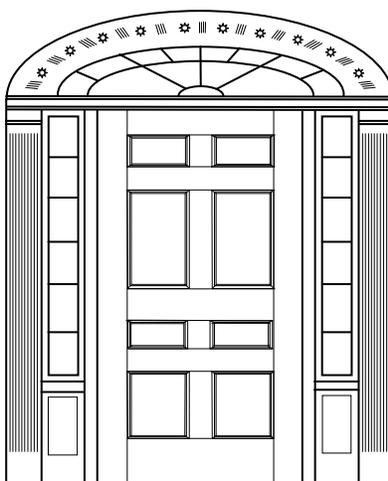
Sidelights

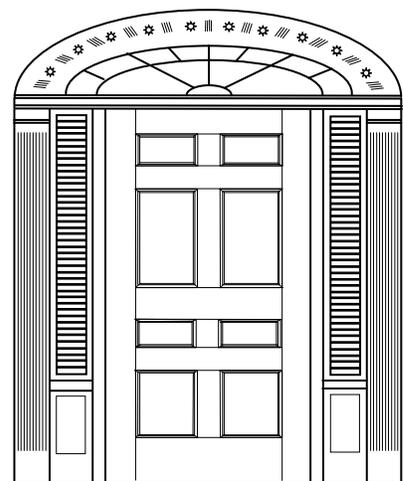
Louvered blinds covering either
solid board infill or sidelights

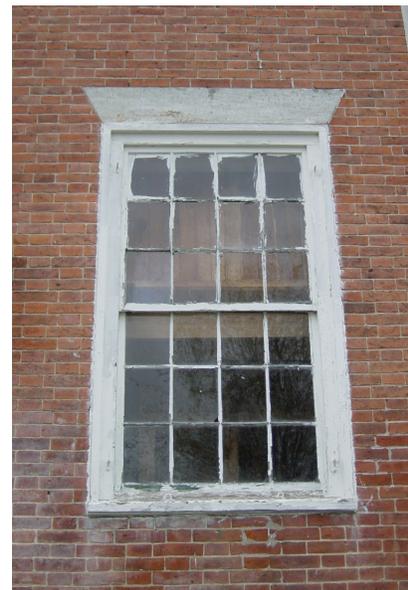
It seems likely that original staff moldings were replaced by the square stock during a program of sash replacement. The sashes in the building have been replaced several times, leaving the upper twelve-light sash to the south of the front entrance, in a window opening that has long been sealed beneath a stairway (and hidden behind closed blinds until recent removal of all blinds), as the only surviving original sash in the building; the lower sash in this opening is a later twelve-light unit.

Right: Twelve-over-twelve window in the front pavilion, to the south (right) of the front door.

Below: the muntin profile of the upper sash in this opening (not to scale). This is the only surviving original window sash in the building.

The statement that “mismatched” sashes might be replaced is not intended to suggest replacement of significant historical units that help to trace the evolution of the building. In particular, the surviving original sash, the sashes with sharp, thin muntins discussed near the top of page 11, and the awning sashes on the first story of the south elevation are significant and ought to be retained. If they cannot be retained in place for any reason, these sashes should be marked with their known history and stored permanently in the building, probably in an attic area to be reserved for the permanent preservation of architectural evidence.

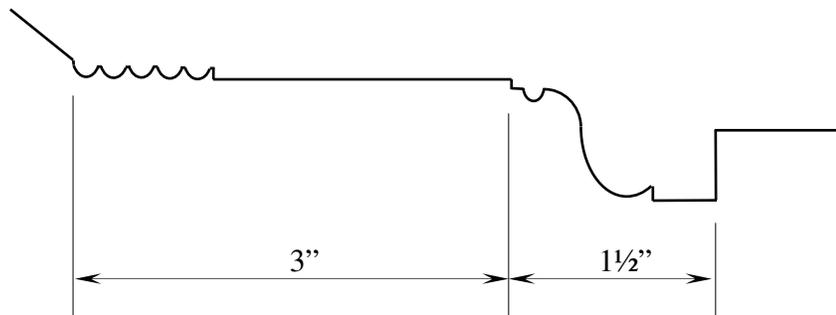
The inspection of April 28, 2008 indicated that some of the windows on the second story retain their original casings of 1816, while all the window and door openings of the first story were altered at the return of the building to academic use in 1927. The original casings of 1816 have the following profile:

Virtually identical door and window casings appear in the nearby Grafton Hotel, a contemporaneous brick building.

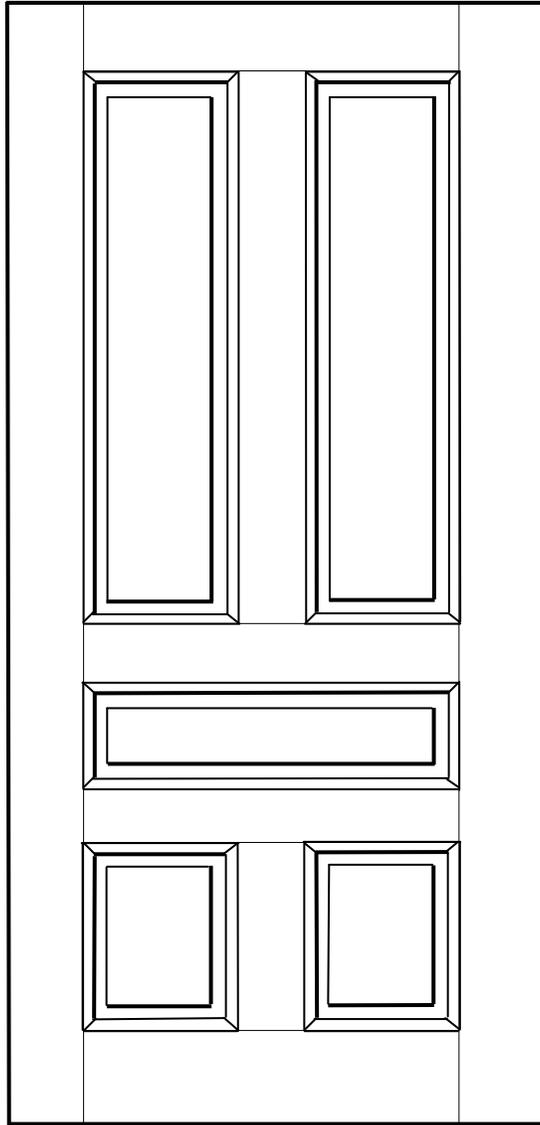
Five-panel doors dating from 1897

Most of these doors are five-panel doors with a single wide panel below the latch rail. They have the cross-section shown below.

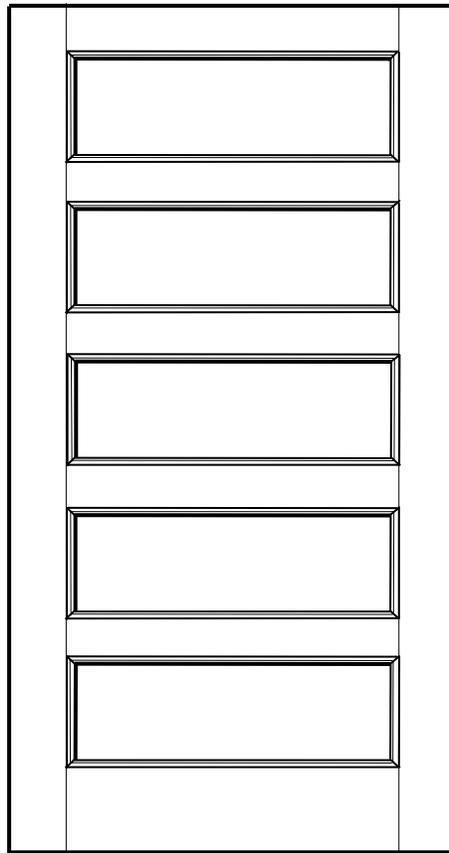
The doors that characterize the 1927 remodeling are mostly seen on the first story, where the former auditorium was subdivided into classrooms flanking a central corridor. Two of them also open into the former library on the second floor, a room that was apparently remodeled as a lodge room for Grafton Lodge, F&AM, in 1929 and was more recently used as a science laboratory. These are five-cross-panel doors, a type that was common during much of the twentieth century:

Five-cross-panel doors, presumed to date from 1927
