REPORT ON MOISTURE CONDITIONS TOBIAS LEAR HOUSE PORTSMOUTH, NEW HAMPSHIRE

JAMES L. GARVIN

APRIL 30, 2009

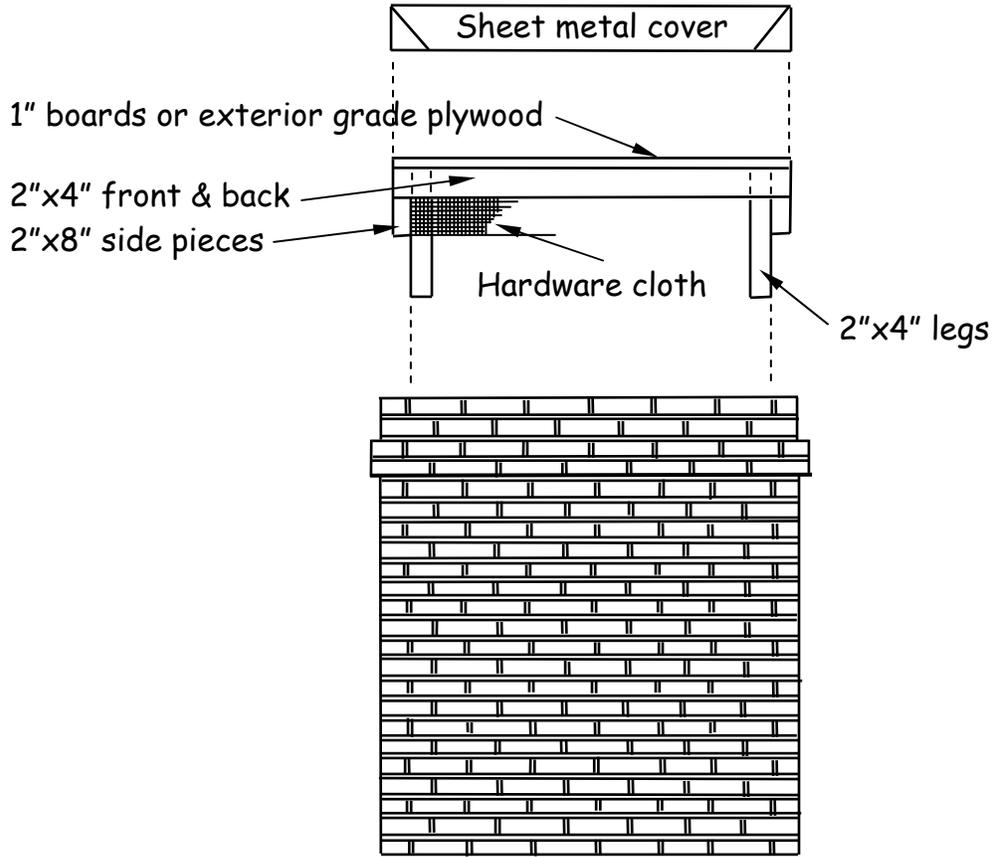
While moisture readings in the woodwork were predictably lower on the second floor and in the attic of the Lear House than at or below ground level, readings in the woodwork near the chimneys showed an elevated moisture content in some areas. This suggests (as is common) that moisture is entering the chimney stacks through the open flues, saturating the brickwork, and migrating to adjacent framing or woodwork. This effect may be especially pronounced in older chimneys, where the bricks below the roof are typically laid in a clay-sand mortar. When mason John Wastrom rebuilt the two Lear House chimneys in 2001, he deliberately reused or replicated the traditional soft mortar below the roof. Thus, these chimneys remain as pervious to water saturation as they have always been.

While it is beneficial to exclude rainwater and snow from the chimney flues, it is likewise beneficial to encourage natural, drying convection currents to continue to rise through the flues and to carry off moisture in the brickwork and in the internal atmosphere of the rooms that are served by the fireplaces.

The drawing on page 7 offers one suggestion (of many that might be devised) for a low-profile wooden cap that would exclude rain and snow from the flues while permitting some degree of air flow upward through the chimney flues.
