NEW HAMPSHIRE DIVISION OF HISTORICAL RESOURCES

REPORT ON THE STARRETT-HARTSHORN HOUSE 22 NORTH MAIN STREET MONT VERNON, NEW HAMPSHIRE

JAMES L. GARVIN
DECEMBER 13, 1999

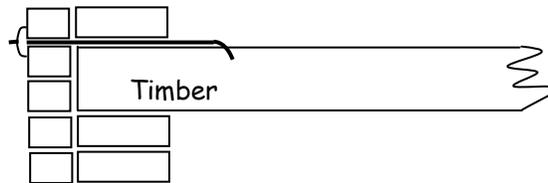
As noted above, the structural connection between the front and rear portions of the house is reflected in the vertical joints in the brickwork at the sides of the house. Other features of the building reflect the need to bind these two separate areas of brickwork together. Along the front, under the porch ceiling, may be seen a series of cast iron washers. These are connected to iron rods that extend back into the house along the principal timbers that run from front to back. The purpose of these anchors is to permit these timbers to act as tension members, keeping the front and rear walls of the building from pulling apart over time. As seen in cross-section, these anchors are usually connected to bars that hook into the timbers, as shown below, rather than to long rods that extend through the full depth of the building. During the early 1800s, it was difficult to obtain rods long enough to run in a single length through the full depth of a structure.

While such anchors are common in tall brick buildings like mills (which are also subject to the vibration of machinery within), they are rare in small brick houses. The masons who added the front walls to the Starrett House probably saw a need to lock the front and rear walls together because the vertical joints on the sides of the building made a rather weak bond along those walls.
