New Hampshire's Concrete Aggregate and Alkali-Silica Reactivity

Statewide Assessment of Fine and Coarse Concrete
Aggregate

Final Report

Prepared by the New Hampshire Department of Transportation, in cooperation with the
U.S. DOT, Federal Highway Administration

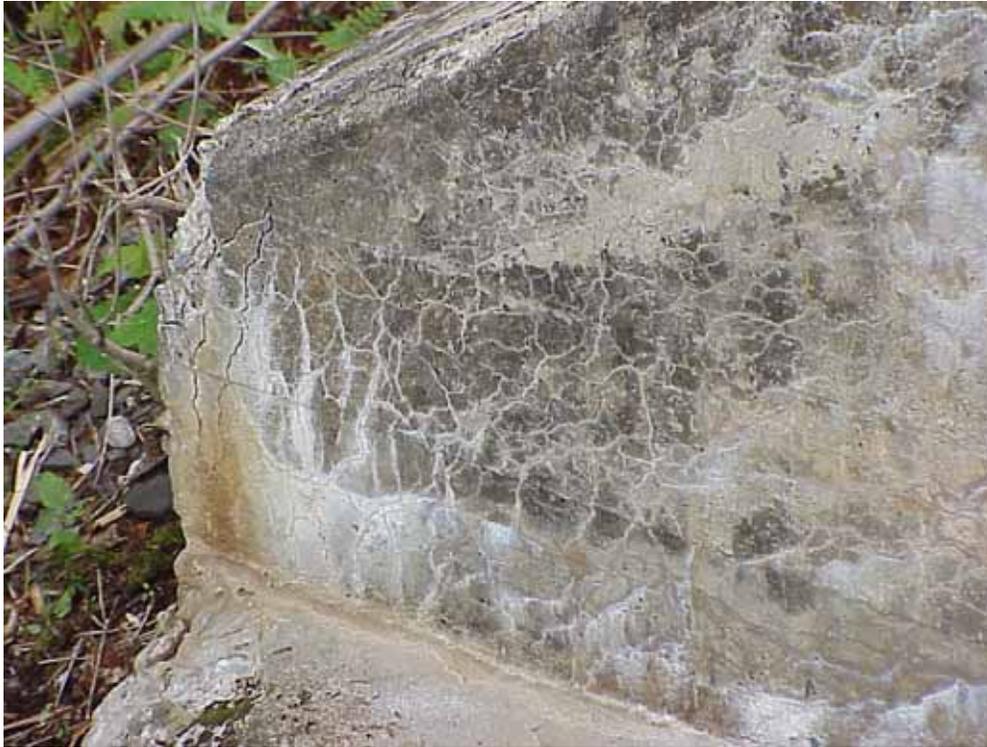
*Figure 3 – Frankenstein Trestle, Crawford Notch, southeastern abutment, wingwall.
Map cracking with white precipitate exuding from cracks (August 2001)*

Harts Location	Railroad Bridge	Frankenstein Trestle	Tested southern abutment and southern pier; large rounded coarse aggregate particles; concrete in very poor condition; severe crumbling and spalling of concrete (C/S)	Severe	A few reaction rings around coarse aggregate particles and large section of matrix florescence
Keene	120/076 (1967)	NH Rte. 9/10/12 over West Street	Spalling upper center of northern abutment, rebar exposed; white precipitate (IBC)	Moderate	Peripheral of several coarse dark mafic aggregates (metamorphic rock ?); microcracks between coarse aggregate particles; several milky white quartz particles are greenish-yellow; estimated 15-20% of surface
Landaff	074/159 (1920)	Syms Noyes Road over Mill Brook	Large open cracks in abutments and underneath deck; large amount of white precipitate; cement is soft; soil washed out in southwestern corner (ARCH)	Moderate	Dull green over entire background (fine aggregate); a few coarse particles (quartz) are bright yellow-green; portion of periphery of one coarse aggregate particle

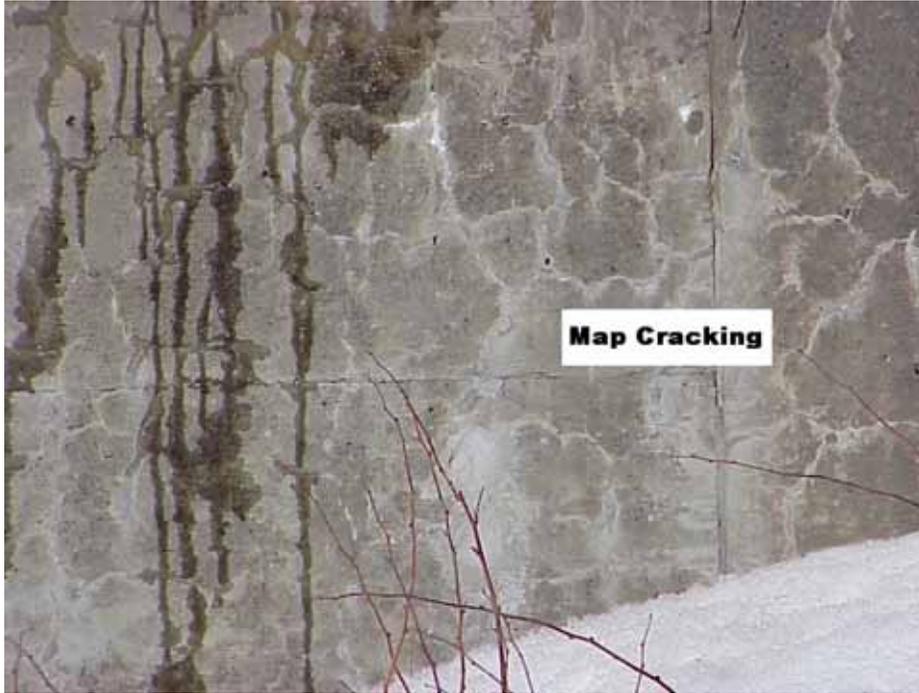
Photo 1 – Map cracking on wing wall, I-89 Northbound bridge over Frye Lane, Grantham, NH.

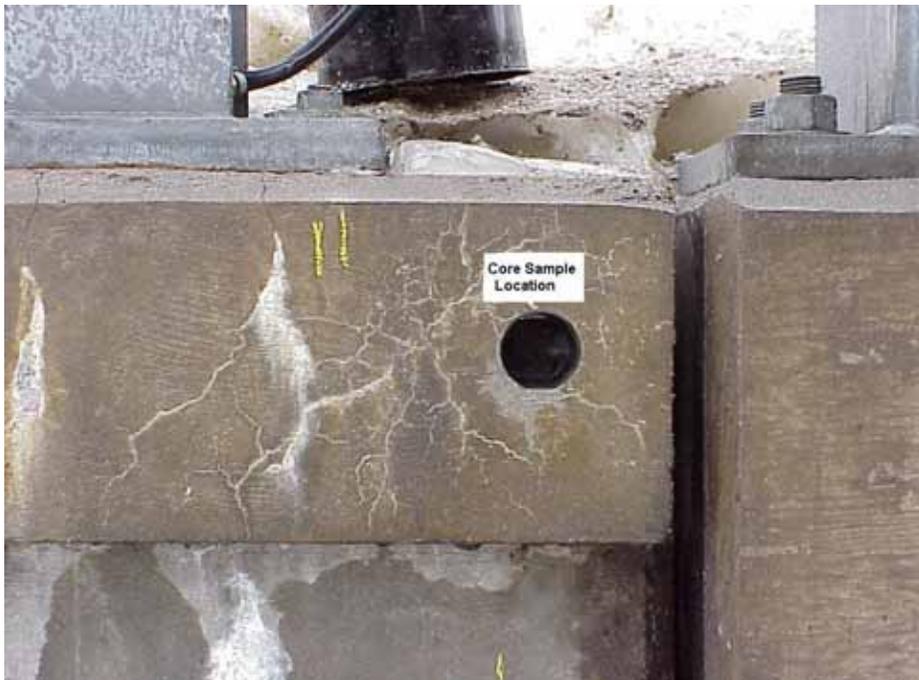
Photo 2 - Map cracking on facies, bridge over I-89 in Grantham, NH.

TABLE 4 (continued)					
TOWN	BRIDGE #	ROUTE	GENERAL CONDITION	ASR PRESENT	DESCRIPTION ASR GEL DEPOSIT
Grantham	125/070	Bridge over I-89	Map cracking on sidewalk and northwest facing bridge facies; white precipitate exuding from some cracks; core samples taken from sidewalk and facies (IBC)	Severe	UV test conducted on concrete cores only; some florescence on interior of coarse aggregates and reaction rims around some coarse aggregates; extensive florescence on portions of the cement paste; coarse aggregate particles are granitic and metamorphic rocks; a few voids lined with clear to milky white precipitates; a few small microcracks in matrix
Grantham	112/147	I-93 NB Bridge over Fyre Lane	Map cracking on abutments and wing walls; white precipitate exuding from some cracks (BOX)	Moderate	Florescence of fine aggregate matrix; peripheral bands around some coarse aggregate particles; ASR gel in microcracks in matrix

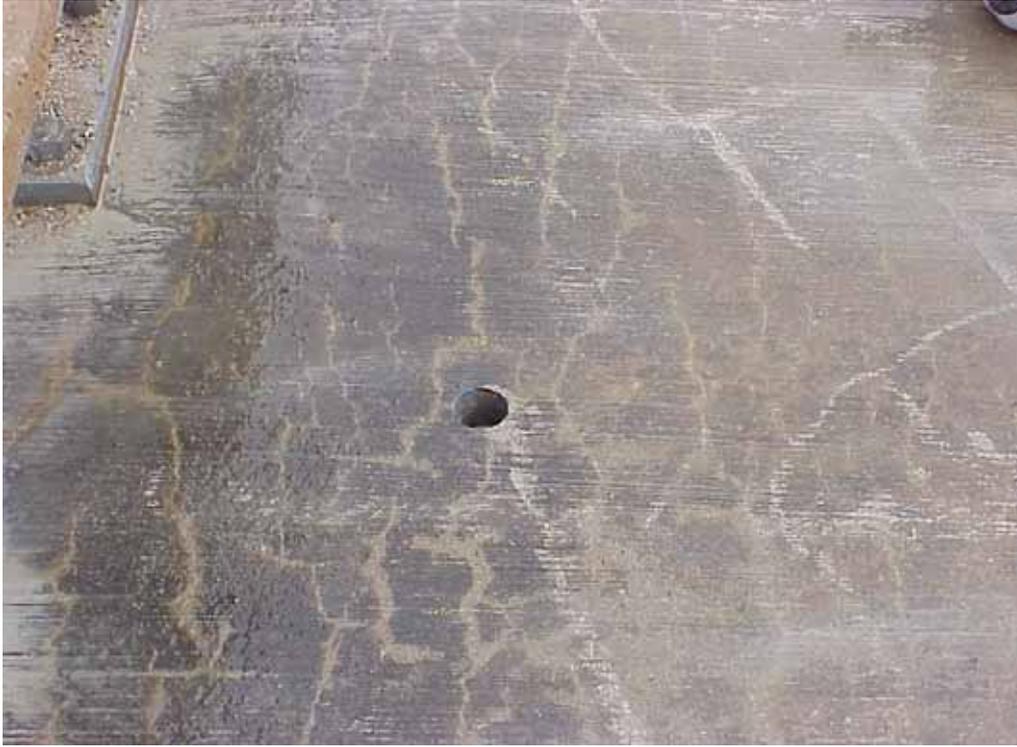
Photo 3 - Map cracking on sidewalk, bridge over I-89 in Grantham, NH.

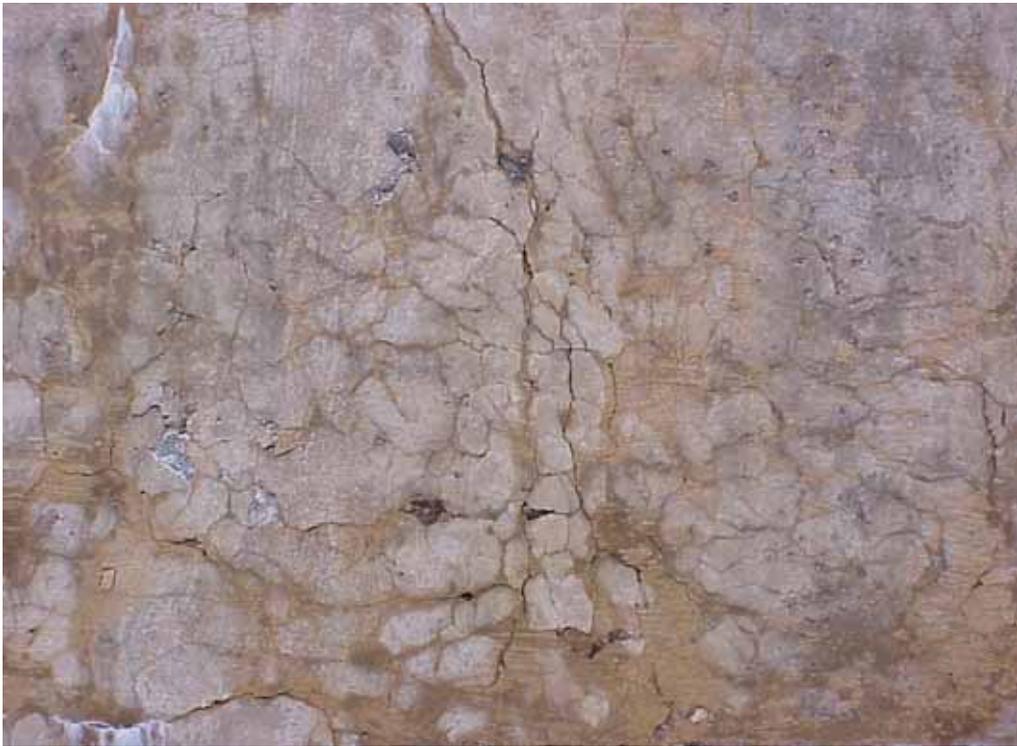
Photo 4 – Map cracking on bridge pier over Connecticut River in Monroe, NH.

Monroe NH/Barnet VT	110/125	Bridge over Connecticut River	Severe map cracking on both abutments and center pier; white precipitate exuding from cracks; severe cracking on center pier (C/S)	Moderate	A few coarse aggregate particles, florescence of cracks in the surrounding cement paste and sections of the fine aggregate matrix
Nashua-Hudson	157/059 (1973)	Circum. over Merrimack River	Very minor cracking at abutment corner; no spalling; minor white precipitate (IBC)	Severe	A dull green film over 30-35% of fine aggregate matrix; a few quartz or granitic particles are yellow-green
Newington	112/107 (1956)	Spaulding Turnpike over Woodbury Ave.	No visible cracks at test location; spalling and white precipitate at southern abutment (IBC)	Slight	Only a few specks of bright yellow green (quartz particles)
Ossipee	175/238 (1969)	NH Rte. 16 over NH Rte 25	Arcuate pattern leading to spalling; exposed rebar; white precipitate (IBC)	Severe	Yellow green film surrounds and intersects a cement like aggregate (15-20% of surface); greenish-yellow over fine aggregate matrix, estimated 50% of surface area

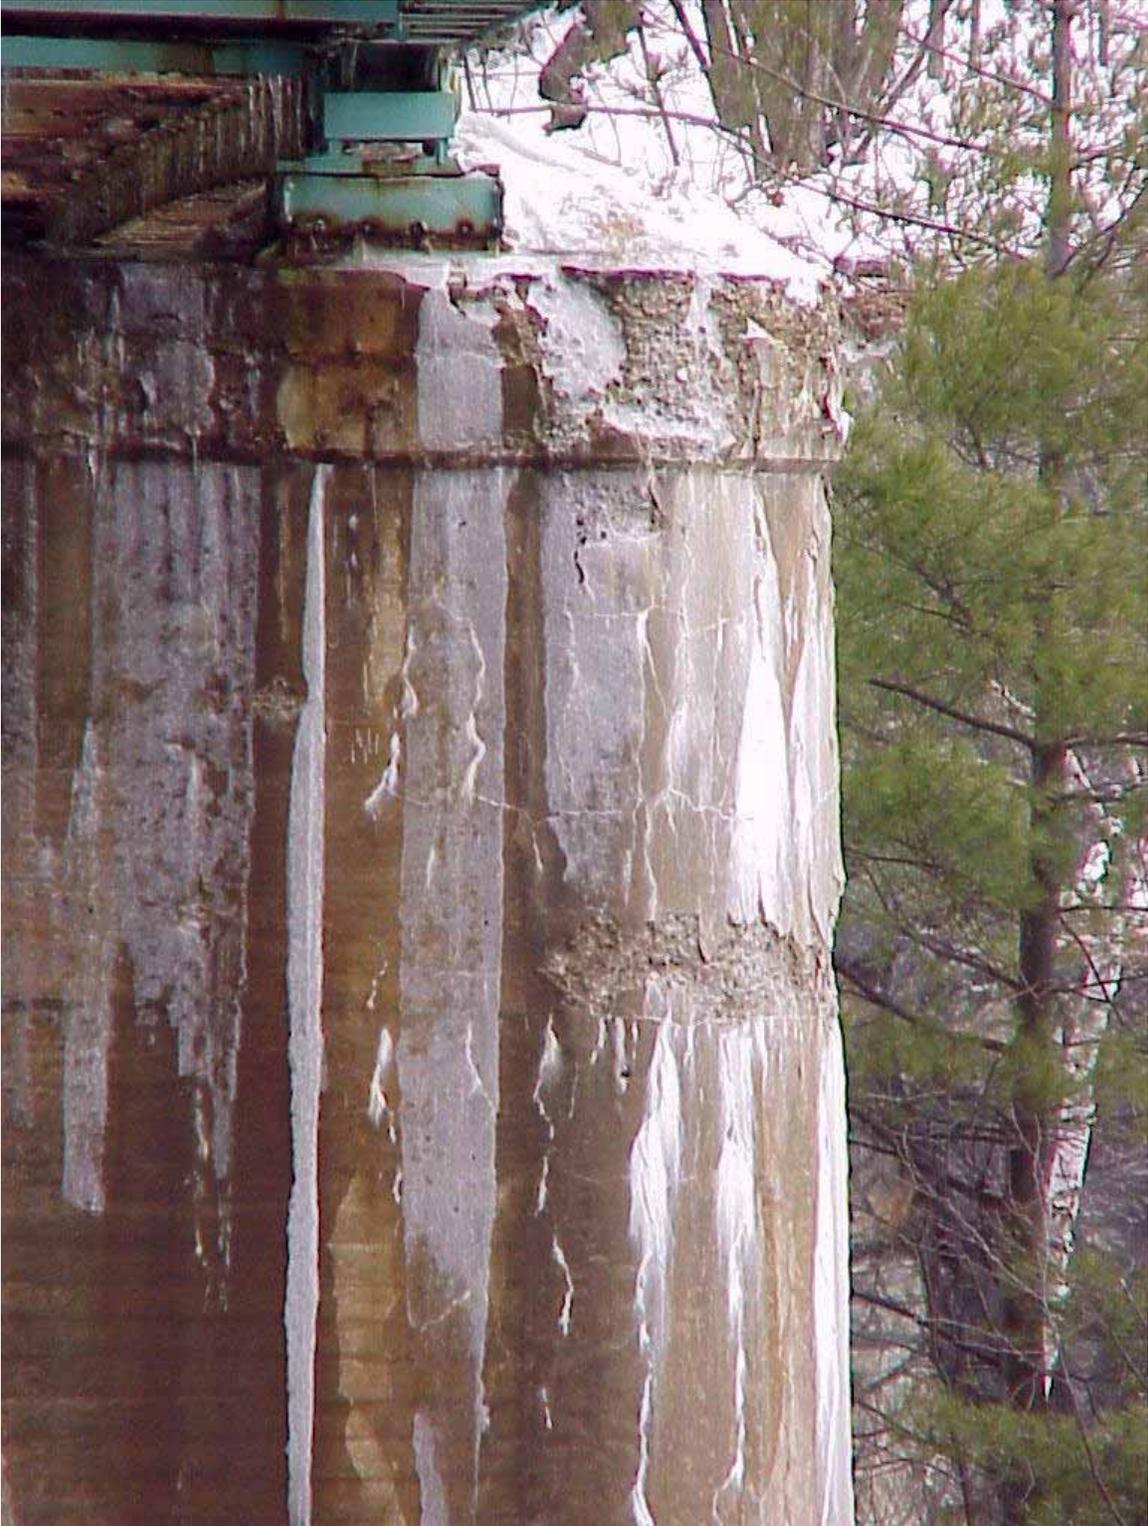
Photo 5 – Map cracking and deterioration of concrete on Connecticut River bridge pier in Monroe, NH.

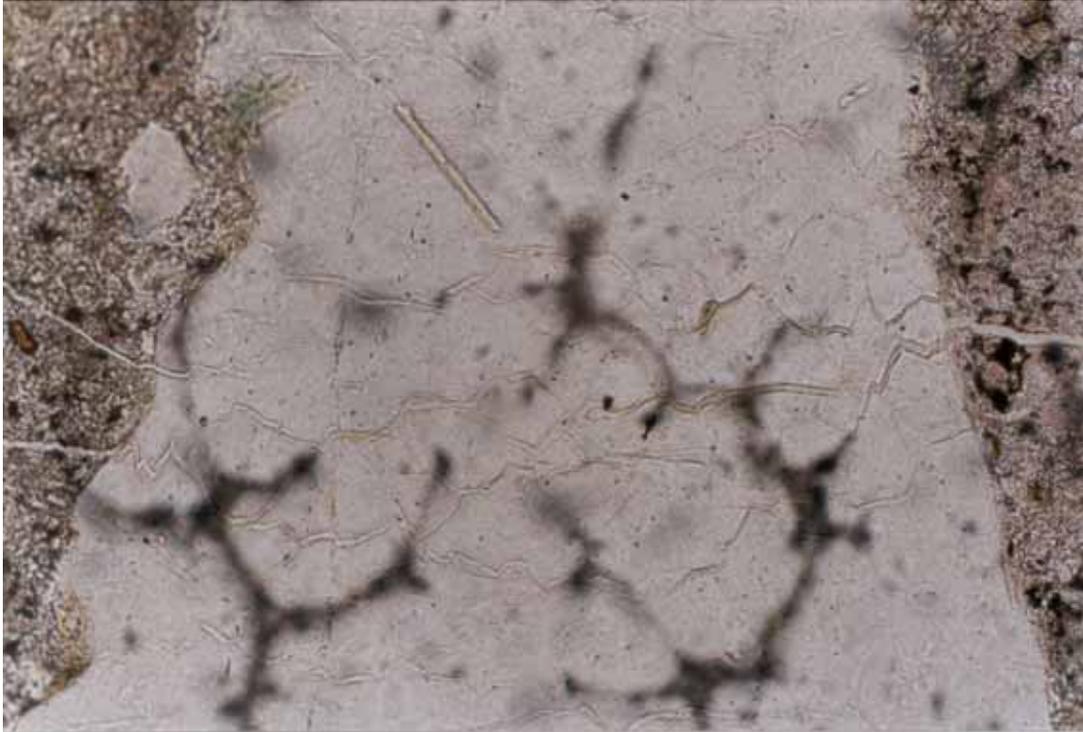
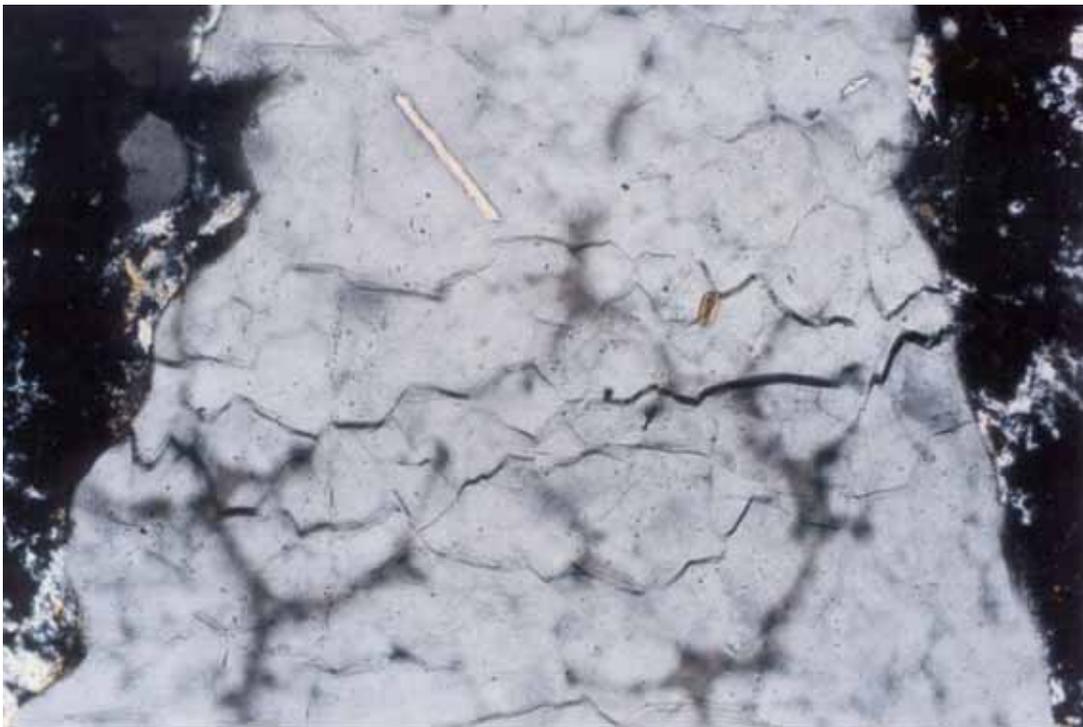
Photo 8 – ASR gel filled micro cracks extending from quartz particle into surrounding cement paste, plane light, 200X, southern abutment, Plymouth railroad bridge.

Photo 9 – Same as photo 8, cross-polarized light.

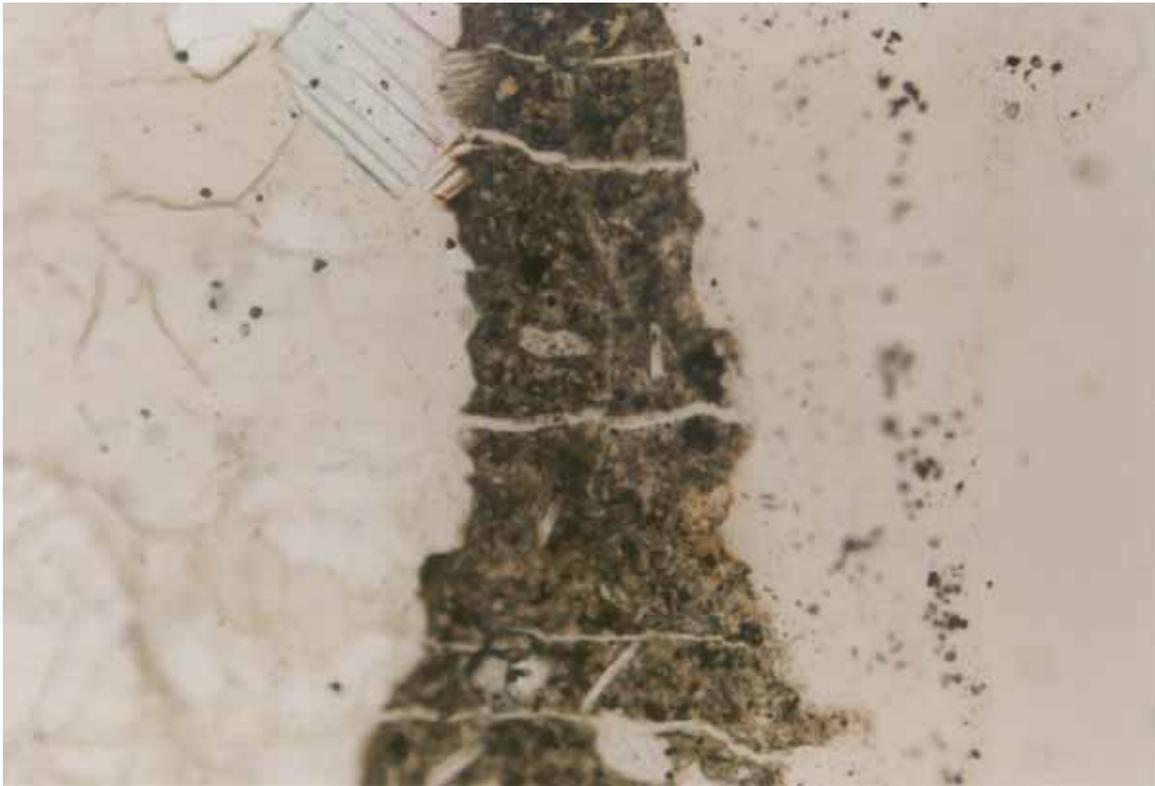
Photo 10 – Micro cracks filled with ASR gel and calcium hydroxide, cracks extending from granite particle, through cement paste and into another granite particle, plane light, 100X.

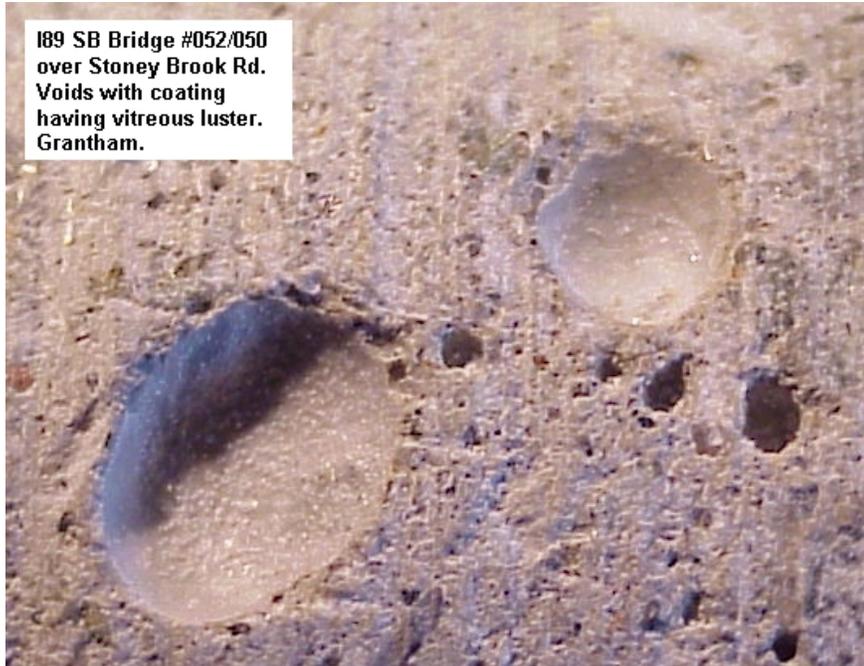
Photo 11 – Voids coated with precipitate having vitreous luster, stereoscopic view, 10X, I-89 southbound bridge over Stoney Brook Road in Grantham, NH.

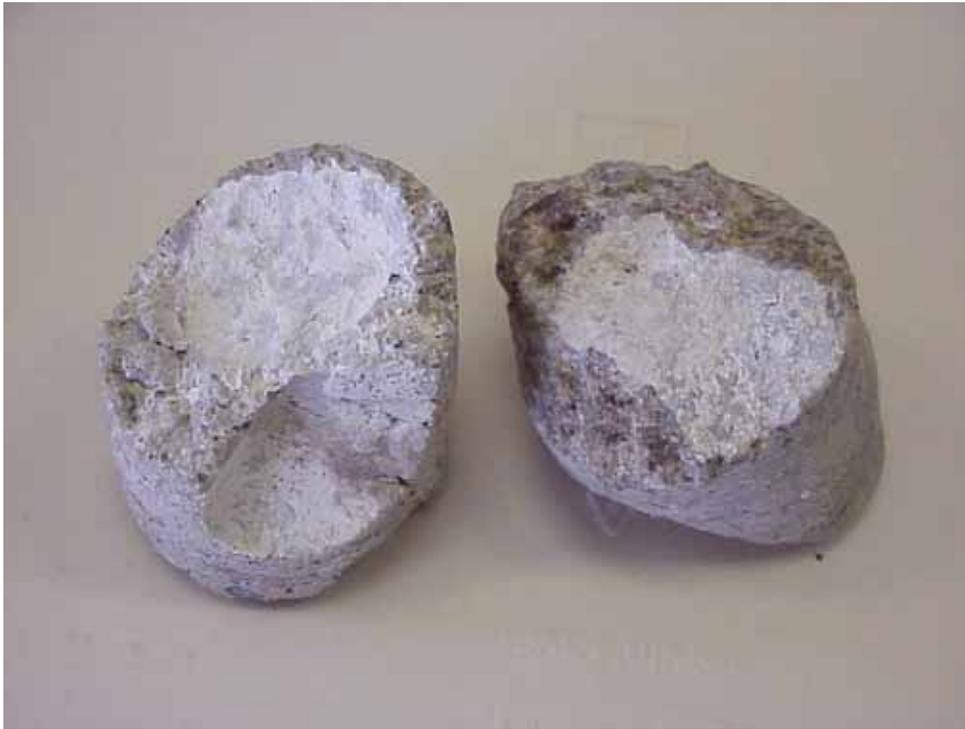
Photo 13 – White precipitate lining pop outs in concrete core taken from southern abutment of Swimming Hole Bridge over Pemigewasset River in Woodstock, NH.

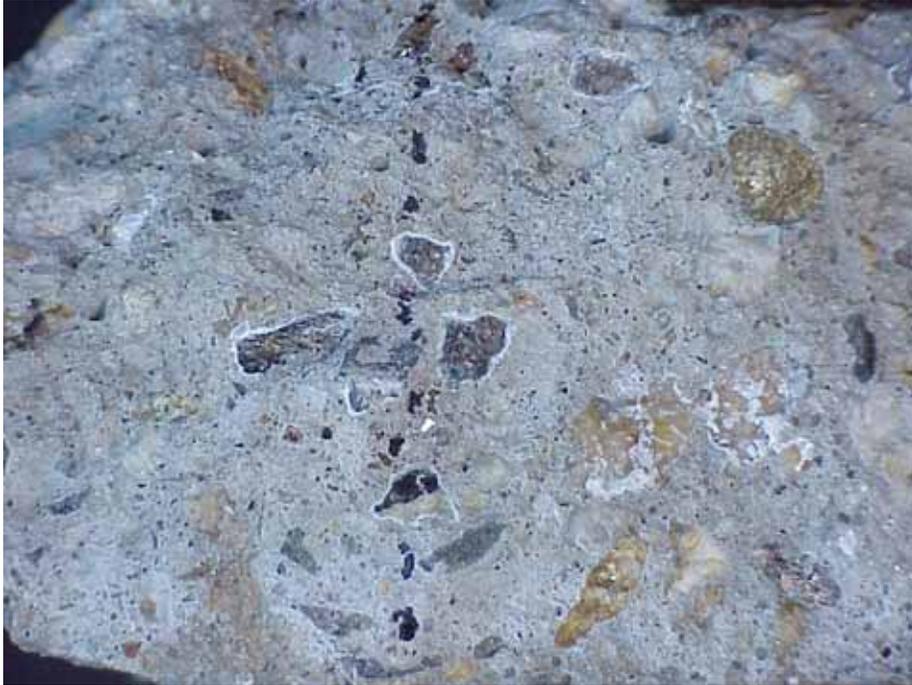
Photo 14 – Reaction rims around aggregate particles in piece of concrete from bridge over I-93 in Salem, NH, plane light.

Photo 15 – UV light analysis on piece of cement from a bridge over I-93 in Salem, NH. Same concrete sample as shown in photo 14.

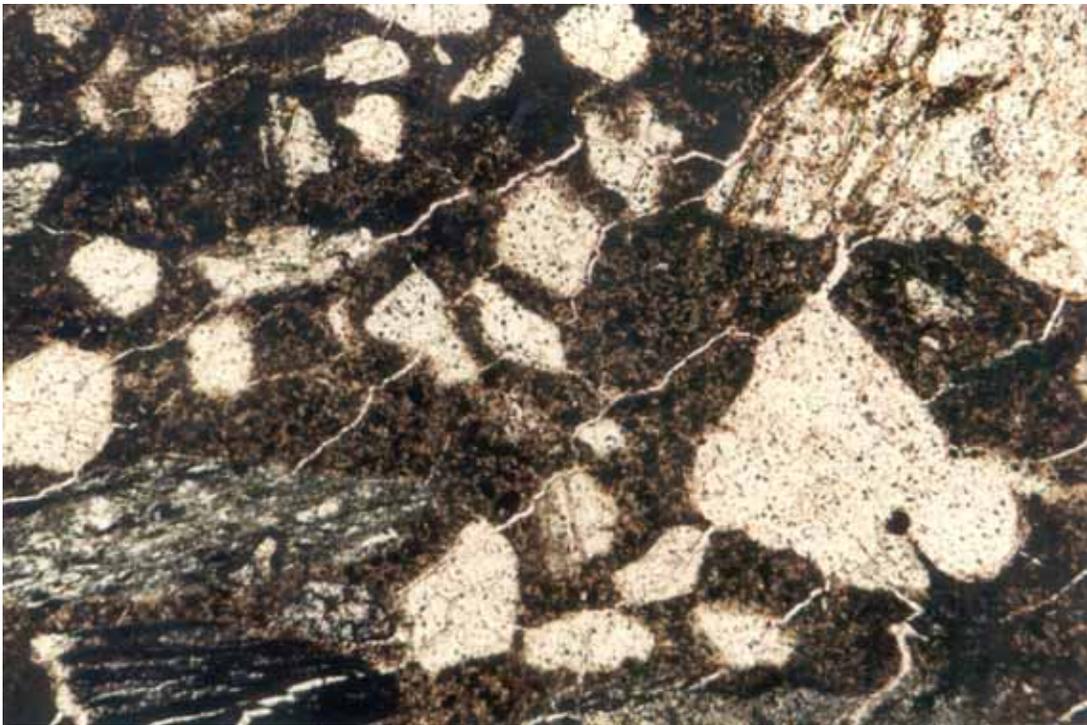
Photo 18 – Micro cracks extending from aggregate particles (igneous and metamorphic rocks), through cement paste and into other aggregate particles, plane light, 50X, pit #33 fine aggregate, Lebanon, NH.

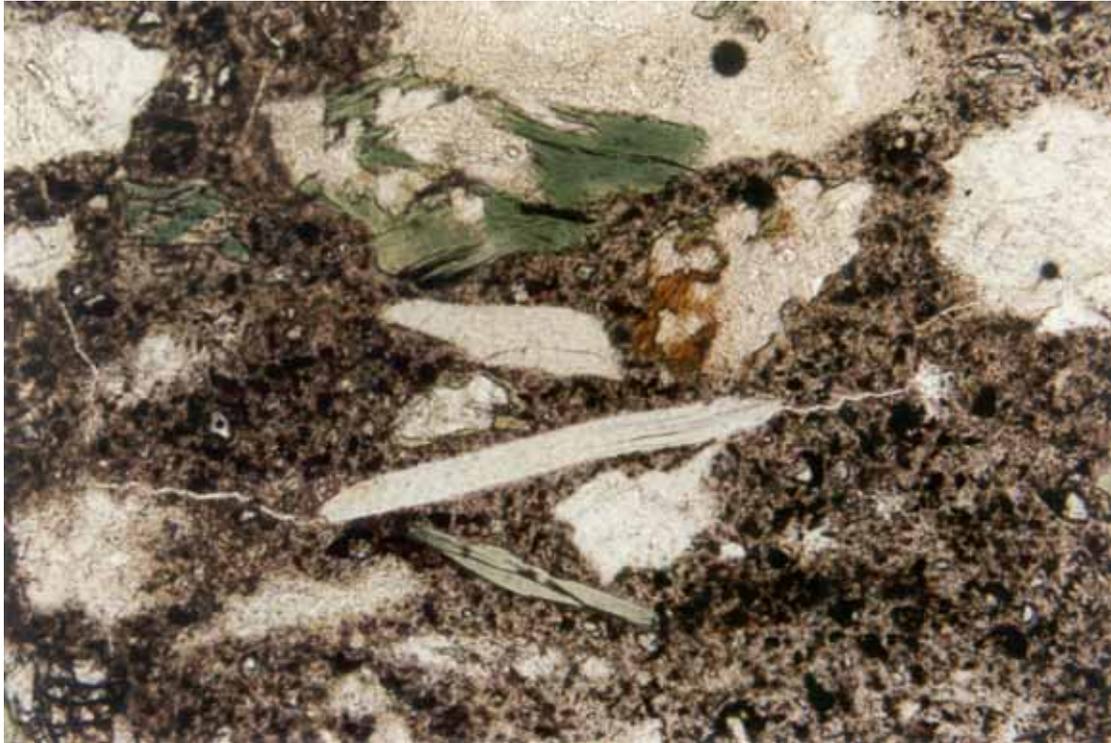
Photo 23 – Micro cracks in quartz and muscovite particles, through cement paste, plane light, 100X, quarry A, manufactured sand, Wilton, NH.

Photo 24 – Same as photo 23 in cross-polarized light.

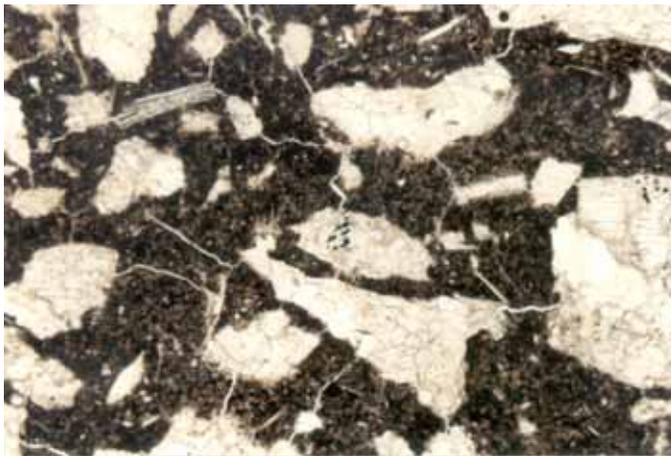
Photo 29 – Micro cracks in cement paste, muscovite and granite aggregate particles, plane light, 50X, quarry M, coarse aggregate.
