BUREAU OF MATERIALS & RESEARCH

MISCELLANEOUS PROBLEM SOLVING No. MPS 2003-01

Evaluation of Steel H-Pile Points

Final Report

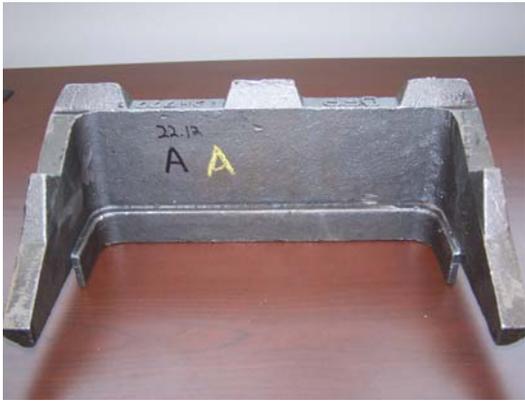
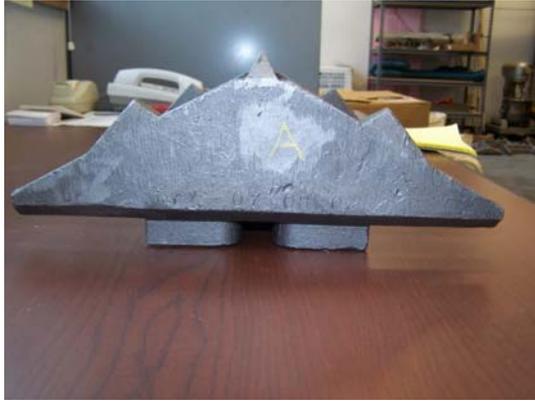
HWT-HS Category - Dougherty Foundation Products, Tuftip Tufloy H-777

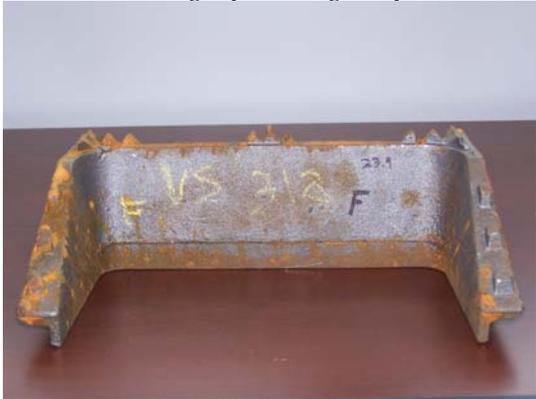
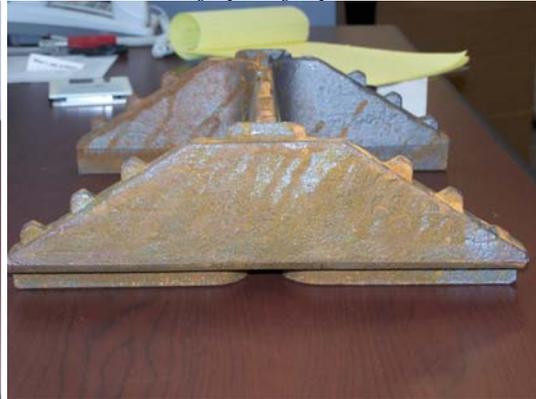
LWT-HS Category - Versa Steel, VS 312N

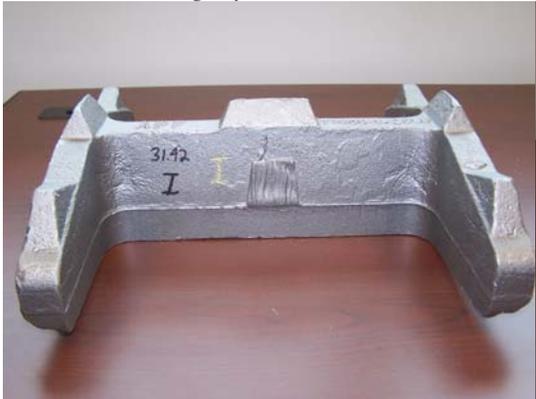
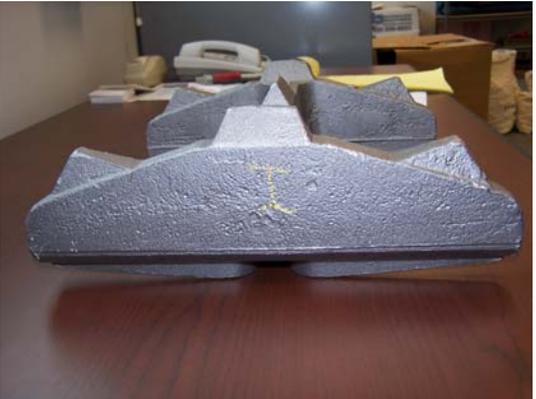
HWT-LS Category - Associated Pile and Fitting Corp, Hard-Bite 77600-B

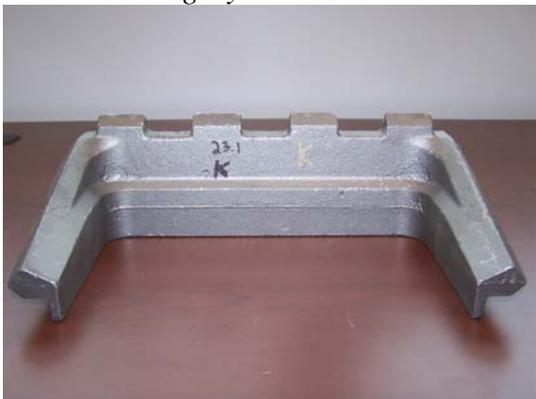
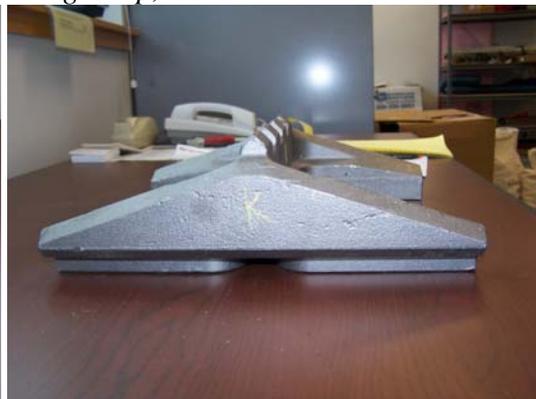
LWT-LS Category - Versabite Piling Accessories, Super Bite PAR-T

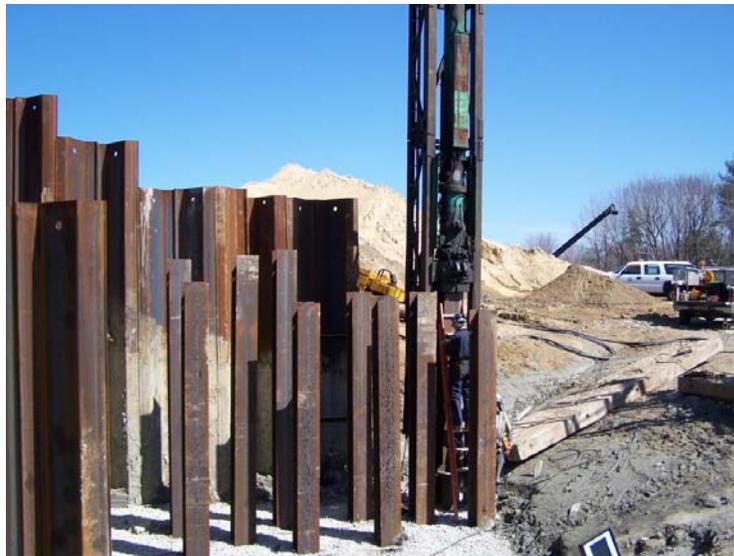
Test setup – Leads are on Pile G, sheet piles are retaining embankment

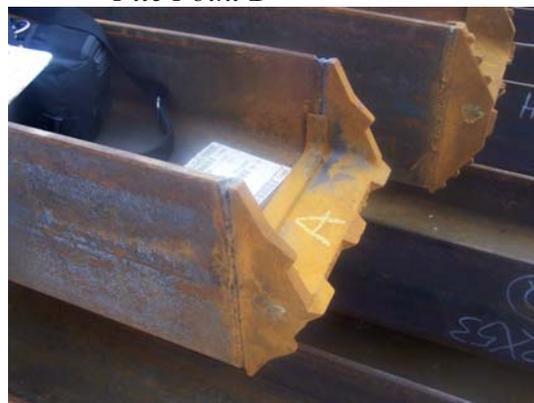
Pile Point A before driving

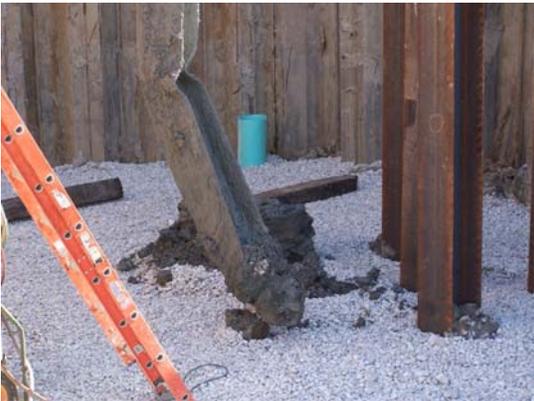
Pile F was an exception, as it sustained severe deformation of the pile and pile point that resulted in eventual pile buckling. During the latter part of the driving period, it became evident from the surface that buckling was occurring as the pile angled away from the vertical. When Pile F was extracted, the pile and point showed severe damage. Pulverized rock was found sticking to the tip of the pile, and it is theorized that the pile skidded on a sloping bedrock surface. This movement along with the greater number of blows applied to this pile compared to the other test piles most likely led to the buckling failure. The point and the end of the pile were severely mangled, and the teeth on the middle of the pile point web were noted to be missing. It should be noted that the teeth on this model, the VS 312N, were much smaller than the teeth on the other three models. If skidding did occur, the smaller teeth may have made it easier for the pile to skid.

Pile F upon extraction

- It is reasonable to specify minimum tooth requirements for pile points, particularly if a sloping bedrock surface is expected. This is due to the possibility that the Pile F failure was in part caused by the slippage of the pile on the bedrock surface. The optimum size, number, or configuration of pile point teeth was not determined.

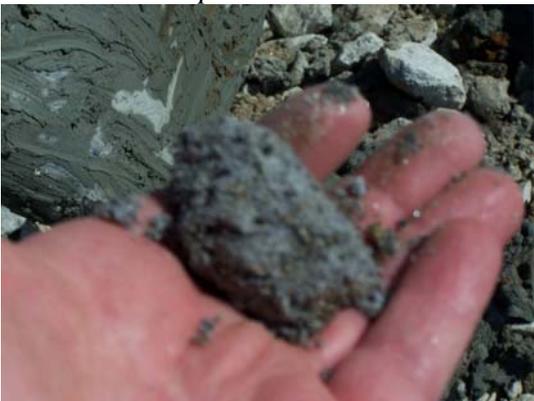
Pulverized rock from Pile Point F

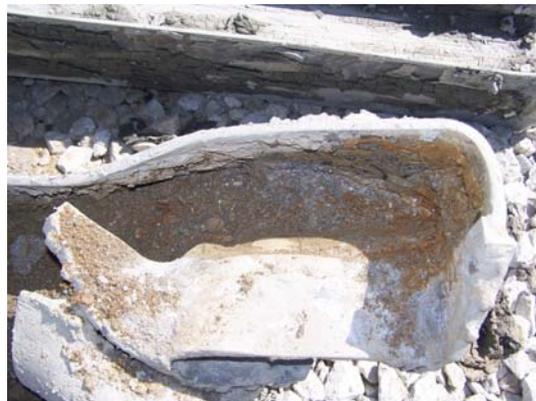
Missing teeth on Pile Point F web

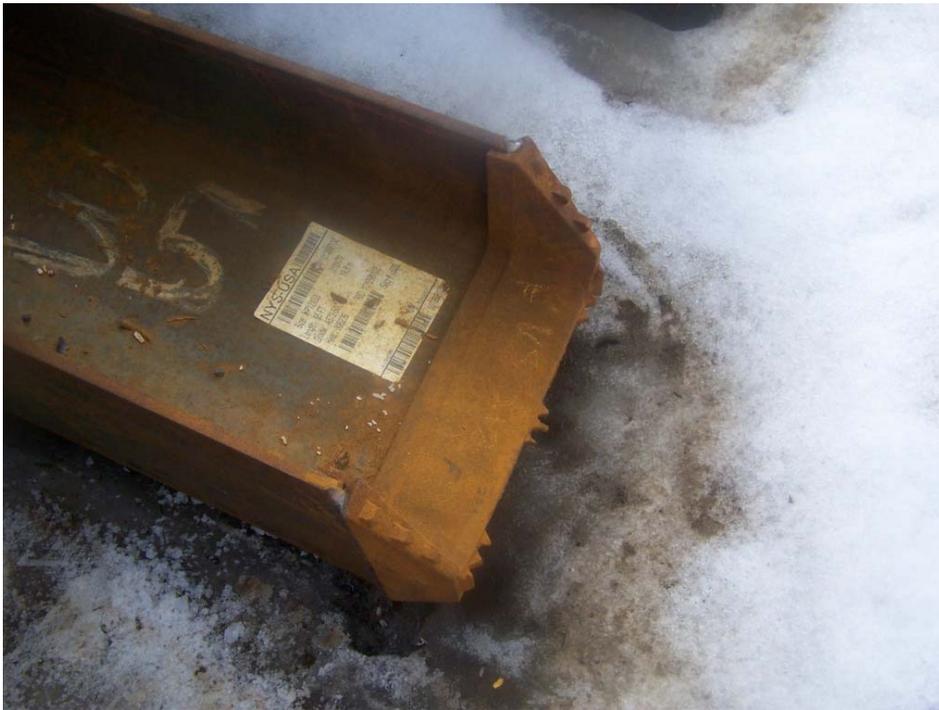
Pile Point F before driving – Note the position of teeth on the web portion

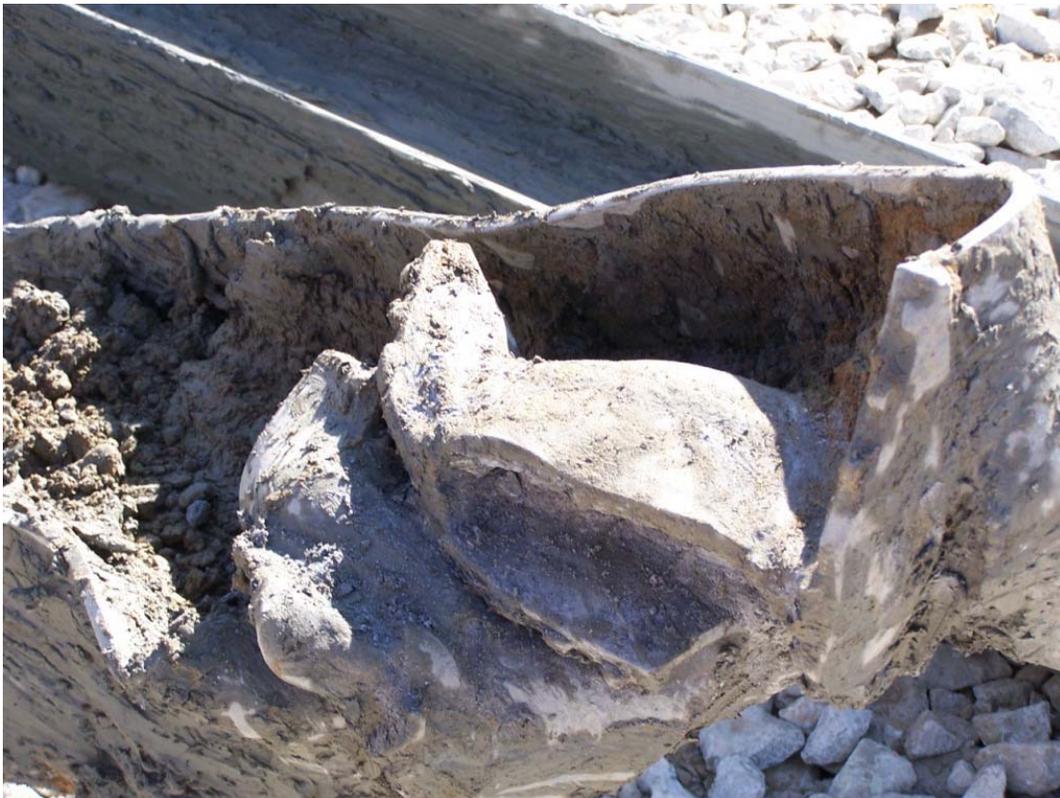
Pile Point F – Note pulverized rock particles on point

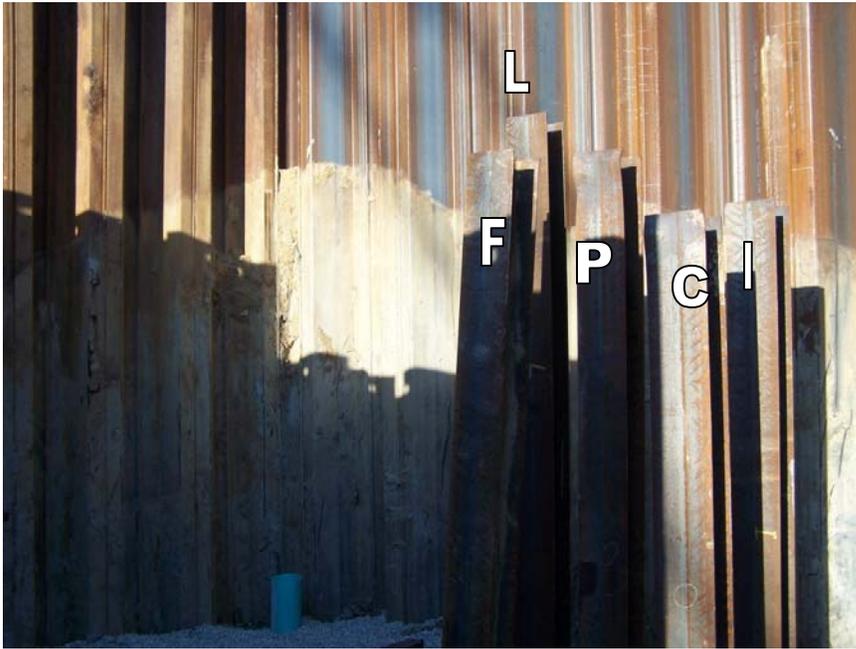
Before extraction from left to right F,L,P,C, and I. Pile F is leaning.

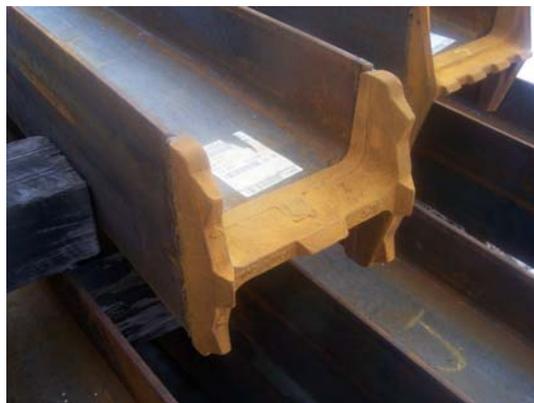
Pile Point I before driving

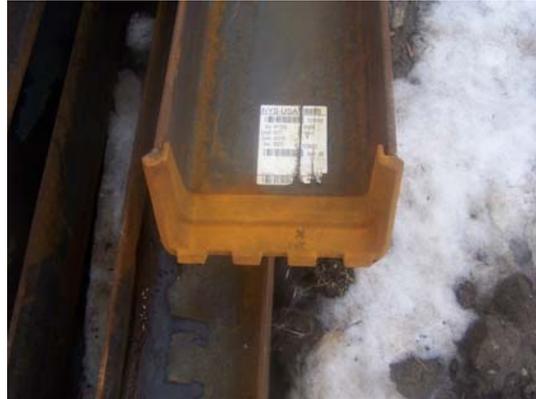
Pile Point K before driving

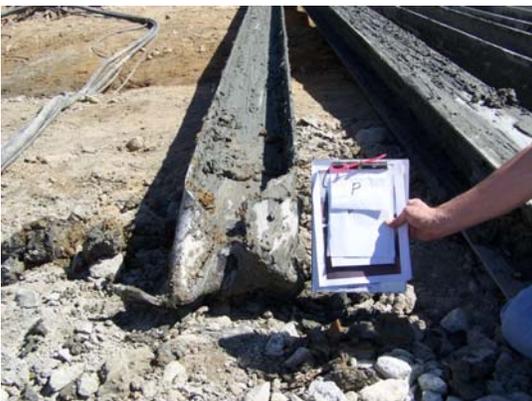
From the above photos it can be seen that with the exception of Pile F, all of the points performed reasonably well. The control piles without points all sustained damage. For the control piles, the PDA indicated damage was occurring only in the case of Pile P where the web actually buckled. The webs of Piles Q and R bent but did not buckle and the PDA did not indicate any damage. The flanges of all the control piles buckled and actually separated on Piles Q and R. This may indicate that the PDA gages attached to the web of the pile are less likely to detect damage that occurs only along the flanges of the H-pile.

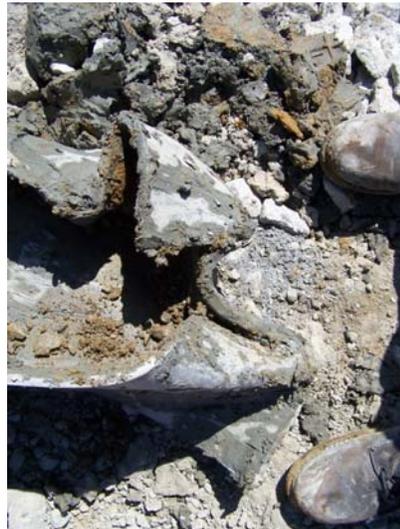
Pile P-Note web buckling

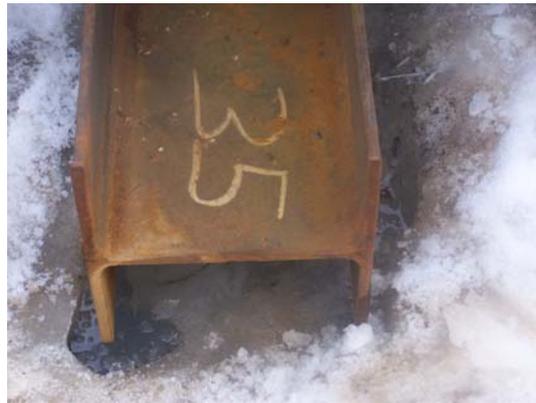
Control Pile Before Damage

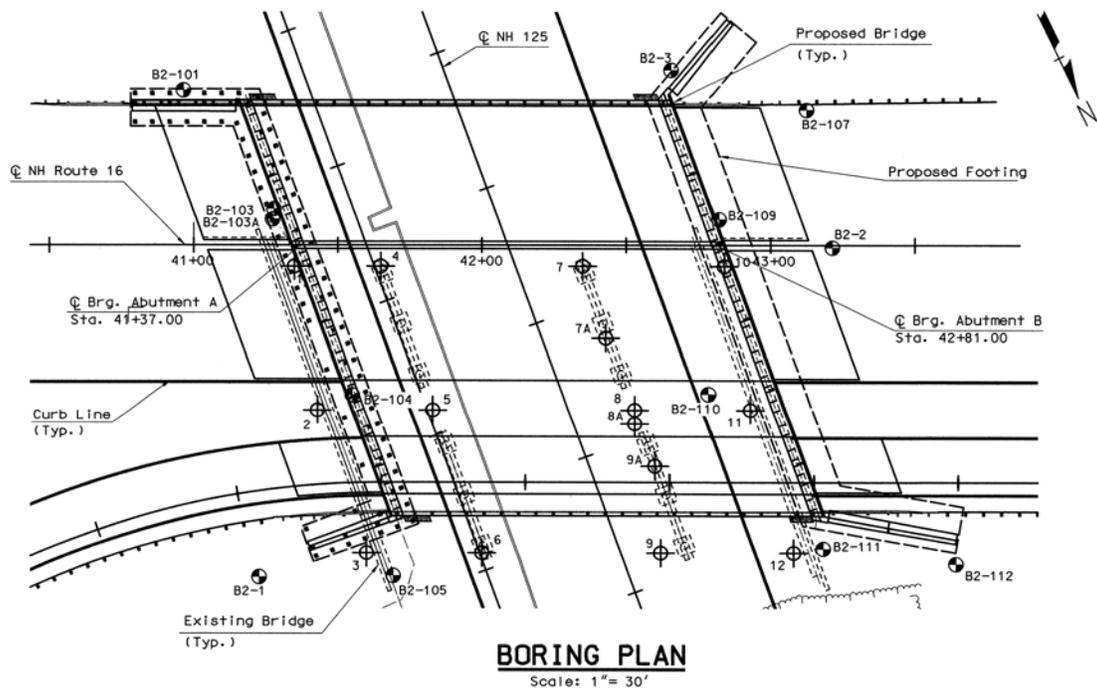
The area where the piles were driven and extracted is between Boring B2-101 and B2-103 in the southeast quadrant of the bridge. As noted in the boring logs, B2-103 hit an object that was impenetrable (most likely a previously driven pile). The drill was repositioned and the logging continued in bore hole B2-103A.
