New Castle-Rye 16127 Preliminary Design

New Castle-Rye Bridge
Public Information Meeting
January 30, 2014

Hoyle, Tanner
& Associates, Inc.

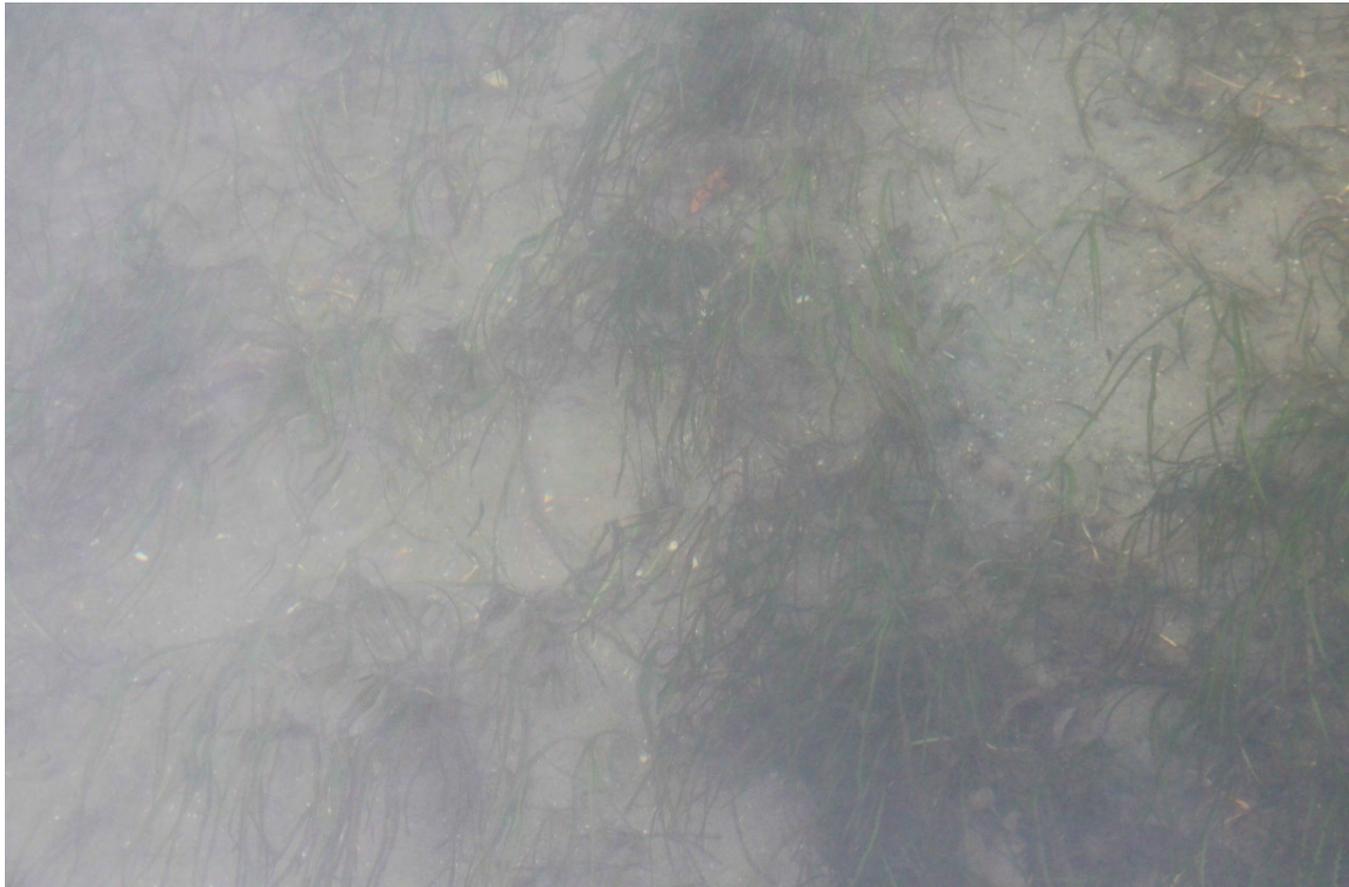
Eelgrass Bed

- Completed Wetland Delineation Report
- Undertook initial field survey to verify location of eelgrass beds
- Will do additional eelgrass survey in spring growing season
- Met with environmental review agencies earlier this month
- Will be working with agencies to define window for the in-water work (likely Nov. 15th - March 15)

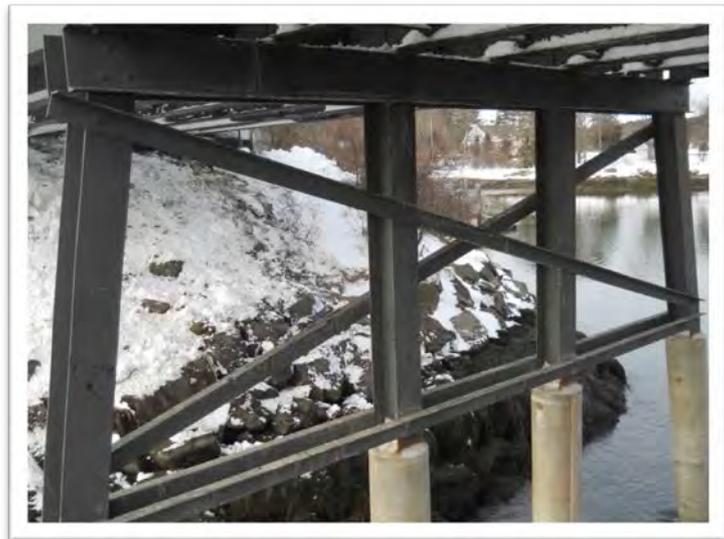
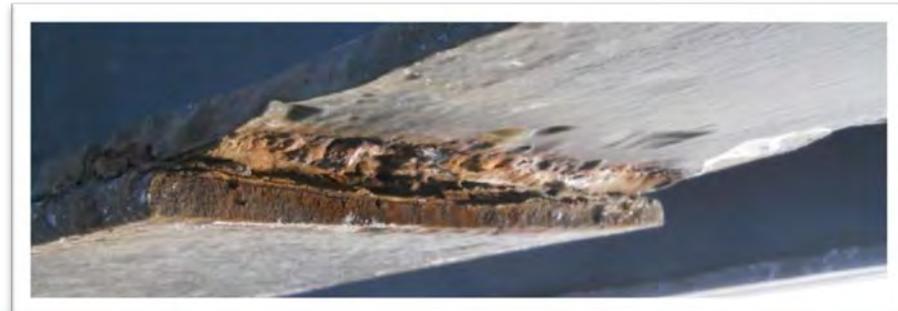
Bridge Background

- Constructed 1941
- Carries two lanes of traffic over a USACE-maintained federal channel
- Narrow shoulders (1') and Sidewalk (4' max)
- Rehabilitated 1975, Repairs in 1978
- Extensive Maintenance, Rehabilitation and Repair work performed since 1994:
 - Two major pier rehabs since 2000
 - Complete re-painting in 2000
 - Major repairs to machinery, electrical systems and housing
 - Frequent repairs to grid deck
 - Repairs to beams 2002, 2008, 2011
- Currently posted at a 15 Ton Weight Limit

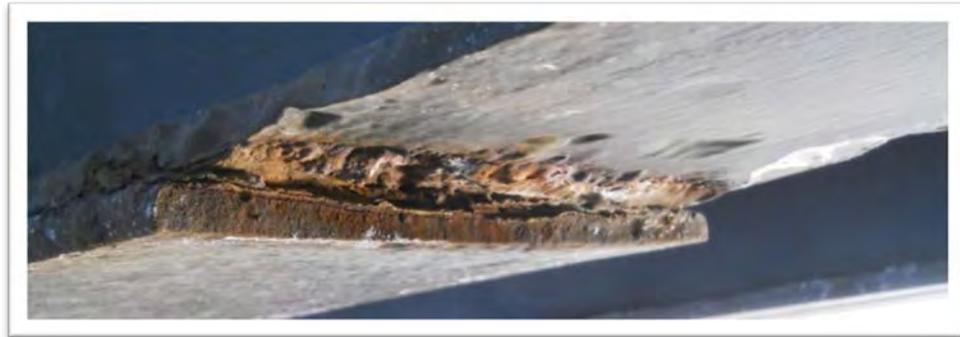
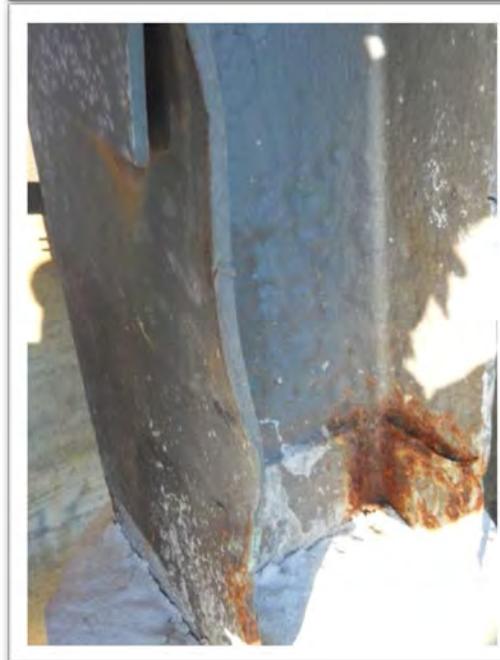
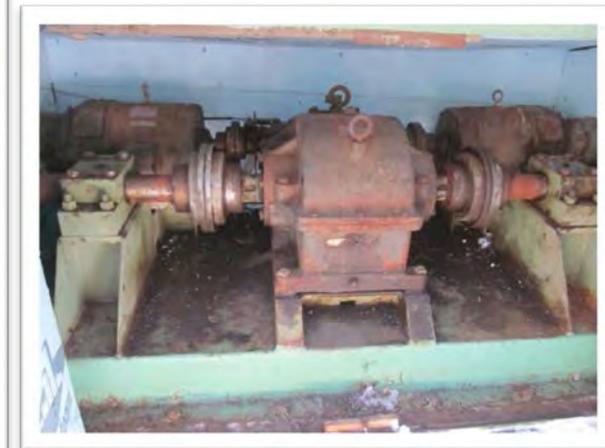
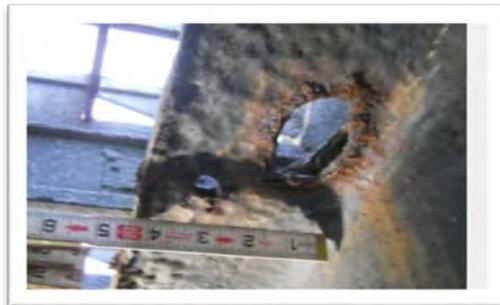
Structural Condition of the Bridge

- Paint masks current condition of bridge
- Stringers, floorbeams and bascule girders exhibit advanced section loss
- Pier caps and piles exhibit advanced section loss; Some piles are buckled
- Machinery is obsolete

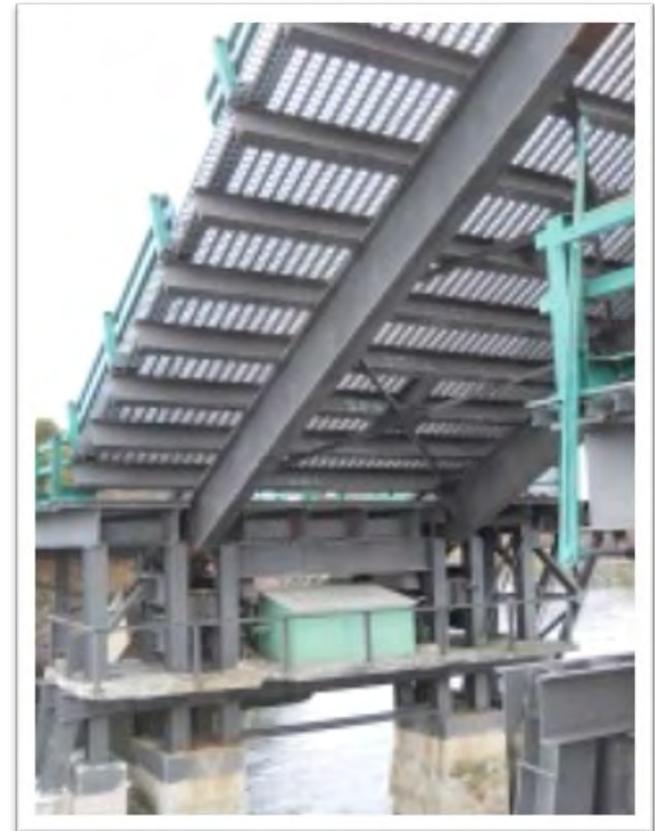
- Rehabilitation would require a complete dismantling of the structure
 - All approach stringers and caps are inadequate
 - Existing piles require retrofit or replacement
 - Machinery platform and trunnions are inadequate
 - Existing machinery requires replacement due to condition and obsolescence
 - Existing operator house is too small, and cannot fit required electrical controls
 - Rehabilitation is effectively construction of a replica bridge
