WETLANDS PERMIT APPLICATION

ADDRESS: **NH 145 over Bishop Brook** TOWN/CITY: **Stewartstown**

Bridge replacement of Br. No. 121/114, NH 145 over Bishop Brook with associated roadwork. The purpose is to remove the bridge from the State's Red List. The two lane bridge is currently on the NH DOT priority list at position 6 due to the rating of the bridge deck as being in poor condition and the rating of the substructure as being in serious condition. Approximately 500' of roadway work is intended and the bridge span will increase to 50'.

Stewartstown 16312- Bridge Replacement- Bishop Brook- Route 145
Wetland Permit Application Photos

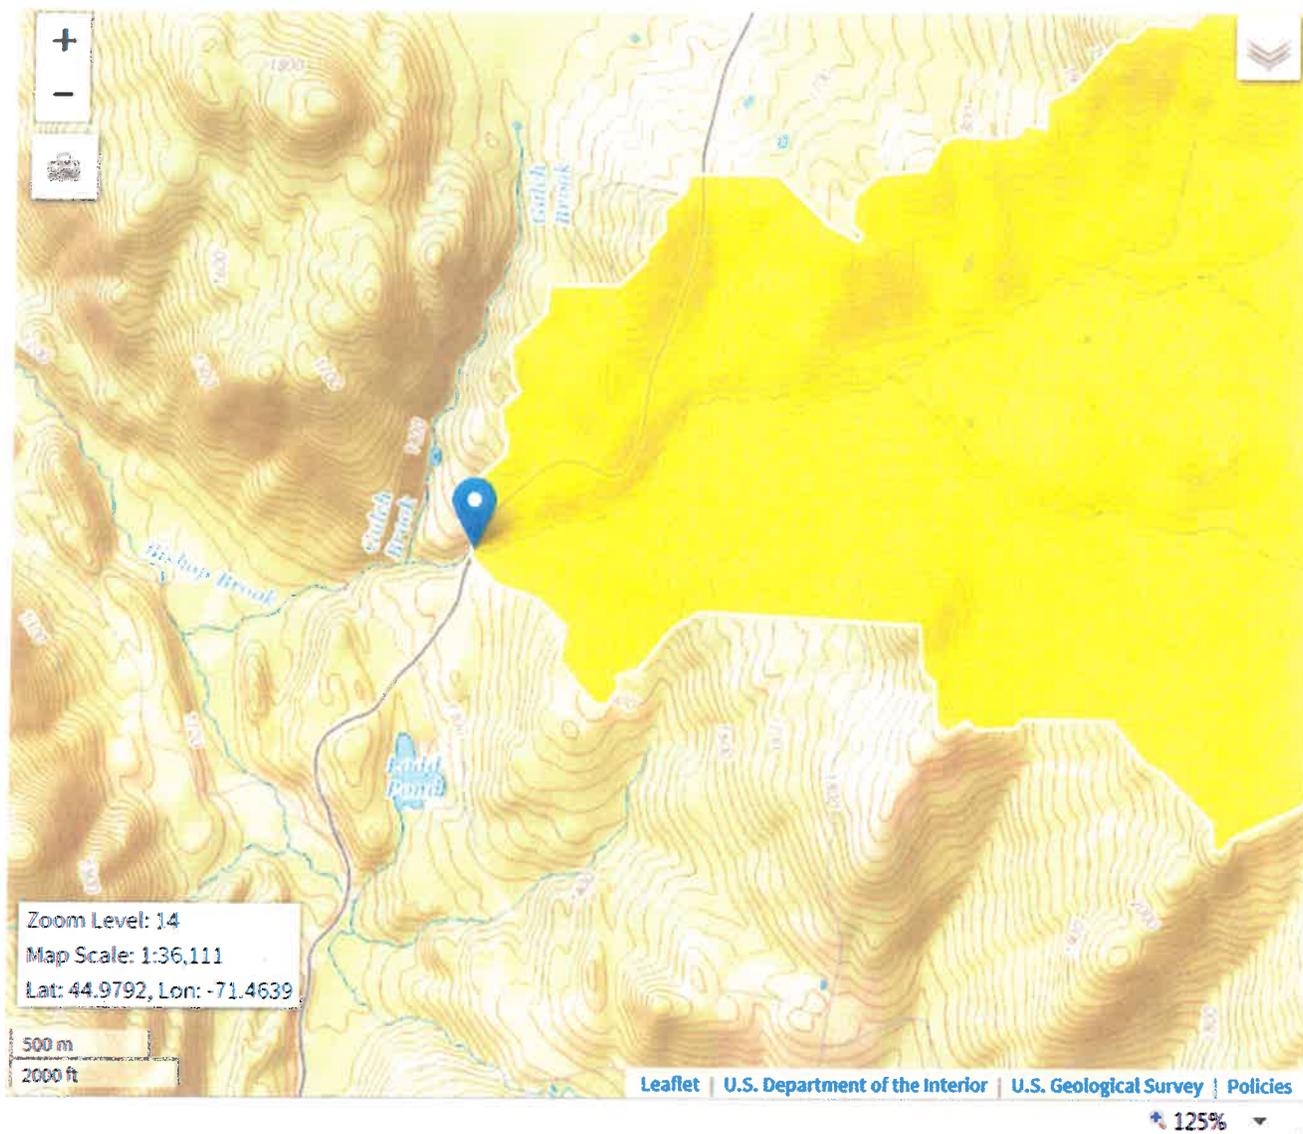
USGS StreamStats Bishop Brook Crossing at Route 145

| Parameter Code | Parameter Description | Value | Unit |
|---|---|---|---|
| DRNAREA | Area that drains to a point on a stream | 4.09 | square miles |

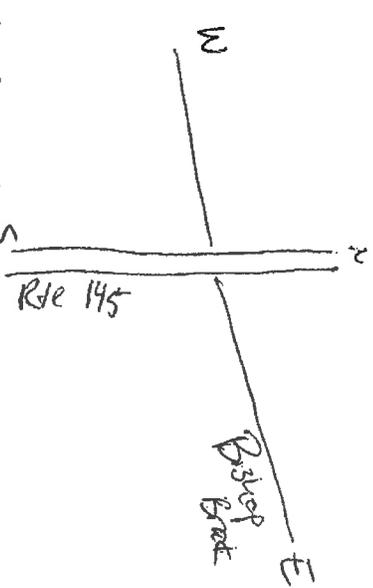
2 ~~many~~ bird nests were observed on bridge tresses - one in poor condition
 No evidence of bats - no guano on rip rap or staining out of crevices
 Look in cracks w/ flashlight - didn't see any evidence of bats

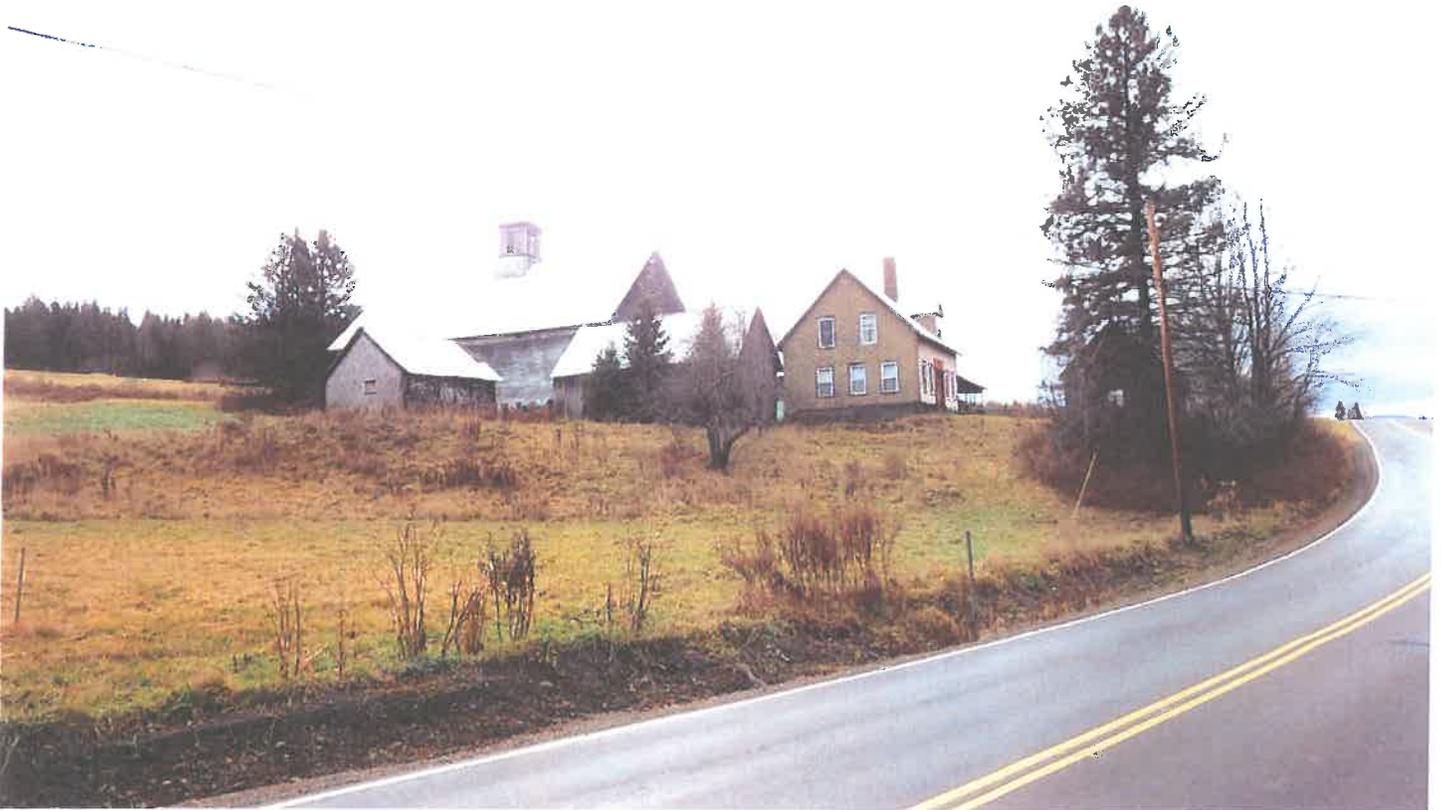
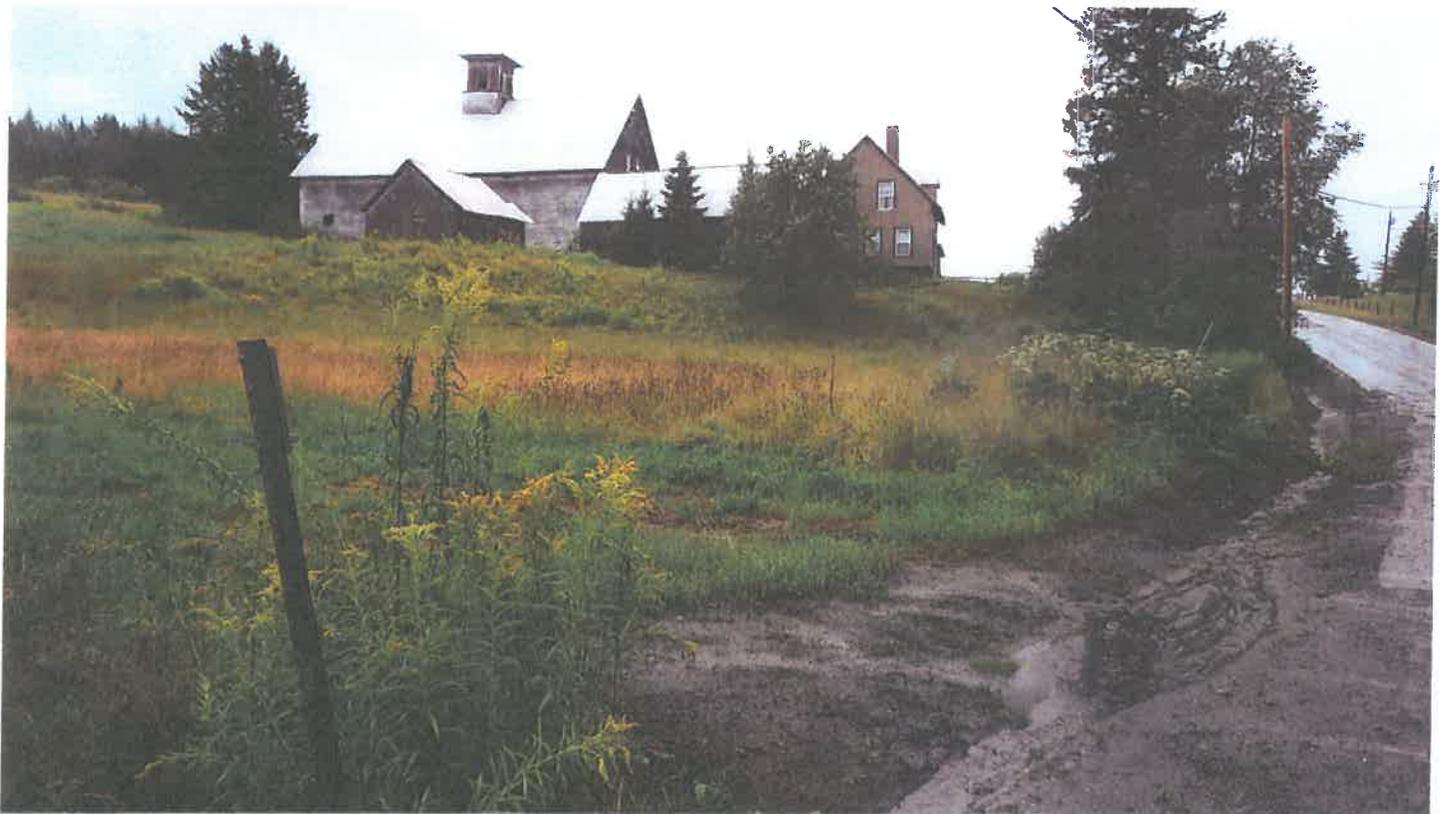
South of bridge and east of Route 145- Locations A (Wetland 11: PEM1E), B (W 12: PEM1Ed) and CC (W 11: PEM1E)

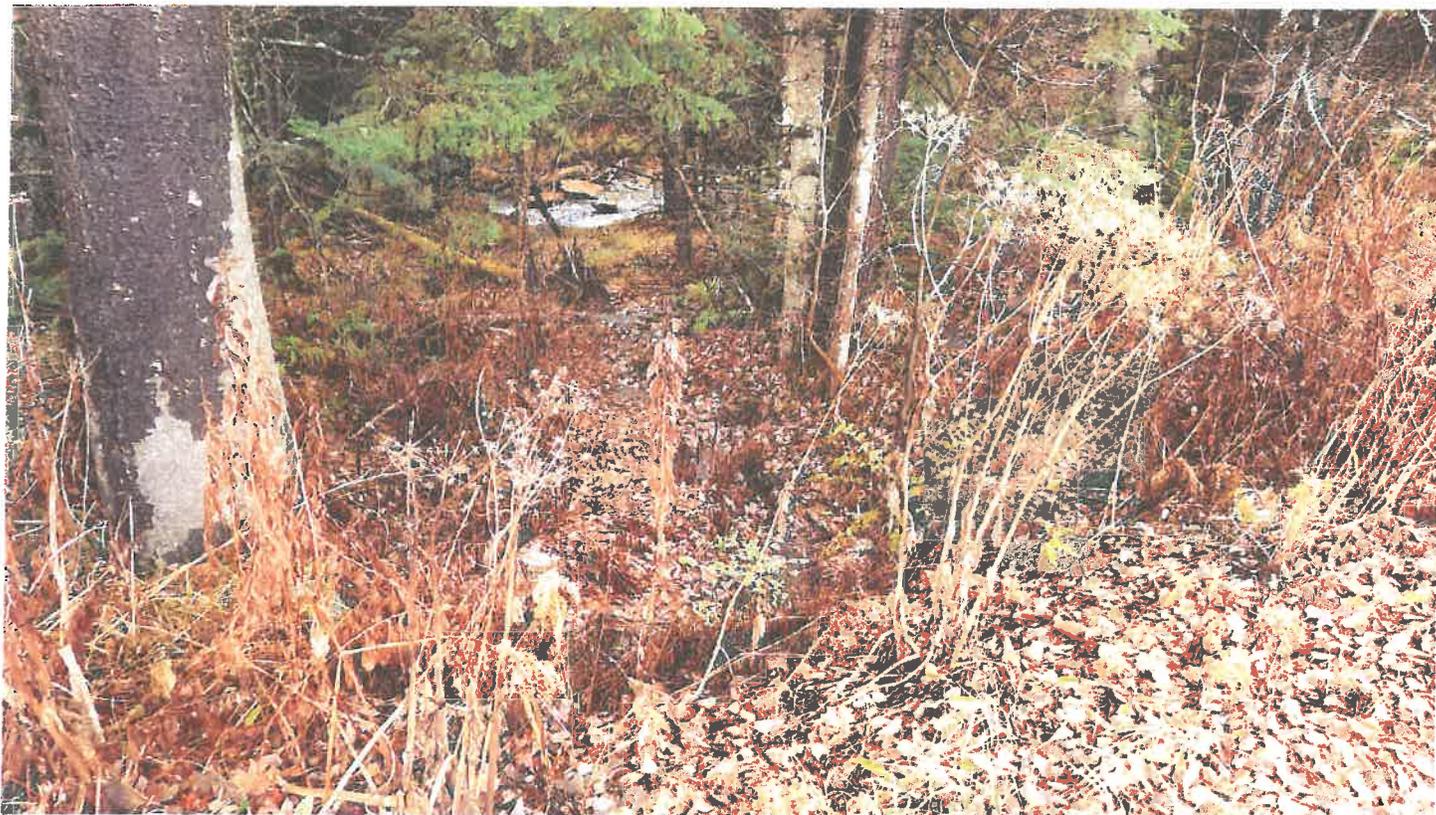
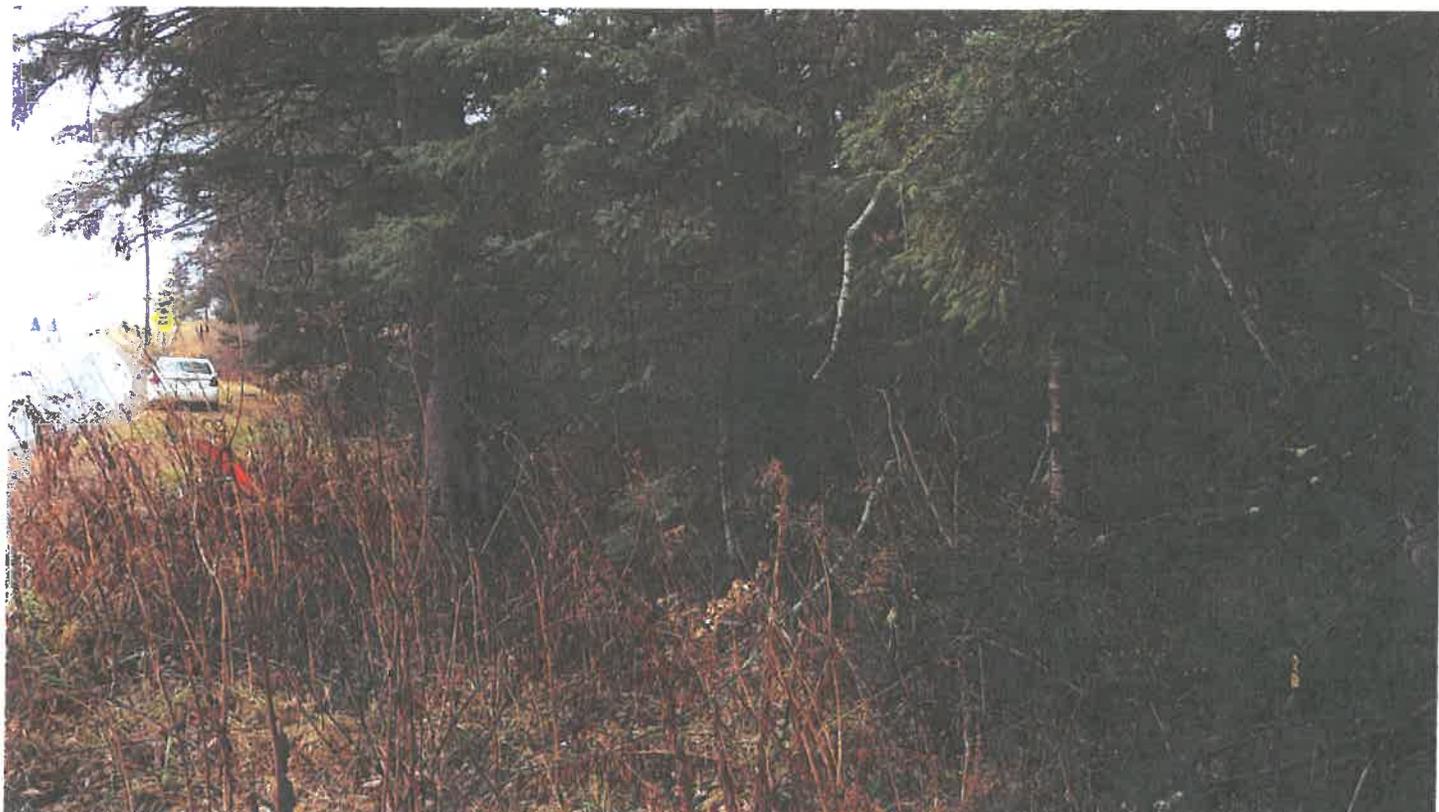
Intermittent stream south of bridge and west of Route 145- Locations C (W 13: R4SB3 bank), D (W 14: Intermittent stream R4SB3), E (W 15: R4SB3 bank), F (W 13: R4SB3 bank), G (W 14: R4SB3), and H (W 15: R4SB3 bank)

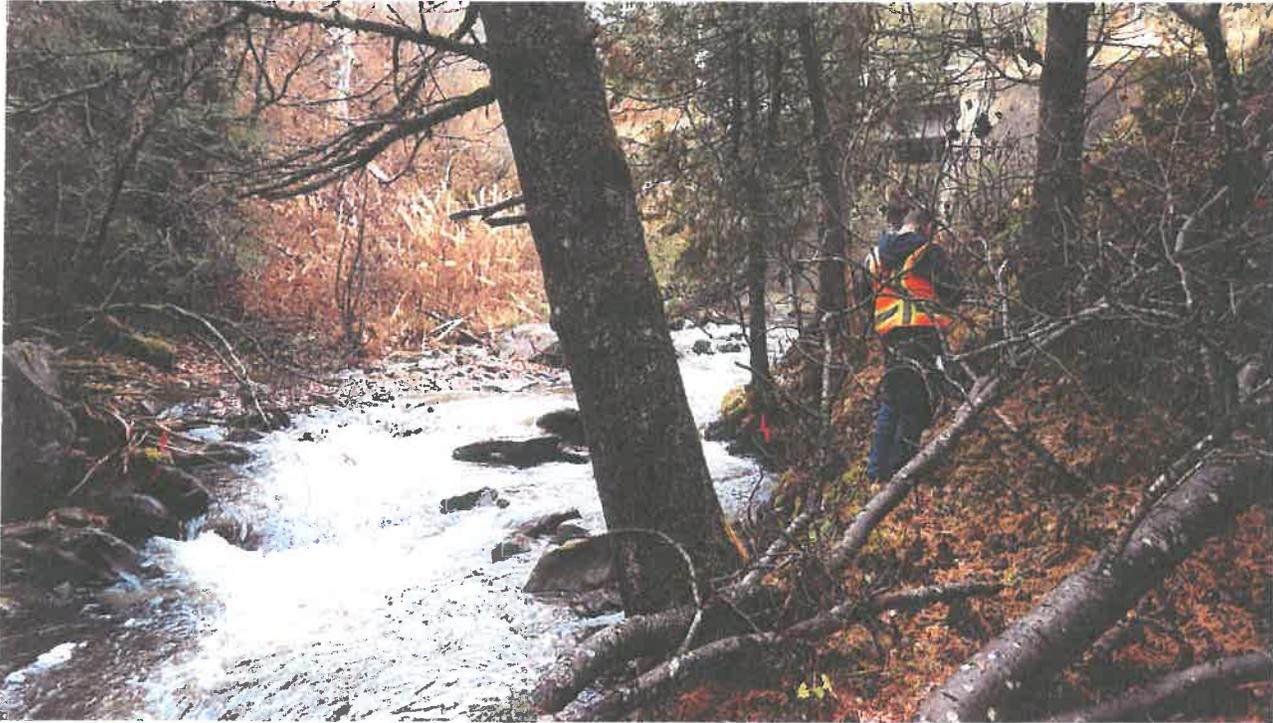
Adjacent Bishop Brook- south of bridge and west of Route 145- I (W:2 R2UB1 bank), J (W:2 R2UB1 bank), K (W:1 R2UB1), L (W:3 R2UB1 bank)

Right side of photo is south side of bridge from further downstream:

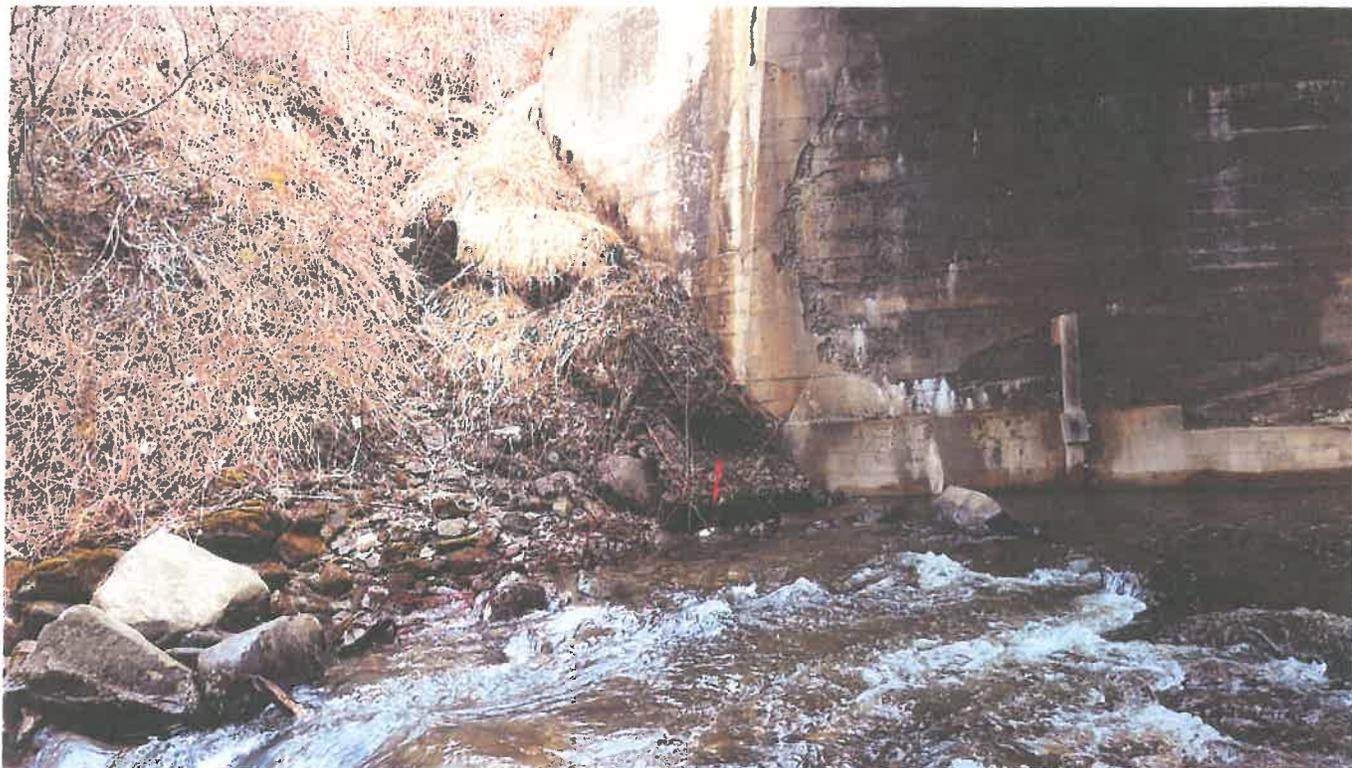
Adjacent Bishop Brook- north of bridge and west of Route 145- L (W:3 R2UB1 bank), M (W:3 R2UB1 bank), N (W:1 R2UB1)

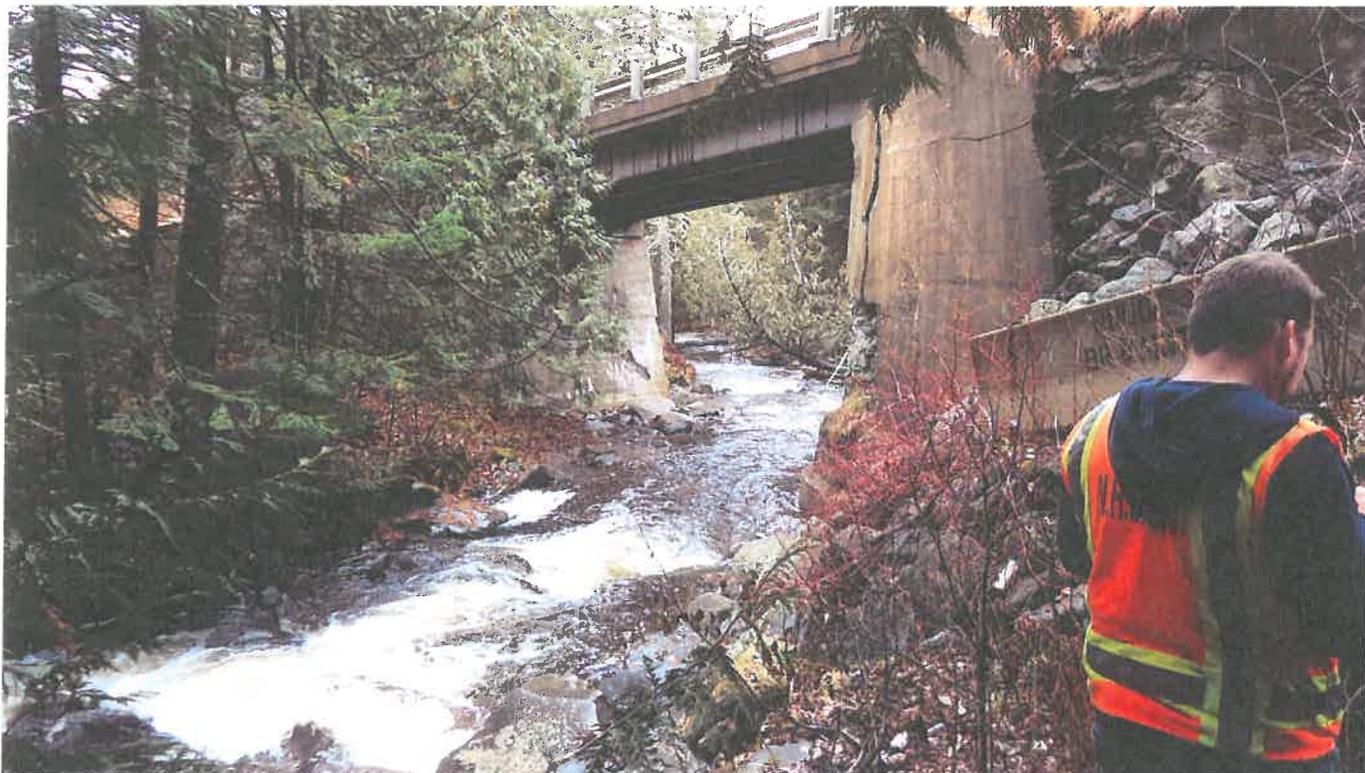
Adjacent Bishop Brook- east of Route 145- north of bridge on right side R (W:5 R2UB1 bank), S (W:5 R2UB1), south of bridge on left side P (W:4 R2UB1 Bank) and Q (W:4 R2UB1 Bank)

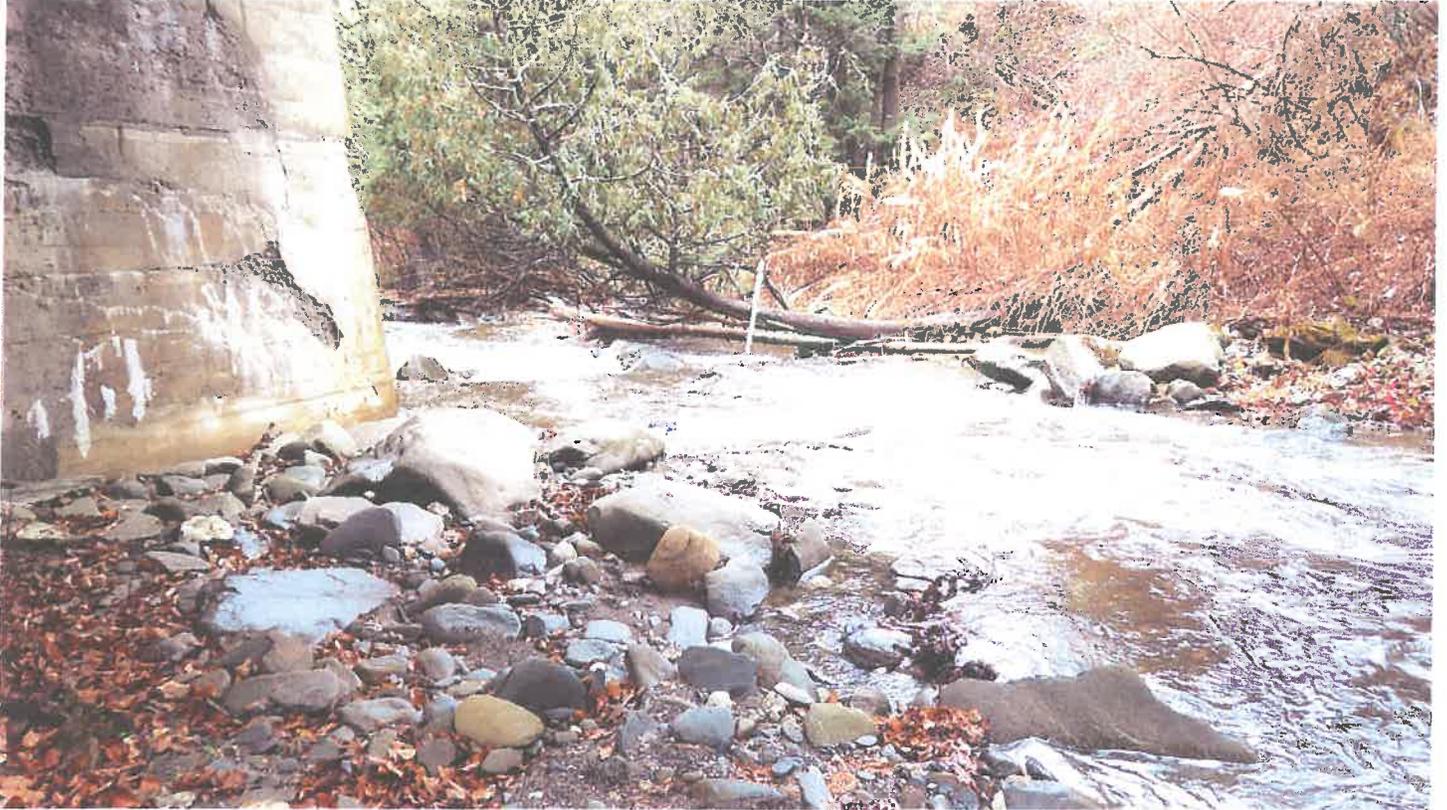
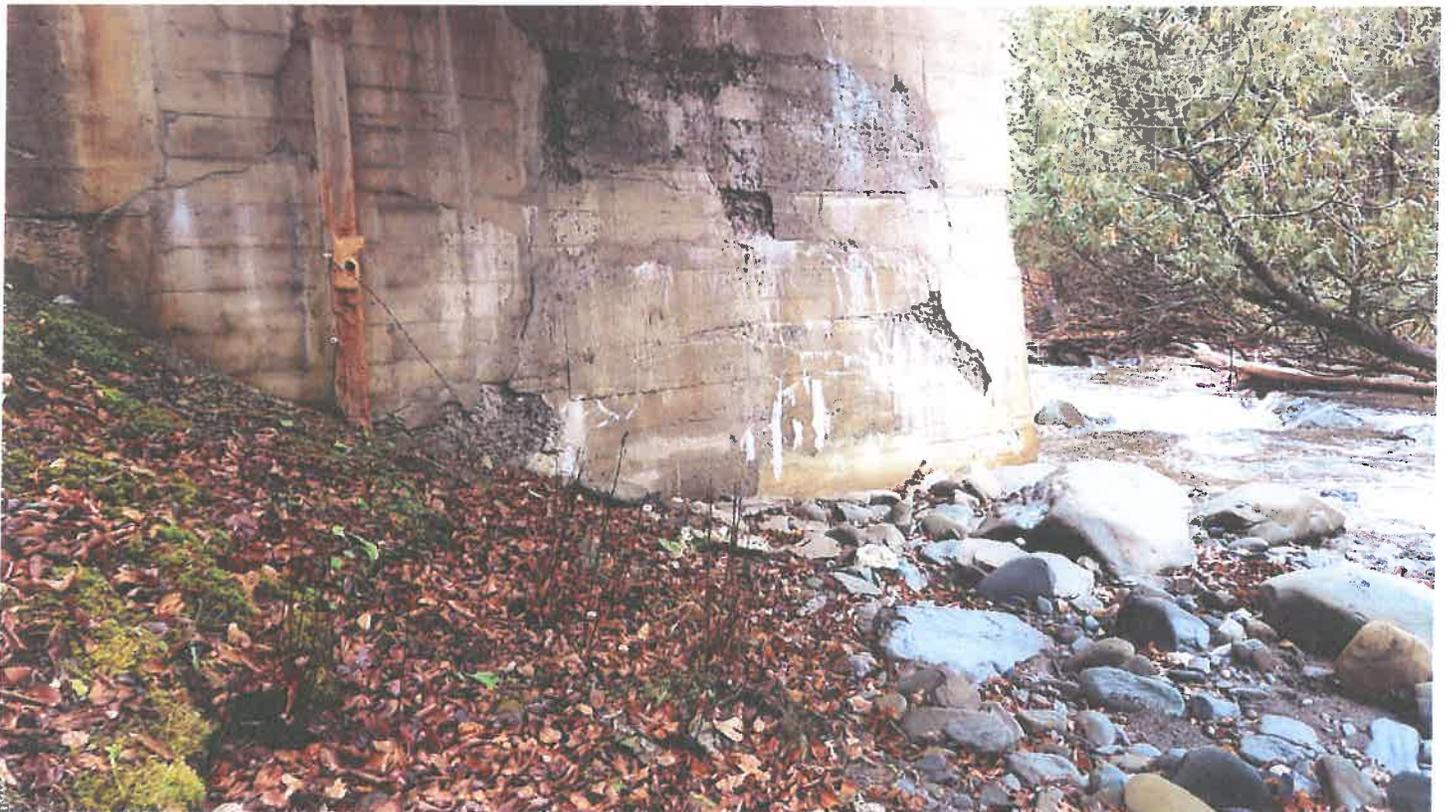
Stewartstown 16312- Bridge Replacement- Bishop Brook- Route 145
Wetland Permit Application Photos
Under bridge on south side of Bishop Brook: O (W:1 R2UB1)

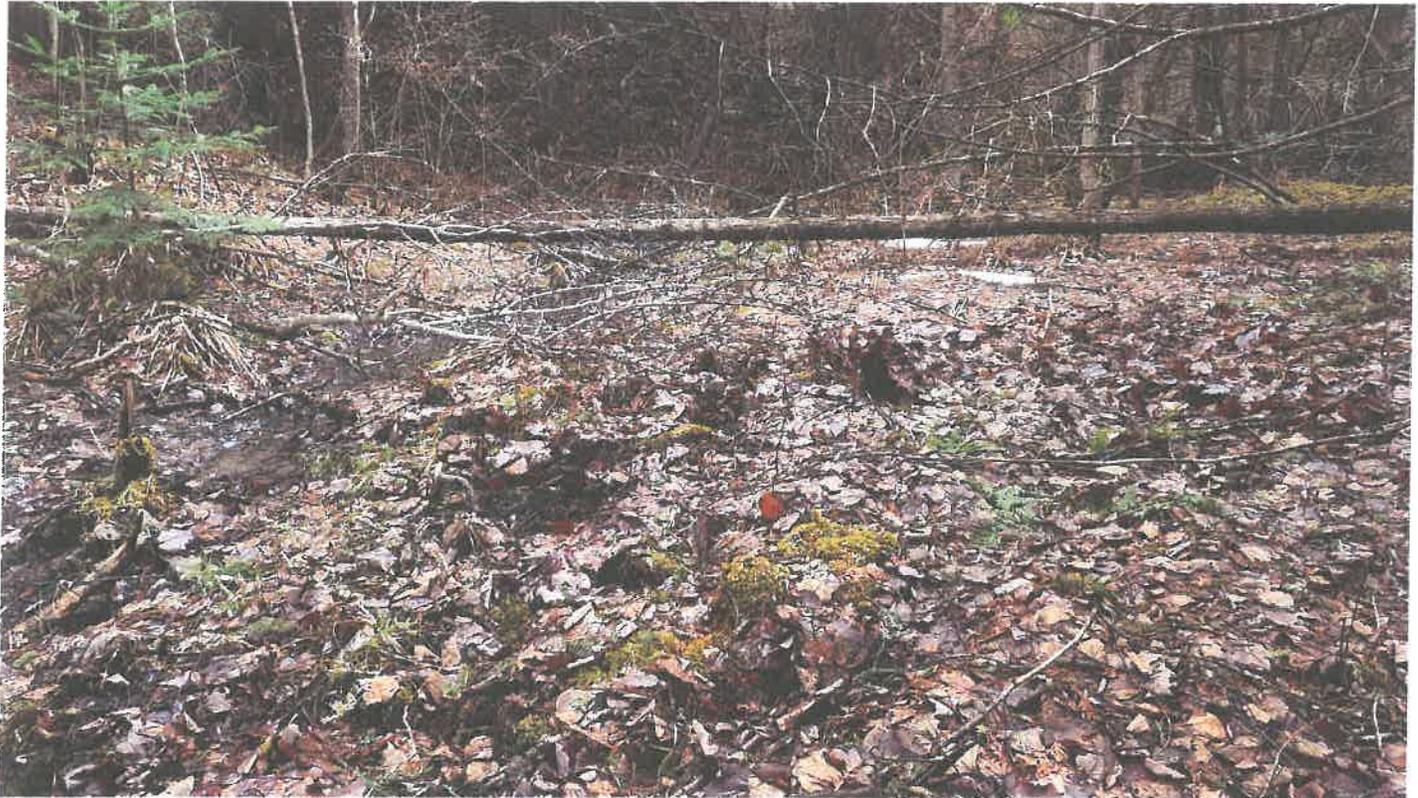
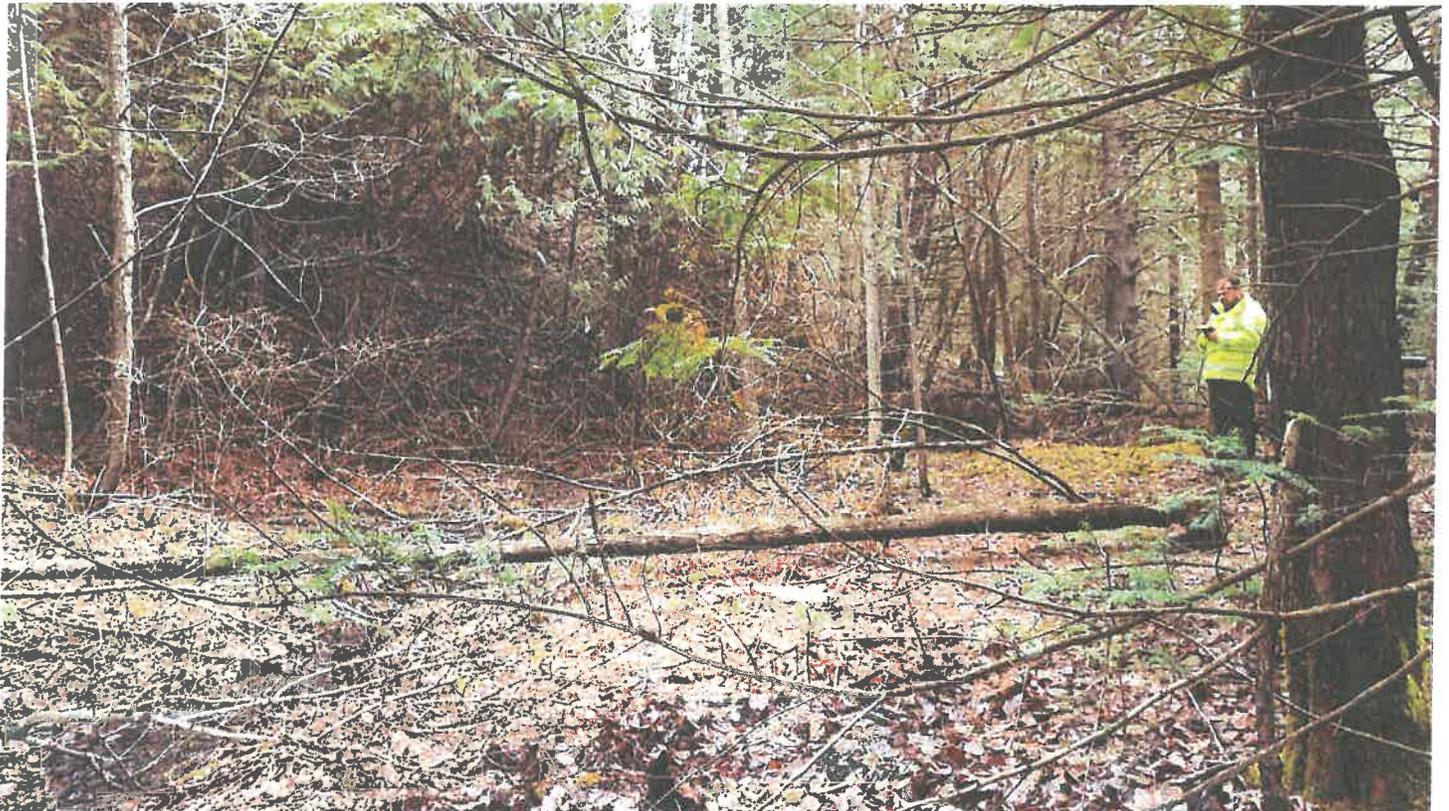
North of bridge, wetland pocket uphill from Bishop Brook, and east of Route 145- W (W:9 PFO1E), X (W:9 PFO1E), Y (W:7 R4SB3), Z (W:9 PFO1E)

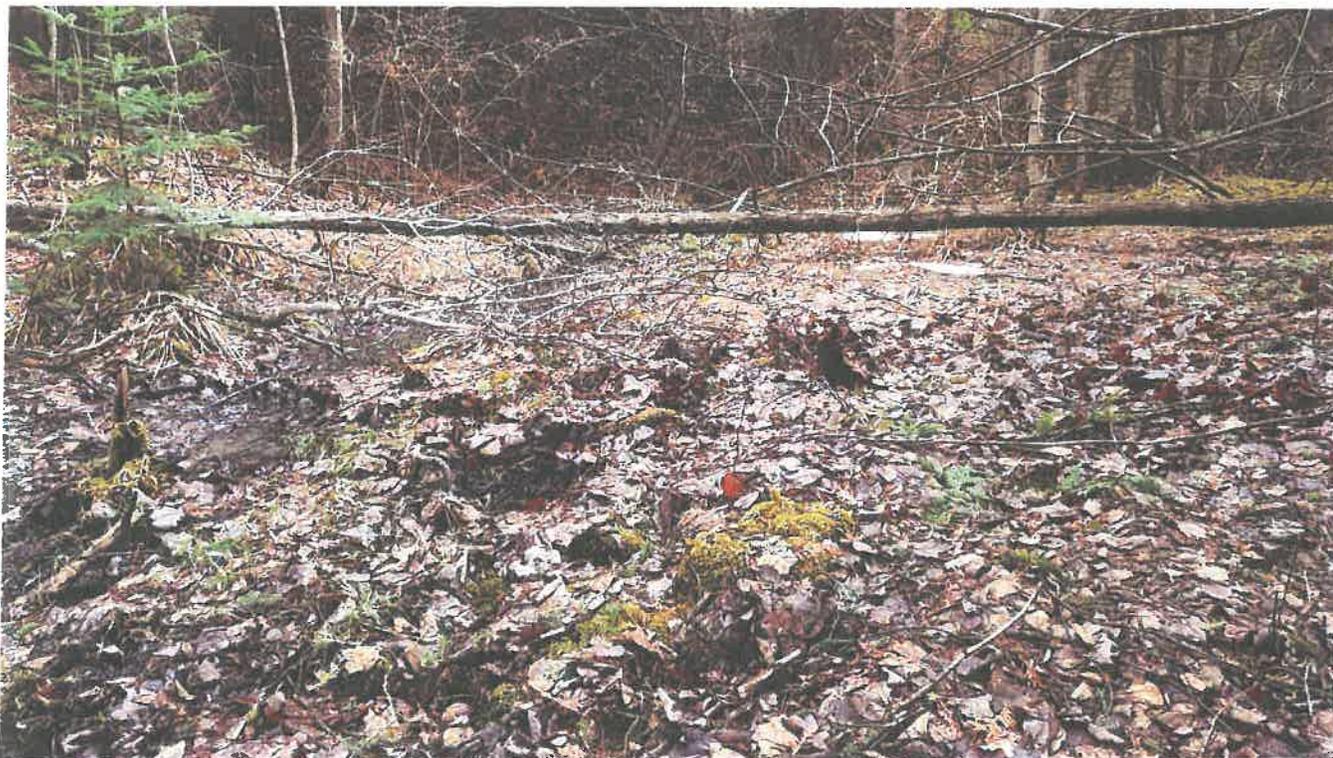
Intermittent stream north of bridge and east of Route 145- AA (W:7 R4SB3) (AA is on the left side of the photo, wetland pocket on the right)
