New Hampshire
DOT
Research Record

Integrated Geophysical Methods for Geotechnical Subsurface Investigations

Final Report

INTEGRATED GEOPHYSICAL METHODS FOR GEOTECHNICAL SUBSURFACE INVESTIGATIONS

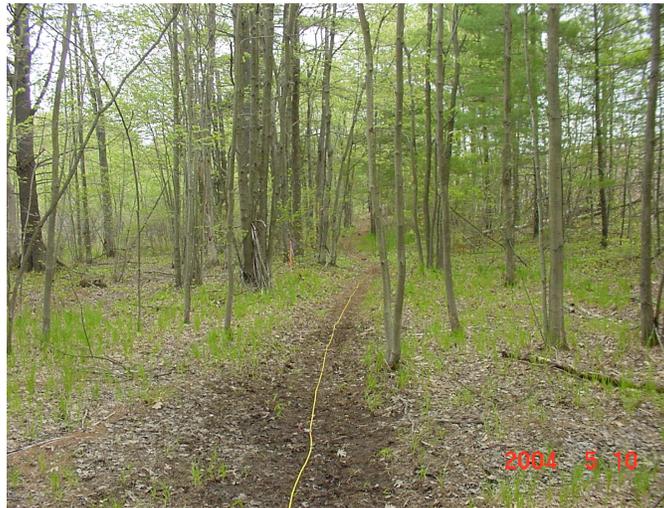
Figure 1: Path along alignment of proposed Exit 12 southbound on-ramp.

To map the subsurface, a path was cleared along the centerline of the new on-ramp (Figure 1). Forty-eight nodes at five-meter spacing were set up as a Wenner-Schlumberger array with 520 quadrapoles capable of obtaining an exploration depth of 38 meters. The multi-electrode unit automatically switched on and off two sets of current and potential electrodes throughout the length of the array until all 520 quadrapoles were read over a period of approximately one hour. The readings were then downloaded from the resistivity imaging unit onto a desktop computer where the results could be analyzed using the RES2DINV software.

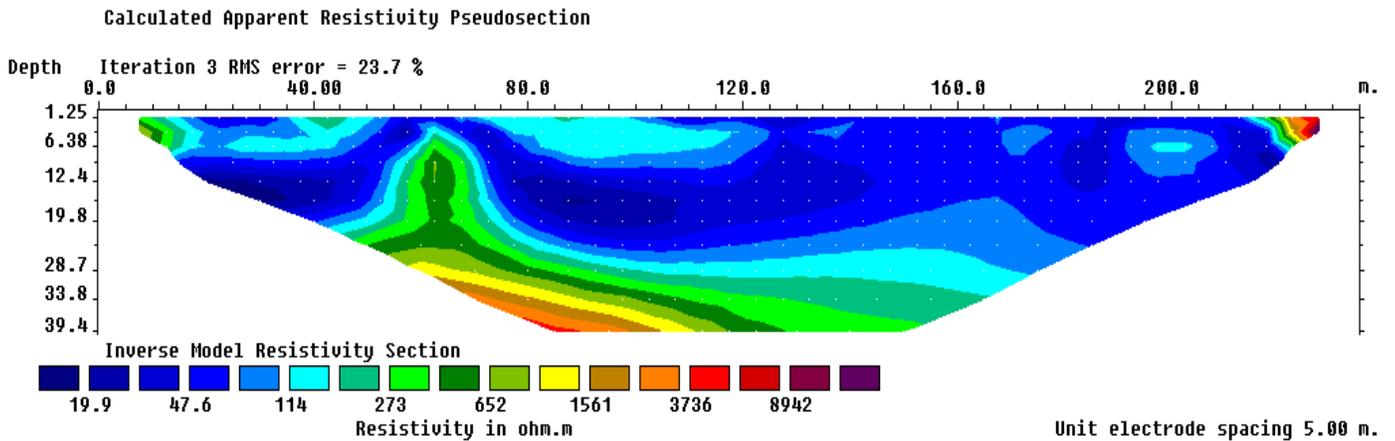
Figure 2: Wenner-Schlumberger resistivity array

Using the analysis software and a least squares type of inversion, the resistivity data were inverted and the results displayed as shown in Figure 2. A large portion of the profile consists of material with resistivity values below 100 ohmmeters, which according to Table 1 are typical of silts and clays. To ground truth the results of the resistivity imaging a second round of test borings was conducted along the same line as the resistivity profile. By comparing the resistivity values to a fence diagram created from the test boring data (Figure 3), a strong correlation can be observed.

The resistivity profile shows the glacial marine clays (blues) to a depth of 20 to 28 meters below ground surface with an area towards the middle of the profile showing slighter higher resistivity values (green). It is possible that these higher values indicate the presence of an old river channel that had previously cut through the glacial marine sediments as the river meandered over time. A fence diagram was created from the

The resistivity results from the Spaulding Turnpike on-ramp project ground truthed well with the test borings. A section of the profile revealed an area of higher resistivity values close to the ground surface. This area could represent an abandoned river channel within the Cocheco River flood plain. This demonstrates that test borings alone can miss areas that could be significant to the geotechnical aspects of a project. For this site, an important question is: Where would you interpret the bottom of the marine clay deposit if test boring data could not be used as a ground truth? On the right side of the resistivity profile, the blues (20–114 ohm-meters) transition into the greens (200-650 ohm-meters) over a depth range of 20 to 28 meters below ground surface. Without test boring data it would be difficult to accurately determine the bottom of the marine clay deposit.

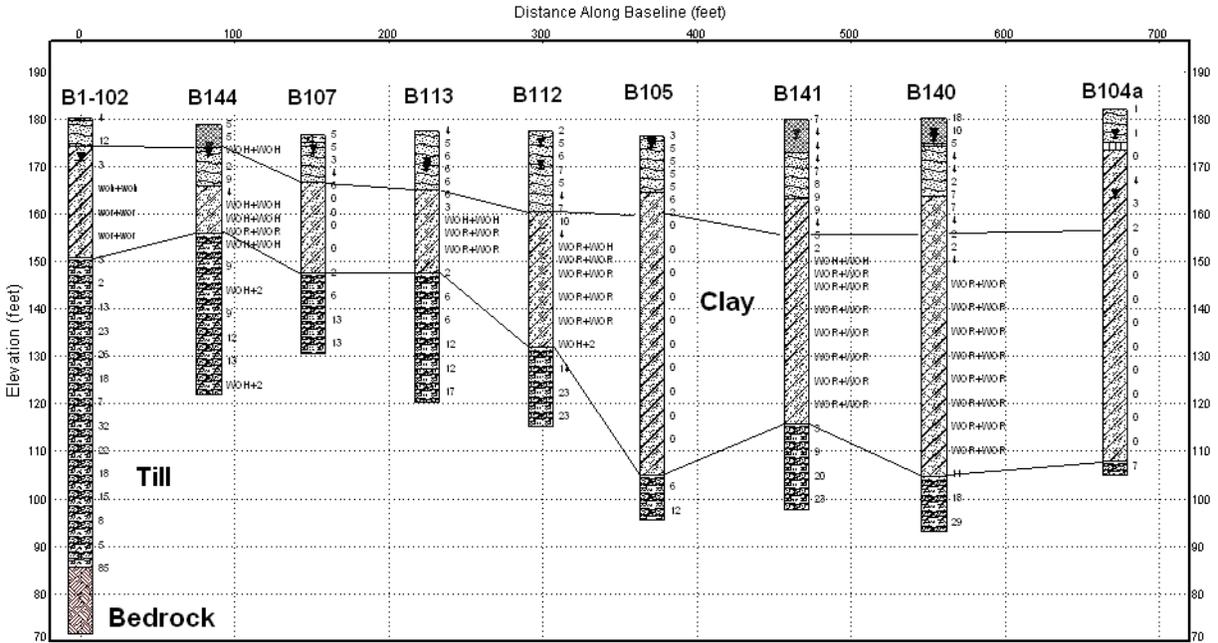
Figure 3: Fence diagram of test boring logs from Exit 12 southbound on-ramp

test boring data showing the glacial-marine clays (zero blow count material) to a depth of 21 to 23 meters below ground surface. By using the known depths of the glacial-marine clays, a bedrock surface could be interpreted on the resistivity profile as somewhere close to the top of the light blue color.

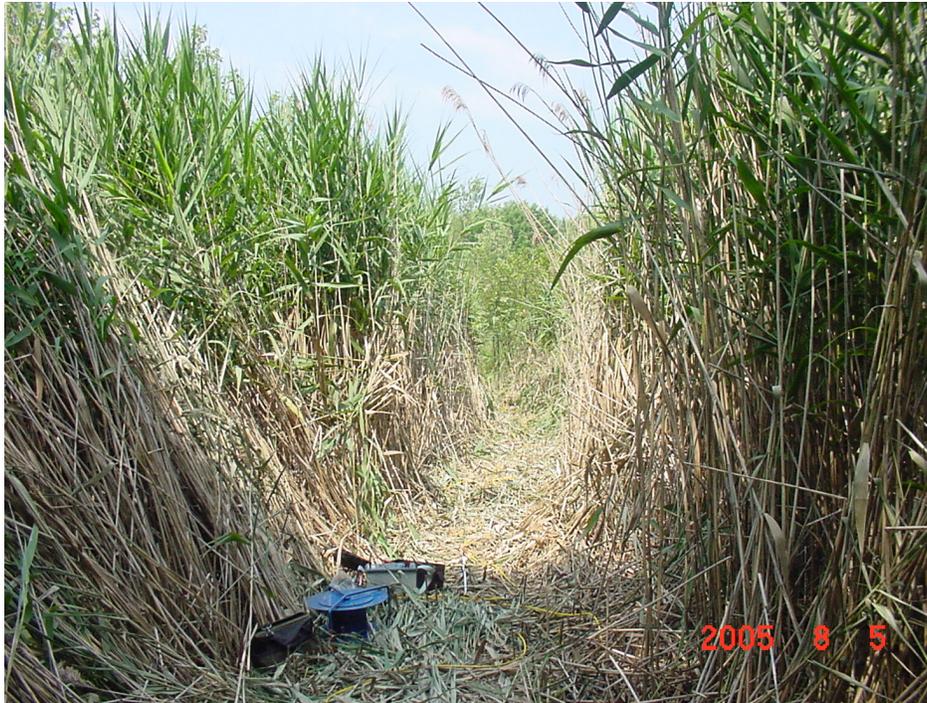
Figure 4: Photo of area with suspected organic deposits.

To facilitate the geophysical investigation, a path was cleared through tall cattails (Figure 4) near the proposed centerline of the new southbound on ramp. Forty-eight stainless steel electrodes were placed at five-meter intervals and a Wenner-Schlumberger array with 360 quadrapoles capable of obtaining an investigation depth of 20 meters was created. The water table was near the ground surface in the area where the electrodes were placed. The data were collected, readings were downloaded onto a desktop computer, and the RES2DINV analysis software was used to analyze the data. Using a least squares type of inversion, the data were inverted and a resistivity profile was created (Figure 5).

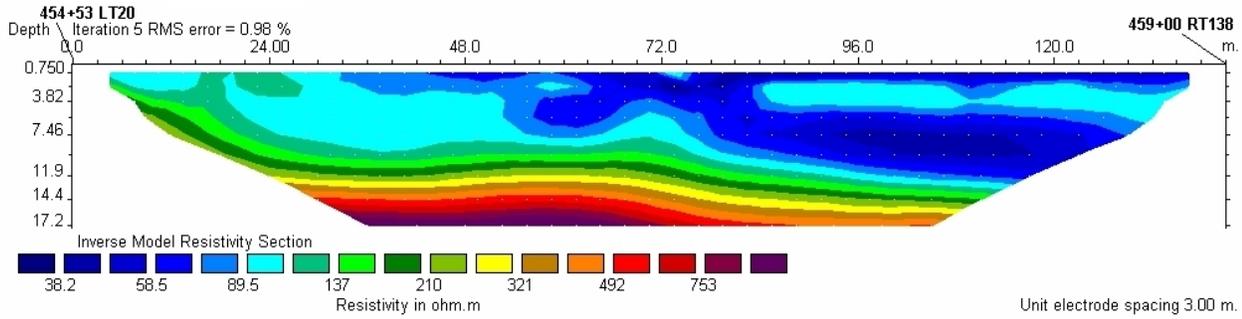
Figure 5: Wenner-Schlumberger array

The inversion results indicated that a large portion of the profile is characterized by a material with low resistivity values (less than 90 ohm-meters). As indicated by Table 1, low resistivity values are typical of wet organic and clayey soils. Based upon the results indicated by the resistivity survey, a series of hand auger probes was conducted to collect soil samples for laboratory analysis and to further map the extent of the deposit. Figure 6 displays the on-ramp alignment, the resistivity line, and the locations of the hand auger probes. Table 2 displays the laboratory results of the soil samples collected through the hand auger probes. This deposit is characterized by soils with high moisture and organic contents to a maximum depth of 35 feet below ground surface.

The hand auger results compared well with the resistivity profile collected for the proposed I-93 Exit 3 southbound on-ramp. The resistivity data was able to confirm suspicions that deep soils with high moisture and organic content were most likely present beneath the area of the proposed high embankment fill. The difficulty was how to confirm the results of the resistivity imaging. The ground was too soft for drilling conventional test borings, so hand auger probes were used to confirm the extent of the deposit and to collect soil samples for laboratory analysis. The use of geophysics on this project was different from that of the other case histories. Resistivity imaging was used as a preliminary type of investigation in an attempt to locate problem soils within the limits of the project. By using resistivity imaging to locate soft soils prior to developing an exploration plan, test borings, test pits, or hand auger probes can then be taken at locations where they will best collect subsurface data key to the design of the project.

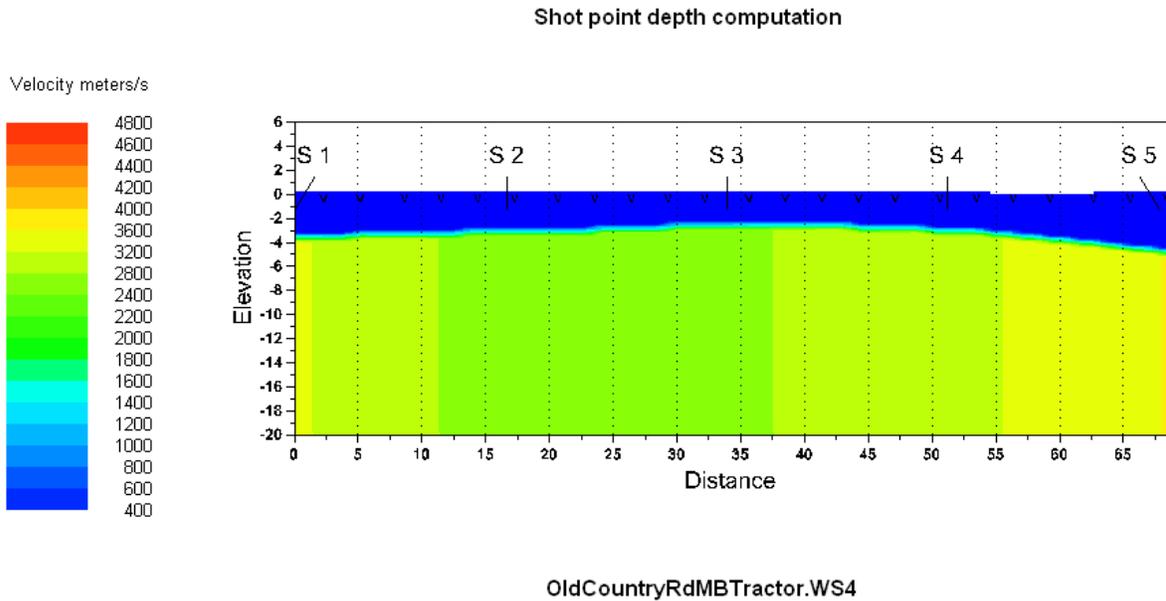
Figure 8: Seismic velocity profile along 1 section of Old Country Road.

Figure 9 is a plan view of the intersection displaying the locations of the test borings and the seismic lines. For the seismic profile displayed in Figure 8, seismic shot S1 was closest to test boring B131 and seismic shot S5 was closest to test boring B118. The yellow and green velocities represent the bedrock while the blue velocities are the overburden soils. The test borings were used to ground truth the seismic profiles.

approximately one meter (4 ft) as the bedrock surface increases in elevation by approximately one-and-a-half meters (5 ft). Similar depths to bedrock are displayed on the seismic profile in Figure 8.

The seismic refraction results from the Old Country Road project also ground truthed well with the test borings. This demonstrates that in areas of shallow bedrock, seismic refraction works well at filling in the gaps between test boring locations. The bedrock surface mapped by seismic refraction did not reveal any sudden changes in the elevation. If the seismic refraction results had indicated sudden changes additional test borings would have been conducted to confirm the refraction results. For this project, the seismic refraction results provided confidence to the geotechnical engineer that the bedrock surface depth encountered through the test borings remained relatively constant over the entire project area.

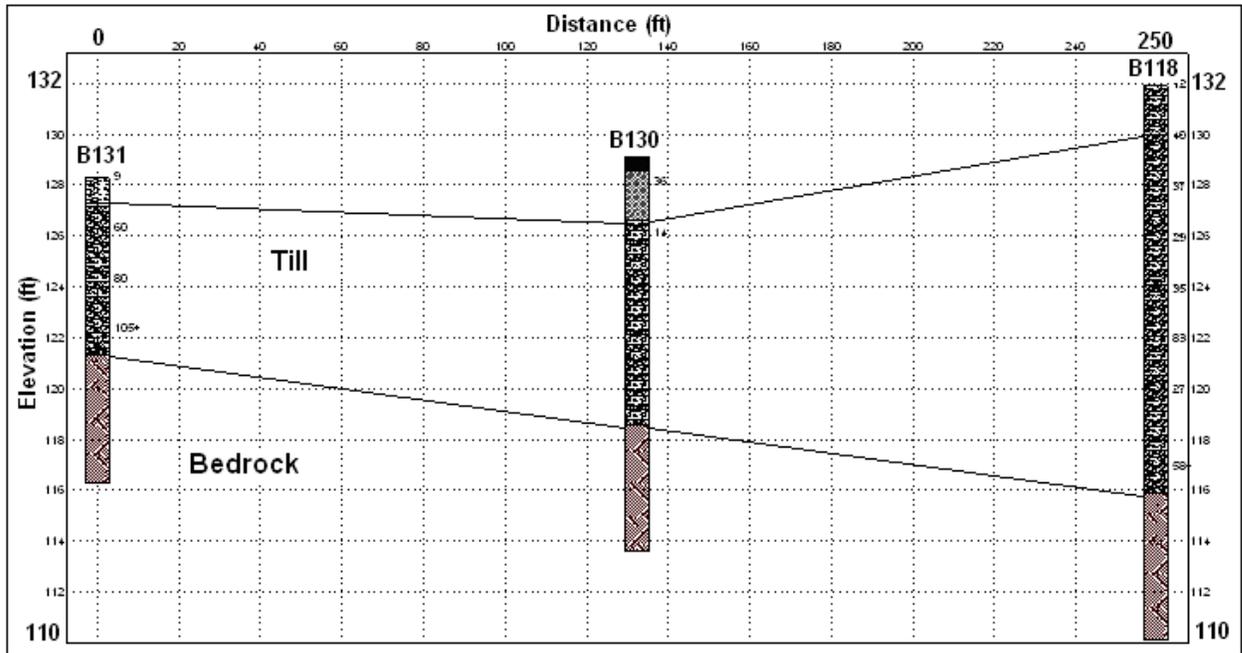
Figure 10: Fence diagram of test borings along a section of Old Country Road.

Displayed in Figure 10 is a fence diagram of the test boring data moving away from the intersection. The ground surface can be seen dropping in elevation by

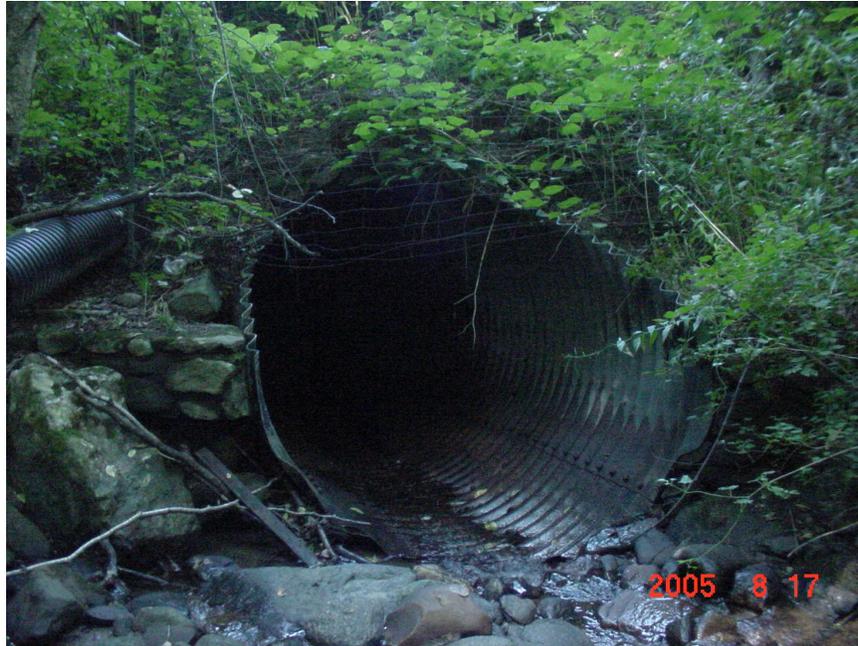
Figure 11: 1.5 meter metal pipe buried beneath 18 meters of roadway fill.

NH Route 12A is located in the western part of the state and travels along the eastern shore of the Connecticut River. The geophysical investigation encountered primarily roadway fill material with possible natural deposits of sand and silt. Figure 12 is a Global Positioning System (GPS) survey showing the locations of the GPR and resistivity profiles, cracks in the pavement, the failed section of roadway, and the location of catch basins and pipes. Also shown is an area of concern based upon the geophysical results.

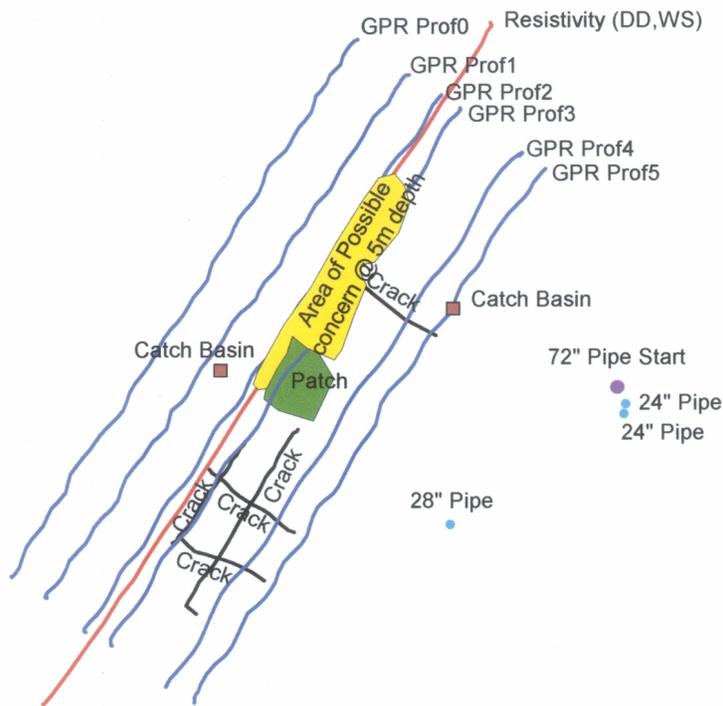
Figure 12: Geophysical and GPS survey of project.

Figure 14 is a resistivity profile that was collected on the southbound shoulder of the roadway adjacent to where the failed surface is located. Twenty-four electrodes were placed at four-meter spacing and a Dipole-Dipole array was set up. The metal pipe buried at 18 meters was not encountered even though the array was designed to reach a depth of 21.5 meters. However, an area with low resistivity values (less than 20 ohm-meters) possibly composed of loose silty fine material (i.e. area of concern in Figure 12) was located and could be a contributing factor to failure of the roadway.

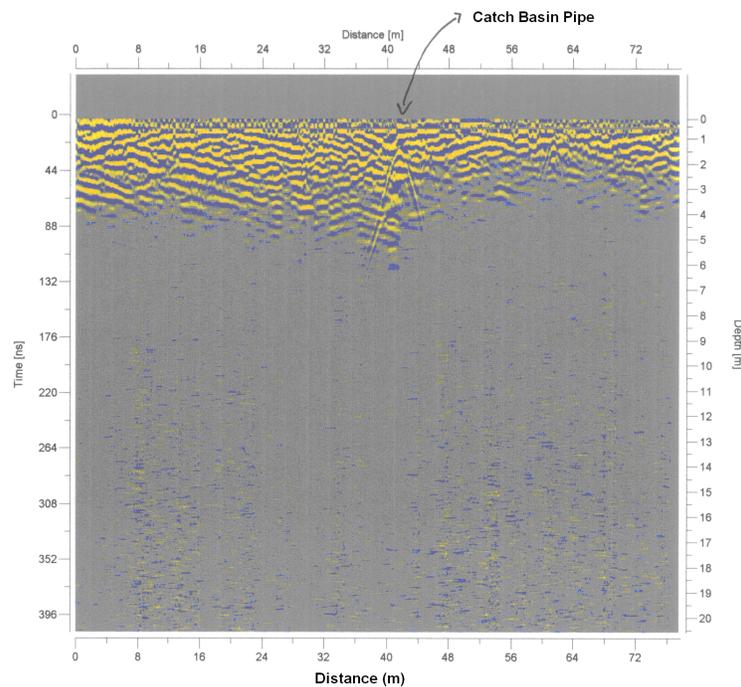
Figure 13: GPR profile showing catch basin pipe.

Figure 13 is one of six GPR profiles that were collected at the site. This profile was collected near one of the catch basins just south of the failed roadway section. A 100 MHz shielded antenna was used to collect data displayed in this profile. As shown in

Figure 13, the maximum depth of penetration was approximately six meters, which was about a third of the depth needed to reach the buried (1.5 meter diameter) metal pipe. A reflection from the catch basin pipe is observed in the profile, but voids or other subsidence are not observed. The remaining GPR profiles were similar to that of Figure 13, voids were not detected and the 1.5-meter diameter buried pipe was not observed.

The geophysical investigation that was conducted to locate the buried 1.5-meter diameter pipe in Walpole was considered to be less successful. It was known ahead of time that trying to obtain a depth of 18 meters with GPR would be difficult. The Maintenance Engineer was informed that GPR would probably only be able to locate near-surface voids and not voids that surrounded the pipe buried at a depth of 18 meters. This proved to be partially correct because GPR was only able to reach a depth of approximately six meters before the signal attenuated. It did not detect any near-surface voids. In order to detect voids, there must be a difference in the dielectric constants between the material surrounding a void and the material filling a void. In this case, either the near-surface voids did not exist, the material that filled these voids and the material that surrounded these voids had similar dielectric constants, or the voids were beyond the resolution of the antennas. The resistivity results also could not locate the buried pipe at a depth of 18 meters. Both the Wenner-Schlumberger and the Dipole-Dipole arrays were centered on the pipe and should have been able to reach a depth of 18 meters. Although the pipe was not detected, the results were somewhat useful because a near-surface area with low resistivity values was observed. Unfortunately, this area of low resistivity did not correlate well with the area of roadway subsidence. To obtain the maximum depth penetration and a higher resolution, a pair of additional arrays should have been designed using all 48 nodes. These arrays should have set the electrode spacing at two-and-a-half meters and at five meters. The combination of these additional arrays would have increased the near-surface resolution as well as the depth penetration of the profiles. With these additional arrays, the buried pipe and any near-surface voids might have been detected.

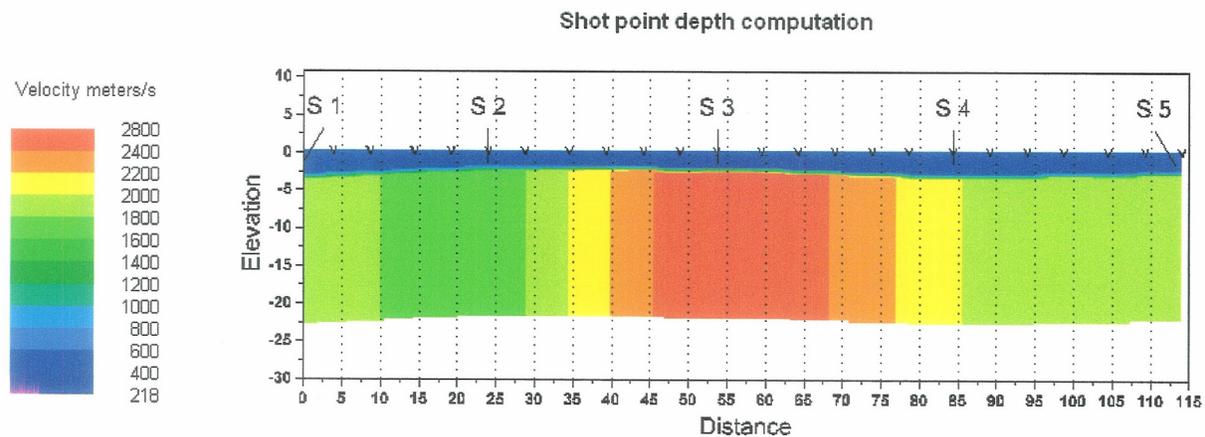
Figure 15: Typical seismic refraction profile along southern side of roadway

Seismic refraction was conducted along the southern side of N.H. Route 25 covering 460 meters of roadway. Figure 15 is a typical seismic profile for the project area. 24 geophones were placed at five-meter spacing intervals and five shots at locations S1 through S5 were fired. The shallow bedrock displayed in the profile agreed well with the test borings and test pits that were conducted along this side of the roadway.

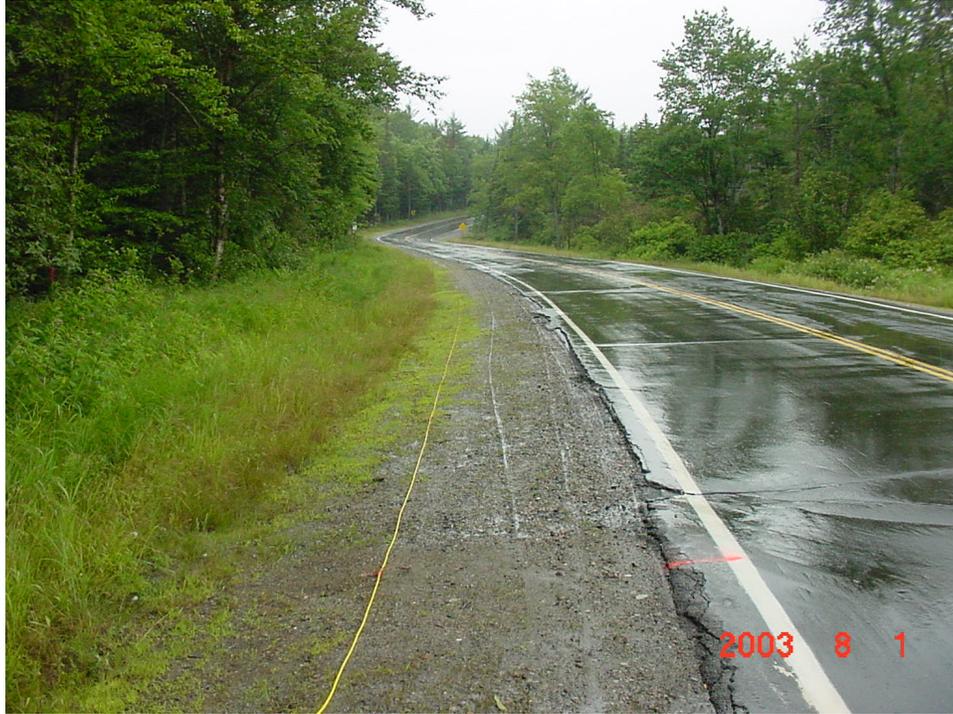
Figure 16: Resistivity line set up along the southern side of the roadway.

Resistivity profiles were collected along the southern side of the road for 470 meters (Figure 16) and along the northern side of the road for 23.5 meters. Figure 17 displays two resistivity profiles collected along the southern side of the road with five-meter electrode spacing. These profiles display soils with relatively low resistivity values over shallow bedrock with higher resistivity values. Figure 18 is similar to Figure 17 except that the bottom profile has an electrode spacing of one half meter. This profile is different from the others in that it displays data only to a depth of 1.2 meters but is at a much higher resolution.

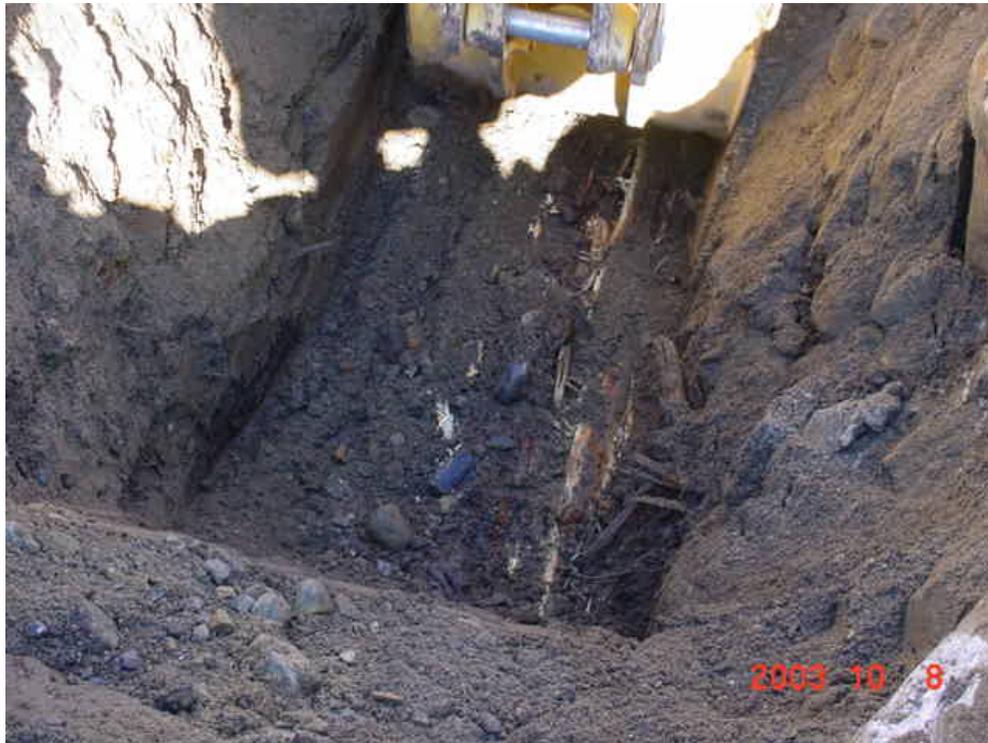
Figure 19: Test pit showing corduroy road.

Figure 19 is a shallow test pit that was dug to a depth of two meters along the northern section of the roadway where resistivity imaging and GPR were conducted. The test pit helped to ground truth these profiles and confirmed the presence of the corduroy road. The logs that compose the corduroy road were smaller in diameter than expected and are placed parallel to the roadway alignment instead of perpendicular. In addition, small branches were found along with the logs.

The geophysical investigation in Warren easily detected the soft soils, shallow bedrock, and water table, but it is questionable whether it detected the corduroy road. The logs used to construct the road had a relatively small diameter and were placed parallel with the roadway as observed in some of the 1.5 to 2 meter deep test pits (Figure 19). The direction of the geophysical investigation was parallel with the roadway which made it difficult for the ground penetrating radar unit to obtain cross-sectional reflections of the small logs buried to a depth of approximately 1.5 meters. The GPR profiles collected using the 500 MHz antenna (Figure 20) display some shallow reflections that could be from the logs, but it would be difficult to confirm the presence of the corduroy road solely based upon these GPR profiles. The resistivity profile collected along the northern side of the road with half-meter electrode spacing (Figure 18) clearly displays the water table beneath the roadway sands. This profile was taken very near the test pit displayed in Figure 19, but the buried logs cannot be detected within the water-saturated soils.

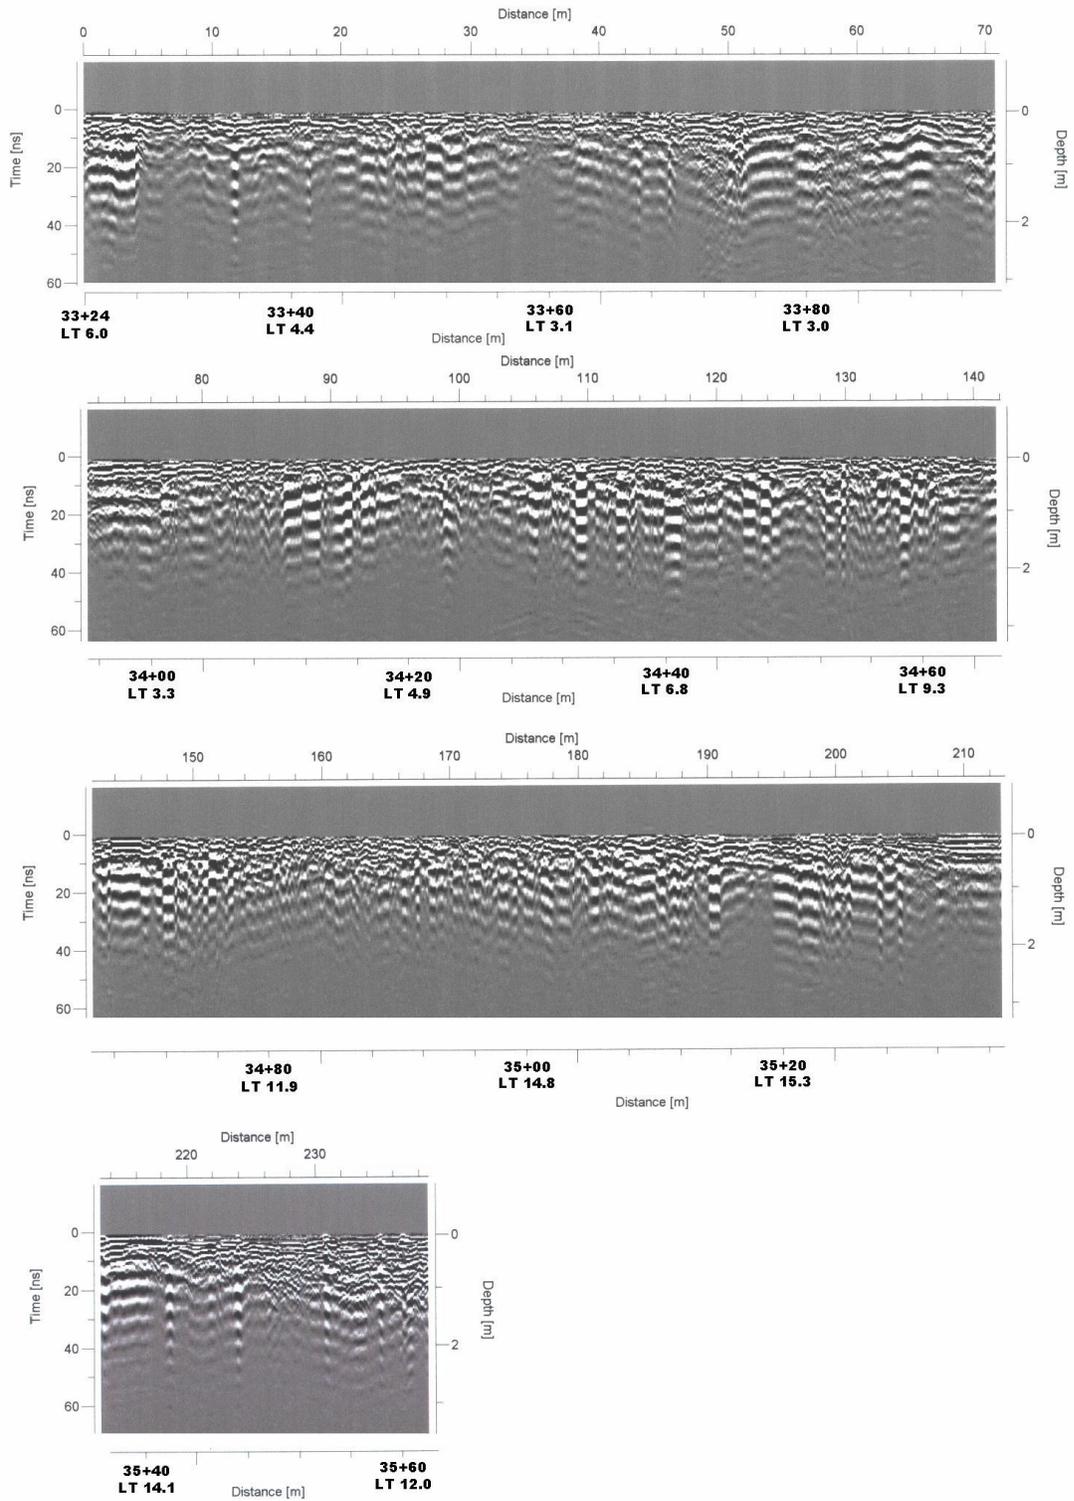
Figure 20: GPR profiles using 500 MHz antenna.

Ground penetrating radar (GPR) was conducted along the southern side of the road for 460 meters, along the northern side of the road for 250 meters, and over the central part of the road for 240 meters. A shielded 100 MHz antenna was used to collect the data for the southern and northern sides of the road, and a 500 MHz shielded antenna was used to collect the data from the central part of the road. Figure 20 displays GPR profiles taken along the section of roadway where the corduroy road was expected. These profiles were collected with the 500 MHz antenna with a depth penetration of approximately two meters.
