HAMPTON FALLS - HAMPTON

I-95 BRIDGE & TAYLOR RIVER POND DAM PROJECT

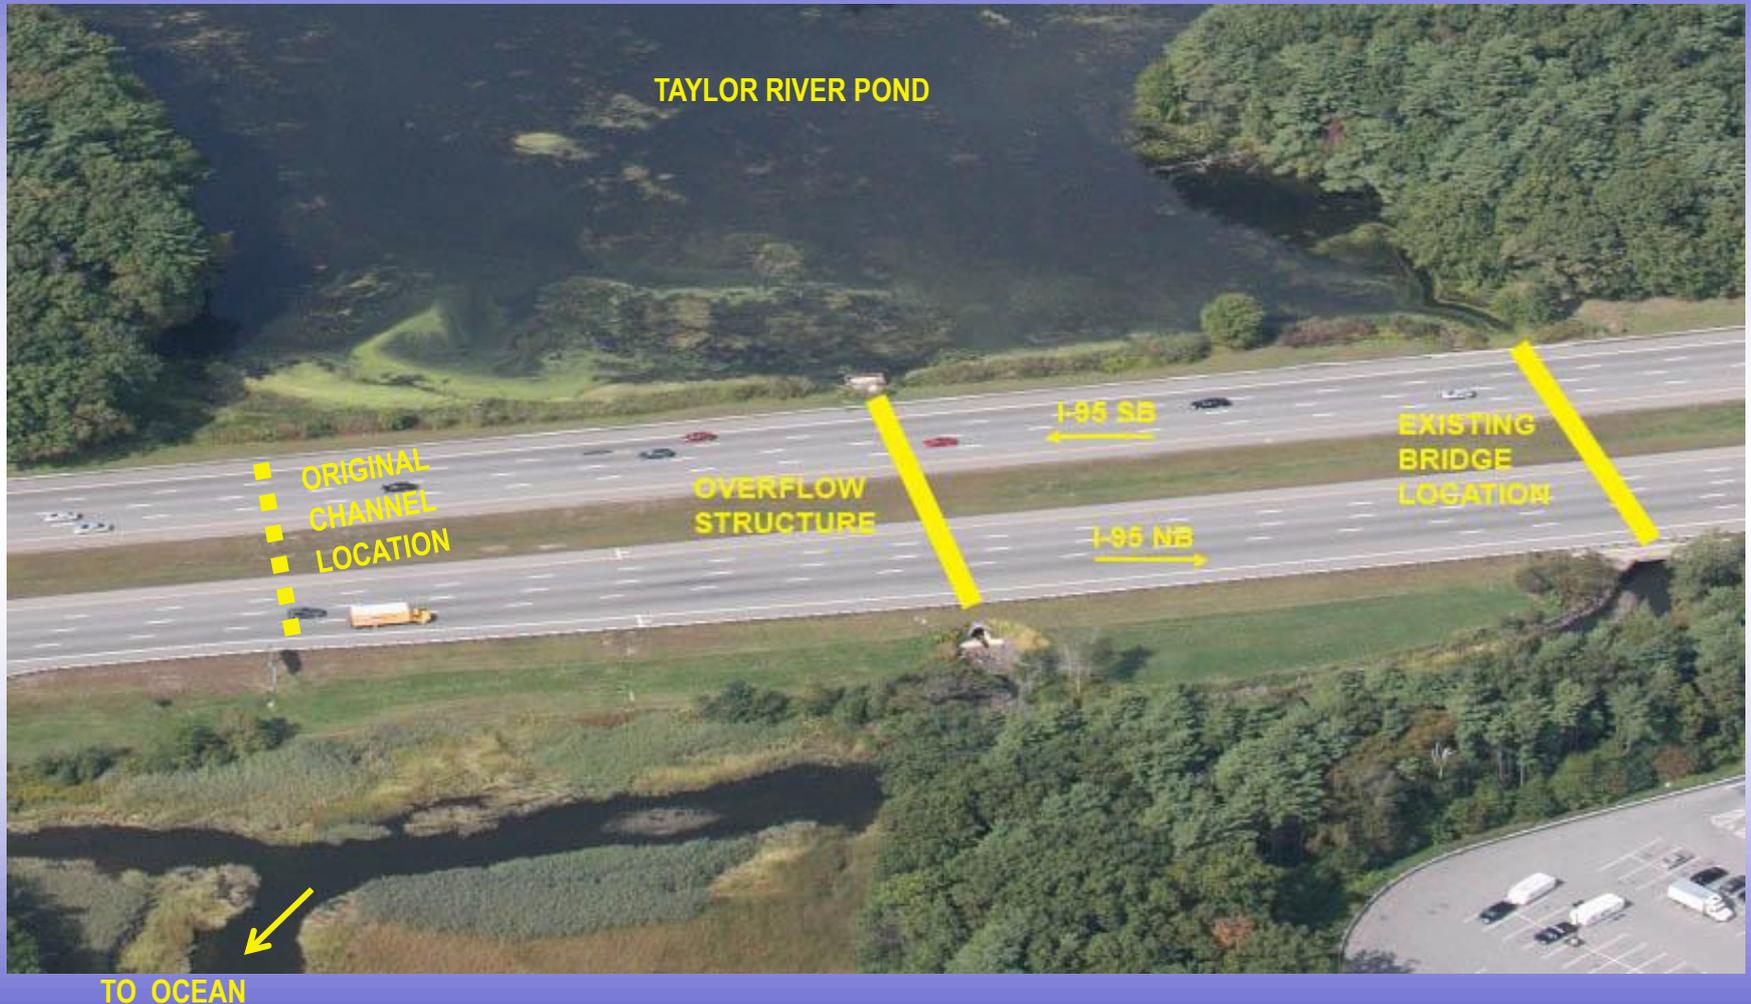
BRIDGE, DAM, AND FISHWAY

- **Flooding concerns adjacent to Taylor River Pond**
- **Deteriorated Bridge**
- **Deteriorated Dam**
- **Deteriorated Fishway**

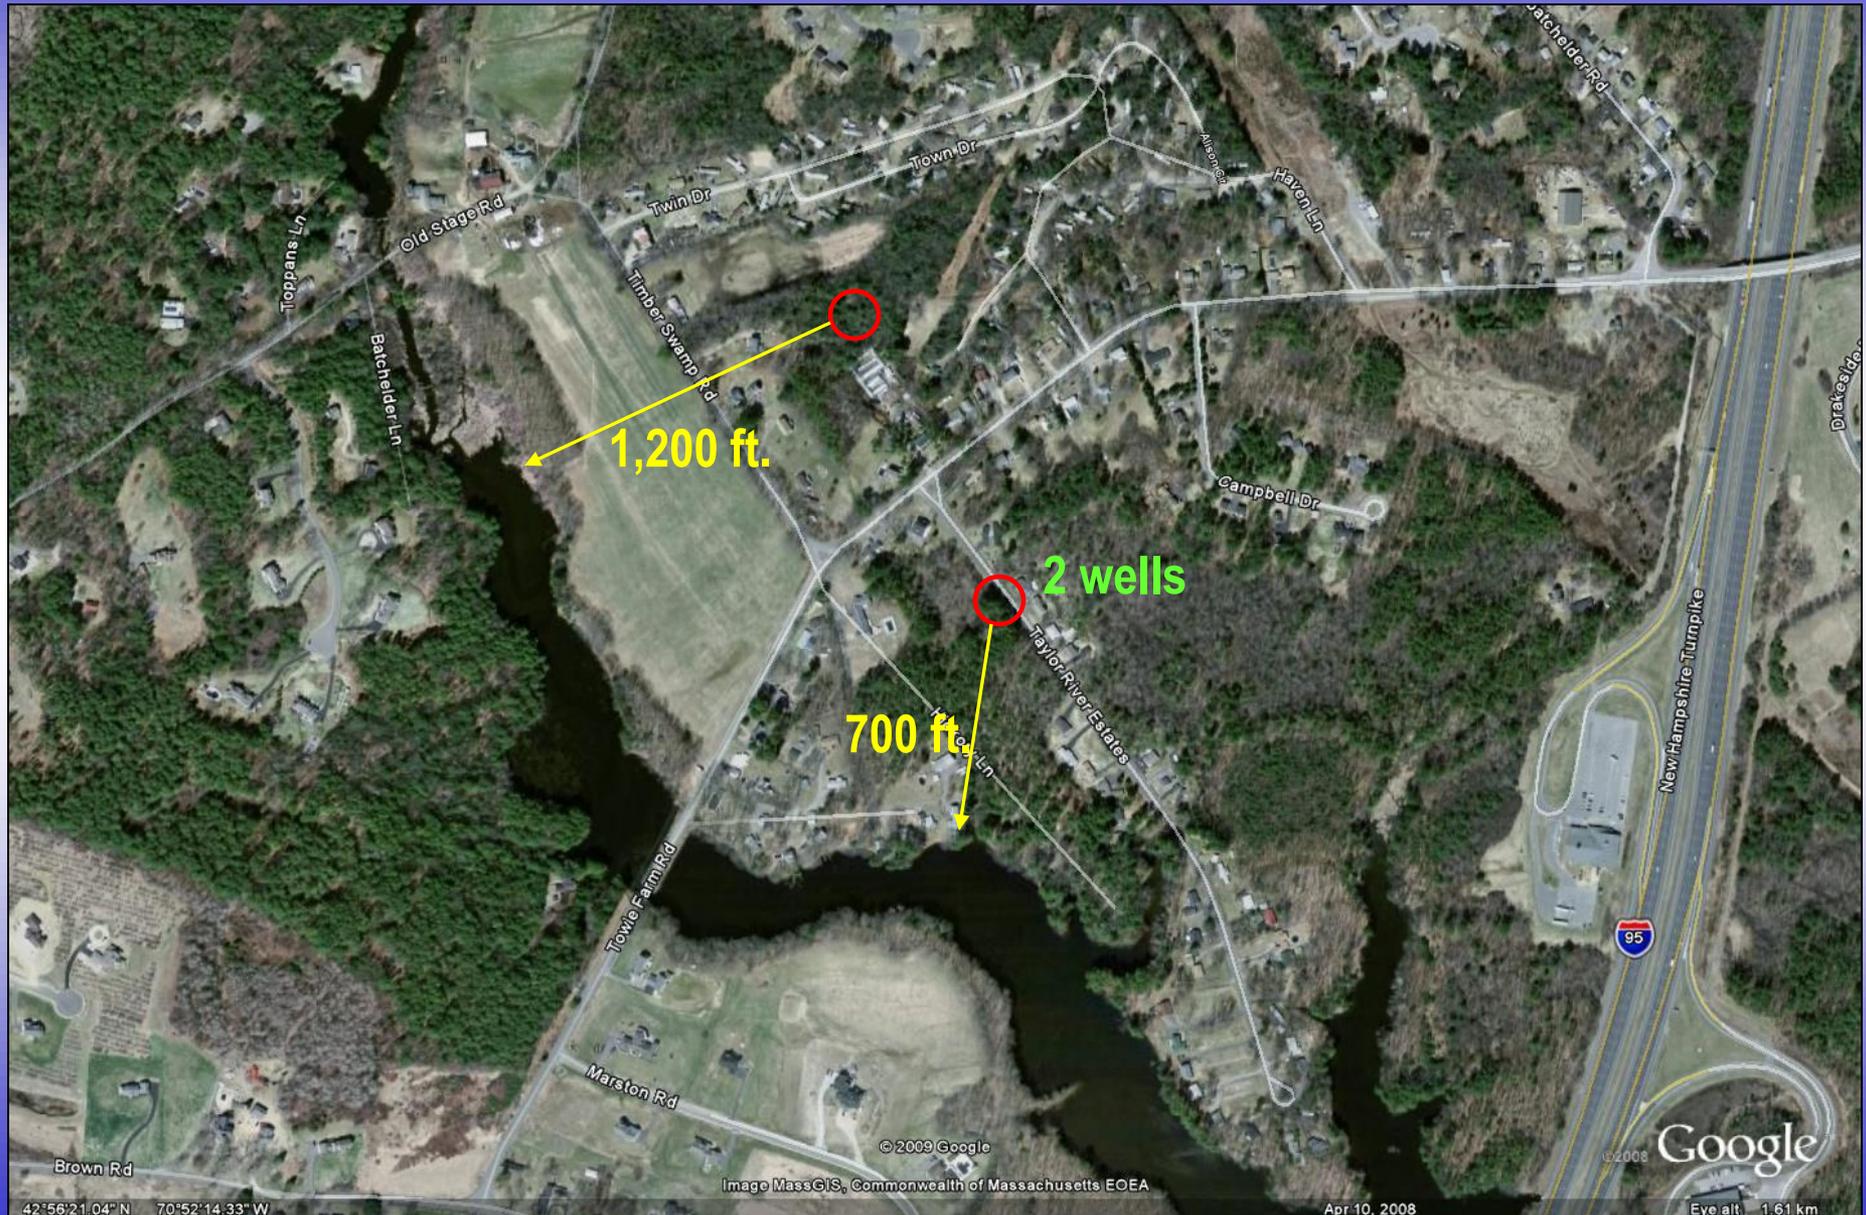
COMMUNITY WELLS

- **No Public Water Services in Hampton or Hampton Falls, all Private or Community Wells**
- **Researched Well Data within 1/4-mile of Taylor River Pond**
- **3 Community Wells:**
 - 2 Serving Taylor River Estates
 - 1 Serving Hemlock Haven Mobile Home Park
- **248 Private Property owners within Study Area:**
 - 118 use community wells
 - 130 use private wells

- Private Wells: Potential Salt Water Intrusion within 200 feet of Pond
- Bedrock Well: Less likely to be impacted than shallow wells
- Shallow wells close to Pond: Susceptible to Salt Water Intrusion or to Reduction in Recharge Rate
- Community Wells: Potentially impacted due to higher Pumping Rate; however, unlikely due to Distance (700 and 1,200 feet) and higher Groundwater Levels

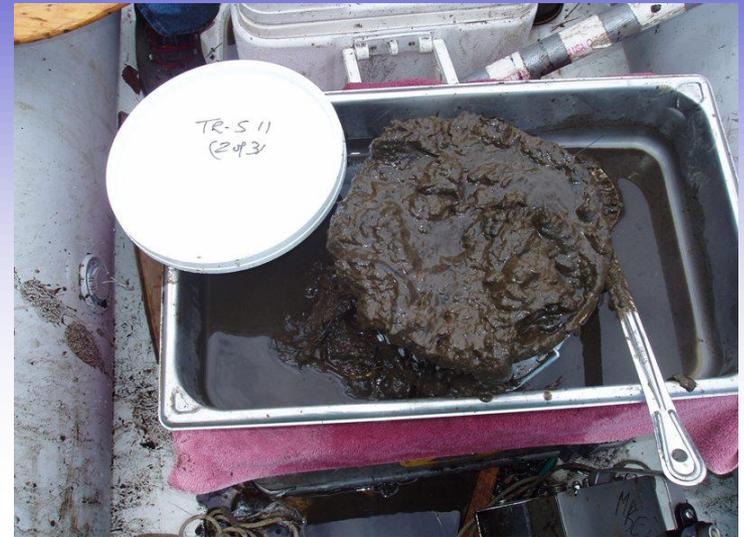
SEDIMENT IN TAYLOR RIVER IMPOUNDMENT

- **Thickness: 1 foot (on average)**
- **Clay to medium sand**
- **Contain pesticides**
 - **No risk for human health from exposure to sediment**
 - **No risk from fish consumption if health advisories are followed**
 - **Sediment at lower impoundment poses risk to bottom-dwelling aquatic organisms and birds** (based on limited risk assessment)
- **Alternatives B and C require mitigation**

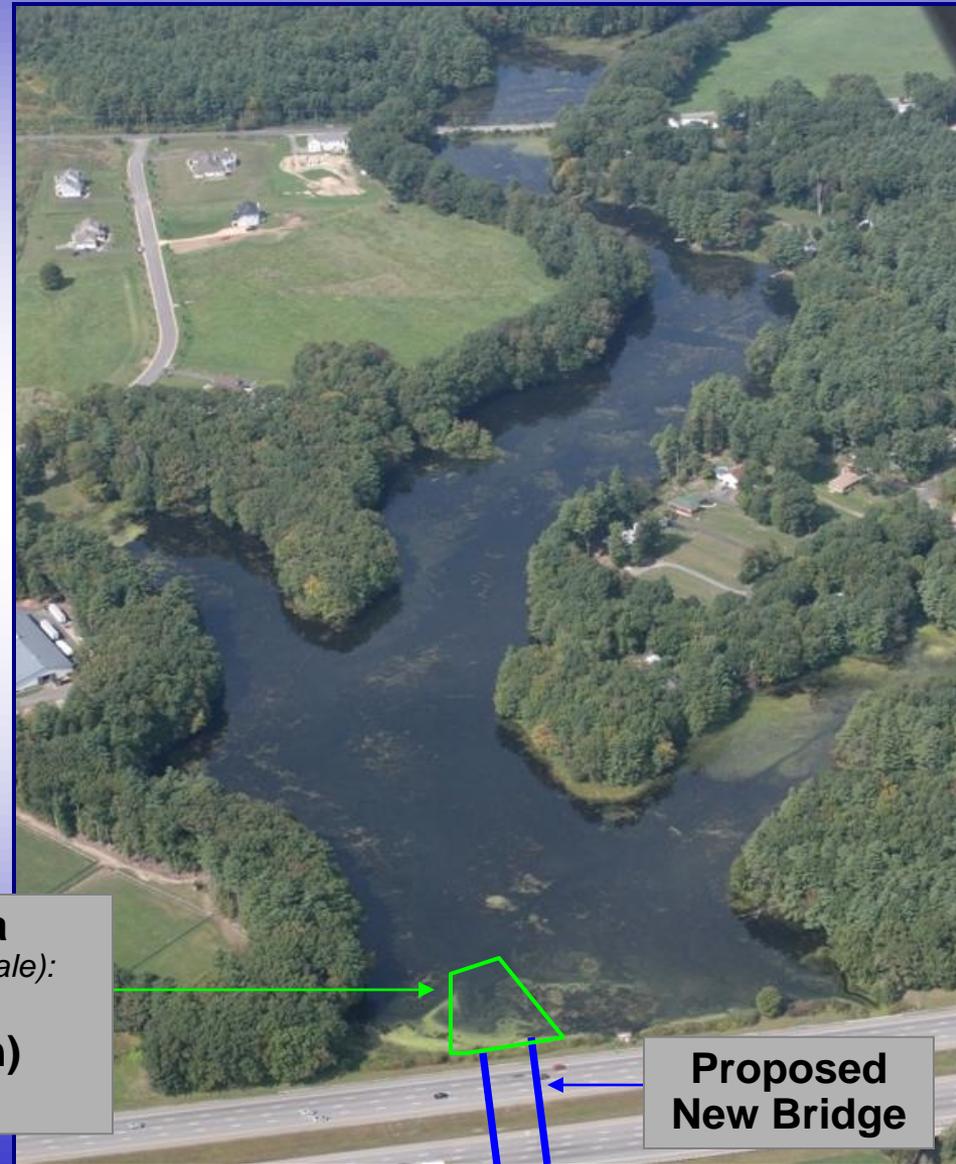
SEDIMENT MANAGEMENT- Alternative B

- Removal of sediment in front of bridge (approx. 1,200 CY)
- Disposal at landfill or nearby state-owned land

Excavation area
(preliminary; not-to-scale):
60 ft (W, up)
140 ft (W, down)
160 ft (L)

**Proposed
New Bridge**

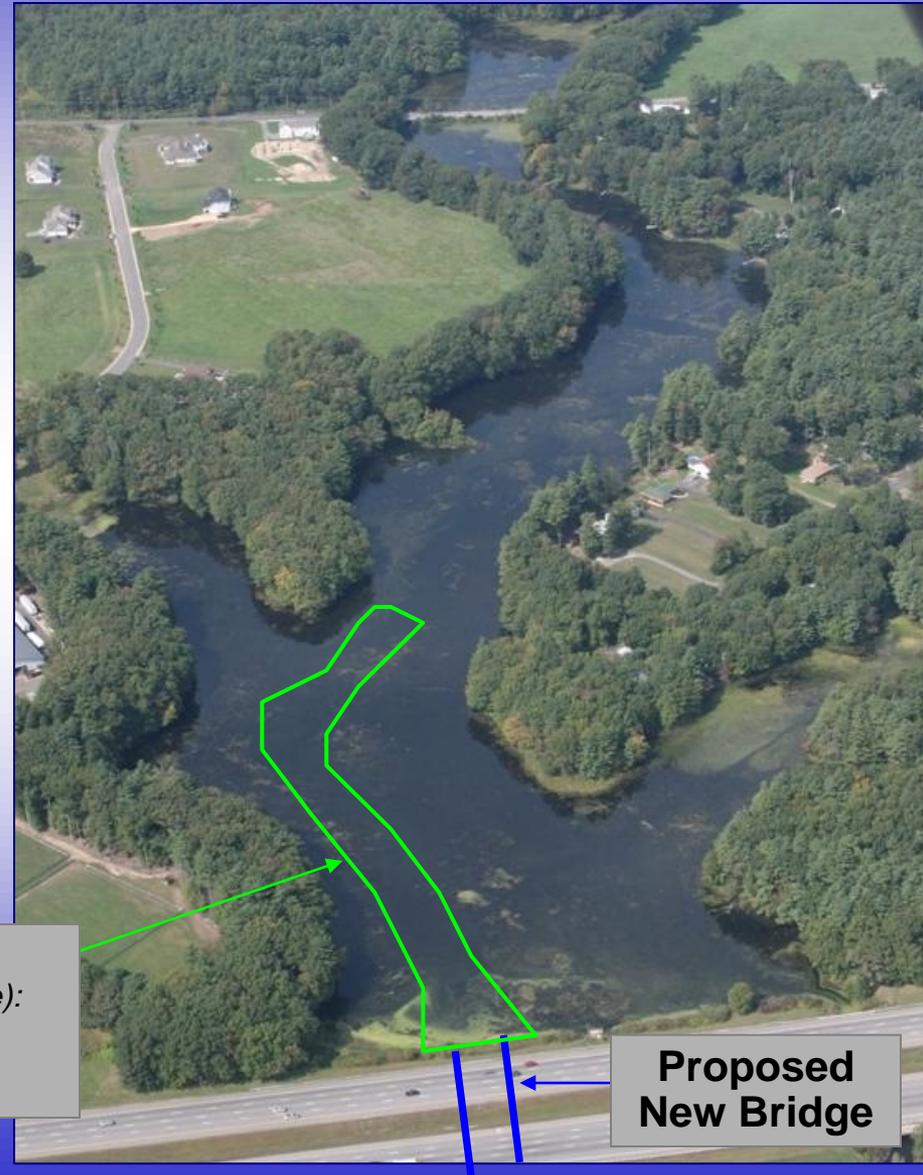
SEDIMENT MANAGEMENT- Alternative C

- **Removal of sediment within channel in lower pond (approx. 7,000 CY)**
- **Disposal at landfill or nearby state-owned land**
- **Stabilization of exposed surfaces next to channel**

Excavation area
(preliminary; not-to-scale):
100 ft (W)
1,000 ft (L)

**Proposed
New Bridge**

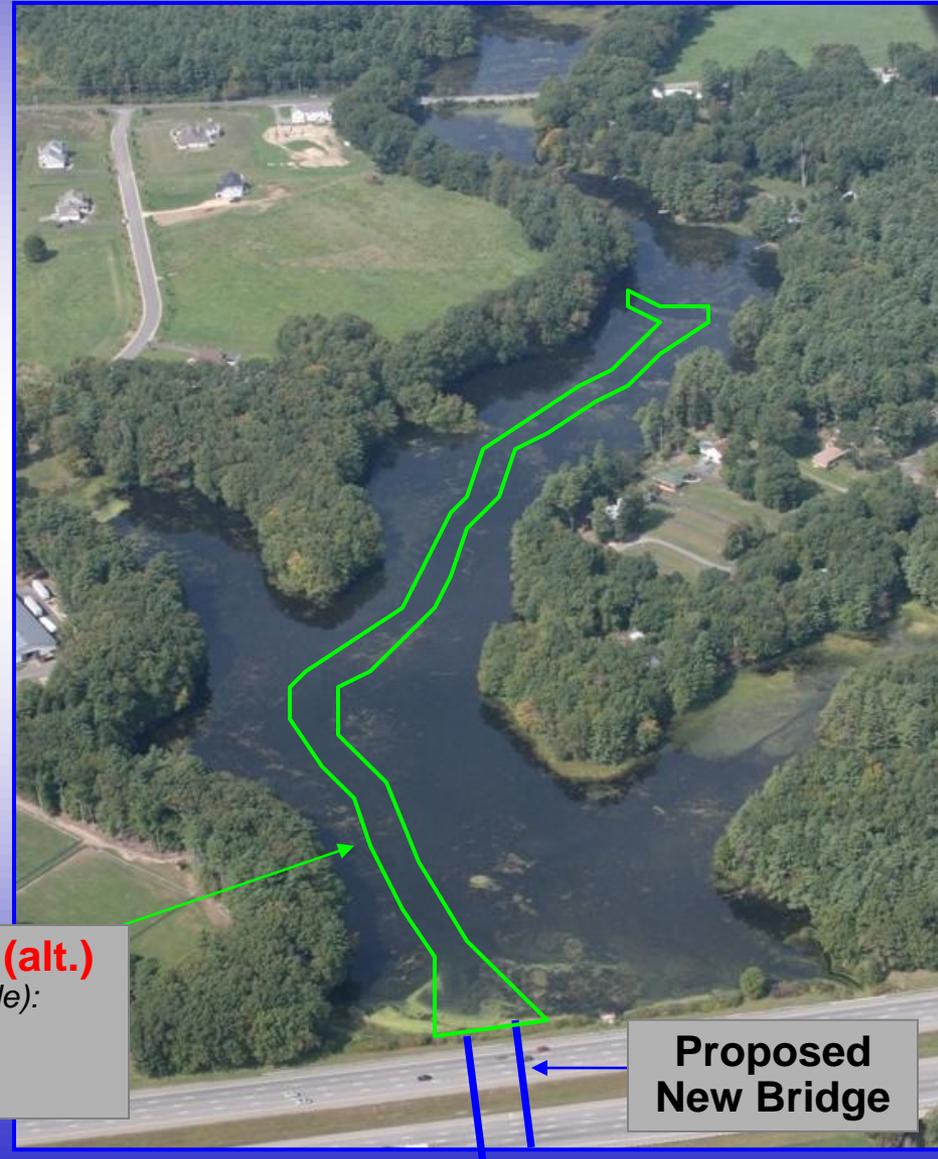
SEDIMENT MANAGEMENT- Alternative C

- Removal of sediment within channel in lower pond (approx. 7,000 CY)
- Disposal at landfill or nearby state-owned land
- Stabilization of exposed surfaces next to channel

Excavation area (alt.)

(preliminary; not-to-scale):

50 ft (W)

2,000 ft (L)

Proposed
New Bridge

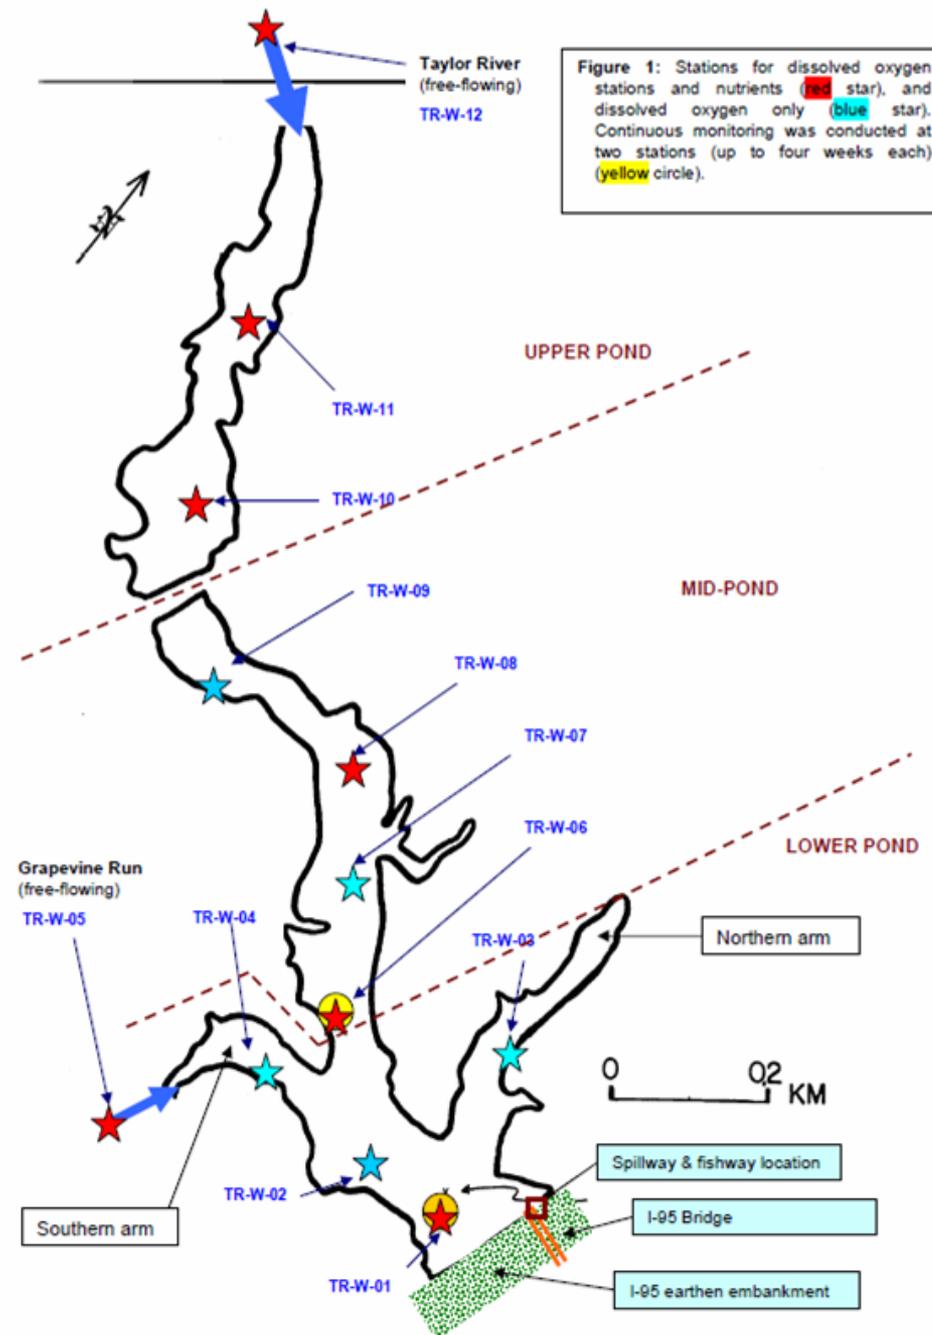
WATER QUALITY MONITORING STATIONS

★ Dissolved Oxygen and Nutrients

★ Dissolved Oxygen

★ Continuous Monitoring

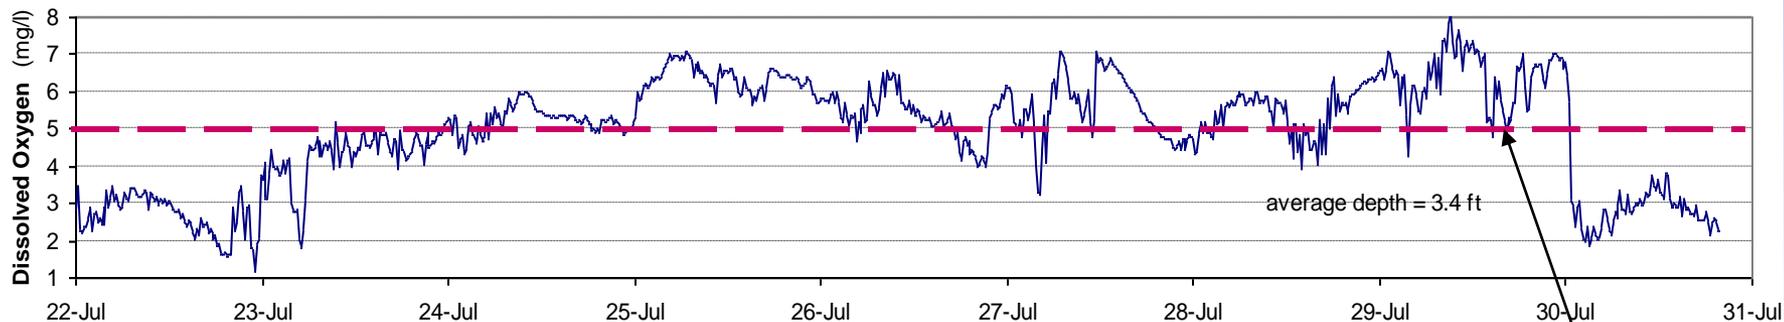
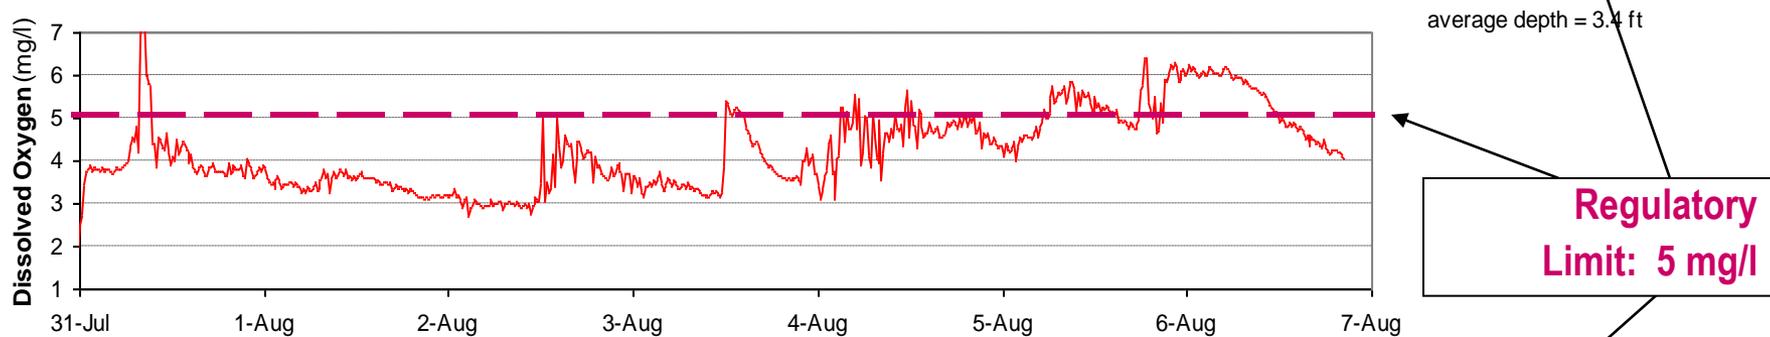
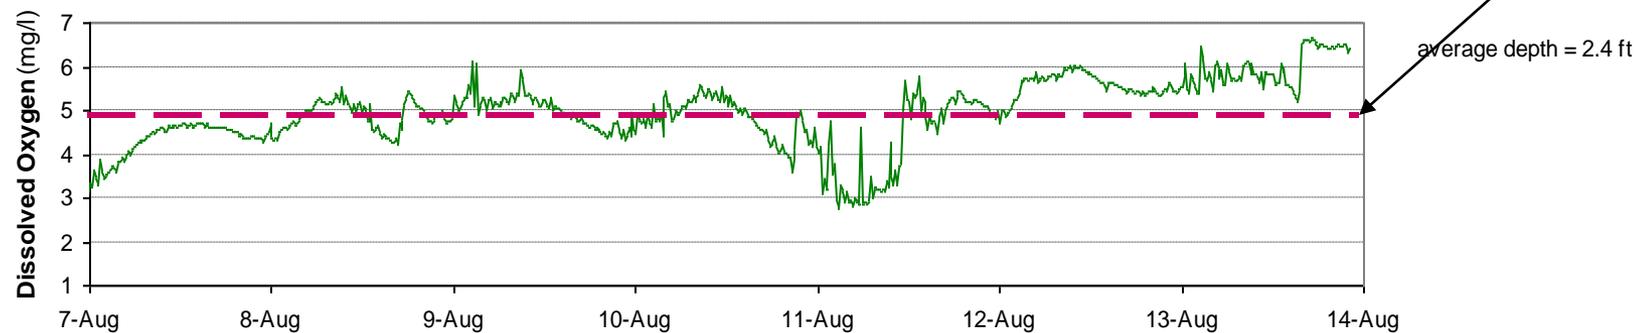
DISSOLVED OXYGEN – Lower Pond, Jul/Aug 2008

**Regulatory
Limit: 5 mg/l**

- **Varies within Pond over Time and in different Areas**
- **Dissolved oxygen concentrations decrease during the summer well below the regulatory limit of 5 mg/l for Class B water**
- **Lowest DO at depth in submerged river channel**
