New Castle-Rye 16127 Preliminary Design

New Castle-Rye Bridge
Cultural Resources Coordination Meeting
November 14, 2013

Hoyle, Tanner
& Associates, Inc.

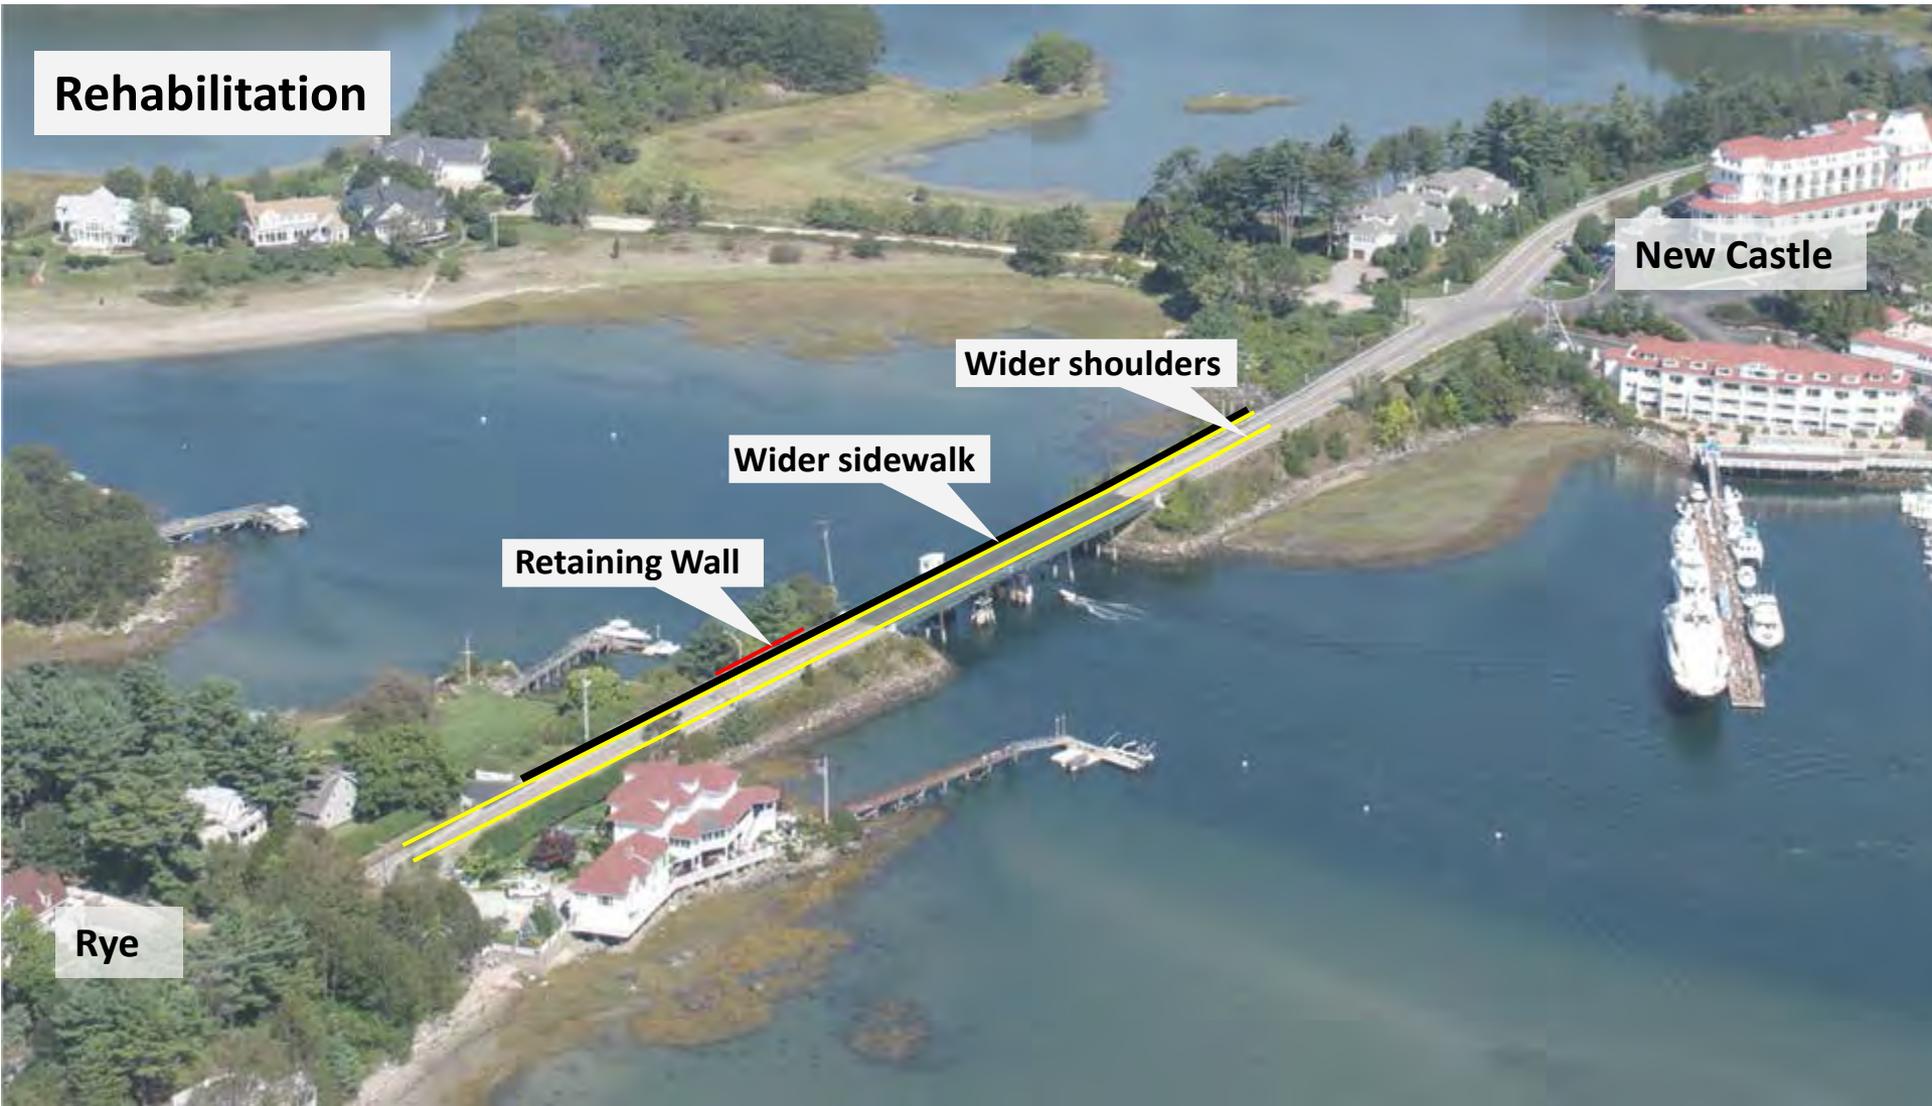
- Rehabilitation
 - Requires intensive structural analysis of existing structure
 - Bridge must carry modern truck loads
 - If possible, bridge should be updated with wider shoulders and sidewalk, and given a solid deck surface
- Replacement with bascule
 - Other moveable structure types eliminated
 - Structure designed with sidewalk and shoulder widths meeting modern standards, and given a solid decking surface
 - Structure layout considers both aesthetics and constructability, minimizing construction duration – a key concern of the community

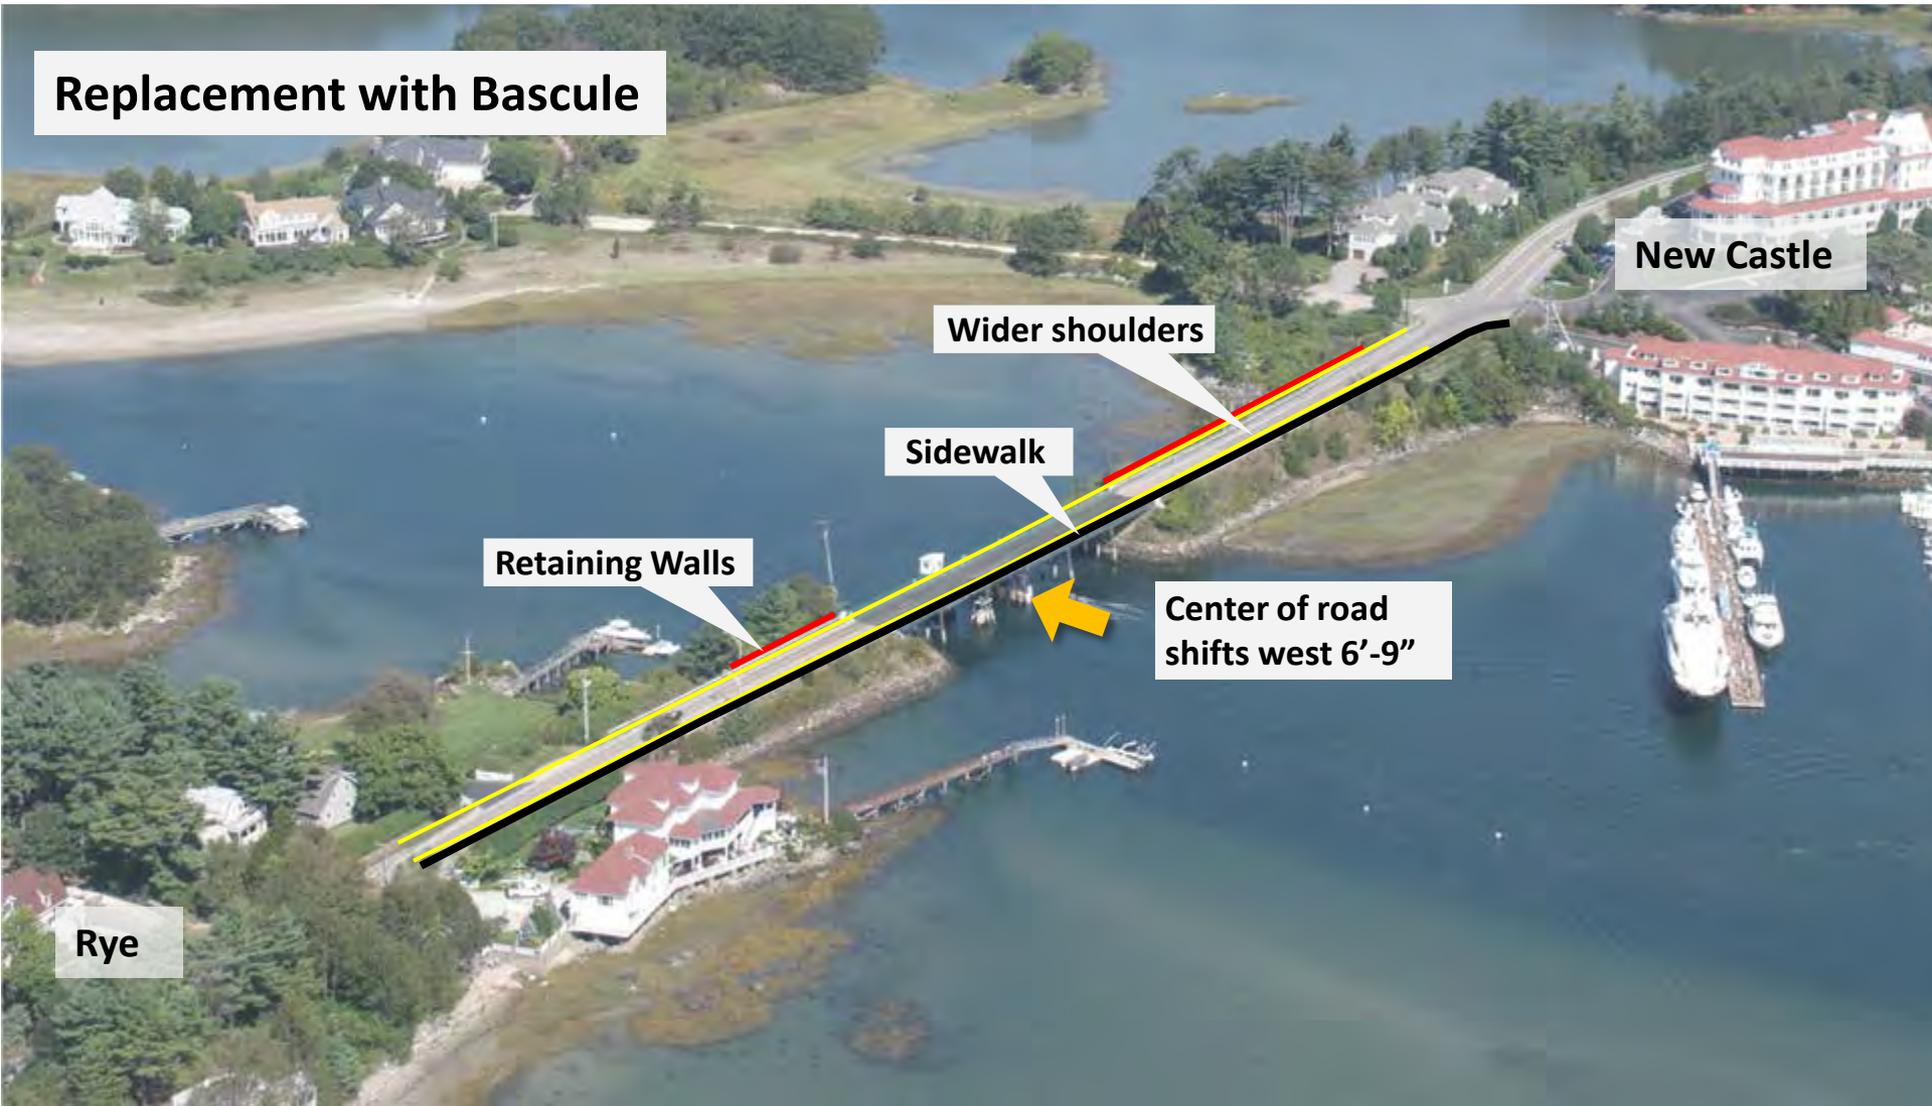
Replacement with Bascule

Wider shoulders

Sidewalk

Retaining Walls

Center of road shifts west 6'-9"

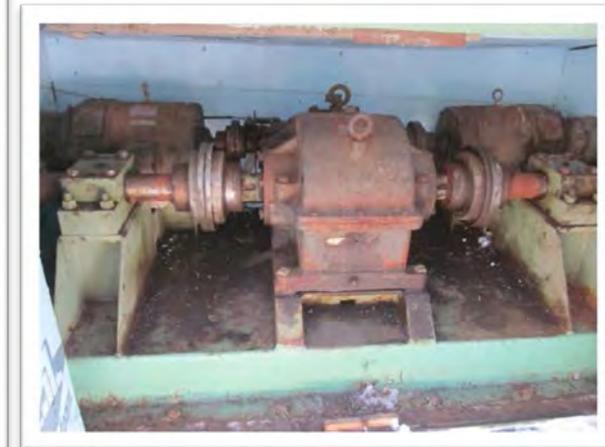
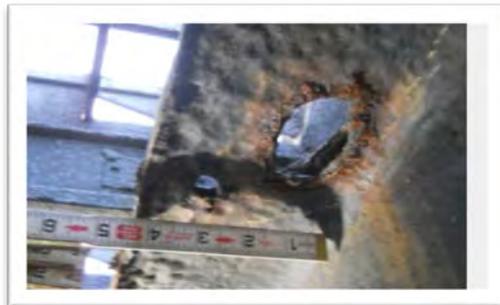
Structural Condition of the Bridge

- Paint masks current condition of bridge
- Stringers, floorbeams and bascule girders exhibit advanced section loss
- Pier caps and piles exhibit advanced section loss. Some piles are buckled
- Machinery is obsolete

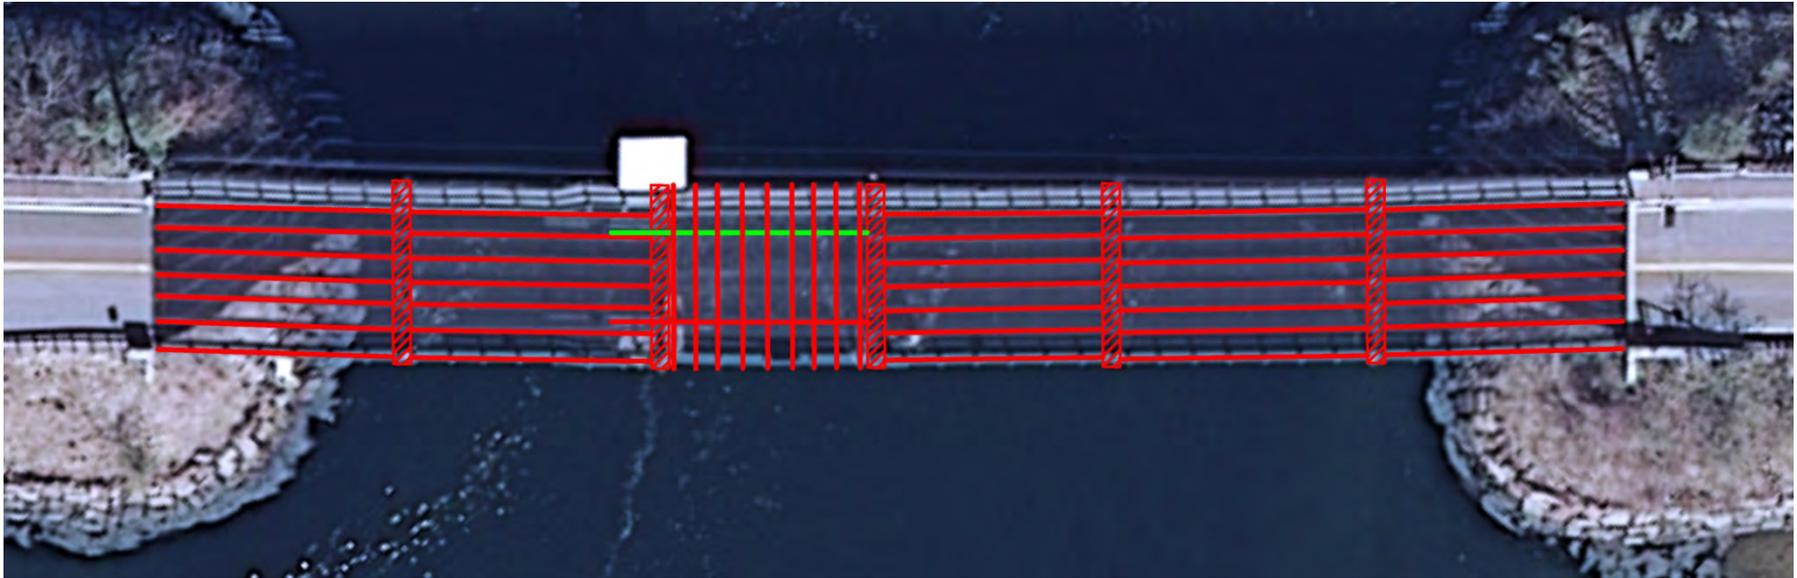
- Analysis determined that virtually all members are inadequate

- MEMBER STRENGTH IS SUFFICIENT
- MEMBER STRENGTH IS INSUFFICIENT

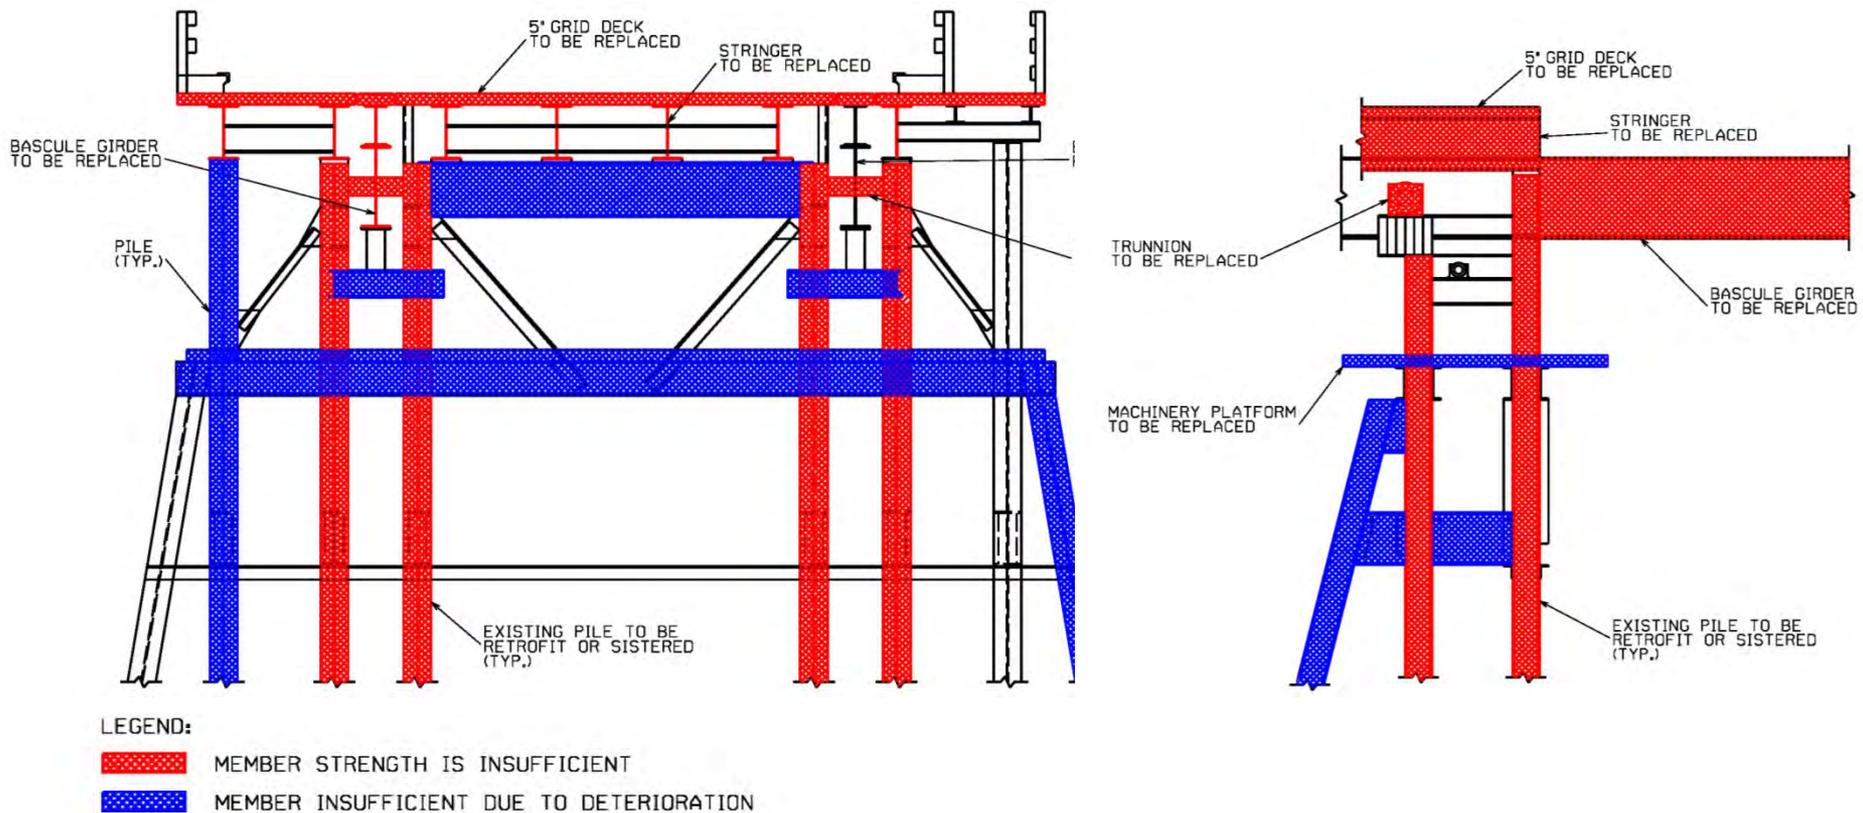
- Analysis determined that virtually all members are inadequate

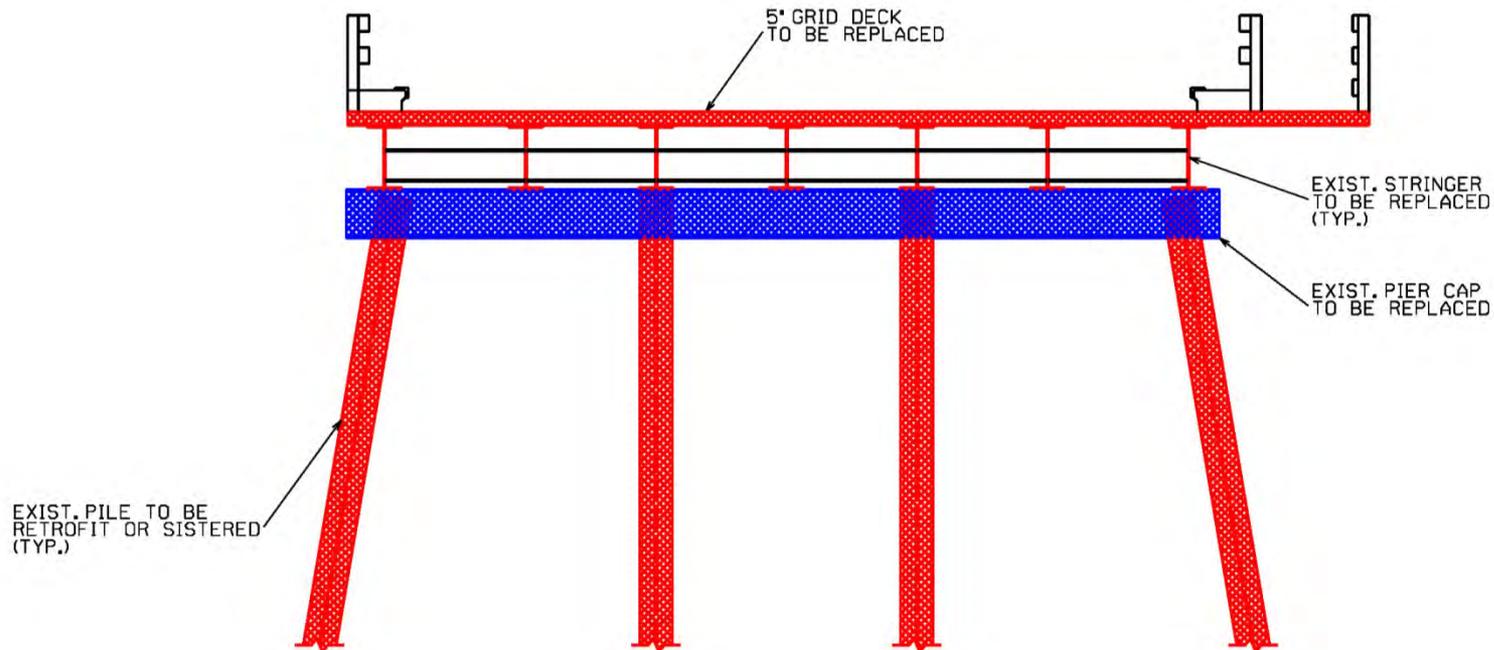
- Analysis determined that virtually all members are inadequate

MEMBER STRENGTH IS INSUFFICIENT
-

MEMBER INSUFFICIENT DUE TO DETERIORATION

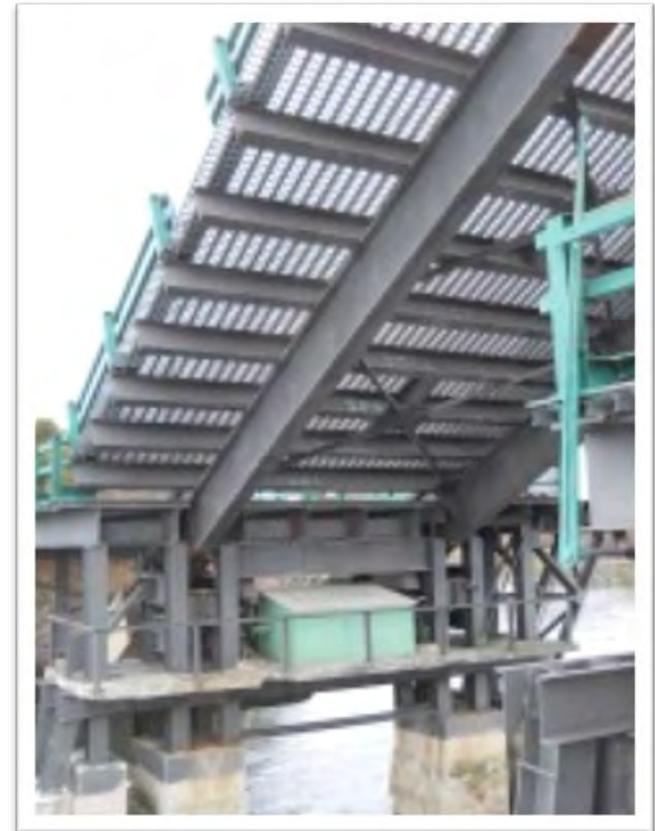
- Rehabilitation would require a complete dismantling of the structure
 - All approach stringers and caps are inadequate
 - Existing piles require retrofit or replacement
 - Machinery platform and trunnions are inadequate
 - Existing machinery requires replacement due to condition and obsolescence
 - Existing operator house is too small, and cannot fit required electrical controls
 - Rehabilitation is effectively construction of a replica bridge

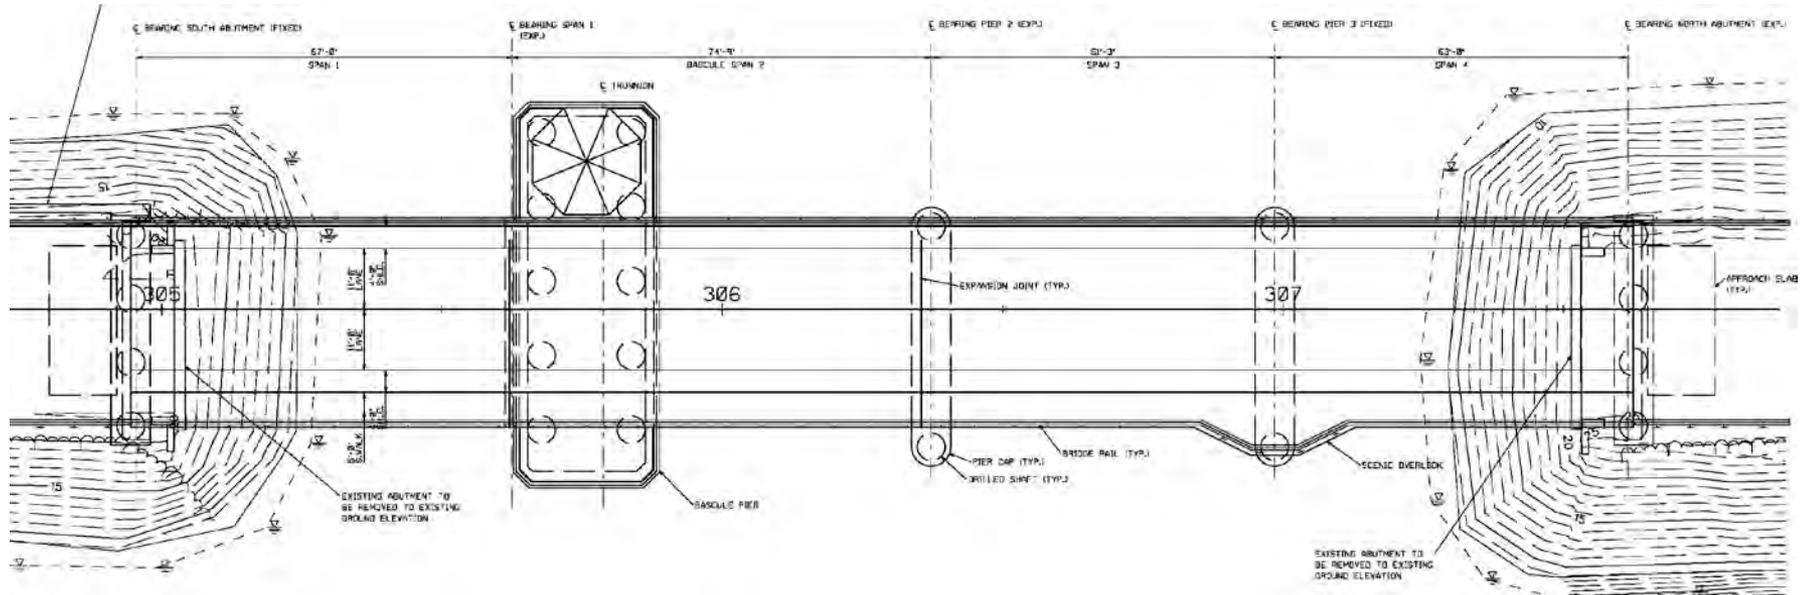
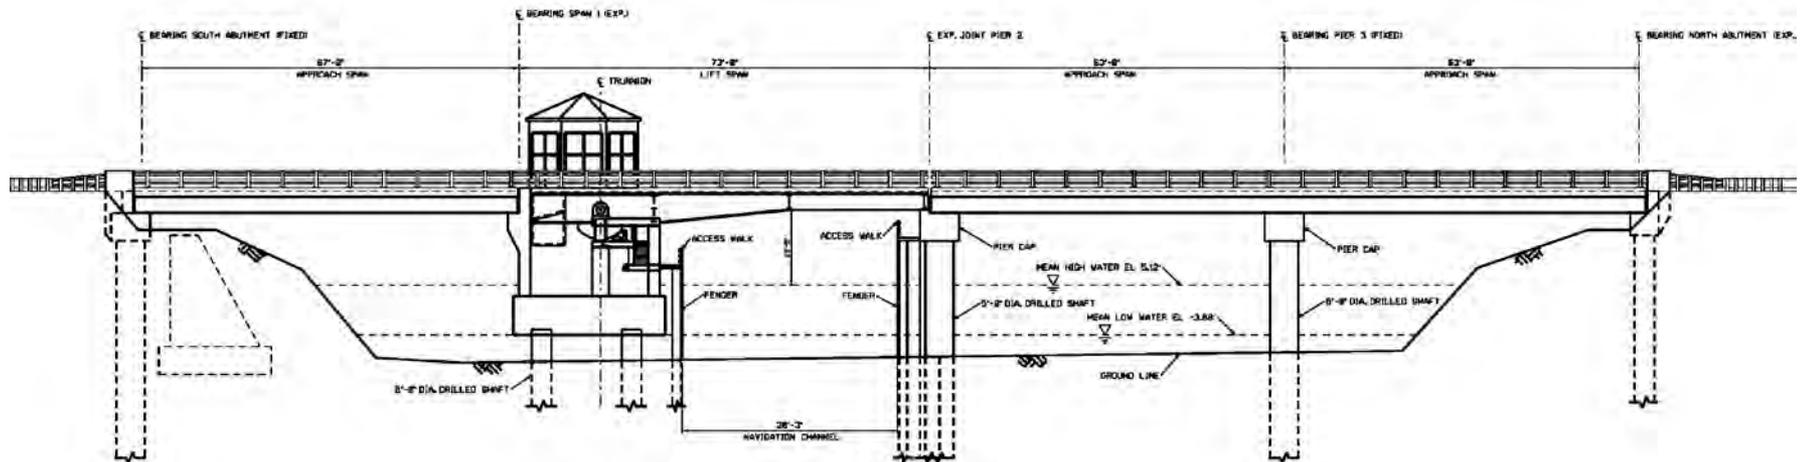
- Three structure types under consideration for approach spans
 - Steel stringers
 - Precast concrete box beams
 - Precast concrete “NEXT” beams – similar in shape to Greek symbol “pi” – π
- Scenic Overlook added to bridge sidewalk
- Closed bridge deck permitted
- Two designs for operator house
 - Similar to existing aesthetic
 - Mimicking look of Historic Wentworth Hotel

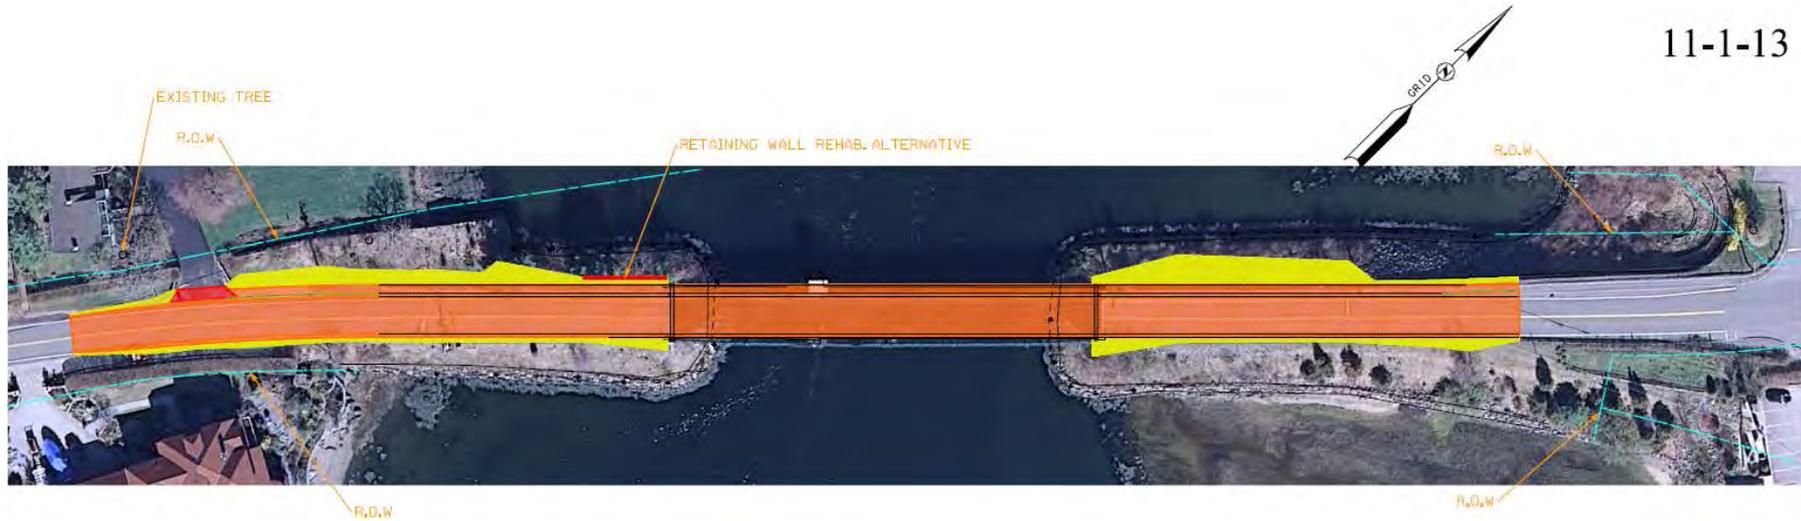
Bridge Rehabilitation Impacts

- Rehabilitation
 - Would require replacement of virtually all of bridge's original fabric, resulting in a "replica" bridge
 - Indirect visual effects anticipated to be negligible
 - Would require prolonged closure (at least 9 months)
 - Little flexibility in construction seasons – impacts public
 - Would not resolve pedestrian and bicycle safety concerns
 - Costs in the order of \$14.5 million, with lifetime costs in the order of \$45 million over 75 years (calculated assuming 2013 expenditure)
 - Shorter life-span (30-40 years)
 - Is not favored by public
 - In accordance with Scammell MOA
 - This alternative would likely result in an Adverse Effect

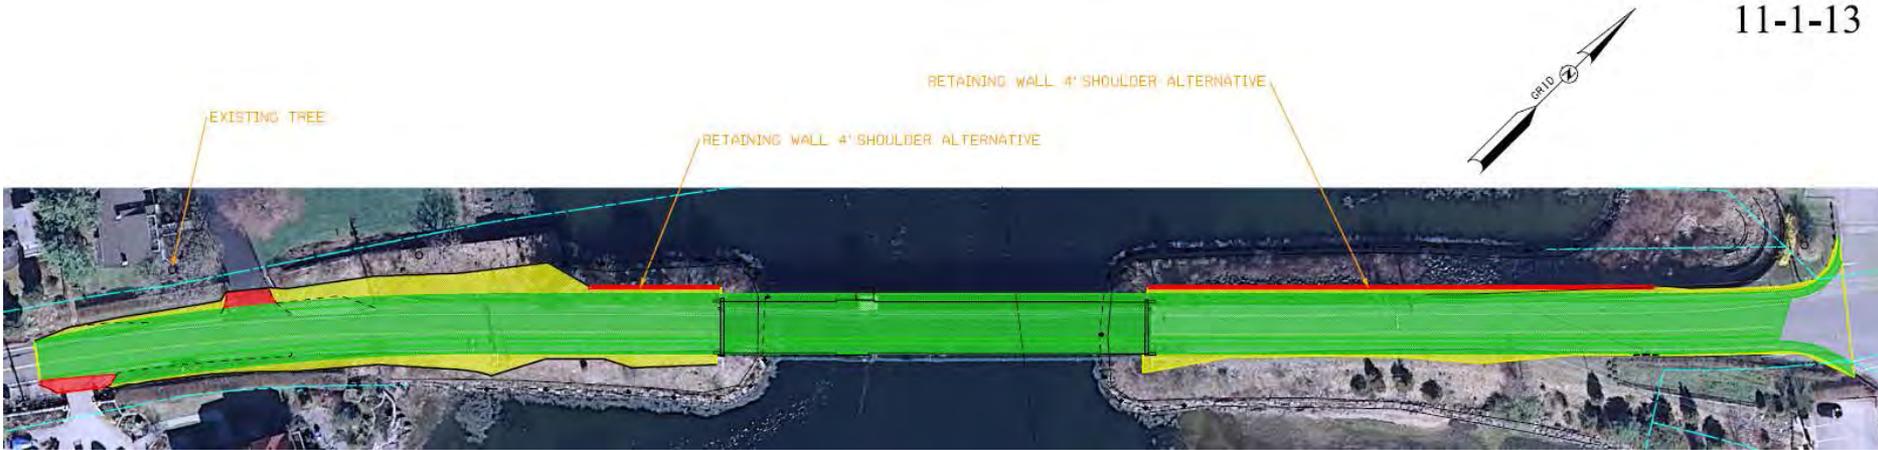
Bridge Replacement Impacts

- Replacement
 - Would replace with bascule span – similar in profile to existing
 - Indirect visual effects anticipated to be minimal
 - Would require brief closure (3 months)
 - Flexibility in construction season limits impacts to public
 - Would improve pedestrian and bicycle safety
 - Cost in the order of \$16.5 million, with lifetime costs in the order of \$30 million over 75 years (calculated assuming 2013 expenditure)
 - Longer life-span (75 years)
 - Favored by public
 - Not in accordance with Scammell MOA
 - This alternative would result in an Adverse Effect
