HISTORIC BUILDING ASSESSMENT WITH GUIDELINES FOR REHABILITATION

WASHINGTON TOWN HALL WASHINGTON, NEW HAMPSHIRE

JAMES L. GARVIN

JULY 8, 2010

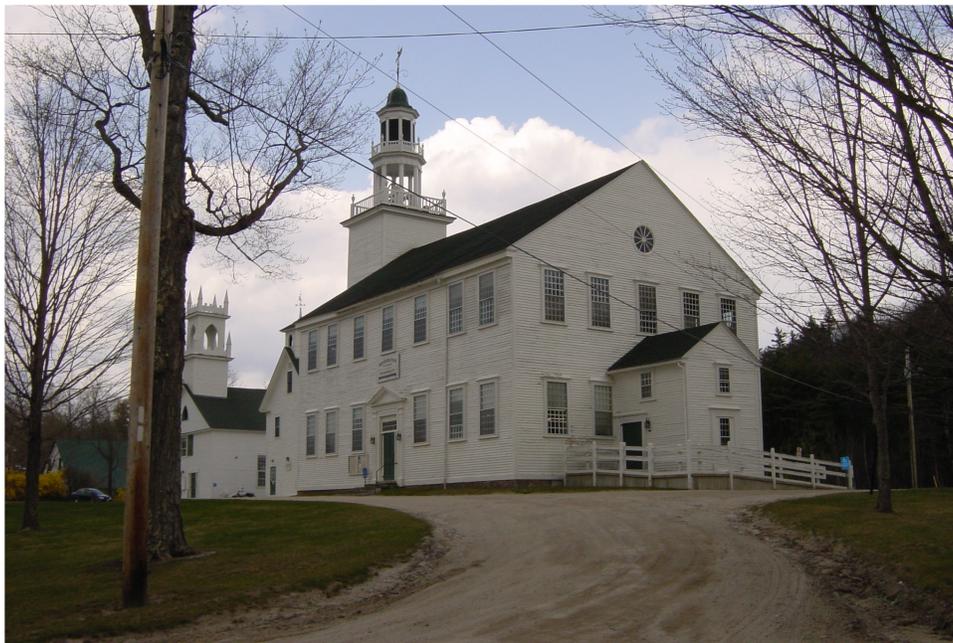
The Washington Town Hall reflects its origins in its outward form. The building has the characteristic qualities of a two-story eighteenth-century meeting house. It is a rectangular, gable-roofed building with its principal entrance on the south-facing façade, which is one of the long sides of the building. Having its origin as a “twin-porch” meeting house, the predominant form of eighteenth-century meeting houses in New Hampshire, the town hall retains a porch or stairway addition on the eastern gable end. In 1820, the original porch on the western end was replaced by a tower that appears to have somewhat larger east-west dimensions than the original porch. The rear or northern elevation of the building, originally a flat wall with a central pulpit window placed halfway between the windows of the main floor and those at the gallery level, is now interrupted by a shed-roofed addition that supplants a former woodshed and men’s privy. The addition provides toilets for the building, and a boiler room.

The main building measures 60'-7½" by 45'-7," and is almost thirty feet "between joints," or between sill and wall plate. Its façade or southern elevation is marked by six windows and a central doorway on the first story and seven windows at the original gallery level, now the second story.

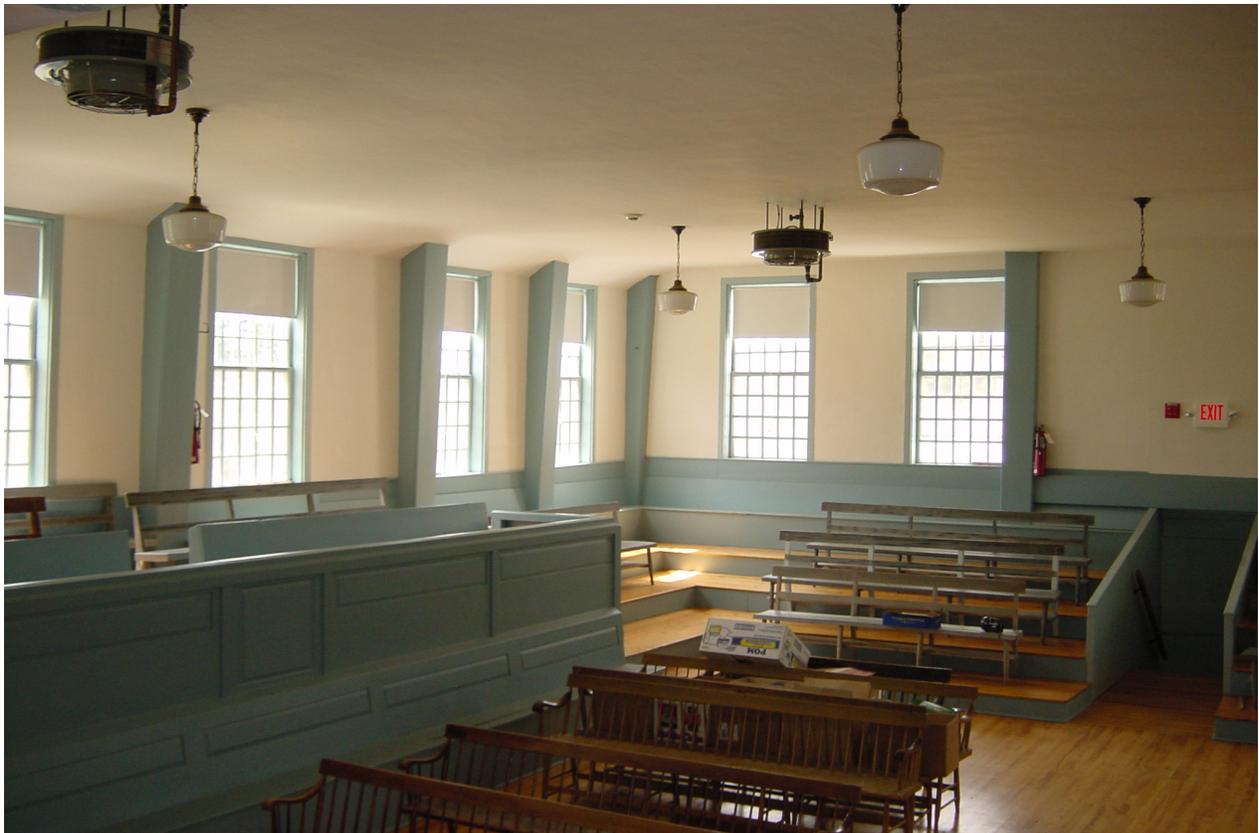
*Second Floor Chapel or Auditorium,
Looking Southwest from the Stage*

The second-floor room, created as a chapel in 1842, is an impressive space with ample light and high ceilings. As noted in the "History and Development of the Property" and in the chronology in the Appendix, this room has undergone a series of changes over the years. In 1859, seventeen years after the second floor was installed in 1842, box pews that remained at the former gallery level were removed and the existing stepped platforms were substituted. We may assume that during these years the room remained oriented toward the reading desk or pulpit that stood at the center of the north wall, directly above the location of the original meeting house pulpit. The paneled enclosure opposite, above the front doorway of the building, appears to have been constructed from old pew paneling as "singing seats" for the choir of the Universalist Society, which used the room as a chapel.
