SUBJECT Dredge & Fill Application
Farmington, 16146

NH Route 153 over Cocheco River Bridge Replacement NHDES Standard Dredge and Fill Application

State of New Hampshire
Department of Transportation
Farmington, New Hampshire
NH 16146 X-A001(152)

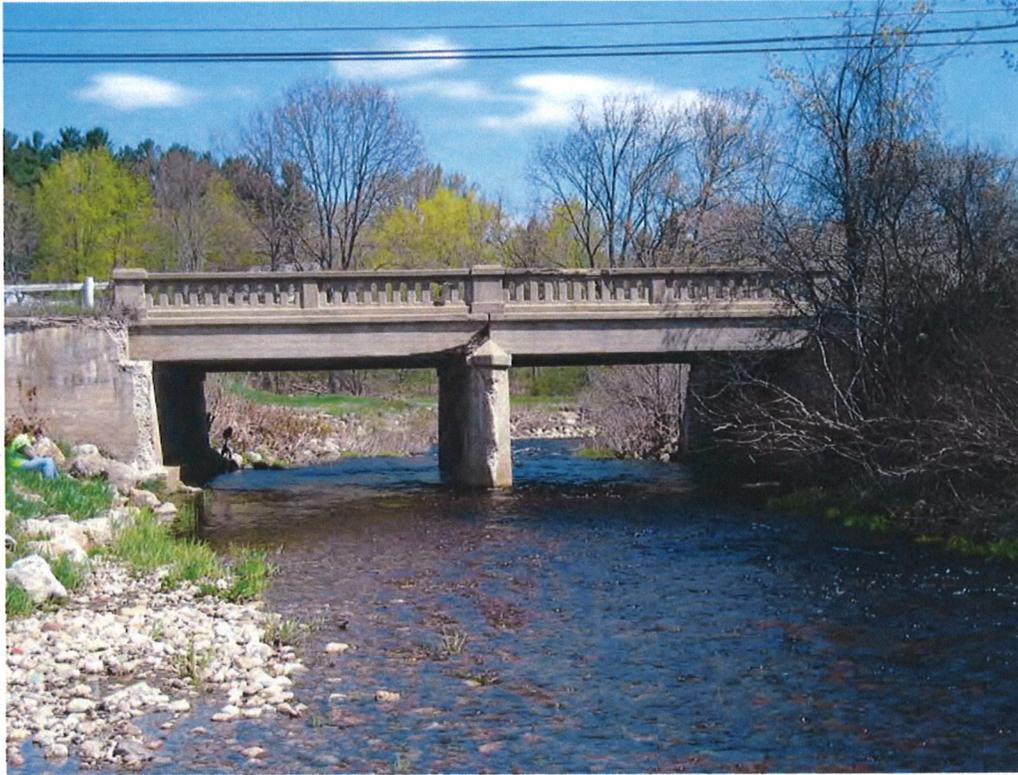
View of NH Route 153 Farmington Bridge – Looking Downstream

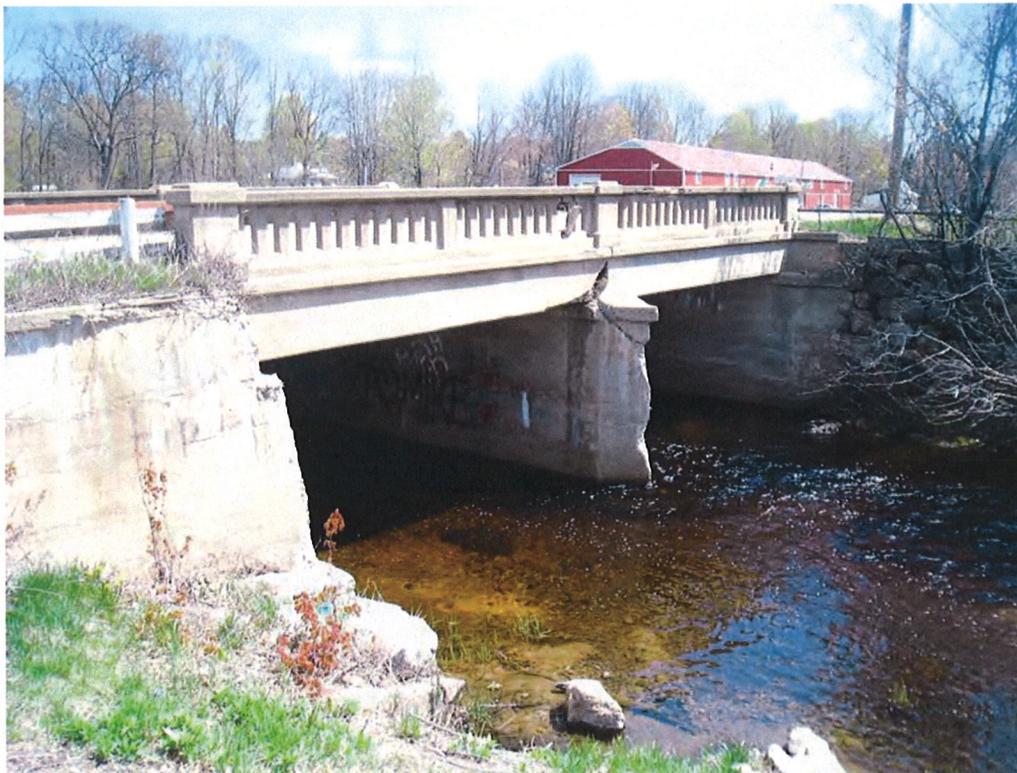
View of NH Route 153 Farmington Bridge: Upstream – Looking East

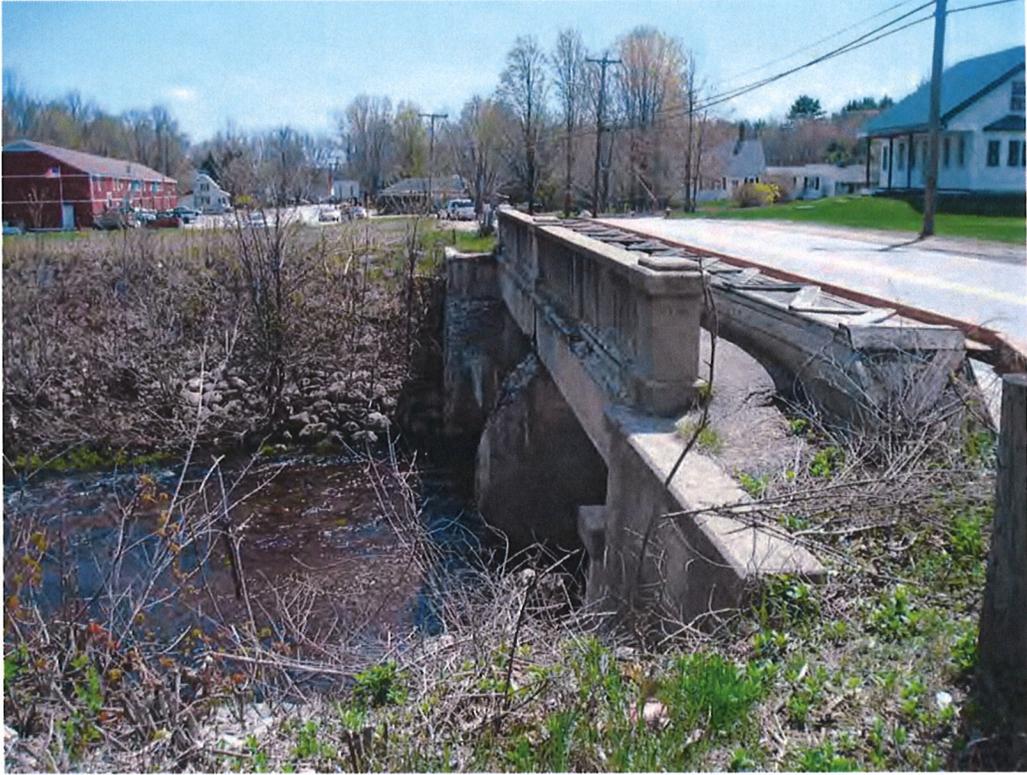
View of NH Route 153 Bridge: Downstream – Looking East

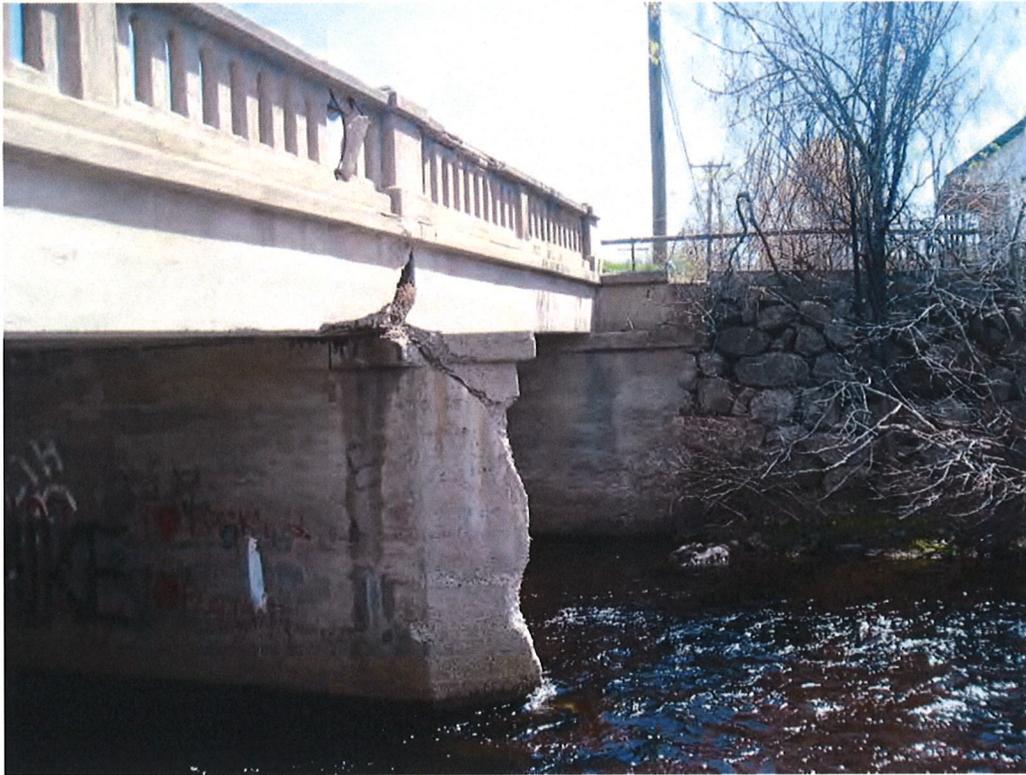
View of Upstream Pier and Rockwall Adjoining with East Abutment

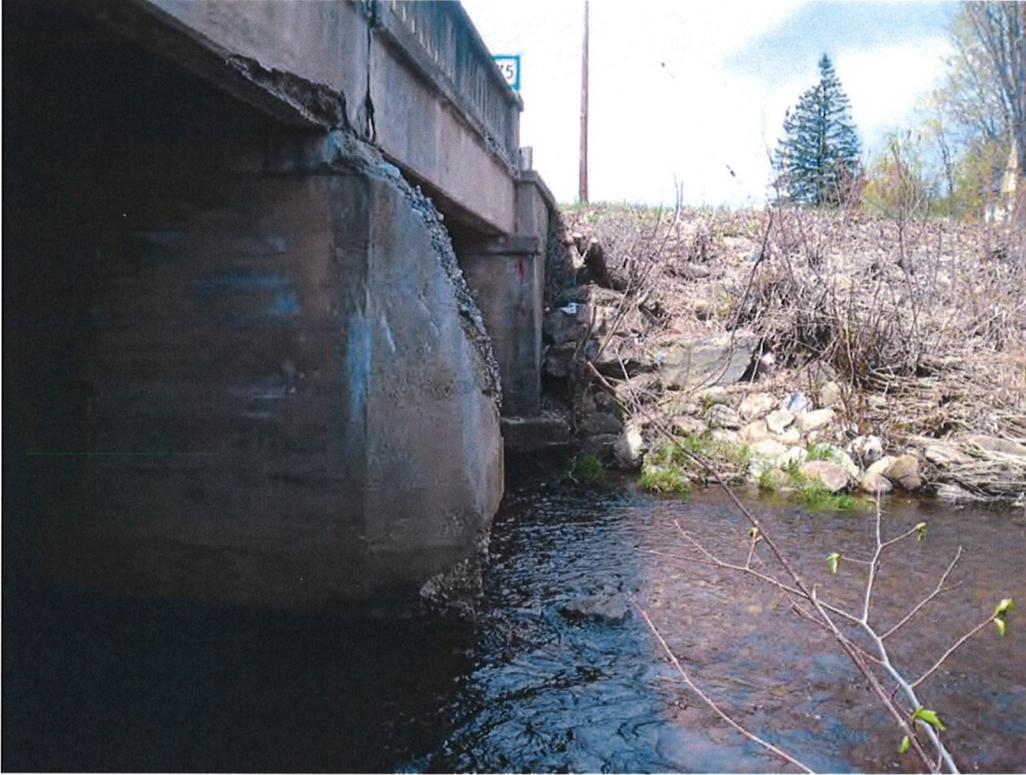
View of Downstream Pier and West Overbank

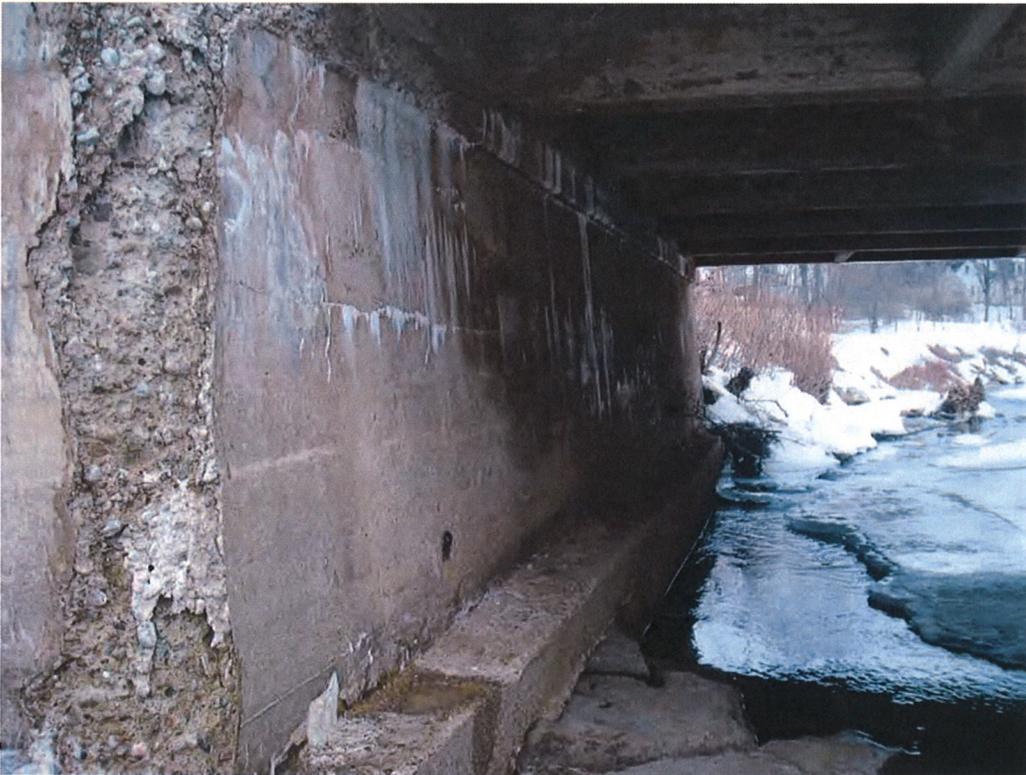
View of West Abutment – Looking Downstream

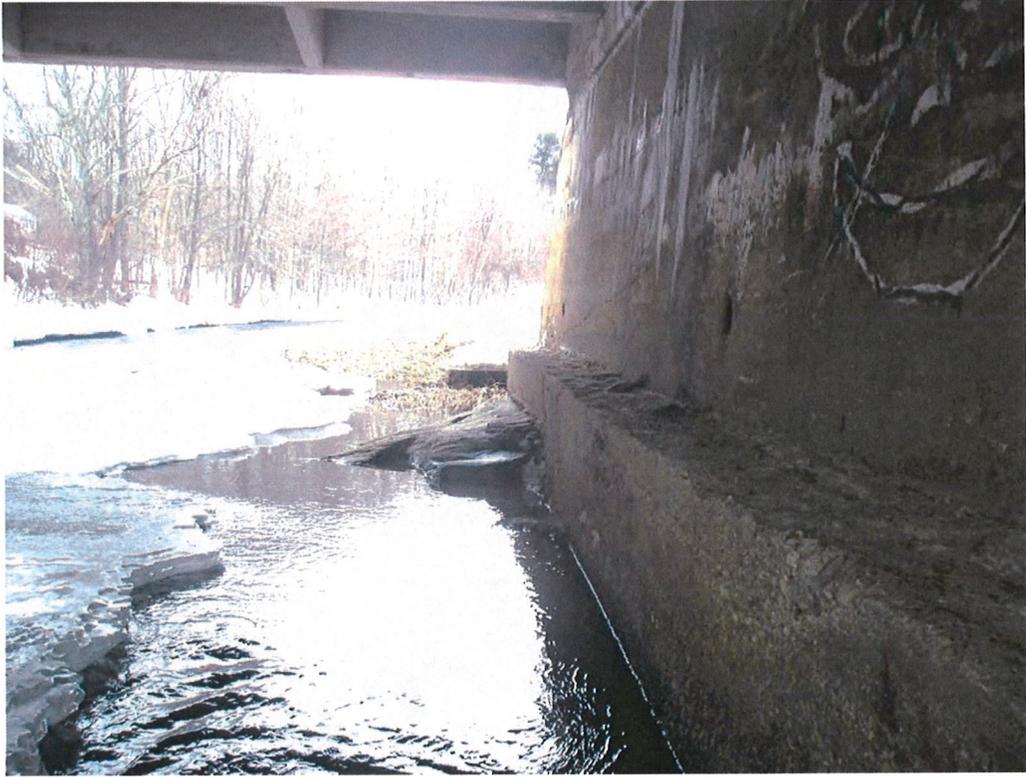
View of West Abutment – Looking Upstream

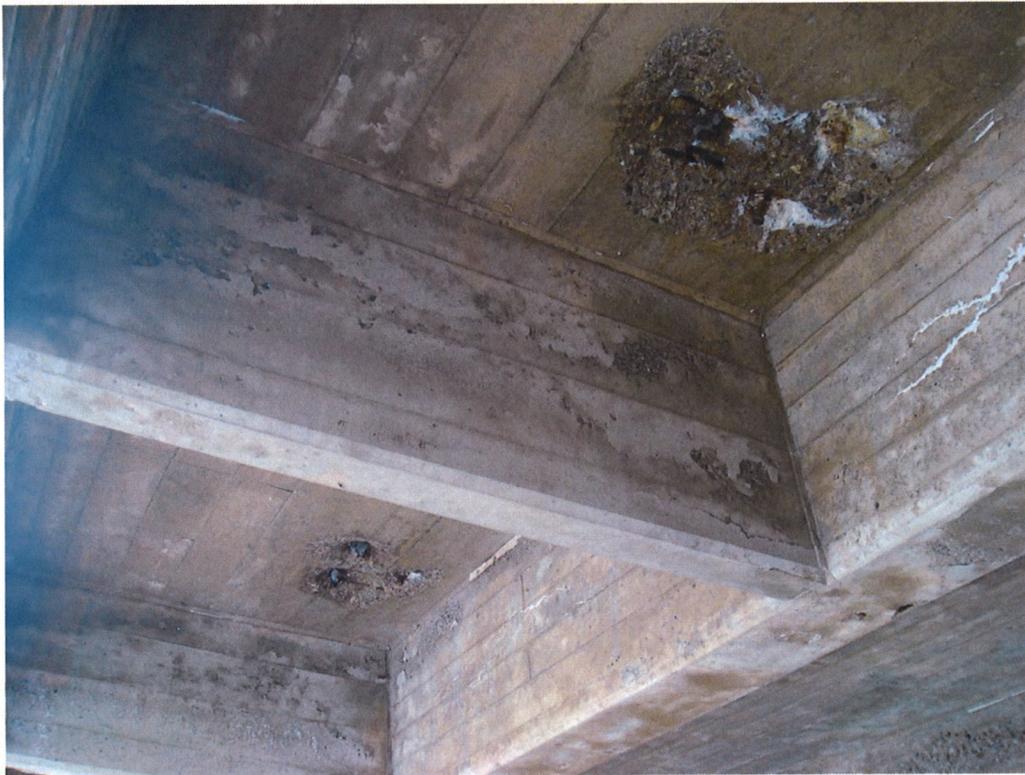
View of Concrete Deck

The existing bridge has sustained substantial deterioration, especially the concrete portions of the structure, including the concrete encasement of the main carrying beams, the deck,

abutments, pier and the railing. Heavy spalling and delamination of the concrete members and exposed rebar is noted repeatedly on the inspection reports. Retaining any portion of the concrete superstructure is not feasible given the current condition. It is possible that the existing steel beams could be retained, with new reinforced concrete encasements, deck and railing constructed. Rehabilitation of the substructures would include removal of the existing deteriorated concrete faces to sound concrete (depth expected of approximately 6"). It is anticipated that 75% of the abutment and pier faces would need rehabilitation, and the entire surfaces must then be sealed.
