**Preparation of Rumble Strips Prior to  
Overlayment**

**Final Report**

**PREPARATION OF RUMBLE STRIPS  
PRIOR TO OVERLAYMENT**

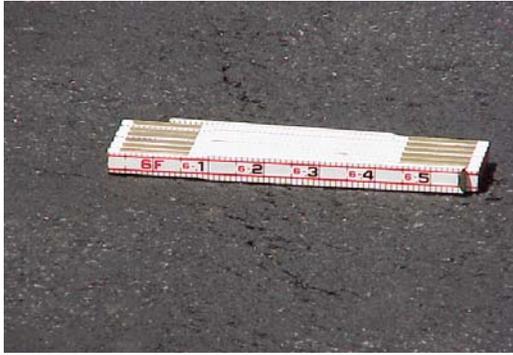
Figure 1 – Cracks along edge of former Rumbles (Section B)

**Section B** (tack and overlay) showed occasional longitudinal cracks along the edge of the rumble strip (Figure 1), indicating movement of the mix by the roller through the affected rumble. An expanded discussion of this condition can be found in the Implementation section later in this report. The rumble strip had reflected through the overlay along the entire length of this section (Figure 2). Additionally, a parallel line of “reflected” rumbles was observed in this section (Figure 3). The prevailing theory is that the vibratory roller drum bounces and/or teeters due to the alternating mix thickness/stiffness in the rumble strip, causing the drum to form an indentation of the surface alongside the original rumble strip.

As noted above, Section A exhibited mild depressions at the one-year inspection. Section B showed occasional cracking immediately following construction and snow plow abrasion after one winter. Aesthetics aside, all four rumble strip overlay preparation scenarios performed equally well after two years of service following the milling of new rumbles. It appears that rumble reflection (likely from HMA densification) occurs relatively soon after construction is complete, having occurred within the first year. There was no evidence of raveling or other deterioration initiated by surface disturbance caused by the milling of new rumbles or by the abrasion/impact of snow plowing.

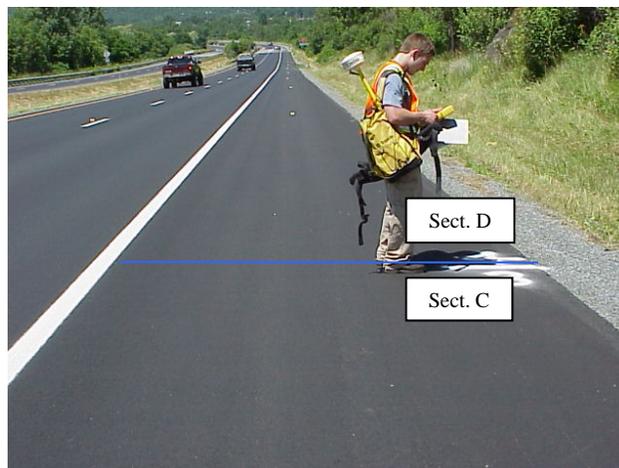
Figure 2 – Shadowing (Sections C and D)

**Section C** (mill, inlay and overlay) and **Section D** (mill and overlay) showed no reflection of the longitudinal milling of the rumble strip, which would have displayed as a rut. A shadow was the only evidence of the former safety feature.

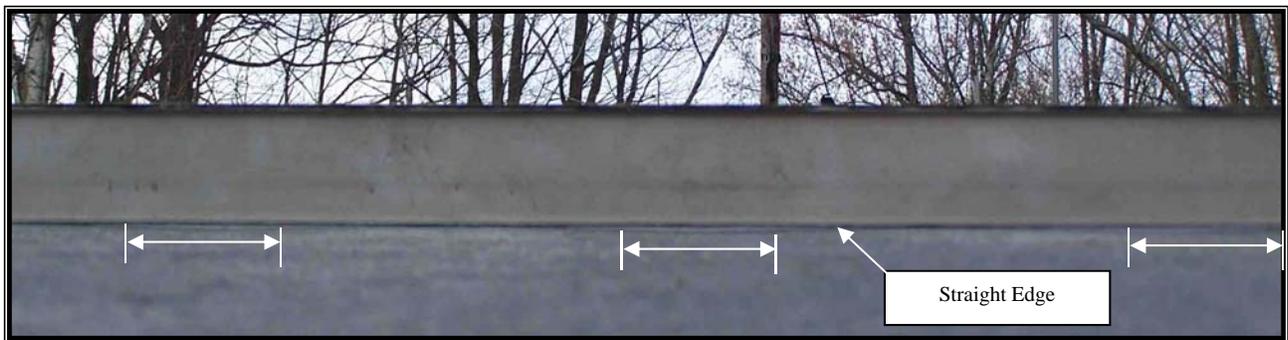
Figure 3 – Depressions observed in Section A

**Section A** (tack, shim and overlay) Mild depressions were now visible (Figure 5), presumably due to additional compaction of the “grader shim”. The bars could now be felt when driven upon. No structural distress was otherwise noted. Arrows in the photo below indicate dips in surface.

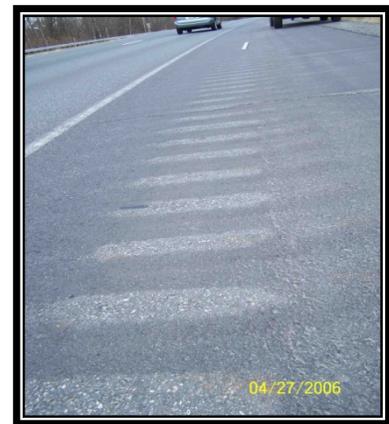
Figure 4 – Reflection and Abrasion (Section B)

**Section B** (tack and overlay) continued to show a pronounced rumble strip reflection, visually enhanced by the abrasion of the rumble bars from snow plowing, as shown at right. This preparation method required the least effort, but resulted in poor aesthetics. No additional deterioration was noted, and pavement performance was satisfactory.

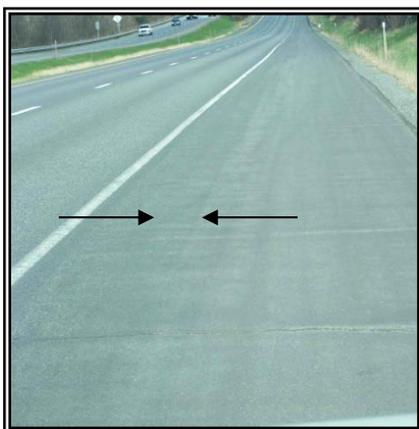
Figure 5 – Section C

**Section C** (mill, inlay and overlay), which required the greatest number of steps to accomplish, still showed no reflection of the milled area, which would have displayed as a rut. Left, the outline of the former rumble strip was vaguely visible on the shoulder surface.

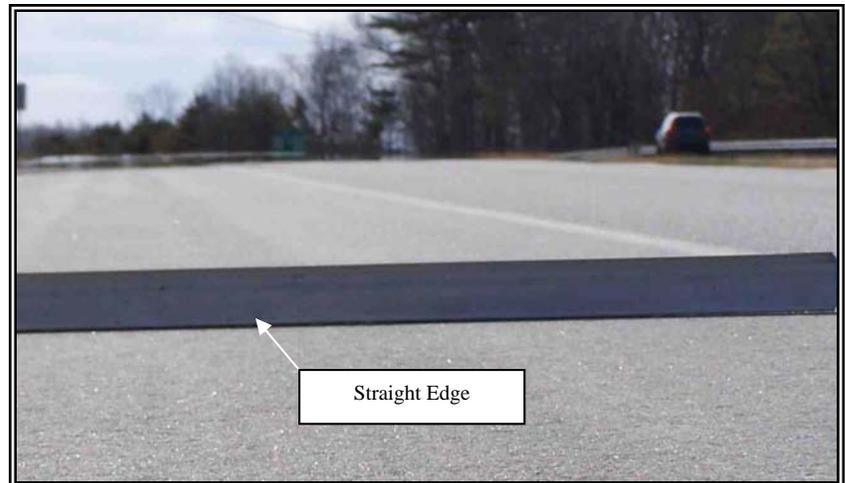
Figure 6 – Section D

**Section D** (mill and overlay), right, also showed no sign of reflection in the area of the former rumble strip, although discoloration (shadowing) was still evident.

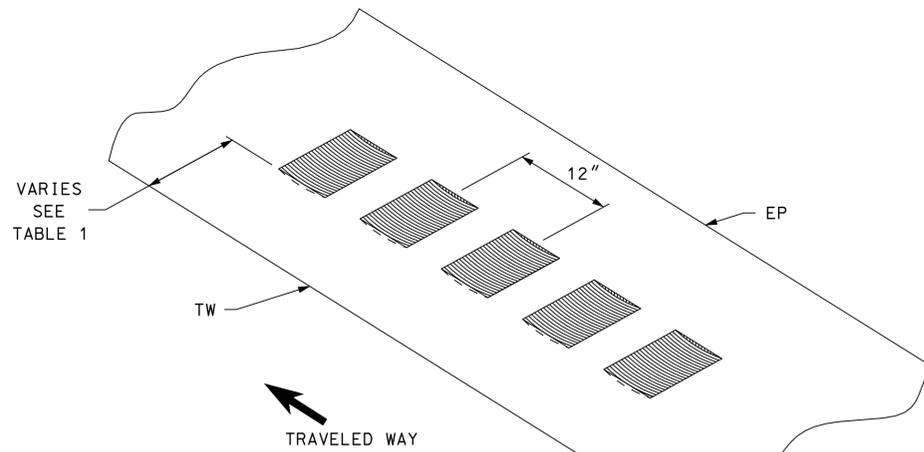
TYPICAL SHOULDER INSTALLATION  
RIGHT SHOULDER DETAIL

ROADWAY TYPE	SHOULDER WIDTH	MEDIAN SHOULDER TW OFFSET	RIGHT SHOULDER TW OFFSET
UNDIVIDED	≥ 8'	N/A	12" OFFSET FROM TW
DIVIDED	> 6'	30" OFFSET FROM TW	30" OFFSET FROM TW
DIVIDED	≤ 6'	6" OFFSET FROM TW	30" OFFSET FROM TW

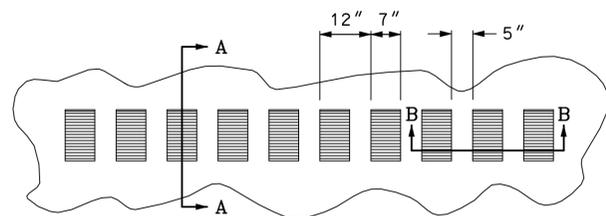
NON-INTERSTATE APPLICATION

- FOR NON-INTERSTATE APPLICATIONS, RUMBLE STRIPS SHALL HAVE A FINISHED DIMENSION OF 7" WIDE IN THE DIRECTION OF TRAVEL AND HAVE A MINIMUM DIMENSION OF 12" LONG MEASURED PERPENDICULAR TO THE DIRECTION OF TRAVEL.

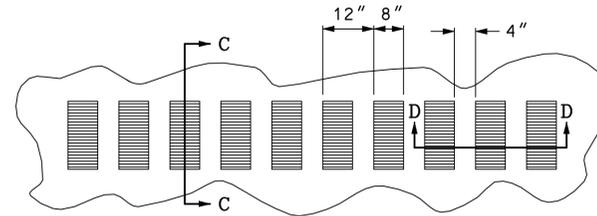
INTERSTATE APPLICATION

- RUMBLE STRIPS SHALL NOT BE MILLED ON ANY PAVEMENT MARKINGS. REPLACEMENT OF PAVEMENT MARKINGS SHALL BE AT THE CONTRACTOR'S EXPENSE.
- FOR INTERSTATE APPLICATIONS, RUMBLE STRIPS SHALL HAVE A FINISHED DIMENSION OF 7" WIDE IN THE DIRECTION OF TRAVEL AND HAVE A MINIMUM DIMENSION OF 16" LONG MEASURED PERPENDICULAR TO THE DIRECTION OF TRAVEL.
