Determination of Eligibility (DOE)

Property Name: Bridge (080/040)

Address: Waukewan Road over Lake
Waukewan Inlet

INDIVIDUAL INVENTORY FORM

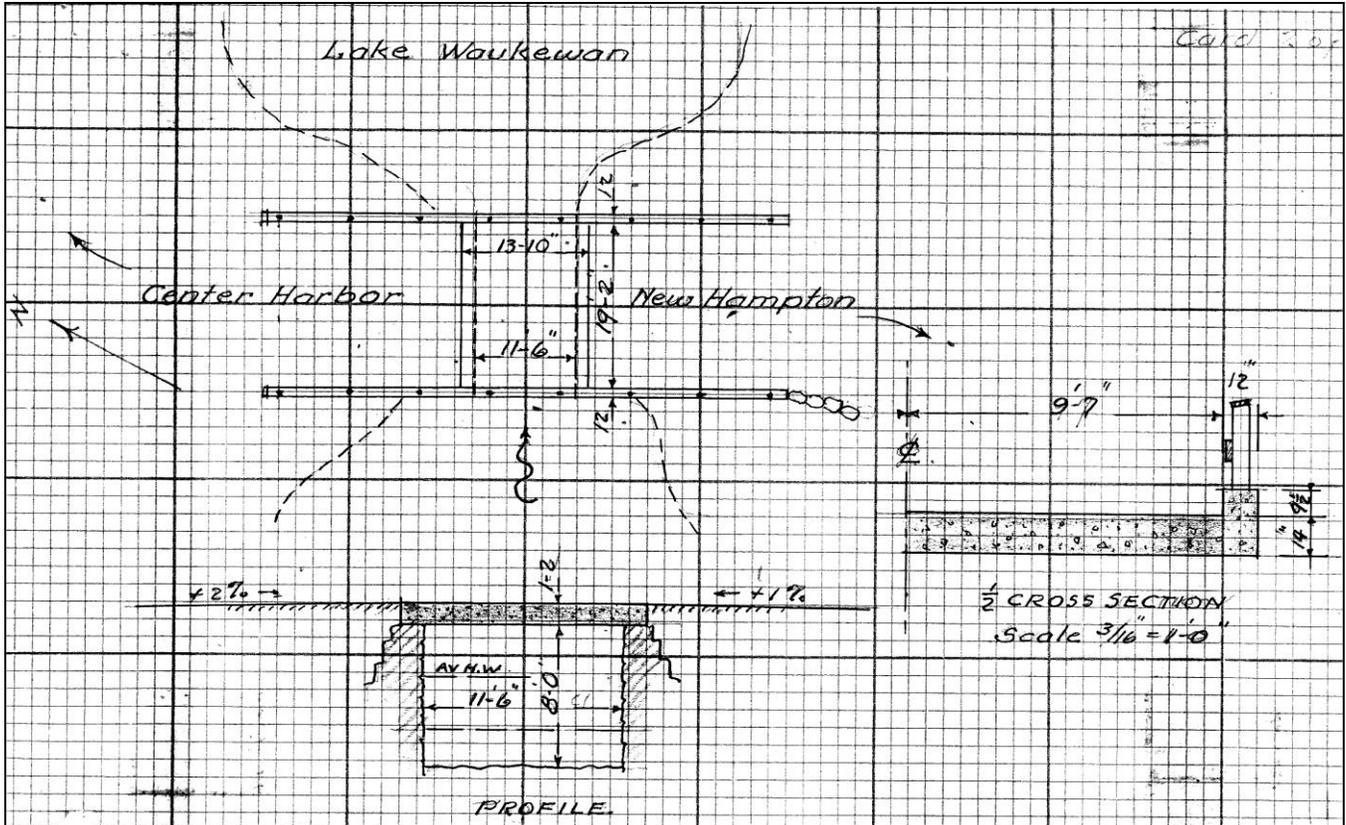
FIGURE 3: Plan, elevation and section sketches from Bridge Card (NHHD Bridge Card 1941).

No individual plans were prepared for the bridge. The bridge card indicates that the "slab standard" was used for its design and the bridge was built by New Hampshire Highway Department (NHHD) forces (see Figures 3 & 4). The bridge is a one-span concrete slab on split-stone abutments with extended U-type wingwalls along the approaches, also of concrete-capped split-stone construction. Dimensions of the bridge according to the NHDOT records are: 11.5' clear span, 13.0' overall length, 21.2' width overall. The original wood guardrails (see Figures 5 & 6) were replaced at some time with standard steel W-type guardrail on steel posts bolted to the edge of the bridge slab and along the approaches. The granite abutments and wingwalls consist of random split granite of varying sizes. The stone is presumed to date from the preceding bridge but portions of the stonework were evidently reconstructed and pointed using cement mortar. This work was probably done with the construction of the present bridge and concrete cap wall.

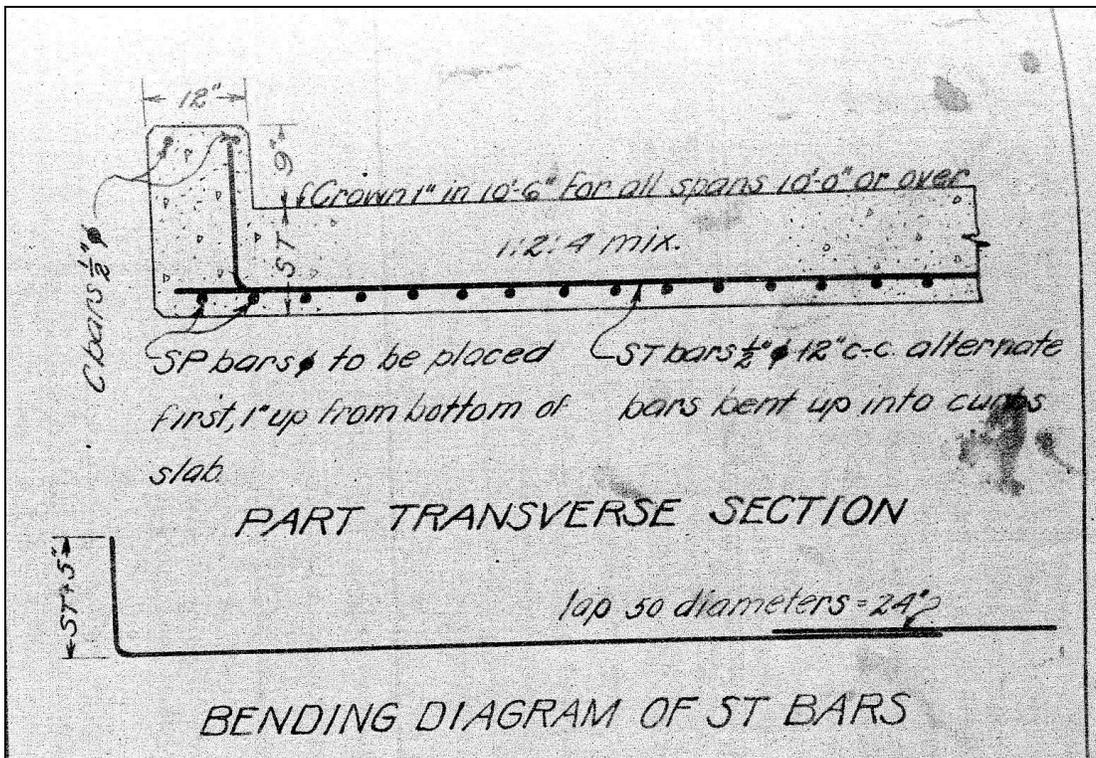
FIGURE 4: New Hampshire Highway Department standard design for reinforced concrete slab spans, October 31, 1924. When the standard was design was used and a separate set of plans were not prepared, the term "slab standard" was typically noted on bridge project and inventory cards in the place of a plan number (NHHD, 1924).

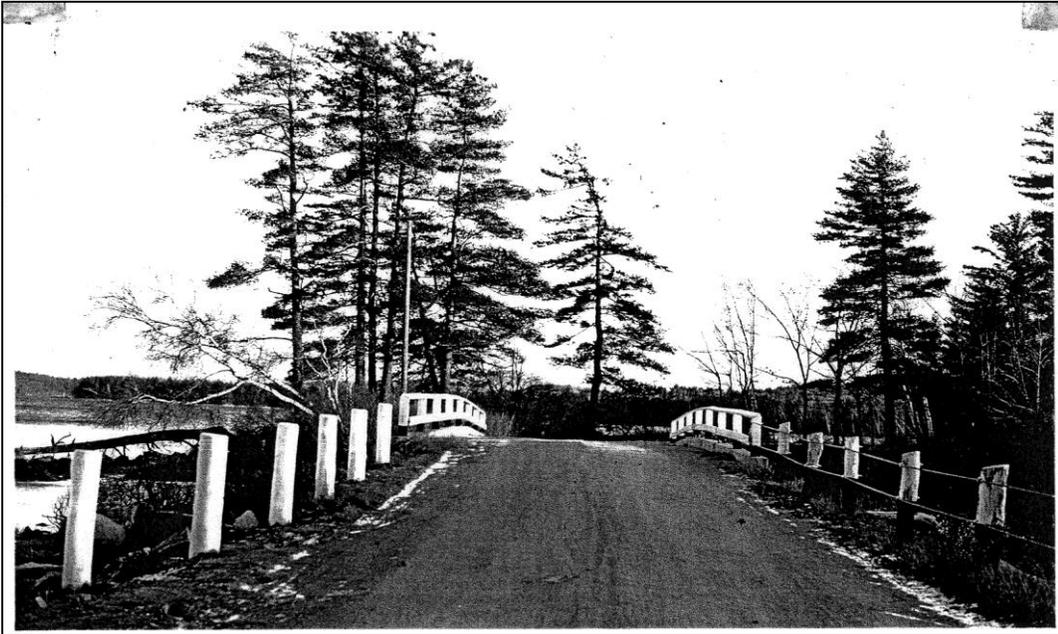
FIGURE 5: Photo of Center Harbor Bridge 080/040, December 11, 1941, showing Center Harbor (north) approach looking south toward New Hampton. Note original wood railings and post and cable guardrails along approaches (NHHD Bridge Card 1941).

46. Statement of Integrity: The property retains integrity of location. The removal of the original wood railings and guardrails the addition of a concrete abutment caps has diminished the integrity of the original association, feeling, workmanship, design and materials of the bridge.

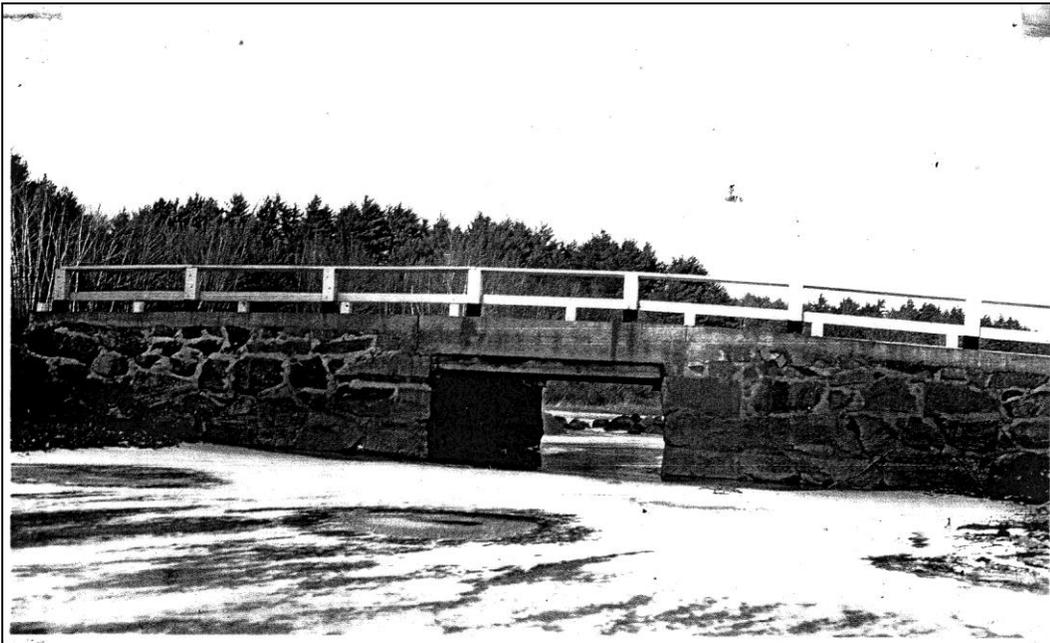
FIGURE 6: Photo of Center Harbor Bridge 080/040, December 11, 1941, showing west (upstream) side of bridge (NHHD Bridge Card 1941).

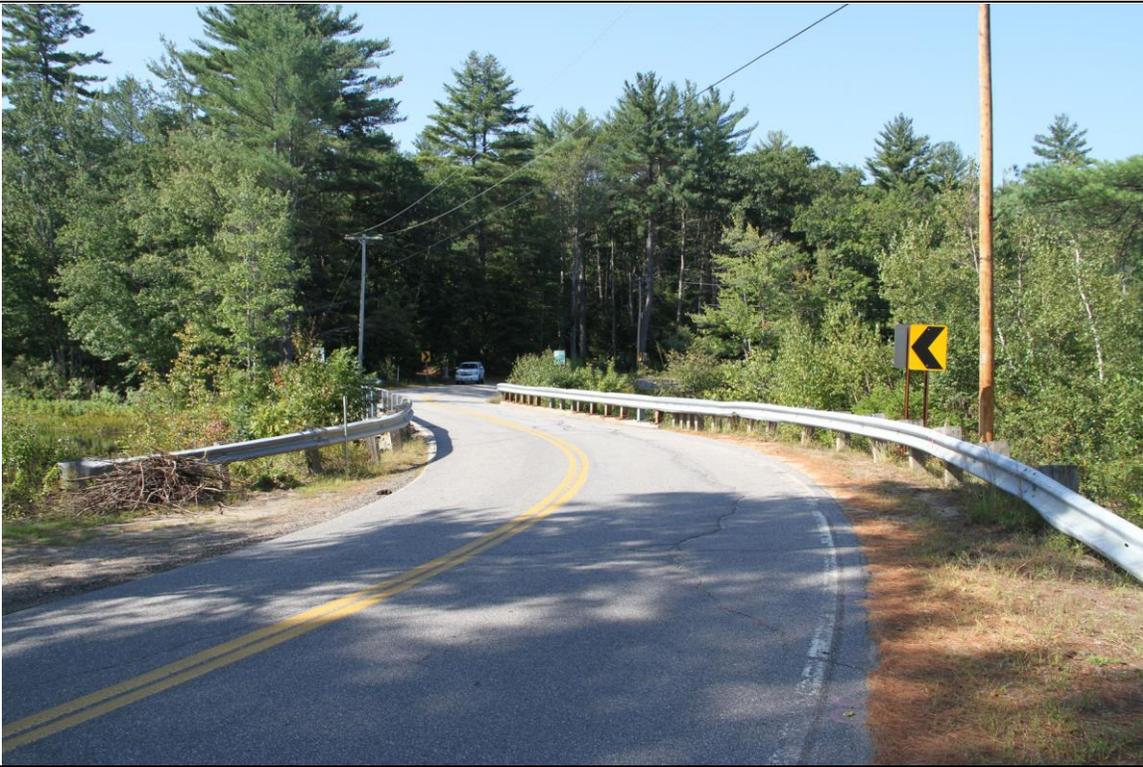
Photo :#	2	Description: Context view and south (New Hampton) approach.
Reference (file name or frame #):	CEN0008_002	Direction: NW

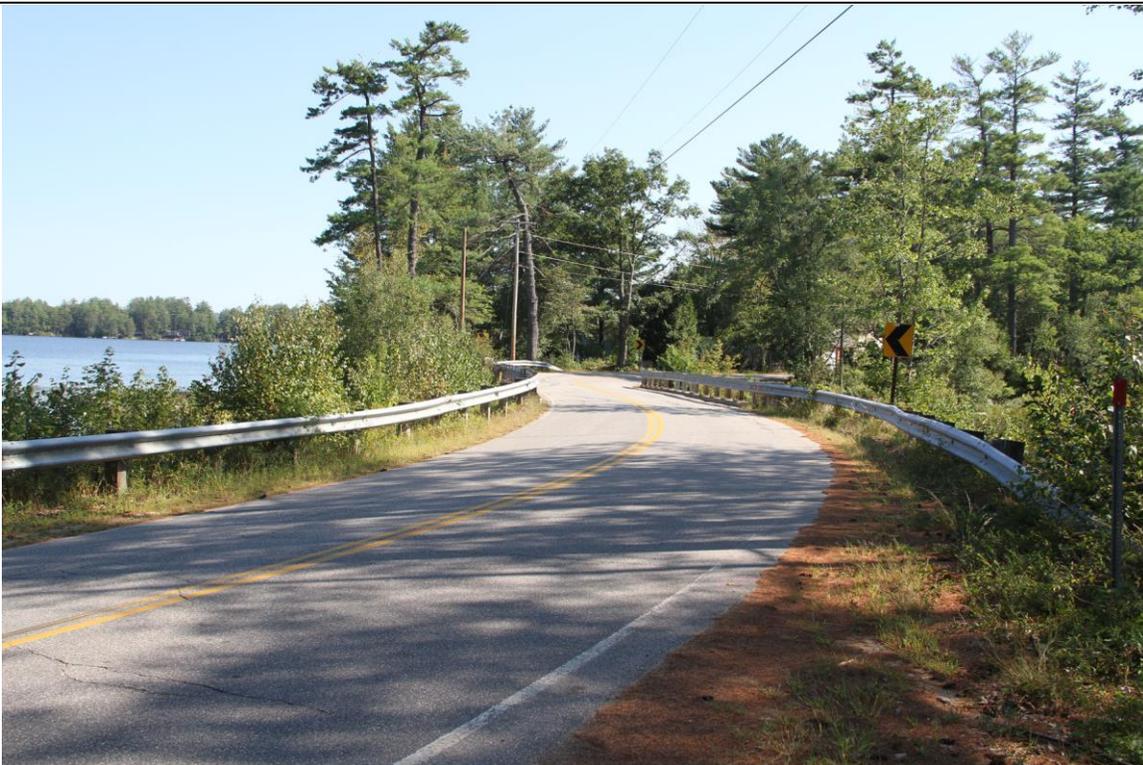
Photo :#	3	Description: Context view and north (Center Harbor) approach.
Reference (file name or frame #):	CEN0008_003	Direction: SE

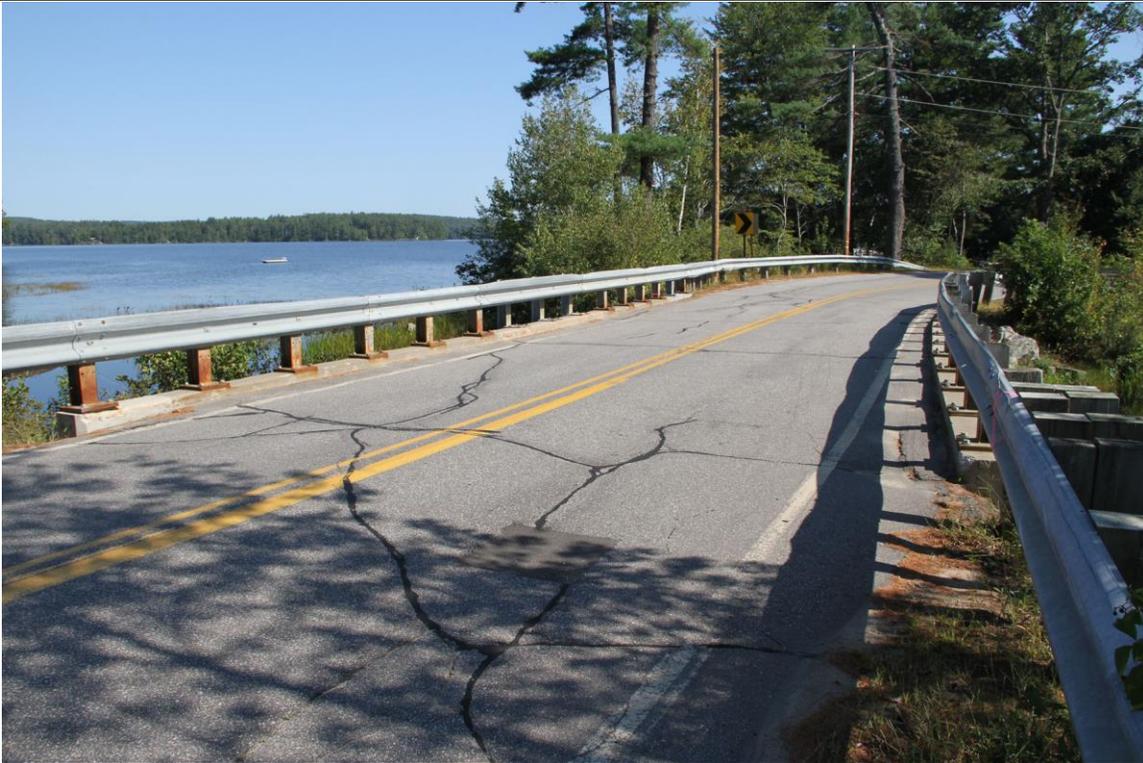
Photo :#	4	Description: Roadway view of bridge showing modern guardrail and steel posts carried on concrete cap added to stone abutments. Lake Waukehan on left.
----------	---	---

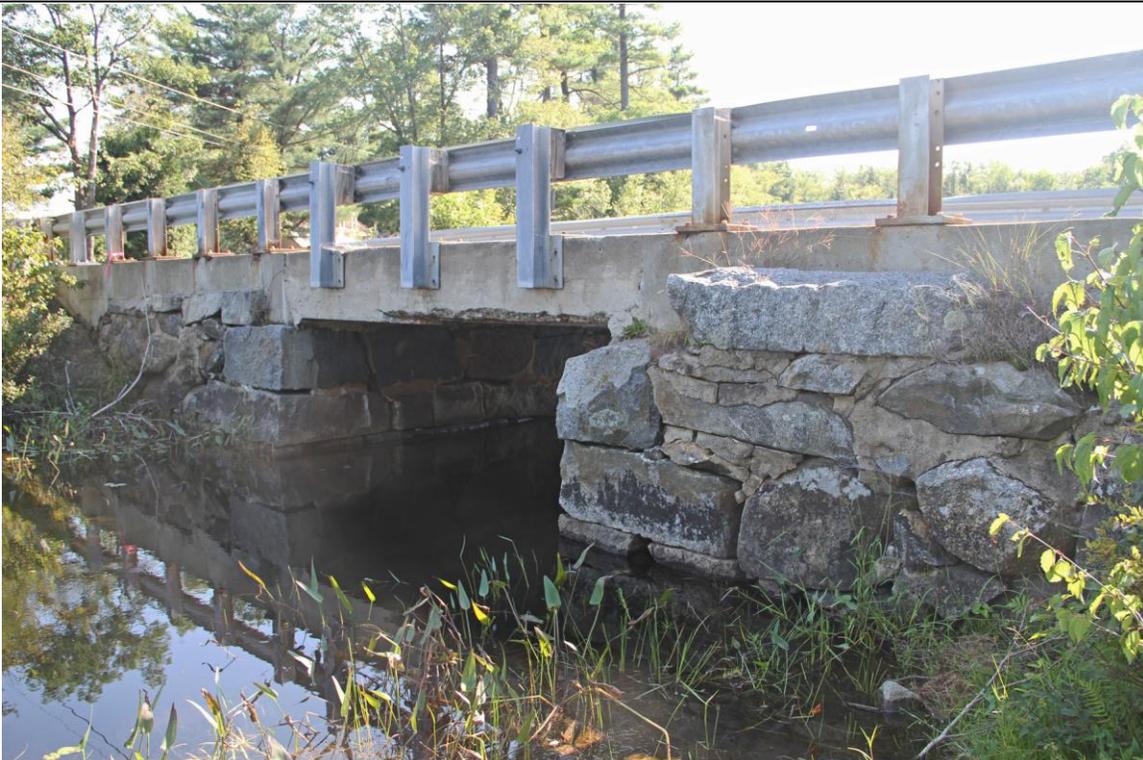
Photo :#	5	Description: East side (downstream or lake side) of bridge showing concrete slab on stone abutments and concrete cap added to abutment wing walls.
----------	---	--

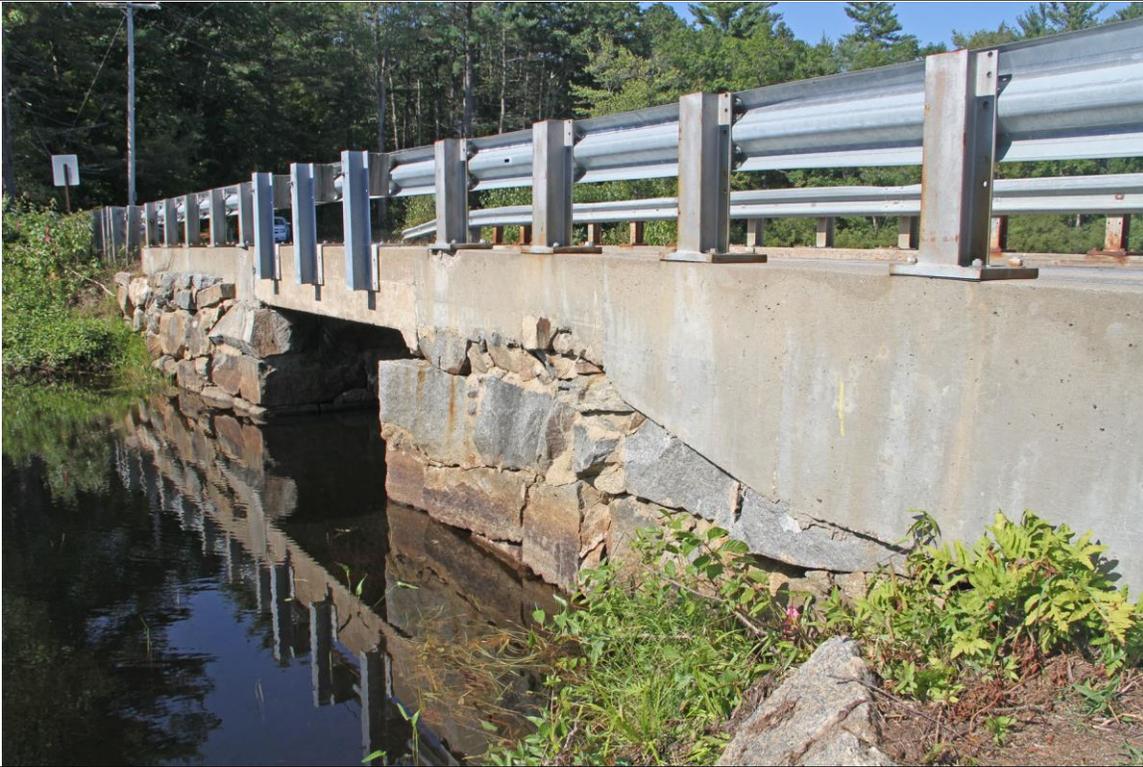
Photo :#	6	Description: West (upstream) side of bridge showing concrete slab on stone abutments and concrete cap added to abutment wing walls
----------	---	--
