1.0 BACKGROUND

The Louis Berger Group, Inc. (Berger) was retained by the New Hampshire Department of Transportation (NHDOT) to evaluate the feasibility of replacing the I-95 bridge, and removing or replacing the Taylor River Pond primary spillway, fishway, and emergency spillway/culvert.

This Feasibility Study examined different alternatives for replacing the bridge, and removing or replacing the primary spillway, fishway, and emergency spillway/culvert. The assessment considered transportation, public safety, flood management, water quality, natural and cultural resources, and socioeconomic issues. The Feasibility Study also reviewed several options to restore anadromous fish¹ passage within the affected portion of the Taylor River.

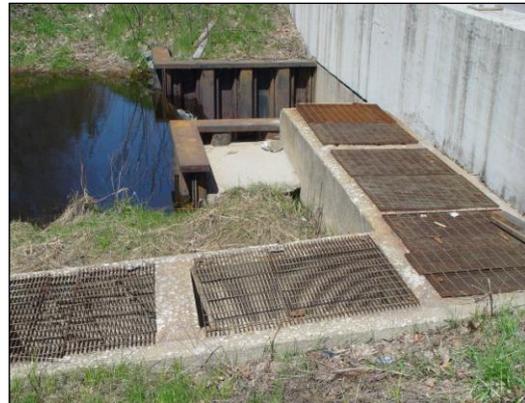
Taylor River Pond Primary Spillway/
Fishway and I-95 Bridge

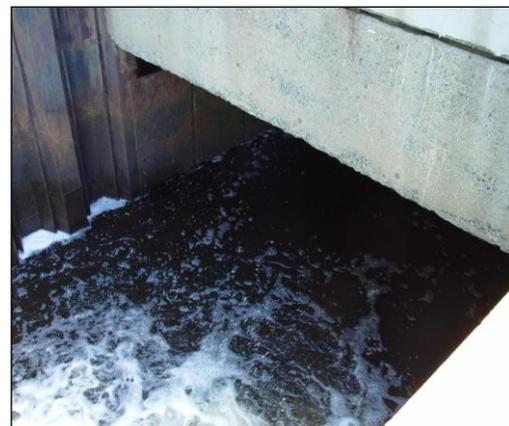
Upstream face of I-95 Bridge

NHDOT indicated that addressing the concerns with the I-95 bridge over the Taylor River is a high priority. The steel sheet-piling wall that supports the reinforced concrete slab bridge is exposed to a corrosive saltwater tidal environment and is heavily rusted. The reinforced concrete slab is also showing signs of deterioration with cracks and spalls.

The existing bridge structure is approximately 207 feet long (measured along the relocated Taylor River) and provides a clear opening width of 15 feet. It is comprised of vertical steel sheet piling supporting a cast-in-place reinforced concrete slab and approximately six to eight feet of roadway fill. The NHDOT Bridge Inspection Reports note that the steel sheet piling is heavily rusted with section loss and holes below the waterline. The reinforced concrete slab shows cracking and spalling, and is leaking. The bridge rail, rail transition and approach rail ends do not meet current standards.

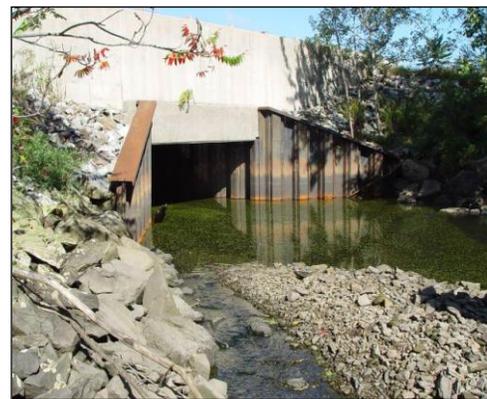
Downstream Face of I-95 Bridge

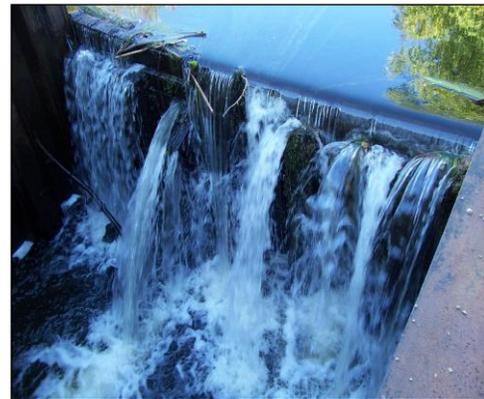
Primary Spillway

to the existing tidal channel. According to information from the NHDOT and the NHDES Dam Safety Bureau, and as observed during the September 26, 2006 inspection, the primary spillway, the emergency spillway/culvert, and the fishway have since begun to deteriorate. The deteriorated fishway has resulted in less efficient fish passage.

1. **Primary Spillway (NHDES Dam #106.08):** The NHDOT-owned primary spillway is 18.5 feet tall and 50 feet long (embankment to embankment), and blocks fish access to upstream habitat, although this is somewhat mitigated by the existing fishway. The 15.2-foot-wide sheet pile primary spillway and 3-foot-high flashboard bay are deteriorating, with numerous leaks and holes. The top of the sheet pile spillway is at elevation 7.54 feet. The timber flashboards were installed on top of the sheet pile

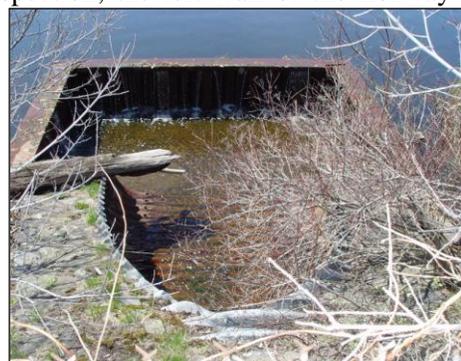
Emergency Spillway and
Entrance to Culvert

4. **Emergency Spillway/Culvert (NHDES Dam #106.09):** The Taylor River Pond emergency spillway is a 35.5 foot long by 1.5-foot-wide sheet pile structure with a spillway elevation of 9.03 feet that flows into a 6.1-foot-high by 8.8-foot-wide steel plate pipe-arch culvert. The pipe-arch culvert carries excess water under the I-95 roadway south of the bridge and spillway location. As stated above,

discharge through this culvert attracts migrating fish during high flows. However, fish are stranded either immediately below the emergency spillway or in the culvert when the water level recedes. This spillway is considered a “Significant Hazard Dam” by the NHDES Dam Safety Bureau. A new concrete invert was recently constructed as a measure to repair the deteriorated culvert invert. The interior dimensions were reduced to a height of 5.66 feet and a width of 7.98 feet.

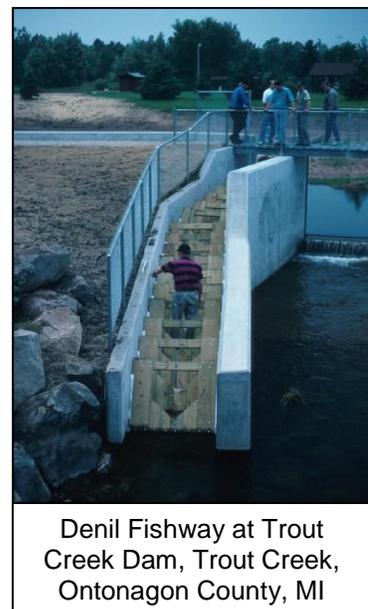
Denil Fishway at Trout Creek Dam, Trout Creek, Ontonagon County, MI

Under this alternative, a new 4-foot-wide Denil fishway with a 30-inch wide downstream entrance would be constructed on the north side of the proposed spillway Dam. Denil fishways are known to be effective fish passage devices for stronger-swimming species such as river herring, American shad, Atlantic salmon, and some riverine species such as suckers. Weaker swimming species such as rainbow smelt or American eel elvers, however, may not be able to traverse a Denil fishway. Eel ramps or eelways have been constructed for the upstream passage of elvers on some New England coastal streams. The inclusion of an eel ramp in the project will be reviewed during the Final Design stage of the project. The new Taylor River fishway would have a slope of 1:6, a single turning or resting pool, with 30-inches between baffles. Normal water depth within the fishway would be 2 to 4 feet.

The Denil fishway is self-regulating over a range of approximately 2 feet in headwater level. “Stoplogs” would be installed at the upstream and downstream ends of the fishway to allow closure during times of
