New Castle-Rye 16127 Preliminary Design

New Castle-Rye Bridge
Public Advisory Committee Meeting
July 23, 2013

Hoyle, Tanner
& Associates, Inc.

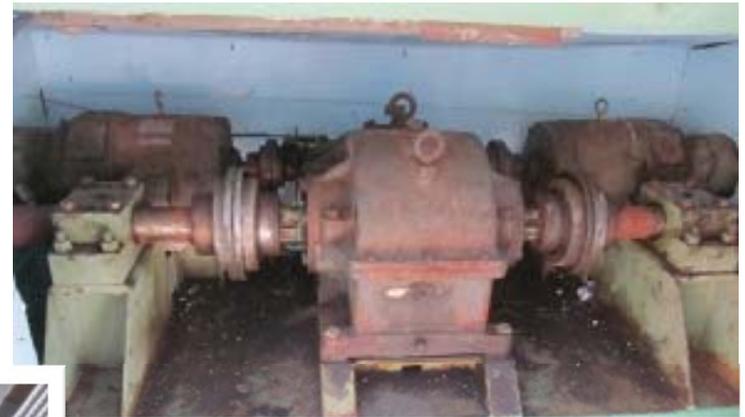
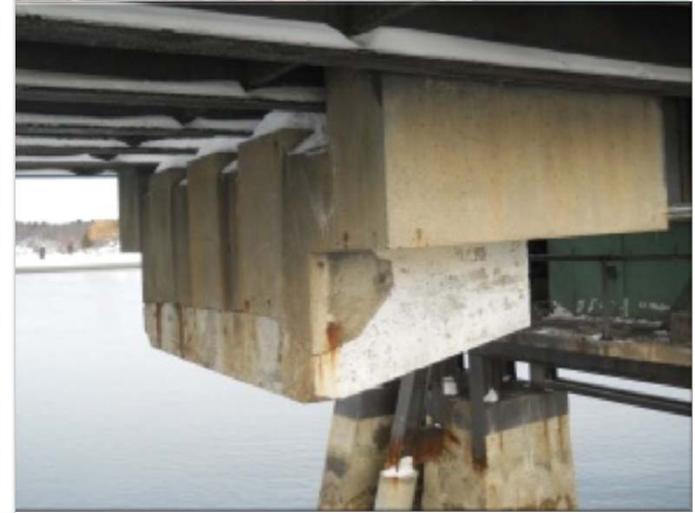
What is a Bascule Bridge?

- Popular bridge type used throughout US
- “Bascule” is a French word for seesaw
- Mechanical system that uses counterweights to “balance” segments
- Rare in NH because of limited shoreline and navigable rivers

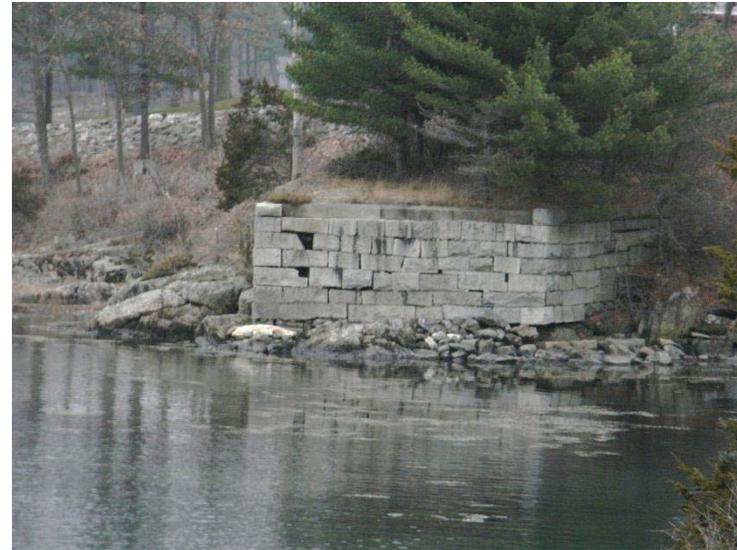
Environmental Considerations for Bridge Design

- Avoidance of disrupting Atlantic sturgeon habitat, spawning season
- Minimize/avoid wetland disturbance
- Avoid eelgrass beds during construction

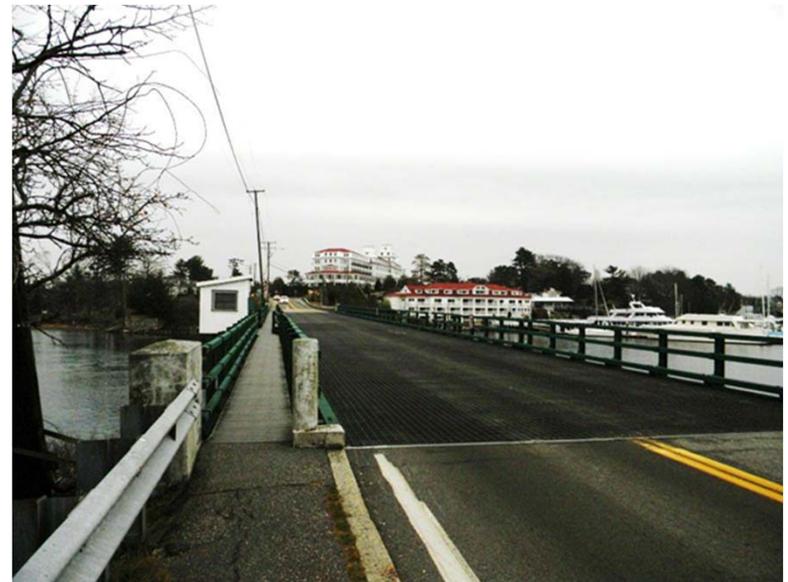
Existing Bridge Conditions

- Narrow roadway shoulders and sidewalk
- Need to cross road on north roadway approach to use bridge sidewalk
- Lack of stormwater treatment on south side of bridge
- Bascule span machinery doesn't meet current code
- Inadequate fail safes on bascule span
- Open deck a hazard to bicyclists and is noisy
- Bridge rail substandard and inadequate for vehicular impact

- Paint masks current condition of bridge
- Stringers, floorbeams and bascule girders exhibit advanced section loss.
- Pier caps and piles exhibit advanced section loss. Some piles are buckled.
- Approach span stringers exhibit varying levels of advanced section loss

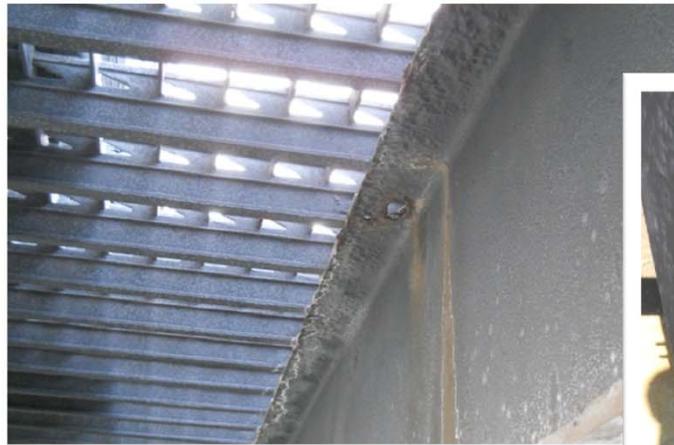
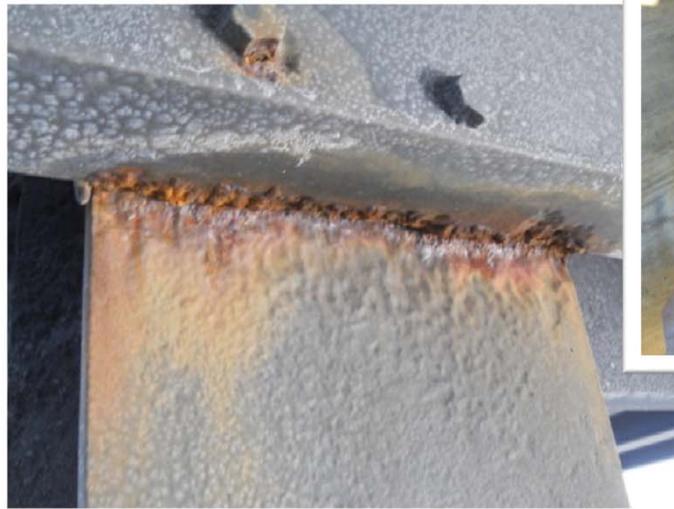
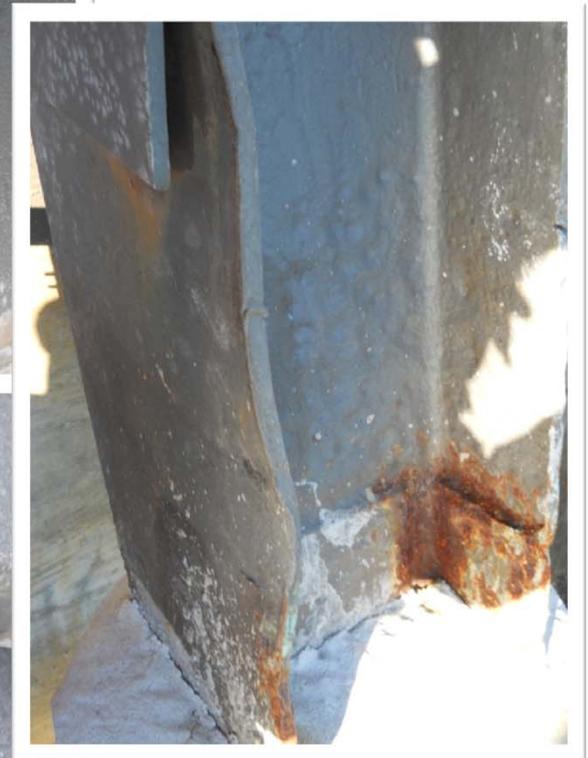
Structural Condition of the Bridge

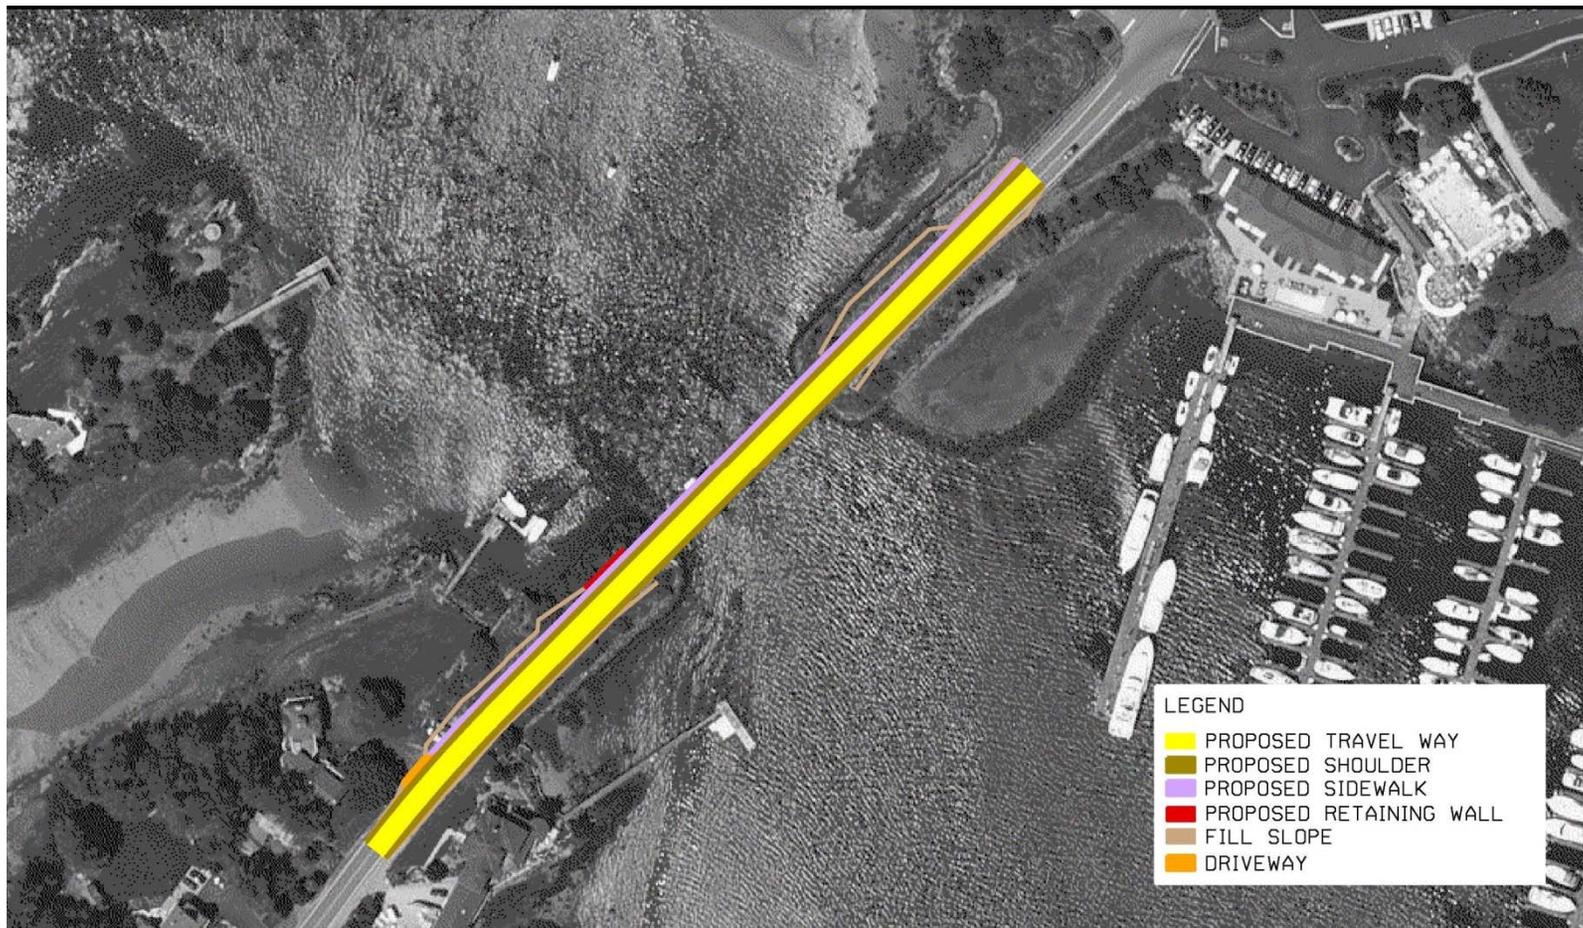
Alternative 1 - Rehabilitation

Existing Horizontal Alignment / Existing Profile

- Considered for Bridge Rehabilitation
- Matches geometry of existing roadway – horizontal and vertical
- Paved roadway shoulder width increased from 1 to 2 feet
- Sidewalk width increased from 4 to 5 feet
- Does not realign north approach sidewalk with bridge sidewalk
- Full bridge closure during rehabilitation of bascule span and rehabilitation substructure.

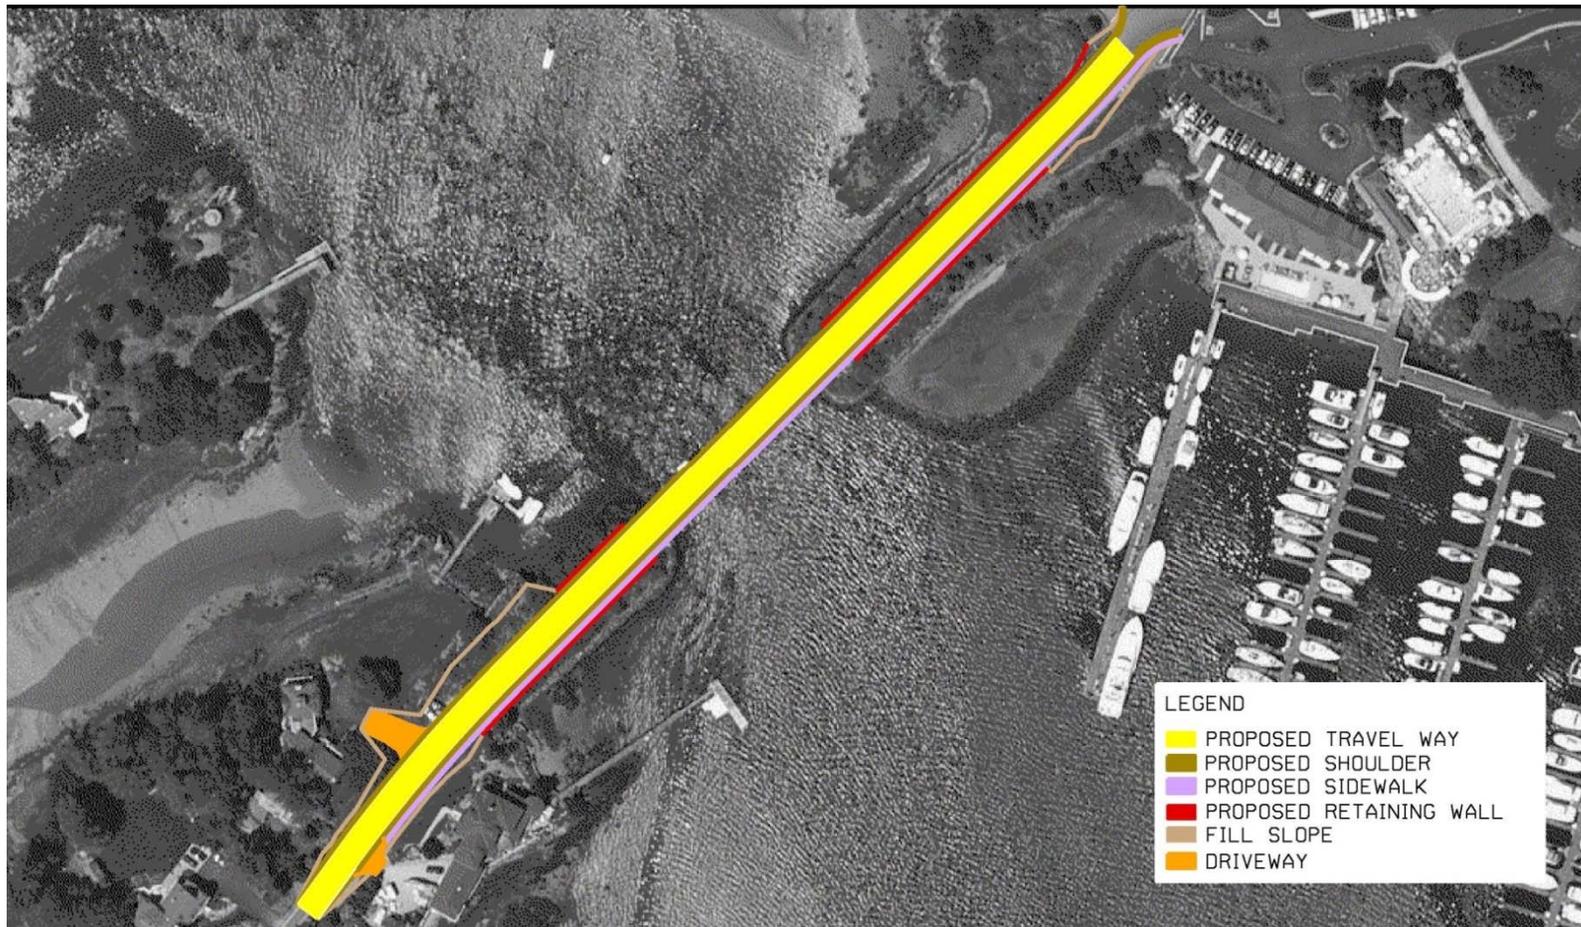
Alternative 2 - Replacement

Existing Horizontal Alignment/Raised Profile

- Raised Vertical profile by 6 feet - 3 inches for Fixed Span
- Profile increase based upon **minimum** requirement of active USCG vessels
- Requires significant driveway tie-ins (re-grading) and potentially reduces sight distance
- Requires new retaining walls in all four bridge quadrants; will impact existing stonewalls, and will require additional work in water. May impact Amurcork tree
- Full bridge closure during replacement of bridge.

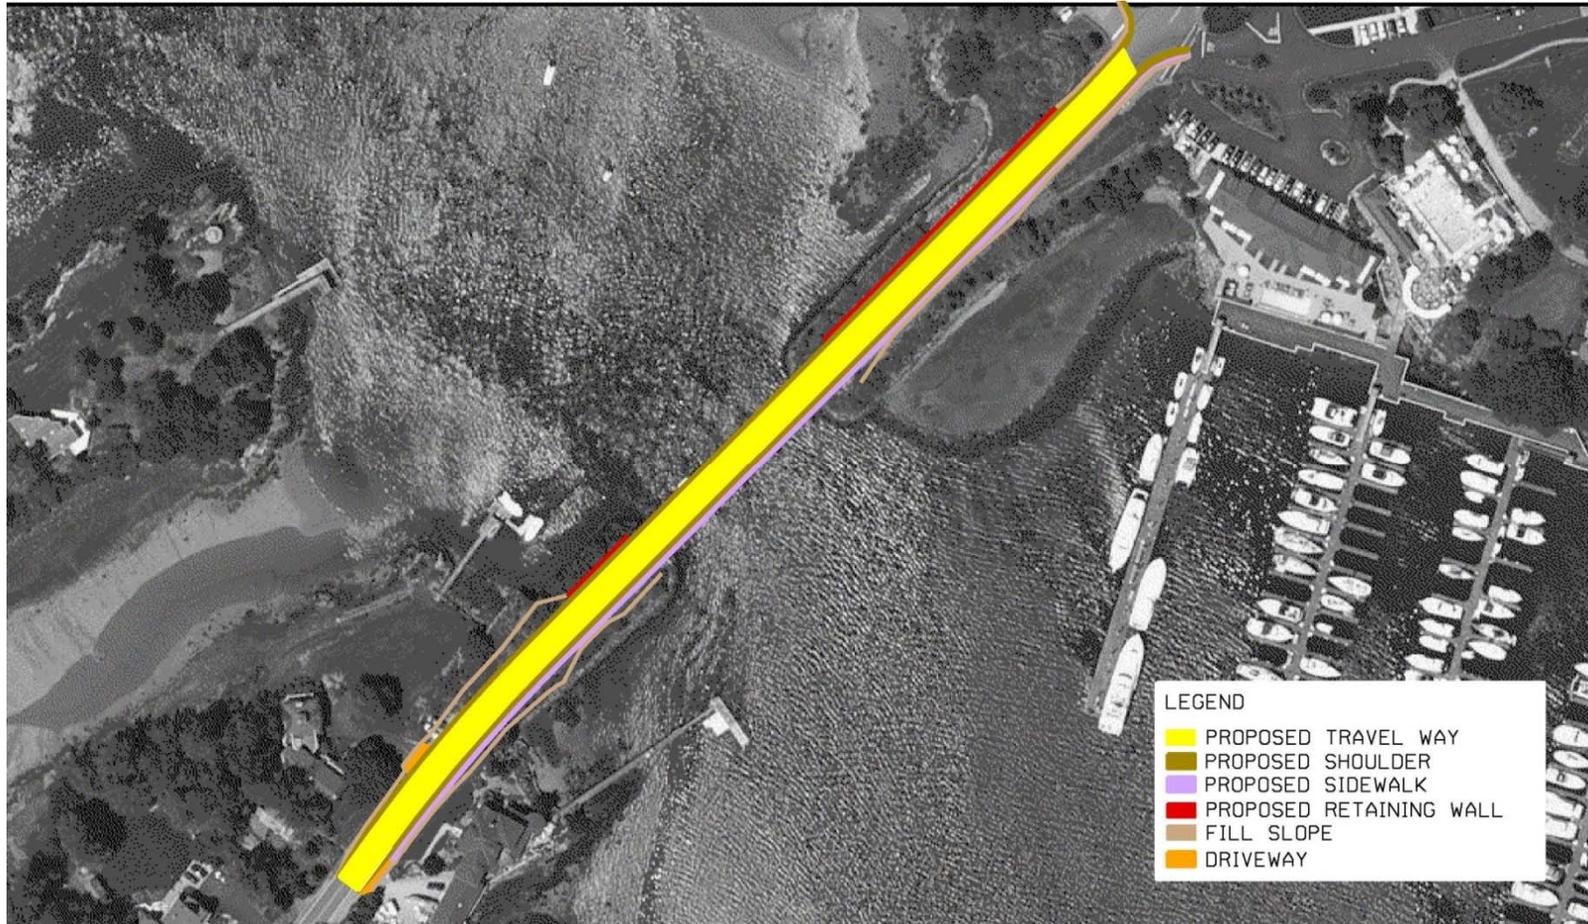
Alternative 3 - Replacement

Shifted Horizontal Alignment

- Matches vertical geometry of existing roadway, widens approach area to bridge by approximately 1 foot – 9 inches on west side; Centerline of Roadway shifts 6 feet – 9 inches west required by sidewalk relocation to north side
- Majority of impacts on western side of roadway
- Roadway with 4 foot shoulders may require extension of existing retaining wall on northwest quadrant; 2 foot shoulders will also be investigated
- Full bridge closure during replacement of bridge.
