Barron Mountain
Rock Reinforcement Evaluation – Phase I
I-93, Woodstock, New Hampshire

Prepared by McMahon & Mann Consulting Engineers, P.C., Buffalo, New York for the New Hampshire Department of Transportation, in cooperation with the U.S. Department of Transportation, Federal Highway Administration

4. Title and Subtitle	5. Report Date
PHASE I: CONDITION ASSESSMENT AND EVALUATION OF ROCK REINFORCEMENT ALONG I-93, BARRON MOUNTAIN ROCK CUT, WOODSTOCK, NEW HAMPSHIRE	February 18, 2004
	6. Performing Organization Code
7. Author(s)	8. Performing Organization Report No.
Kenneth L. Fishman, Ph.D., P.E.	
9. Performing Organization Name and Address	
McMahon & Mann Consulting Engineers, P.C. 2495 Main Street, Suite 432 Buffalo, New York 14214	11. Contract or Grant No. 13733L, X-A000(181)
12. Sponsoring Agency Name and Address	13. Type of Report and Period Covered
NEW HAMPSHIRE DEPARTMENT OF TRANSPORTATION PO BOX 483, 1 HAZEN DRIVE CONCORD, NH 03302-0483	INTERIM REPORT – PHASE I FALL 2003
	14. Sponsoring Agency Code

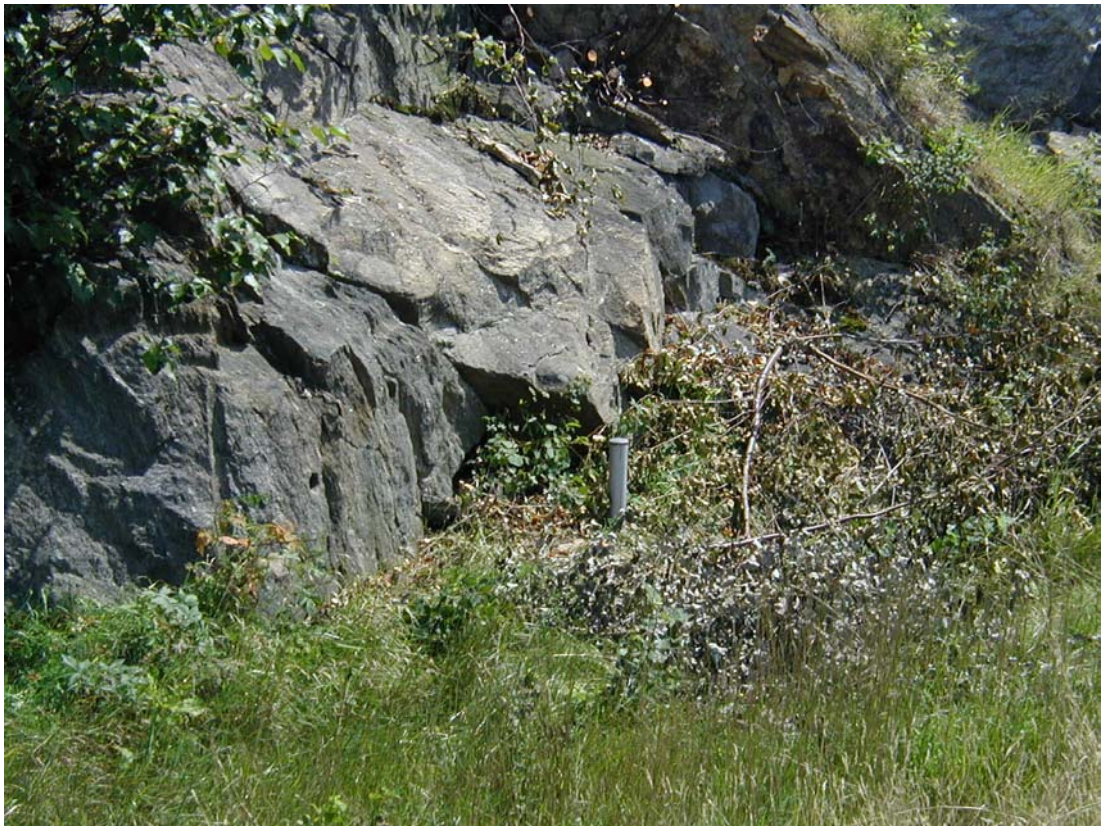
Figure 8. Well Used for Groundwater Sample #2

The second location was from an existing observation well located near the base of the rock cut near Station 1777+00. The observation well, shown in Figure 8, is an approximately four inch diameter steel casing, originally installed to monitor microseisms as part of an instrumentation and monitoring program instituted in 1972, subsequent to the rock slide. MMCE measured the depth of the observation well and the depth to water within the well as 94 feet and 30 feet respectively. A groundwater sample was retrieved from the well after purging three casing volumes of standing water from the well. Well purging is necessary to obtain a sample that is representative of the hydrogeologic regime, and not standing water in the well. Subsequent to purging, a sample of ground water was extracted from the well using a dedicated bailer.
