Barron Mountain
Rock Reinforcement Evaluation – Phase II
I-93, Woodstock, New Hampshire
Validation of NDT Results for Condition Assessment of
Rock Reinforcements

1. Report No. FHWA-NH-RD-14282C		2. Gov. Acc. No.	3. Recipient's Catalog No.
4. Title and Subtitle PHASE II: CONDITION ASSESSMENT AND EVALUATION OF ROCK REINFORCEMENT ALONG I-93 BARRON MOUNTAIN ROCK CUT, WOODSTOCK, NH Validation of NDT Results for Condition Assessment of Rock Reinforcements		5. Report Date SEPTEMBER, 2005

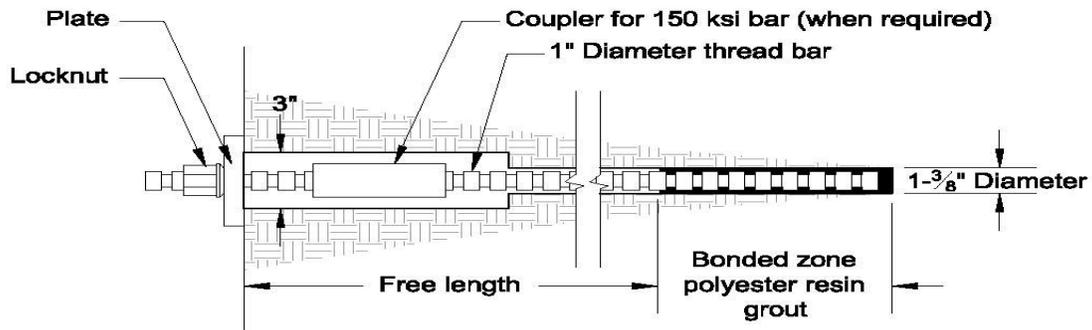
Figure 2. Rock Bolt Details

Figures 2 and 3 portray the rock bolt and tendon installations, respectively. Rock bolts and rock tendons include 1 inch and 1.25 inches diameter steel thread bars, respectively. Most of the reinforcements are Dywidag, Grade 150, high-strength prestressing steel thread bars. Some rock bolts are Grade 80 threaded steel rods supplied by Bethlehem Steel. Prestressed rock bolts are essentially end point anchorages, grouted at the distal end with polyester resin grout, and supported by an anchorage assembly consisting of a nut and a bearing plate at the rock face (proximal end). Rock bolts were initially prestressed to 20 or 40 kips depending on the steel grade. Tendon elements are fully grouted with Portland cement grout, and the proximal ends are recessed into the rock mass. The tendons are passive elements, i.e. they were not prestressed, and there is no anchorage assembly.

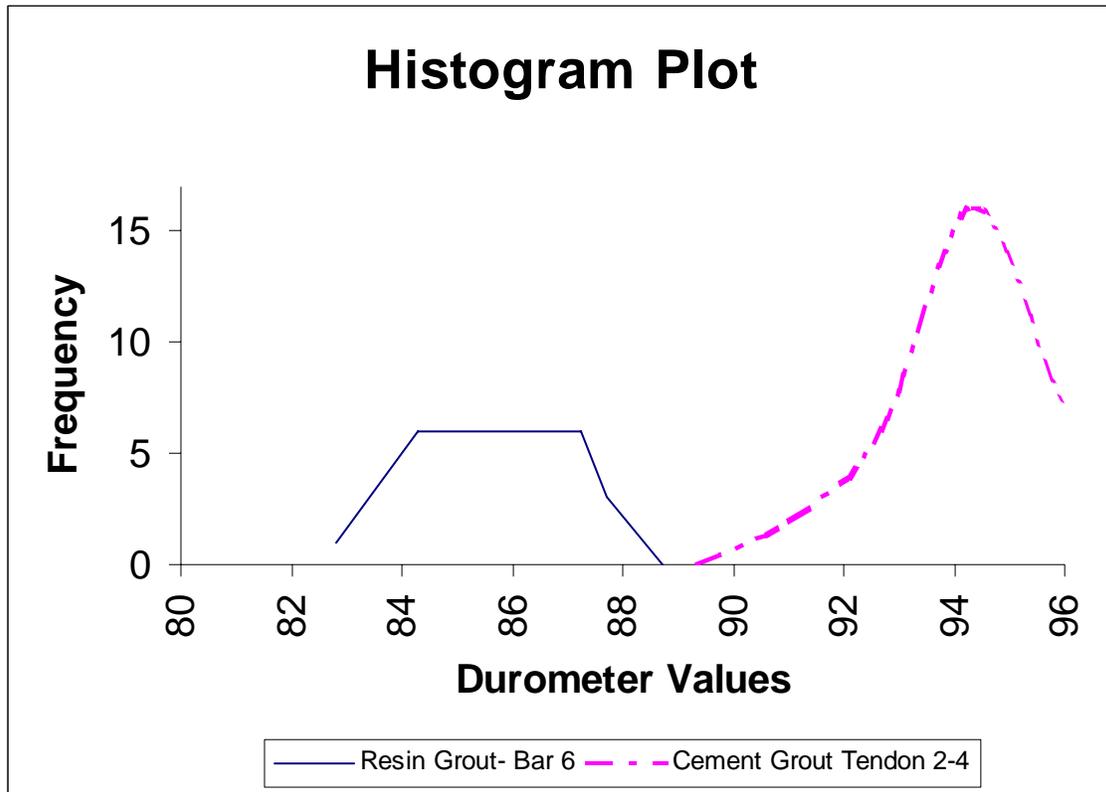
Figure 7. Histogram of Resin Grout and Portland Cement Grout Hardness Measurements.

Figure 7 compares histograms for the Portland cement and resin grout hardness measurements. Hardness measurements for the Portland cement grout ranged between 84 and 96, with an average of 93 and standard deviation 2.1. Hardness measurements for the polyester resin grout ranged between 83 and 90, with an average of 85 and standard deviation 1.8. The comparison shown in Figure 7 indicates that hardness testing may be a useful technique to identify grout type. Grout hardness measurements are very consistent along both samples. Based on this data, differences between Portland cement or resin grout condition appear to be more in terms of the amount of coverage of the reinforcement elements, rather than with respect to the consistency of the different grout mixtures.

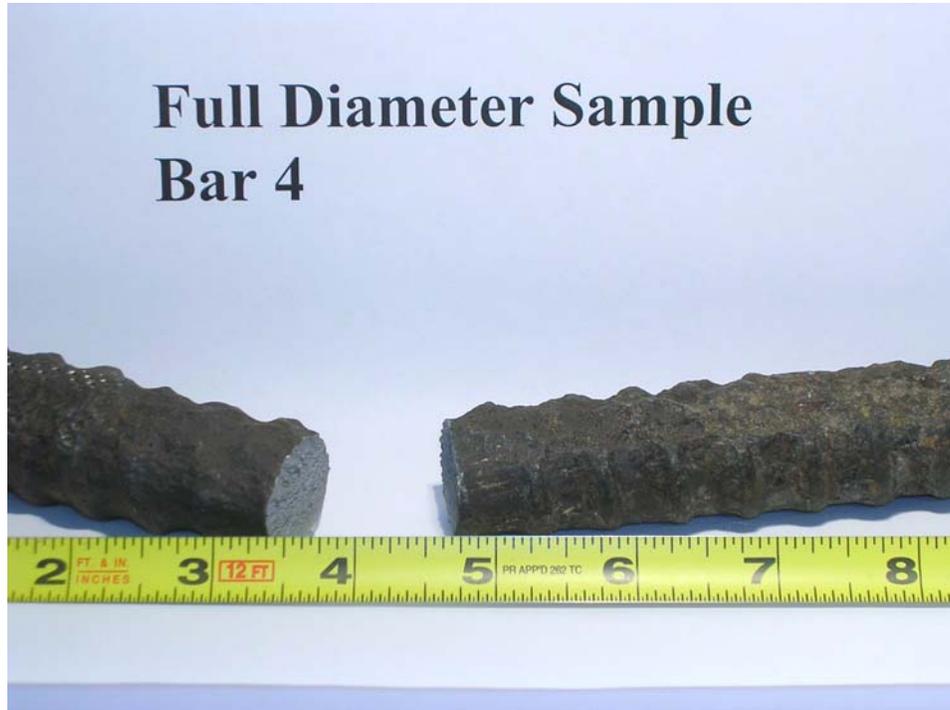
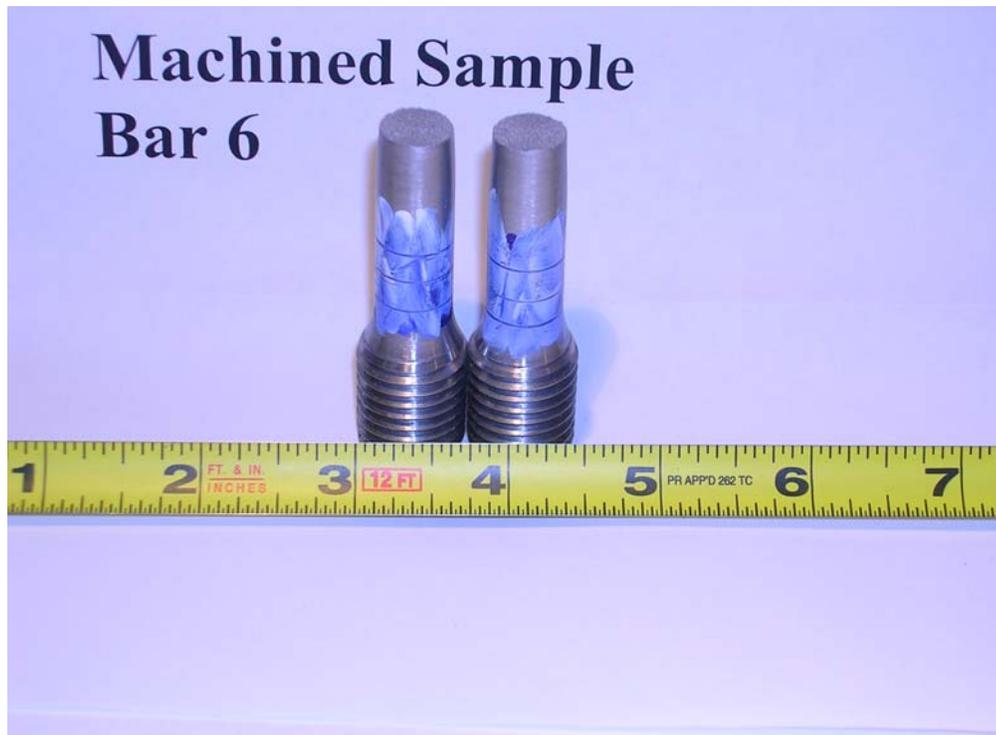
Figure 10. Tension Test Specimens

WMT&R tested one machined-section and one full section from each pair of specimens. The purpose of testing the full sections was to determine if the ultimate tensile stress (UTS) was affected by a change in geometry due to non-uniform loss of section, or localized corrosion such as pitting. The machined sections have a controlled geometry and are similar to the test specimens described in ASTM A 370, "Standard Test Methods and Definitions for Mechanical Testing of Steel Products." Machined sections had an initial diameter of 0.5 inches and a gage length of 2 inches. Full sections were approximately 18 inches long with a gage length of 2 inches. Typical specimens are pictured in Figures 10 (a) and (b). Results from tension testing are summarized in Table 2.

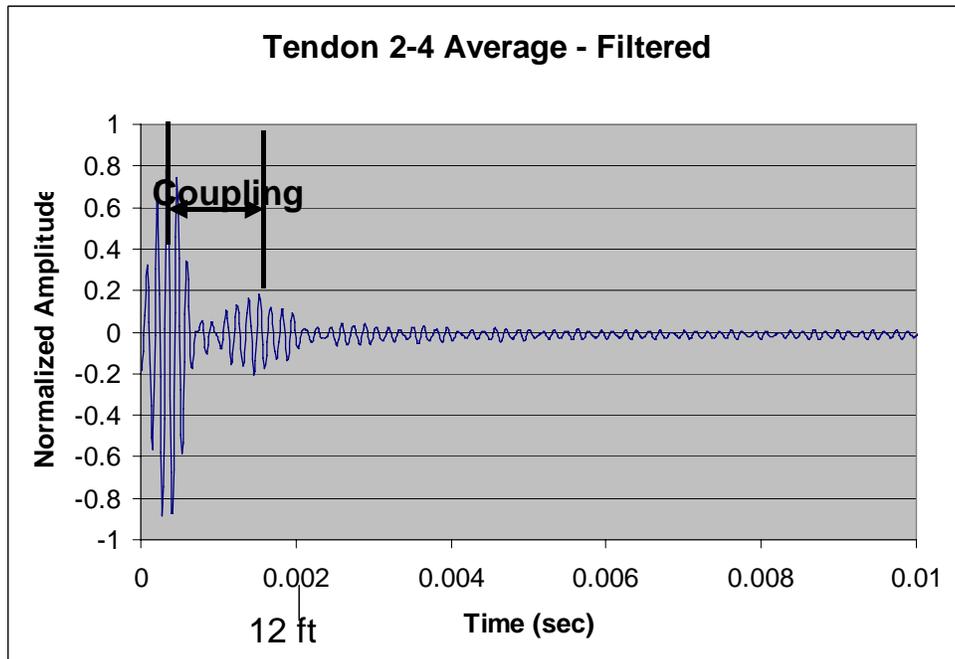
(d) Tendon MMCE # 2-4

The compression wave velocity of steel is taken as 16,000 ft/sec and 12,000 ft/sec for Portland cement grout. Reflections were observed from relatively proximal locations denoted as L_1 , and from a more distal location, L_2 , often corresponding to the length of the bolts (L_T). Direct observations are described in the comments column including loss of section from corrosion, the presence of couplings and rock conditions observed during drilling of replacement bolts as noted on the drillers logs (Appendix V). In most cases L_1 and L_2 are either correlated with direct physical observations, or with the known lengths of the bolts; within approximately three feet, i.e., corresponding to the wavelength inherent to the impact test. Figures 12 (a), (b) (c) and (d) depict reflections observed along Rock Bolts G-19, G-8 (MMCE #4 and #6) and MMCE #16, and Tendon - MMCE # 2-4.

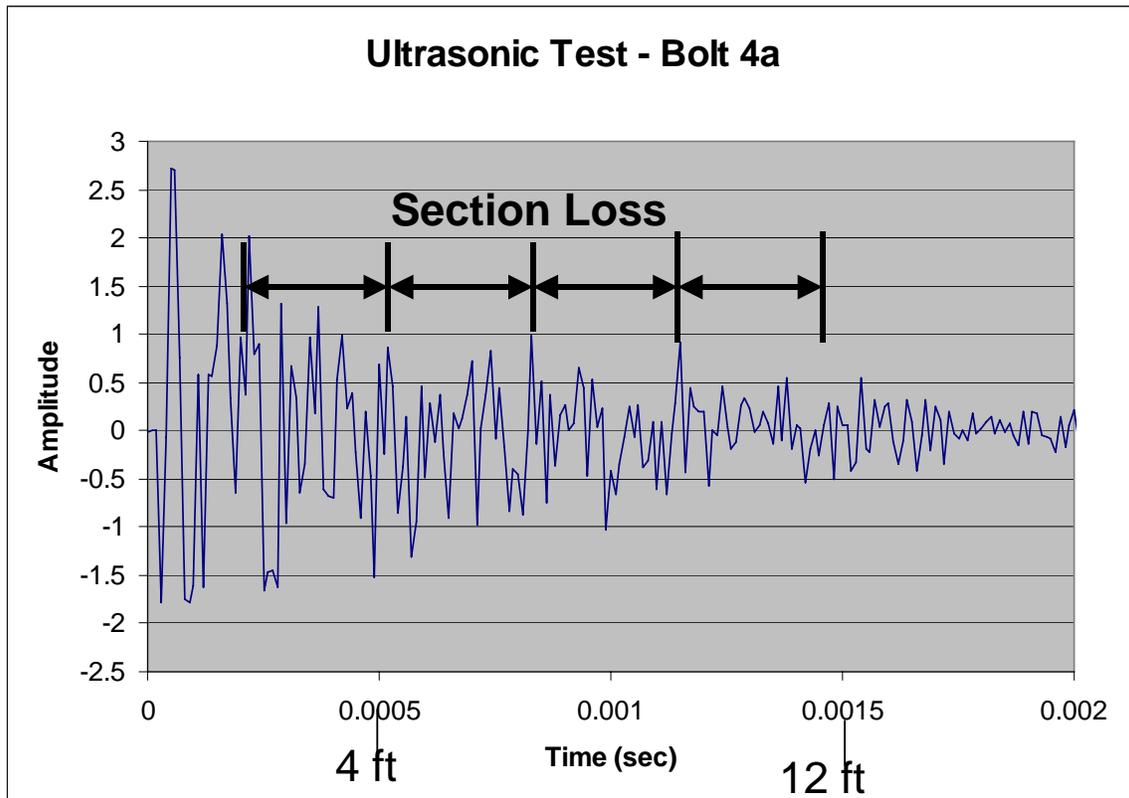
Figure 13. Wave Form From Ultrasonic Test for G-19 (MMCE #4).

Given the details of the anchor head assembly, reflections from a loss of section directly behind the anchor plate are difficult to identify from results of ultrasonic testing. This is because the data are masked by a strong reflection from the anchor head location. Results from the ultrasonic test on Bolt G-19 (MMCE #4) are shown in Figure 13 and a relatively subtle reflection approximately two feet from the end of the element is evident corresponding to the area where significant loss of cross section ($\approx 20\%$) is observed.
