**MEMORANDUM**  
**BUREAU OF RAIL & TRANSIT**  
**BICYCLE & PEDESTRIAN SECTION**

Subject: Field Review of Inactive Portions of Hampton Branch Railroad Corridor on May 29, 2009

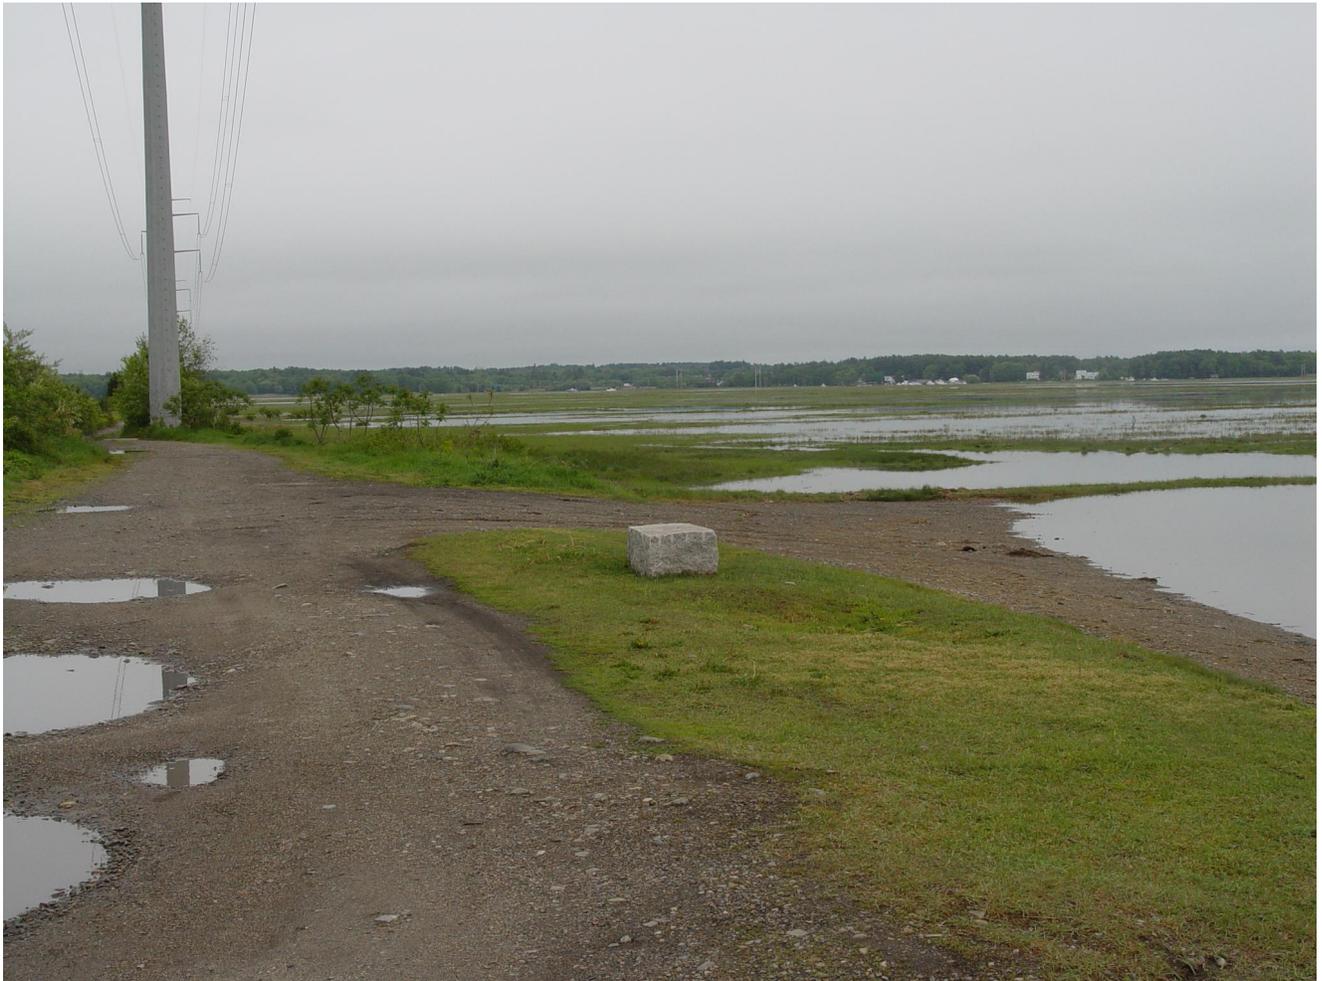
The above noted participants met at the Hampton Branch RR corridor at the end of Depot Road in Hampton Falls. The field review of facilities included the Hampton Branch RR corridor from Brimmer Road to the NH 101/US 1 traffic Circle. The review also included a half-mile section of RR corridor in Seabrook between Railroad Avenue and Walton Road.

Throughout this segment of the Hampton Branch rail corridor, the rail bed was once double-tracked. Substantial portions of westerly ties and rail still remain in place. Throughout the Hampton marshes, railroad bed subsidence, surface erosion and wave rap are evident.
