**IN-DEPTH INSPECTION AND CONDITION REPORT
FOR THE
PORTSMOUTH MEMORIAL BRIDGE
OVER THE PISCATAQUA RIVER**

October 2009

VOLUME 2 OF 2

Underwater Inspection Report

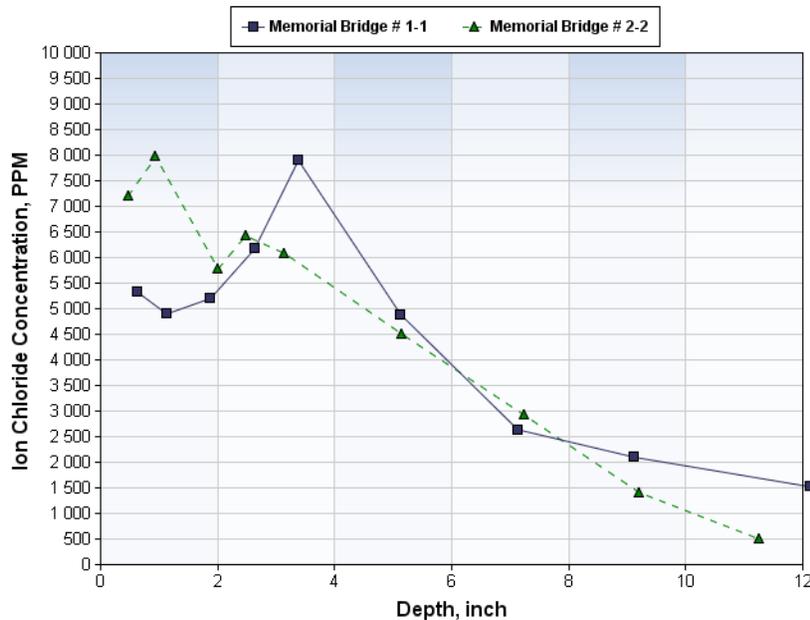
Figure 2 – Experimental chloride profiles – Memorial Bridge after 89 years of exposure

Chloride profiles were performed on two concrete cores selected from the received cores (see Table 1). The selected concrete cores represent different piers and different water level. Figure 2 presents the chloride profiles determined on the selected concrete cores. On the graphs, 0 on the X-axis represents the surface exposed to seawater. In this figure, it can be observed that, near the surface, the chloride concentrations are relatively high (around 7,000 ppm).

Chloride profiles have shown in Figure 2 (see section 2.6) show that the investigated piers are contaminated with chlorides. From the results, the concrete is contaminated with chlorides to a depth of at least 12 inches. Chloride profiles in Figure 2 suggest that the concrete from piers is exposed to high salinity water.

The ion chloride profiles in Figure 2 indicate that the chloride content is over the critical value of 720 ppm up to 12 in. depth. However, the corrosion initiated by chloride contamination should propagate slowly where concrete element is totally immersed. The fully saturation of concrete leads to the lack of oxygen around the embedded rebars. The

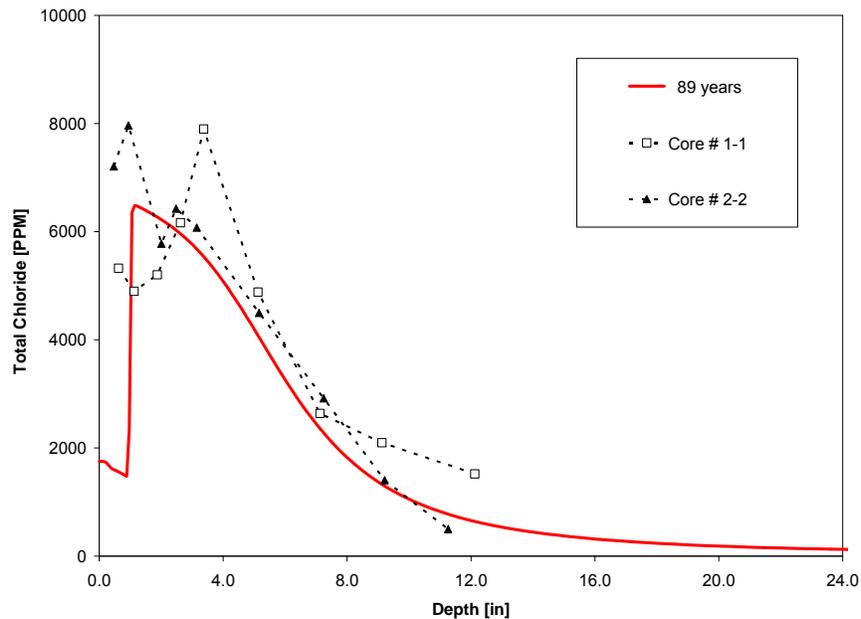
Figure 7 - Chloride profiles measured on Memorial Bridge and STADIUM® numerical simulation

Exposure conditions were determined for both investigated structures. Figure 7 presents the experimental chloride profiles along with the numerical simulation results used to reproduce them using the exposure conditions presented earlier. A red line represents numerical simulations. It can be seen that STADIUM® simulations reproduced the actual chloride penetration relatively well. However, the average ionic diffusion coefficient had to be increased to a value of $30 \times 10^{-11} \text{ m}^2/\text{s}$ compared to a maximum value measured of $19 \times 10^{-11} \text{ m}^2/\text{s}$. This is explained by the variability in the results and possible damage in concrete where the chloride profiles were determined. This would result in a higher ionic diffusion coefficient than the measured one where it was selected deep enough inside the structure where the concrete was sound.

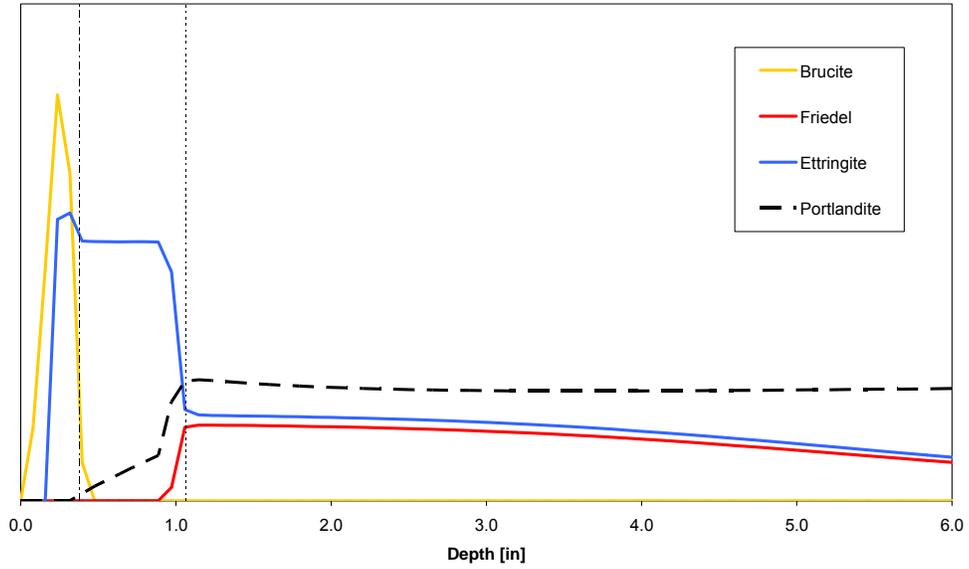
Figure 8 - Solid Phases - Memorial Bridge - Today

The state of solid phases presented earlier (Portlandite, Ettringite and Brucite) was assessed using STADIUM[®] modeling software. These results are best shown in graphical representation. At an age of 89 years, the solid phases for Memorial Bridge are given in Figure 8 while in 50 years in the future they are shown in Figure 9. Currently, based on STADIUM[®] modeling, the formation of ettringite has reached $1 \frac{1}{8}$ in. This depth corresponds to the dissolution of portlandite. For this depth, there is a risk of concrete cracking. The formation of brucite, another expensive product, has reached $\frac{3}{8}$ in.

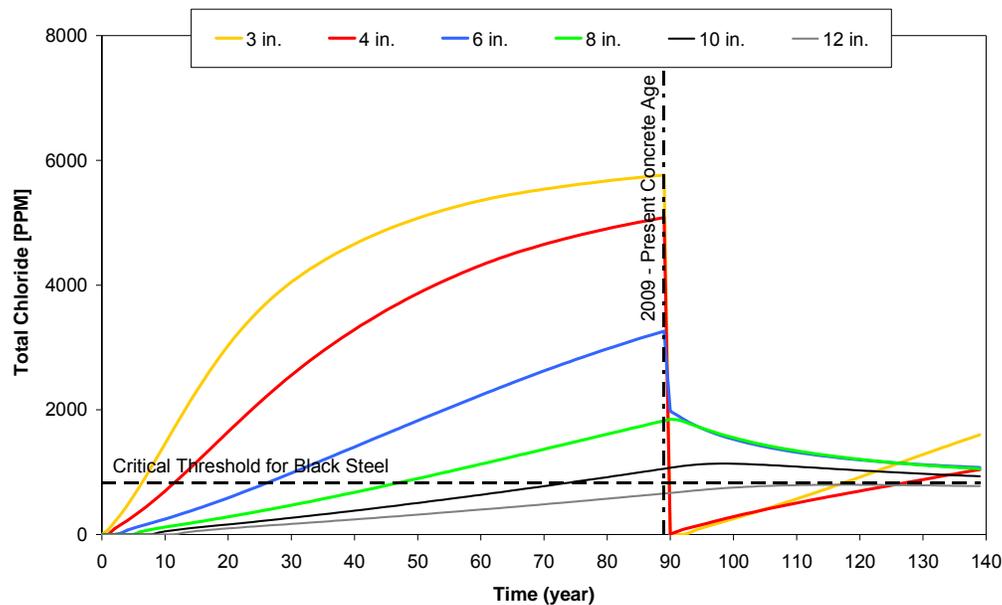
Figure 10 - Memorial Bridge - 6-inch repair - Mixture 2

Figure 10 presents the chloride content evolution with time for different depths inside the concrete for a 6-inch repair with mixture 2. This type of repair stops the increase of chloride content to a depth of 10 in. or more. However, since the concrete is highly contaminated, the time to initiate corrosion for a concrete cover of 3 in. is not prevented for more than 28 years.

Moreover, the results for Mixture 1 are not presented since the difference between both concrete in preventing corrosion is negligible. Still, it is a more appropriate choice to repair with mixture 2 since its mechanical properties should be similar to the in-place concrete.

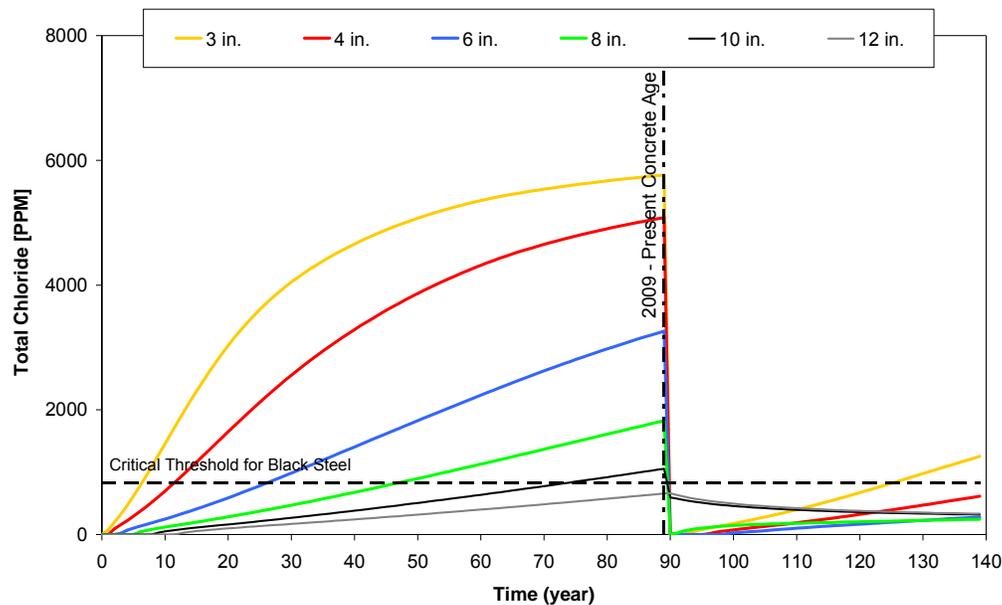
Figure 11 - Memorial Bridge - 10-inch repair - Mixture 2

Figure 11 presents the chloride content evolution with time for different depth inside the concrete for each structure for a 10-inch repair with mixture 2. Analysis of the figure clearly shows the beneficial influence of removing old contaminated-concrete to higher depth. This type of repair stops the chloride ingress for a depth of 10 in. or more like a 6-inch repair. However, the impact of this deeper concrete repair is greater.

In the figure, it is shown that the chloride concentration at a depth of 3 in. inside the repair materials will reach the critical concentration in less than 50 years (i.e., 36 years). Thus, the simulations indicate that the repair material should have a certain quantity of corrosion inhibitor to increase the critical chloride content for corrosion. From our calculation, the addition of 1 gal/yd³ of corrosion inhibitor should be sufficient to provide 50 years of corrosion protection. At 4 in. inside the repair materials, the critical chloride concentration should be reached after more than 50 years.

Moreover, the comments mentioned in the 6-inch repair regarding the mixture choice still apply.

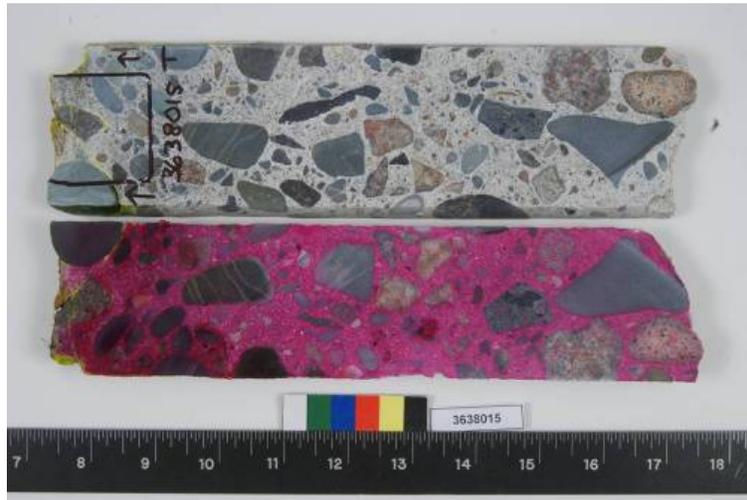
Figure B1 - North Pier of Memorial Bridge, 1-1, RJLG ID 3638015. Prior to cutting, the top exposed surface (left side of image) was impregnated with fluorescent-dyed epoxy to preserve the surface fractures. The top section of the half core was cut perpendicular to exposed surface. The thin section was taken from the upper face at the exposed surface. The lower cut face was treated with the pH indicator, phenolphthalein, but the epoxy at the surface has interfered with the test.

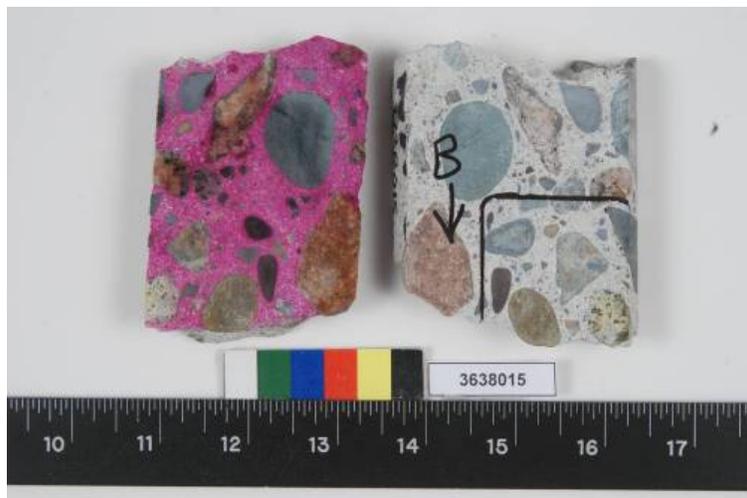
Figure B2 - North Pier of Memorial Bridge, 1-1, RJLG ID 3638015. The bottom section of the core was cut perpendicular to the exposed surface. The thin section was taken from the right face. The left cut face was treated with the pH indicator, phenolphthalein.

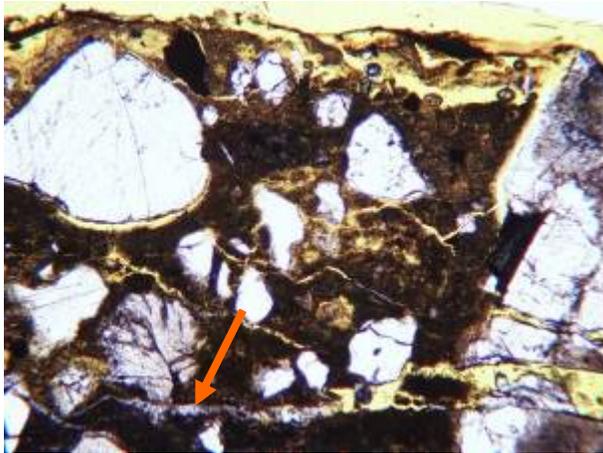
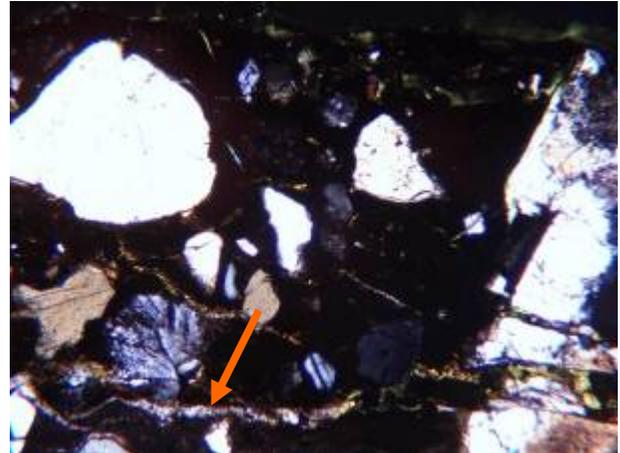
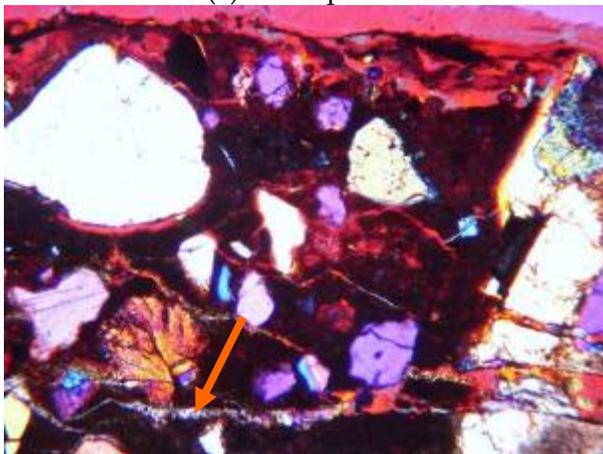
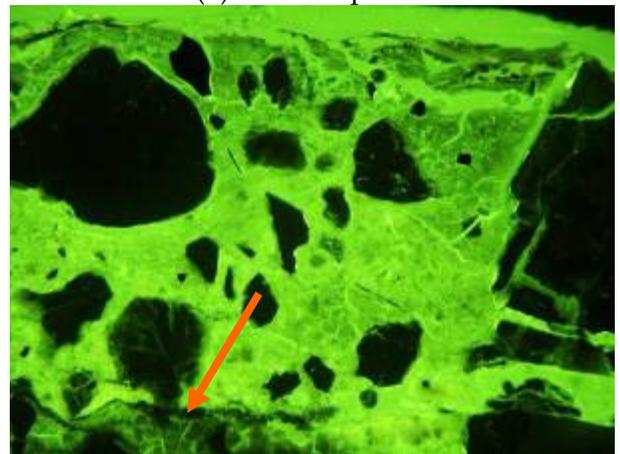
Figure B4 - North Pier of Memorial Bridge, 1-1, RJLG ID 3638015T. Optical images in different light modes showing cracks parallel to exposed surface in carbonated paste. Some cracks are filled with calcium carbonate; an example is indicated by an orange arrow in each image. Image area is 2.6 mm wide.

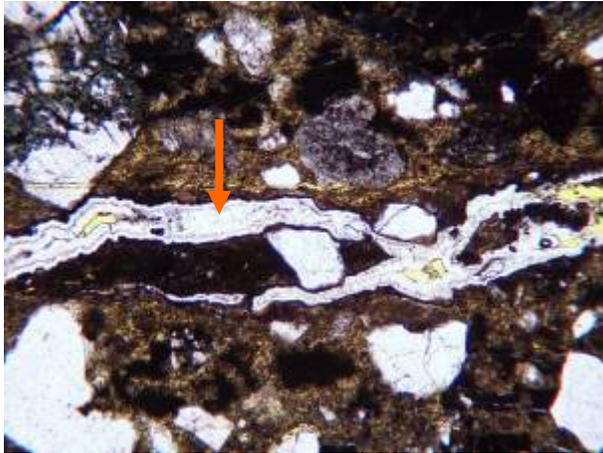
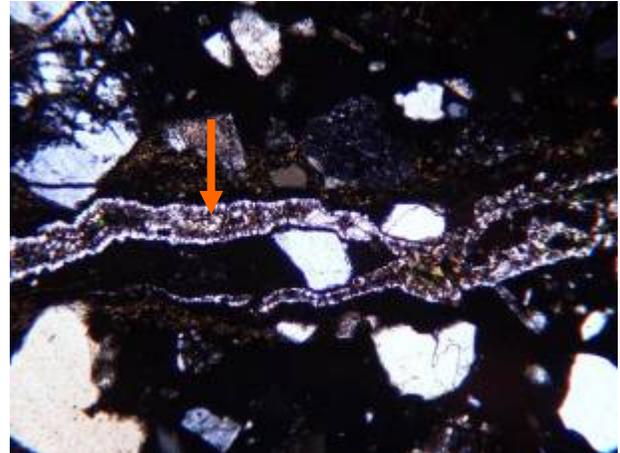
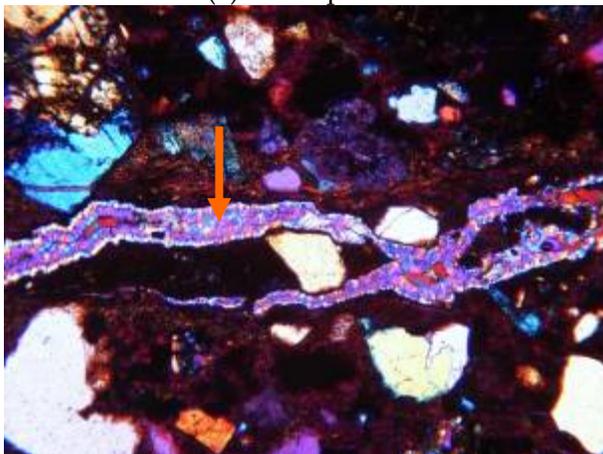
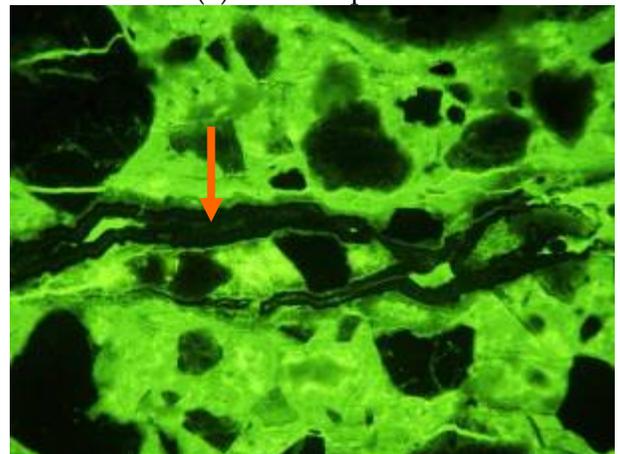
Figure B5 - North Pier of Memorial Bridge, 1-1, RJLG ID 3638015T. Optical images in different light modes showing magnesium hydroxide in cracks as indicated by an orange arrow in each image. Image area is 2.6 mm wide.

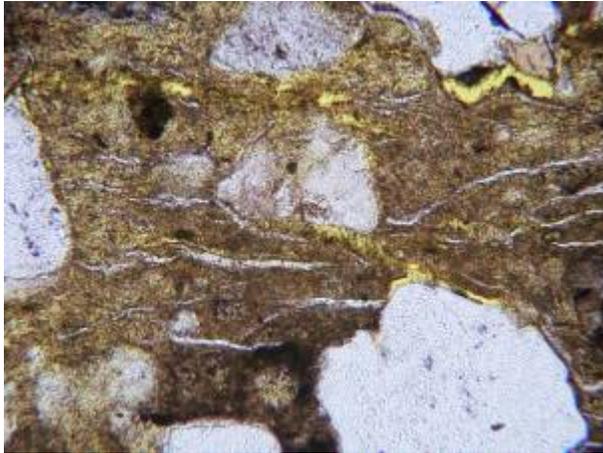
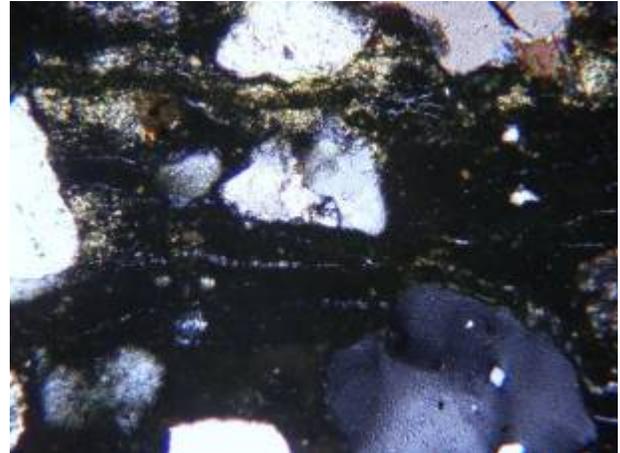
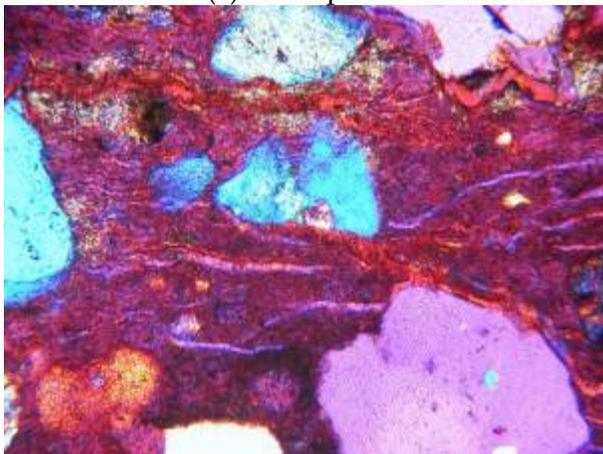
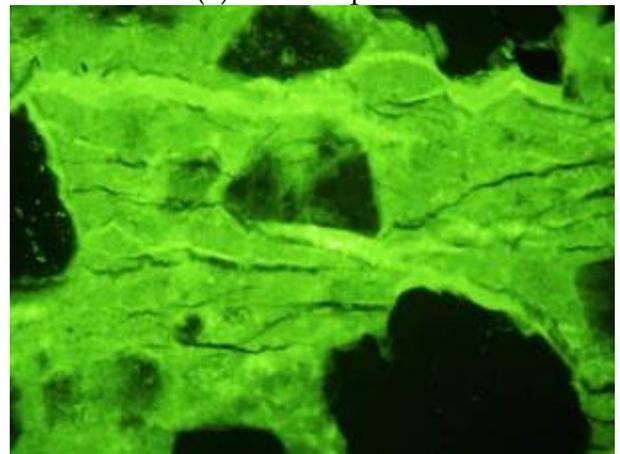
Figure B6 - North Pier of Memorial Bridge, 1-1, RJLG ID 3638015T. Optical images in different light modes showing parallel cracks lined with ettringite which appears white in plane polarized light. This field of view is also seen in Figure 8.

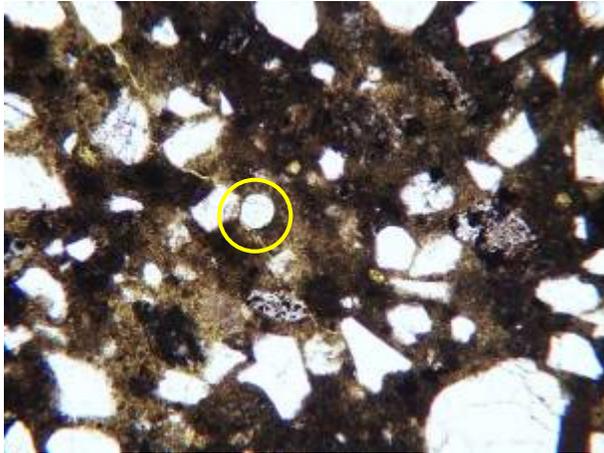
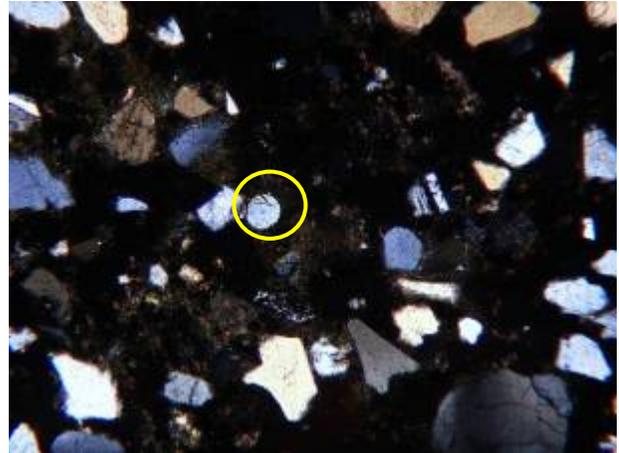
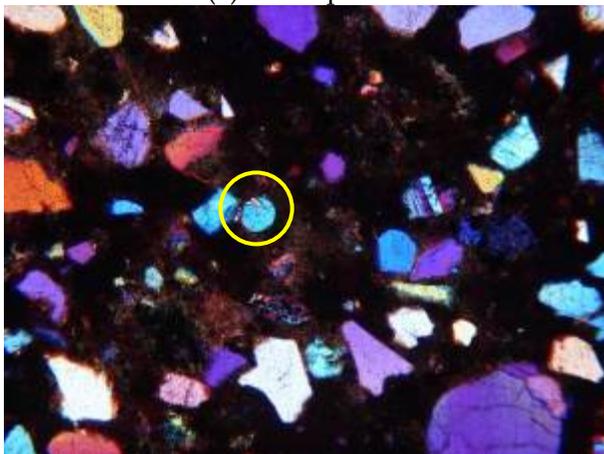
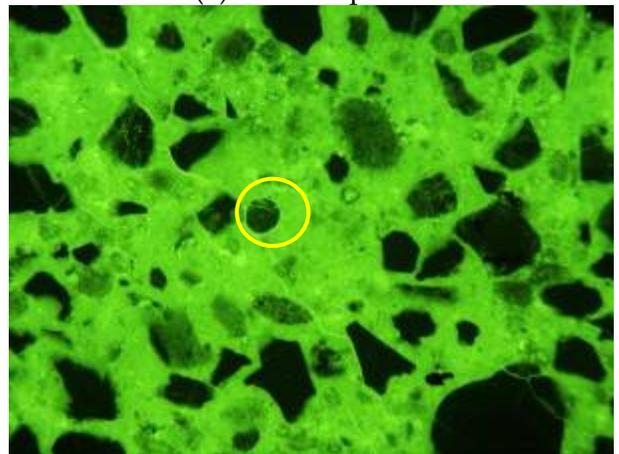
Figure B7 - North Pier of Memorial Bridge, 1-1, RJLG ID 3638015B. Optical images in different light modes showing a void filled with monosulfate (circled) in dense paste. Image area is 2.6 mm wide. The same field of view is seen in Figure B32.

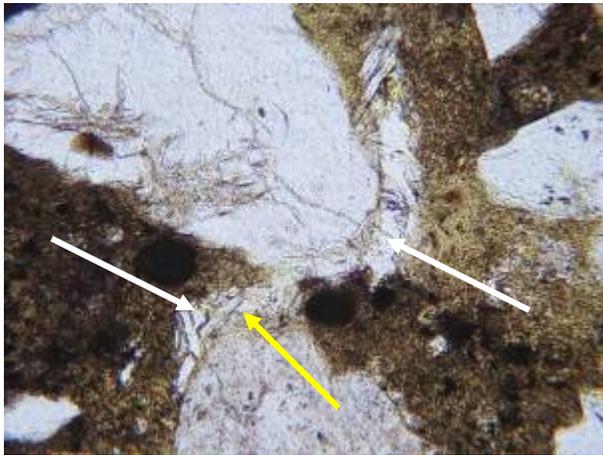
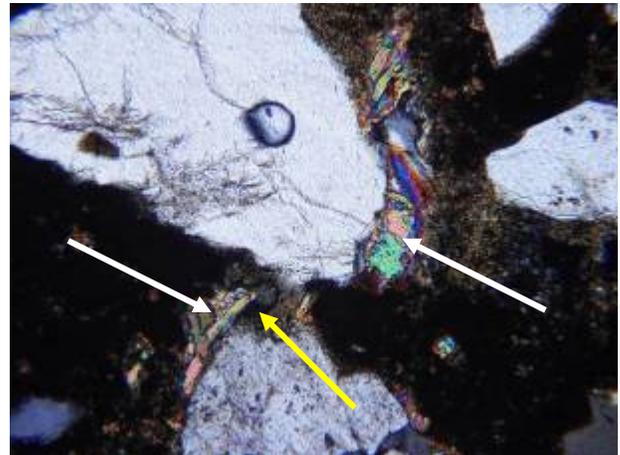
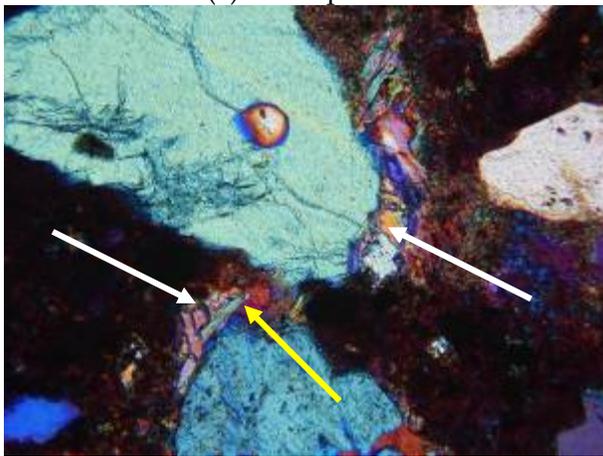
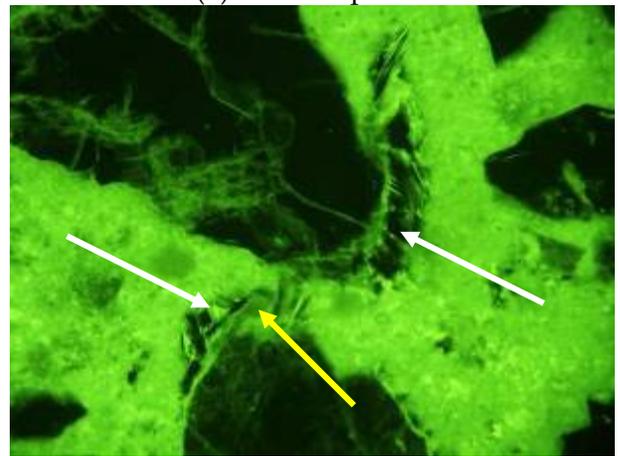
Figure B8 - North Pier of Memorial Bridge, 1-1, RJLG ID 3638015B. Optical images in different light modes showing monosulfate (yellow arrow) and calcium hydroxide (white arrows) in crack approximately 1' from exposed surface at water line. This same field of view is seen in Figure B34. Image area is 1.0 mm wide.

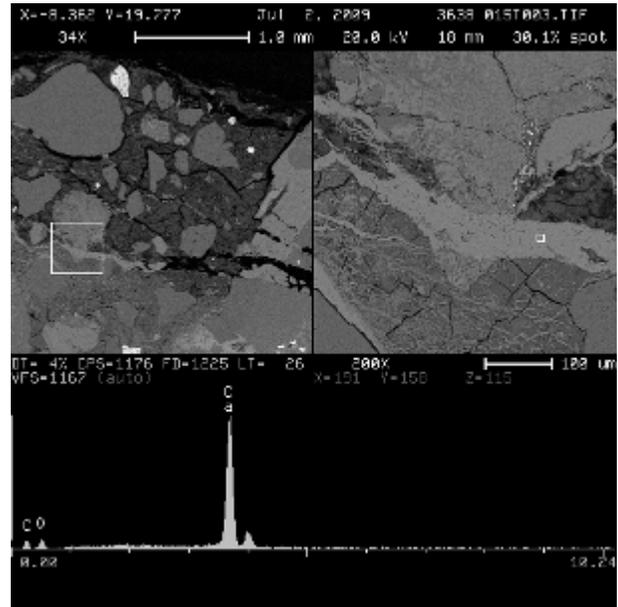
Figure B10 - North Pier of Memorial Bridge, 1-1, RJLG ID 3638015T. SEM images with EDS spectrum showing calcium carbonate in the crack.

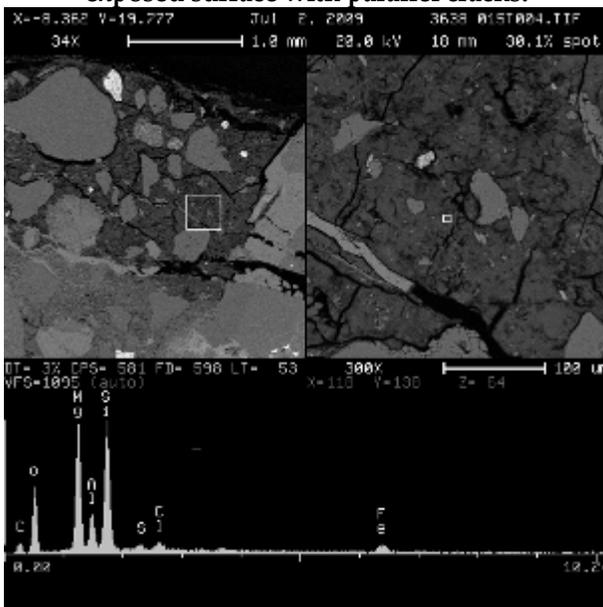
At the exposed surface, there were cracks parallel to the surface and a portion of the cement paste was converted to magnesium silicate, which has no strength (see Figure 3). Calcium carbonate, magnesium hydroxide (see Figure 4), and ettringite (see Figure 5) were found in the cracks near the exposed surface. Ettringite is a sign of external sulfate attack, whereas the calcium carbonate and magnesium hydroxide result from exposure to seawater.

Figure B11 - North Pier of Memorial Bridge, 1-1, RJLG ID 3638015T. SEM images with EDS spectrum showing decalcified CSH converted to magnesium silicate with aluminum.

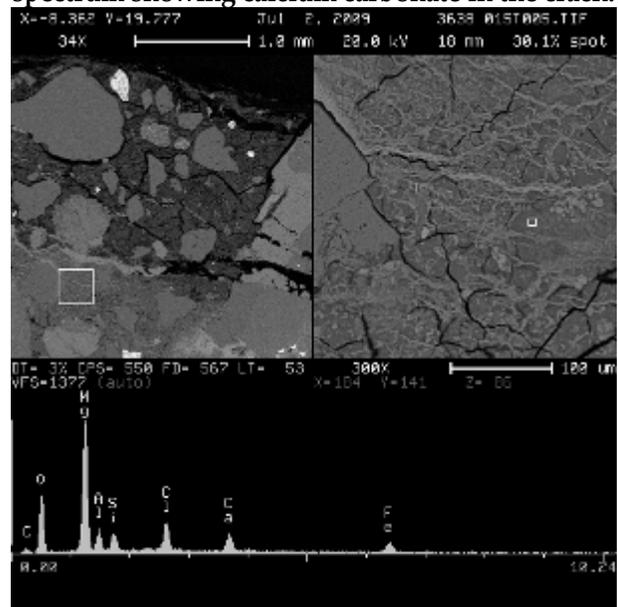
Figure B12 - North Pier of Memorial Bridge, 1-1, RJLG ID 3638015T. SEM images with EDS spectrum showing CSH rich in magnesium and chloride.

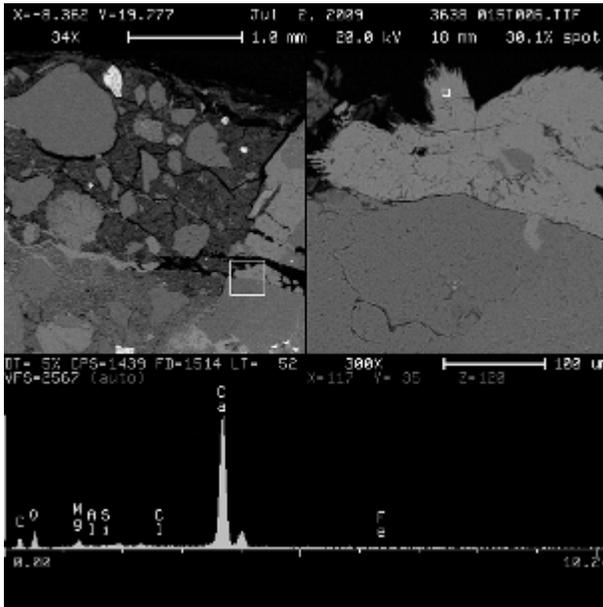
Figure B13 - North Pier of Memorial Bridge, 1-1, RJLG ID 3638015T. SEM images with EDS spectrum showing the composition of vaterite form of calcium carbonate.

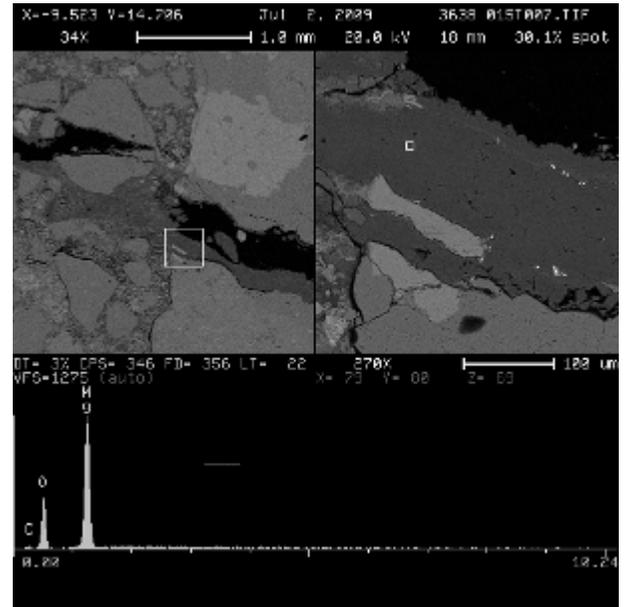
Figure 4 - North Pier of Memorial Bridge, core #1-1 (RJLG ID 3638015T). SEM image showing crystalline magnesium hydroxide (Brucite) in a crack.

Figure B14 - North Pier of Memorial Bridge, 1-1, RJLG ID 3638015T. SEM images with EDS spectrum showing the composition of magnesium hydroxide (brucite) in crack.

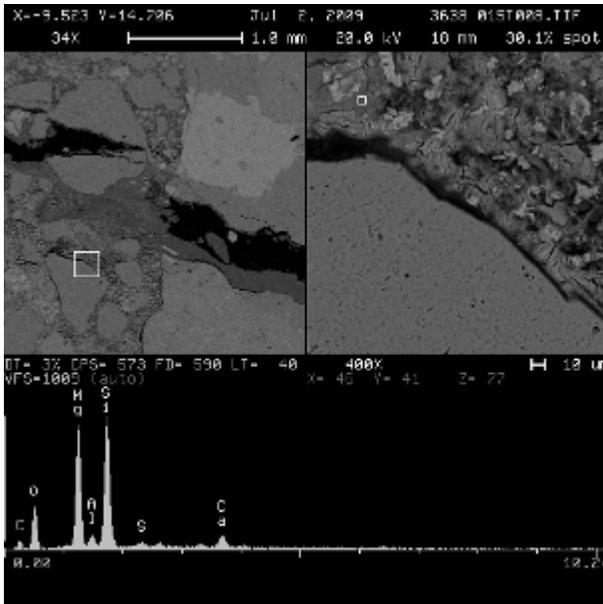
Figure B15 - North Pier of Memorial Bridge, 1-1, RJLG ID 3638015T. SEM images with EDS spectrum showing CSH converted to magnesium silicate with aluminum.

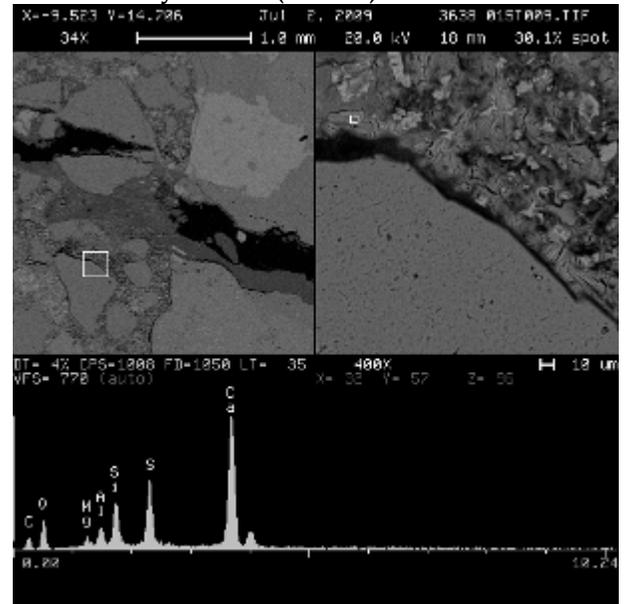
Figure B16 - North Pier of Memorial Bridge, 1-1, RJLG ID 3638015T. SEM images with EDS spectrum showing the composition of thaumasite. The majority of the material lining the crack is ettringite, as seen in Figure B17.

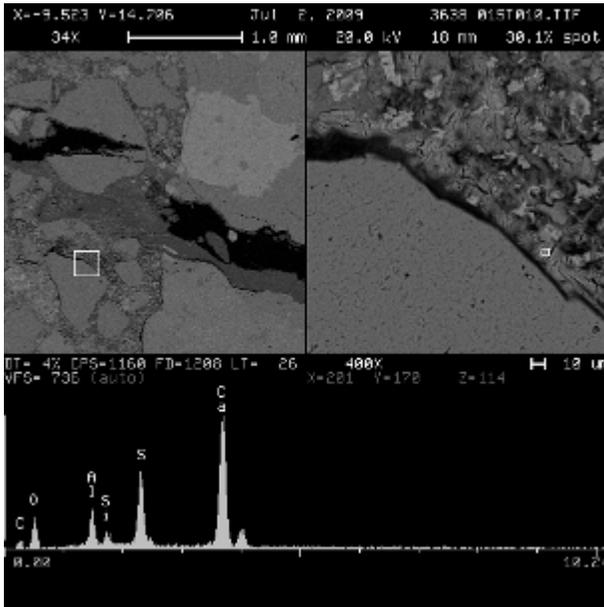
Figure B17 - North Pier of Memorial Bridge, 1-1, RJLG ID 3638015T. SEM images with EDS spectrum showing the composition of ettringite in a crack.

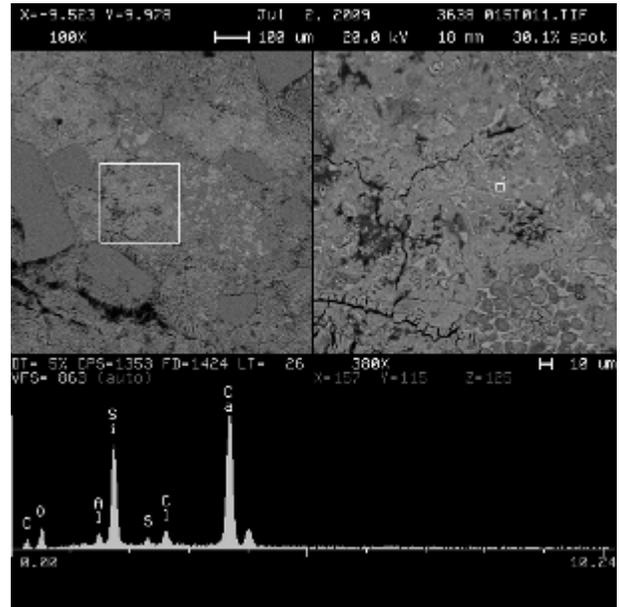
Figure B18 - North Pier of Memorial Bridge, 1-1, RJLG ID 3638015T. SEM images with EDS spectrum showing the composition of CSH with traces of sulfur and chloride.

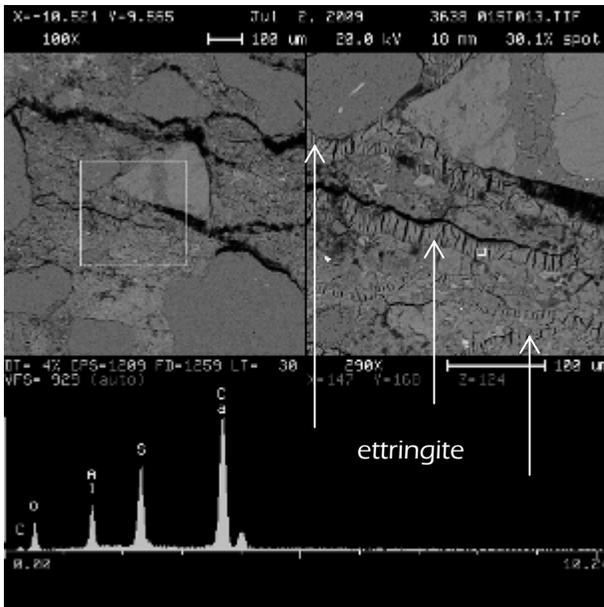
Figure B19 - North Pier of Memorial Bridge, 1-1, RJLG ID 3638015T. SEM images with EDS spectrum showing the composition of ettringite in crack.

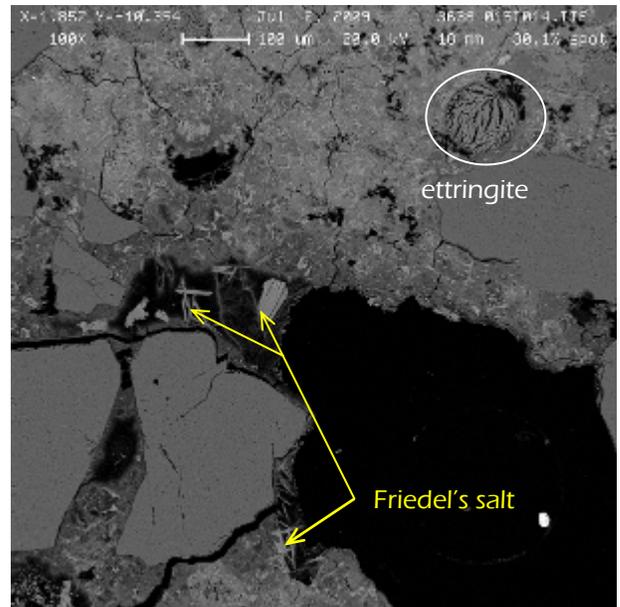
Figure B20 - North Pier of Memorial Bridge, 1-1, RJLG ID 3638015T. SEM image showing Friedel's salt crystals and ettringite in an air void (near bottom of section).

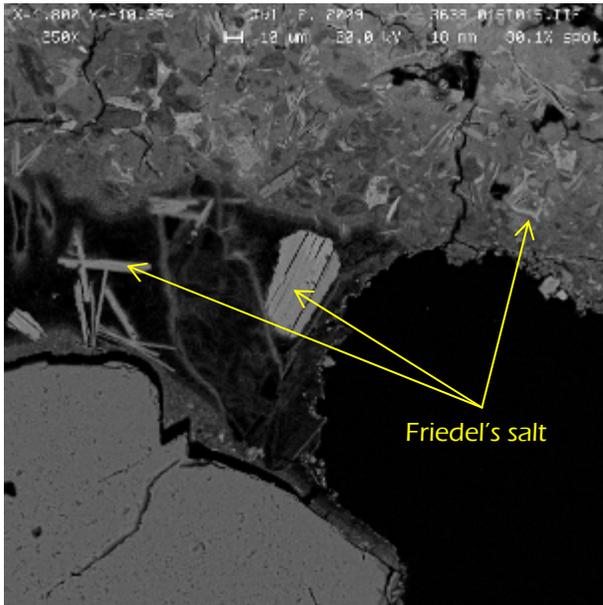
Figure B21 - North Pier of Memorial Bridge, 1-1, RJLG ID 3638015T. SEM image showing Friedel's salt in crack (also smaller crystals in paste).

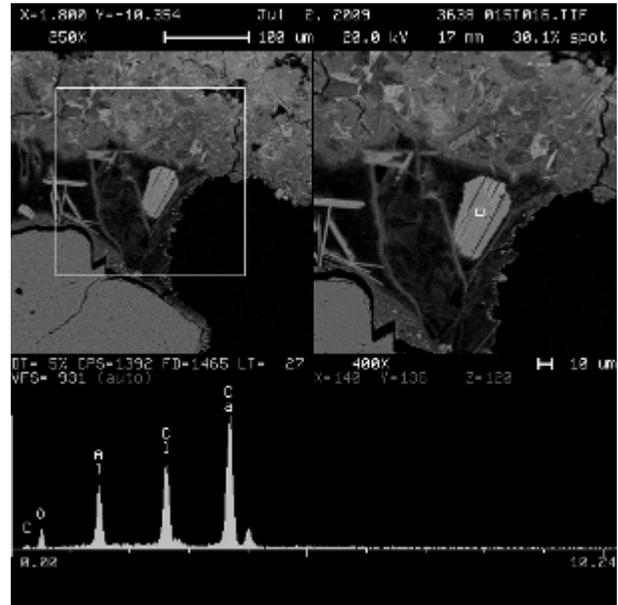
Figure B22 - North Pier of Memorial Bridge, 1-1, RJLG ID 3638015T. SEM images with EDS spectrum showing the composition of Friedel's salt.

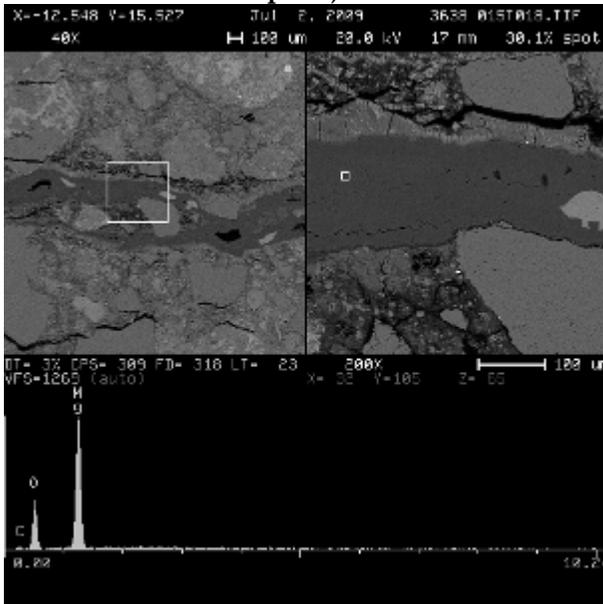
Figure B23 - North Pier of Memorial Bridge, 1-1, RJLG ID 3638015T. SEM images with EDS spectrum showing the composition of crystalline magnesium hydroxide. This is the same location as seen in Figure B5.

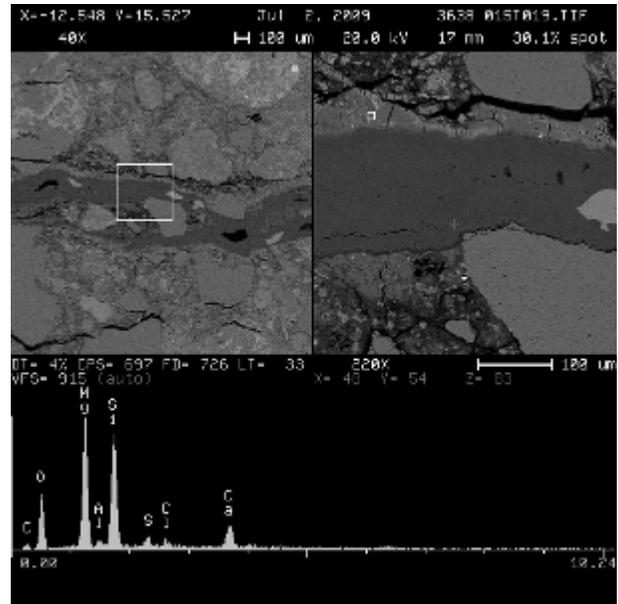
Figure B24 - North Pier of Memorial Bridge, 1-1, RJLG ID 3638015T. SEM images with EDS spectrum showing CSH converted to magnesium silicate with trace of aluminum. This is the same location as seen in Figure B5.

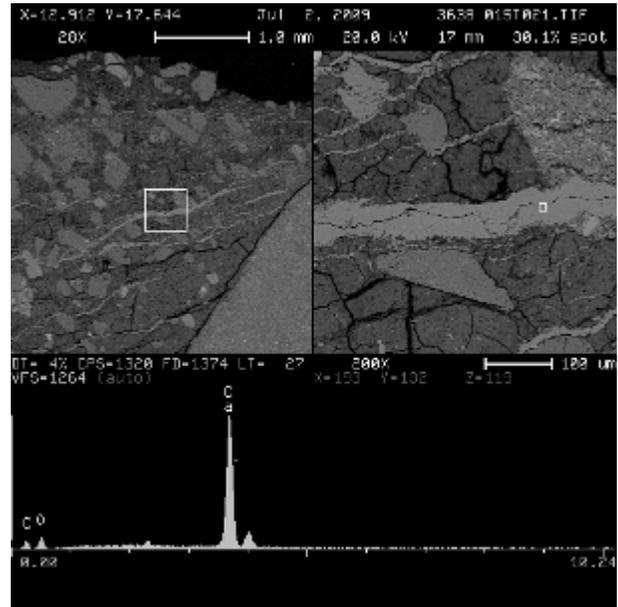
Figure B26 - North Pier of Memorial Bridge, 1-1, RJLG ID 3638015T. SEM images with EDS spectrum showing the composition of calcium carbonate in crack at the exposed surface.

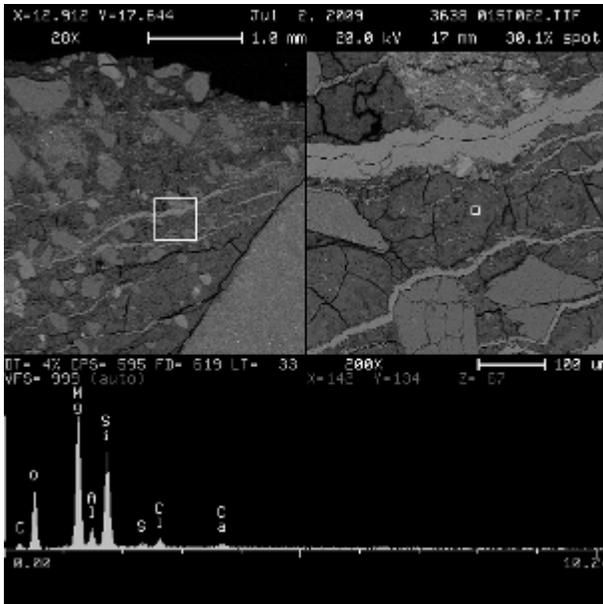
Figure B27 - North Pier of Memorial Bridge, 1-1, RJLG ID 3638015T. SEM images with EDS spectrum showing CSH converted to magnesium silicate with aluminum.

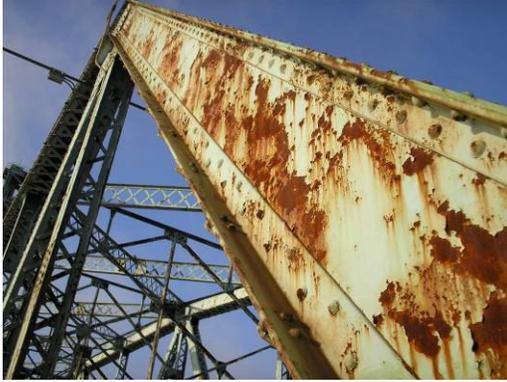
Photograph 1 – Top chord portal

The coating system applied to the bridge steel was in poor condition. Approximately 50% corrosion was observed over the surfaces of the steel members. The above deck portions on the truss spans were in poor condition. Corrosion was observed in the splash zone as well as the upper truss members.

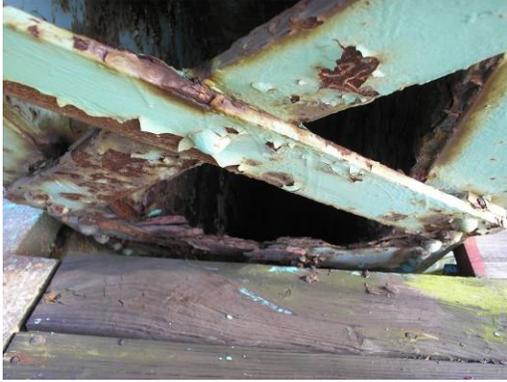
The interior portions of the box members were in poor condition, with the amount of corrosion similar to the exterior portions. Pack rust was observed at the lattice bar connections. Section loss was observed on some of the rivet heads.

Photograph 5 – Corrosion on lattice

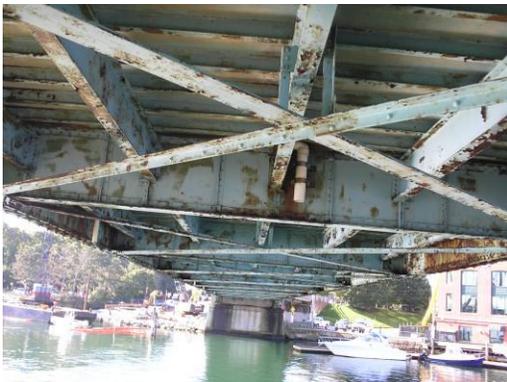
Photograph 7 – Below deck on fixed truss

The coating on the below deck members was in poor condition. Increased corrosion levels were observed under the open grating deck portions of the lift span. Areas of pack rust, pitting, and section loss were observed on the stringers and floor beams. Section loss was observed on some of the rivet heads and stratified corrosion was noted on the bearing pin nuts.

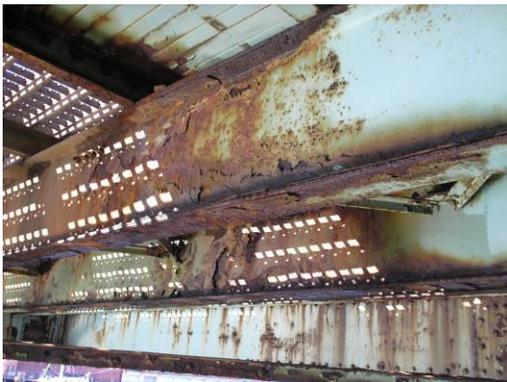
Photograph 9 – Corrosion on stringer

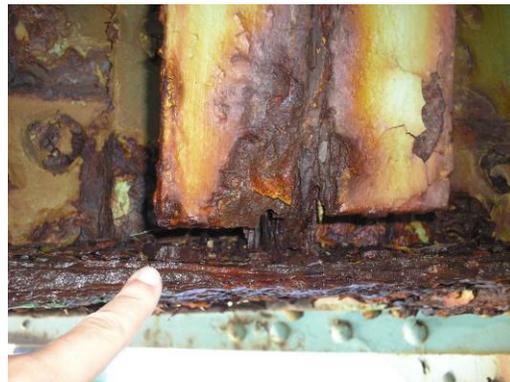
Photograph 10 – Section loss at floor beam

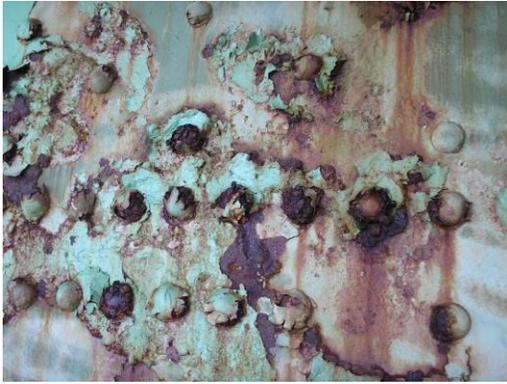
Photograph 11 – Section loss on rivets

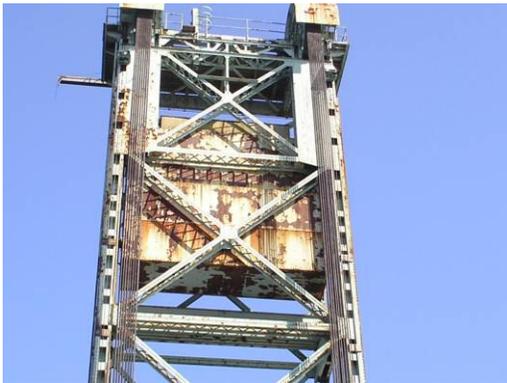
Photograph 13 – Tower and counterweight

The lift span towers were in poor condition overall. Corrosion was observed on the tower members as well as the mechanical portions located on top of the towers.

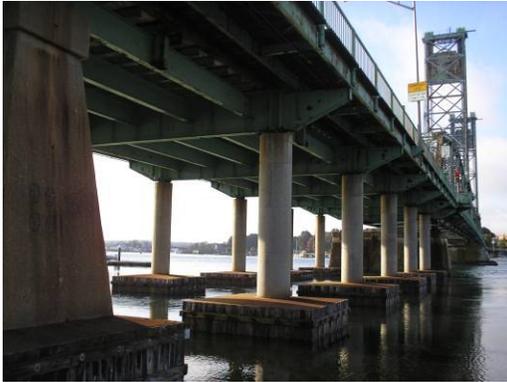
Photograph 17 – Kittery approach

The Kittery approach spans were in poor condition overall. Corrosion was observed to be increased on the fascia members and on the steel members adjacent to the deck drains.

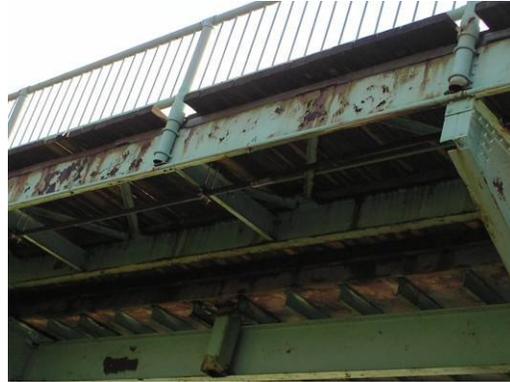
Photograph 18 – Fascia corrosion

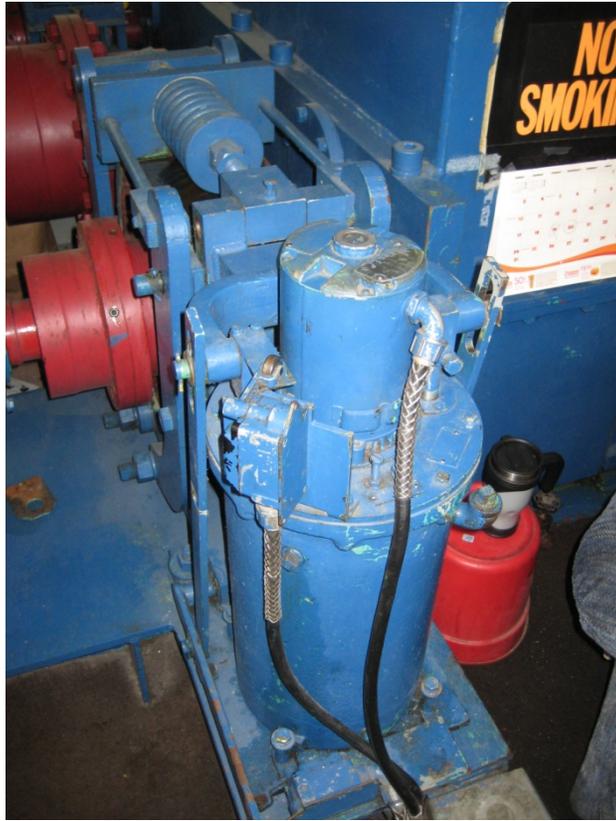
Despite the good condition of the thruster brakes, it should be considered that the brakes are obsolete GE brakes and are no longer commercially available products (See photo M-1). Acquisition of spare or replacement parts may not be readily available in the event that any of the brake components fail. Minor work on the thruster brakes would consist of leaving the thruster brakes as is, considering their acceptable condition. The moderate and major work on the thruster brakes would be a complete replacement of the entire thruster brake with a new thruster brake of the same capacity.

Photo M-1: The thruster brakes are old style GE brakes and are no longer commercially available products.

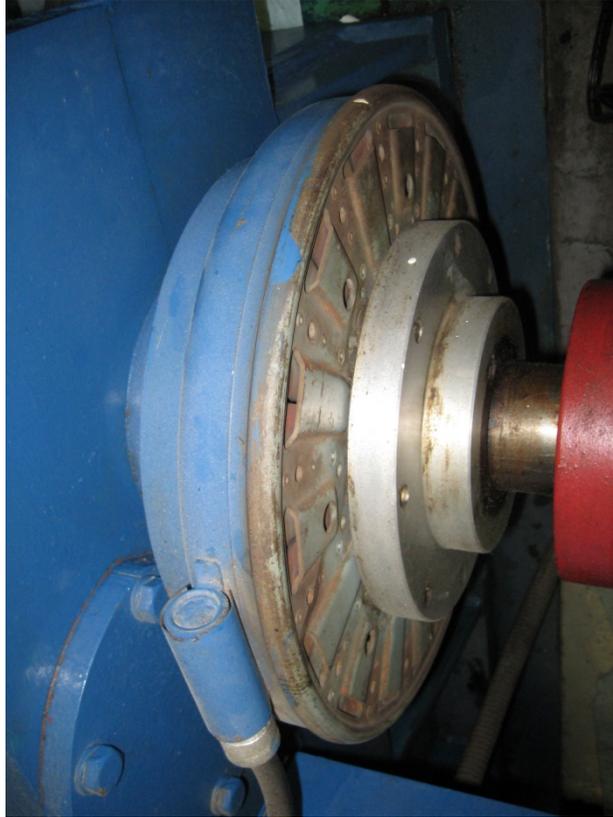
The electro-magnetic disc brakes are in similar condition and situation as the thruster brakes (See photo M-2). The electro-magnetic disc brakes function properly but are of an outdated model and may suffer from a lack of availability of replacement parts. Another issue presented by the electro-magnetic disc brakes is that they are of a lesser capacity than the thruster brakes and bridge staff have indicated that they have had issues in the past related to the use of the electro-magnetic brakes in stopping the movable span.

The current brake arrangement also does not meet the requirements of the AASHTO movable bridge design code (2008 ed. 5.6.1) which states that mechanically operated bridges shall utilize two sets of brakes. One set, the motor brakes, shall be located on the motor input shaft. The other set of machinery brakes, shall be located as close to the operating ropes as possible. Ideally, one of the existing sets of brakes should be moved closer to the operating rope drums to be compliant with the recommendation of the AASHTO movable bridge design code. Practically, this course of action is not feasible given then existing machinery layout. A brake moved closer to the driving pinion would be of significantly greater capacity and cost. The available space in the machinery room also prohibits the placement of a significantly larger brake.

Photo M-2: The electro-magnetic disc brakes are old and are no longer commercially available products.

A similar course of action as the thruster brake is recommended for the electro-magnetic disc brakes. The minor and moderate rehabilitation alternatives assume no corrective action for the mechanical work on the electro-magnetic disc brakes. The major rehabilitation work assumes a complete replacement of the electro-magnetic disc brakes as part of the total replacement of the movable span.

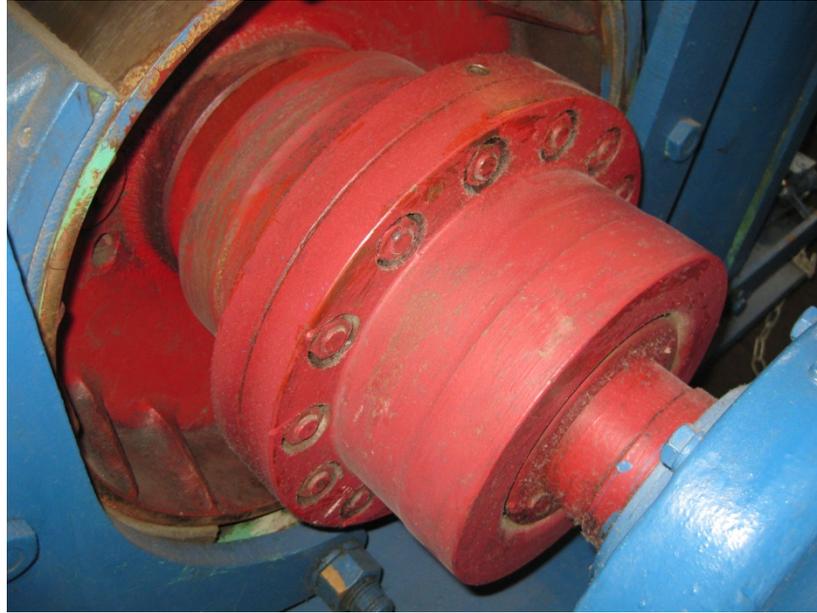
Photo M-6: It should be noted that the motor couplings C1 and C2 are gear type couplings.
