**IN-DEPTH INSPECTION AND CONDITION REPORT
FOR THE
PORTSMOUTH MEMORIAL BRIDGE
OVER THE PISCATAQUA RIVER**

October 2009

VOLUME 2 OF 2

Underwater Inspection Report

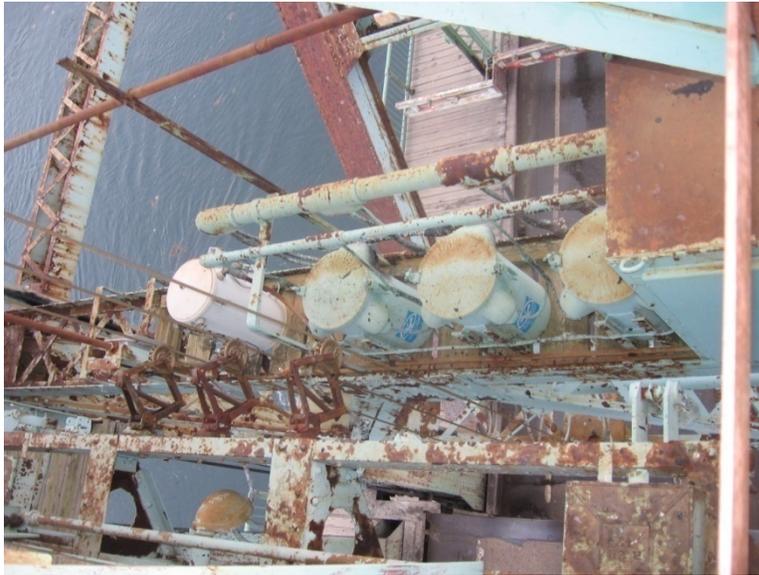
Photo E-1: Catenaries are problematic since they ice up in the winter and local switching is required to provide heating power from the transformers that are installed on the top of the bridge truss level at the south end to melt the ice

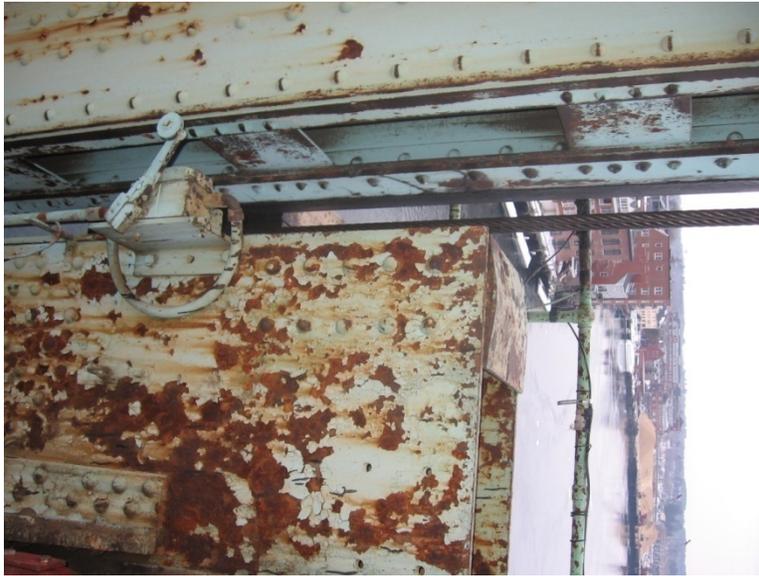
Photo E-9: Many of the existing lever arms limit switches normally used for span full open and over travel indication switches are not functional
