Paint Evaluation Report

**COATING CONDITION ASSESSMENT
OF PORTSMOUTH-KITTERY
MEMORIAL BRIDGE
PROJECT NO. 13678-E**

November 20, 2009

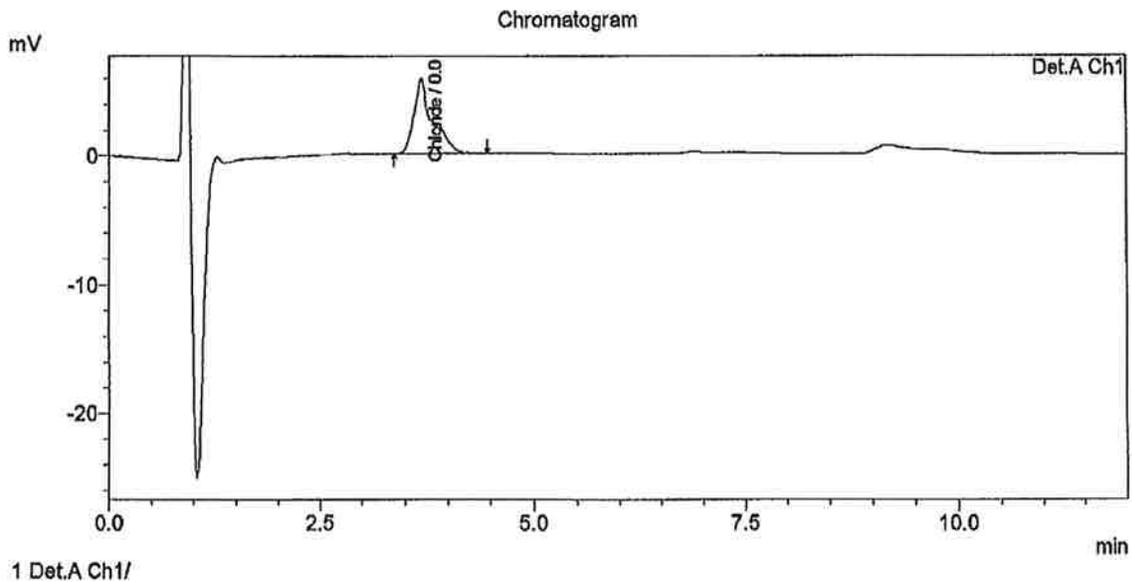
Sample Name : KTA-13 HDR
 Sample ID : UNK-0007
 Injection Volume : 25 uL
 Data Filename : 290673-5.lcd
 Method Filename : IC method.lcm

Detector A					
ID#	Name	Ret. Time	Area	Conc.	
1	Phosphate	0.000	0	0.000	
2	Chloride	3.693	87792	0.000	
3	Nitrite	0.000	0	0.000	
4	Bromide	0.000	0	0.000	
5	Nitrate	0.000	0	0.000	
6	Sulfate	0.000	0	0.000
