### NOTES ON THE CARTLAND HOUSE LEE, NEW HAMPSHIRE

JAMES L. GARVIN

JULY 24, 2007

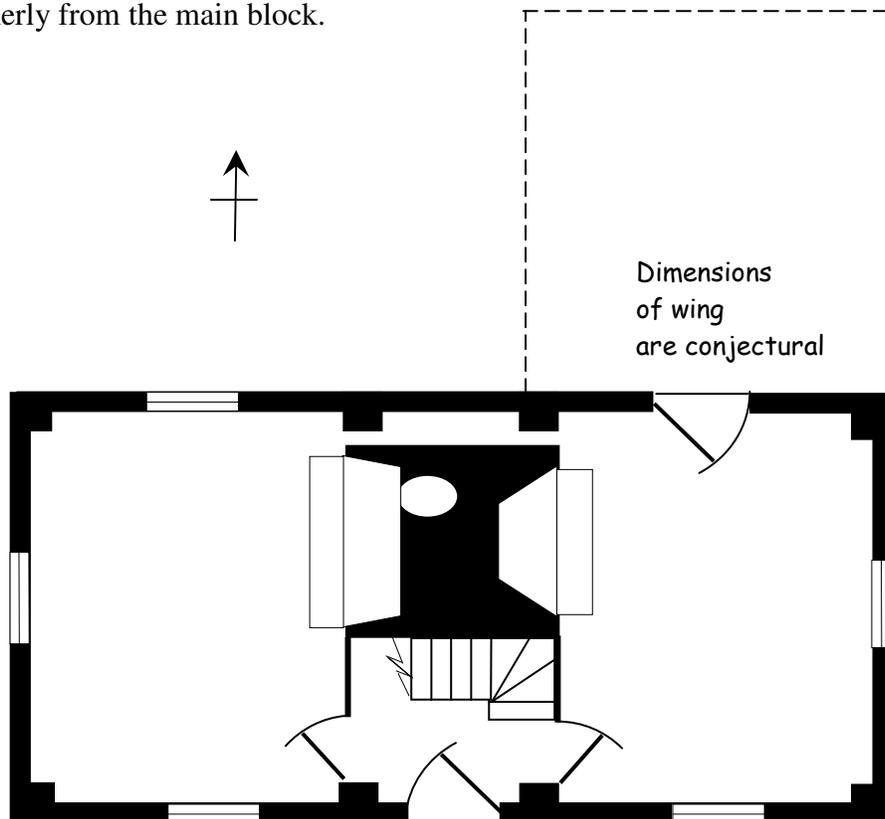
To judge from the remaining roof frame, the original Cartland House was a two-story, center-chimney dwelling, one room deep. The house faced south, and the eastern end of the roof frame indicates that the building had a hip and that it was L-shaped in plan, as shown below. There is no way to determine whether the house had a second chimney at some location in the wing that extended northerly from the main block.

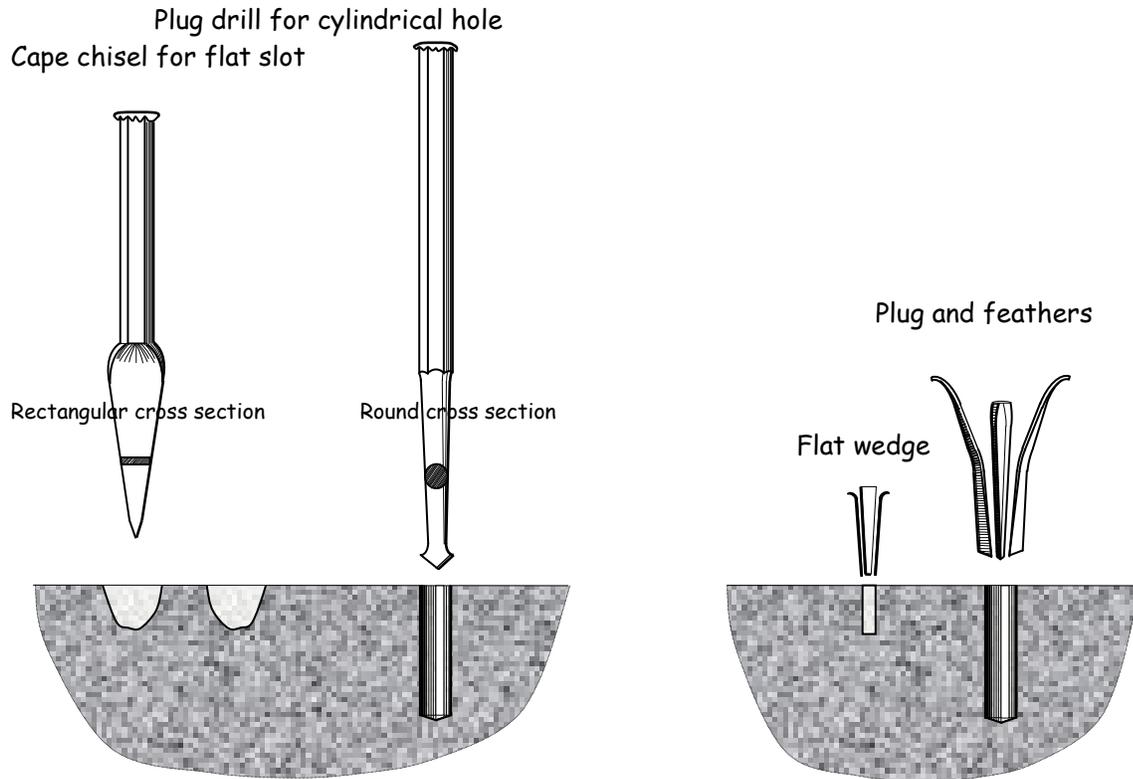
As shown below, the use of the plug drill and plugs-and-feathers creates a distinctive mark at the edges of the split stone, easily differentiated from the flat indentations made by the older method of chiseling a line of flat slots in the stone and inserting flat iron or steel wedges.

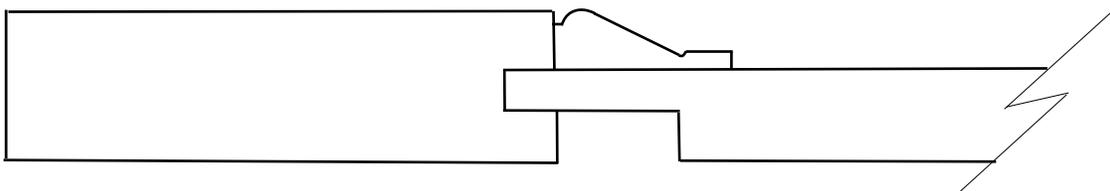
On the interior, the doors that lead from the small stairhall of entry display a characteristic Greek Revival cross-section, as shown below.
