**New Hampshire Bureau of Turnpikes
Renewal and Replacement Program Assessment**

May 16, 2017

Re: 2017 Renewal and Replacement Program Assessment

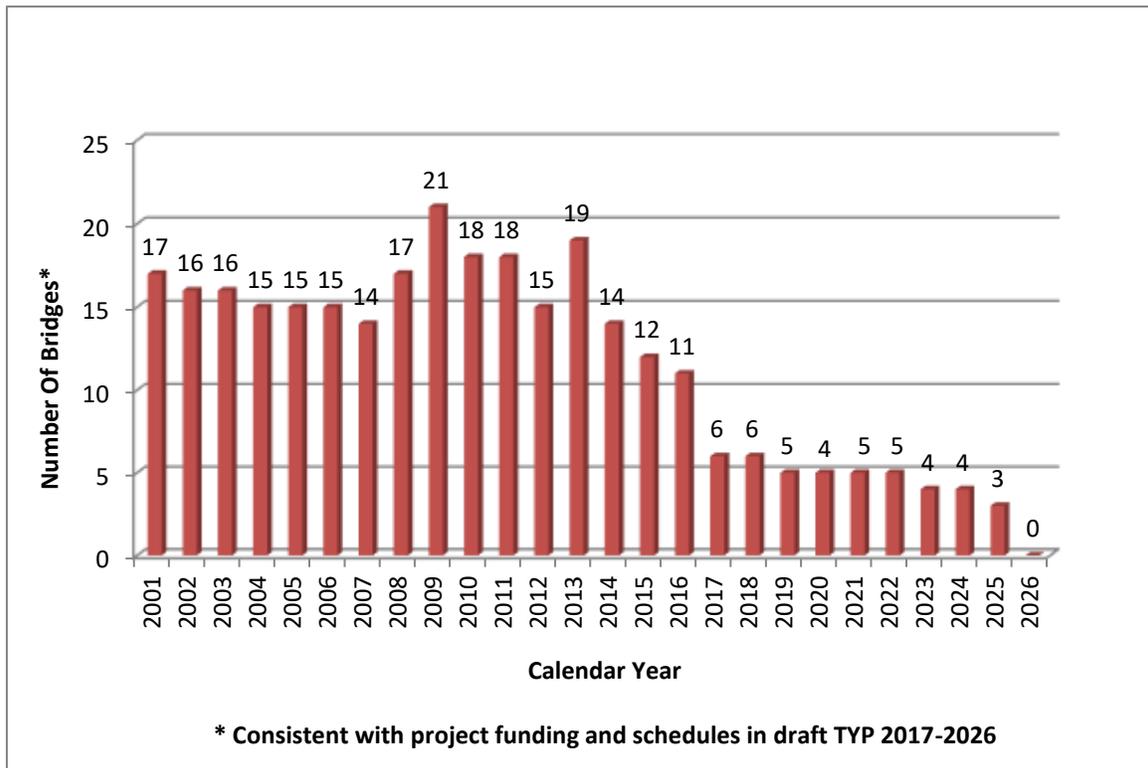
Figure 15: Turnpike Red List Bridges

These funding sources mainly focus on bridges with moderate to severe deficiencies (i.e., NBI ratings of 6 or less). HNTB developed a list of Bureau bridges that fell under this umbrella (54 bridges); refer to the table in Appendix C. The 54 bridges listed include fourteen CIP bridges, six Red List bridges, and 12 Near Red List bridges. All current Red List bridges will be replaced/rehabilitated by FY 2026 in the current CIP schedule; refer to Figure 15. These bridges are already funded and therefore have been excluded from R&R level repairs. Bridge Maintenance Operations has completed work as straight forward as joint repairs to more extensive deck replacements. Bridge Maintenance Operations also completes preservation efforts such as bridge washing every year.
