Barron Mountain
Rock Reinforcement Evaluation – Phase II
I-93, Woodstock, New Hampshire
Validation of NDT Results for Condition Assessment of
Rock Reinforcements

1. Report No. FHWA-NH-RD-14282C		2. Gov. Acc. No.	3. Recipient's Catalog No.
4. Title and Subtitle PHASE II: CONDITION ASSESSMENT AND EVALUATION OF ROCK REINFORCEMENT ALONG I-93 BARRON MOUNTAIN ROCK CUT, WOODSTOCK, NH Validation of NDT Results for Condition Assessment of Rock Reinforcements		5. Report Date SEPTEMBER, 2005

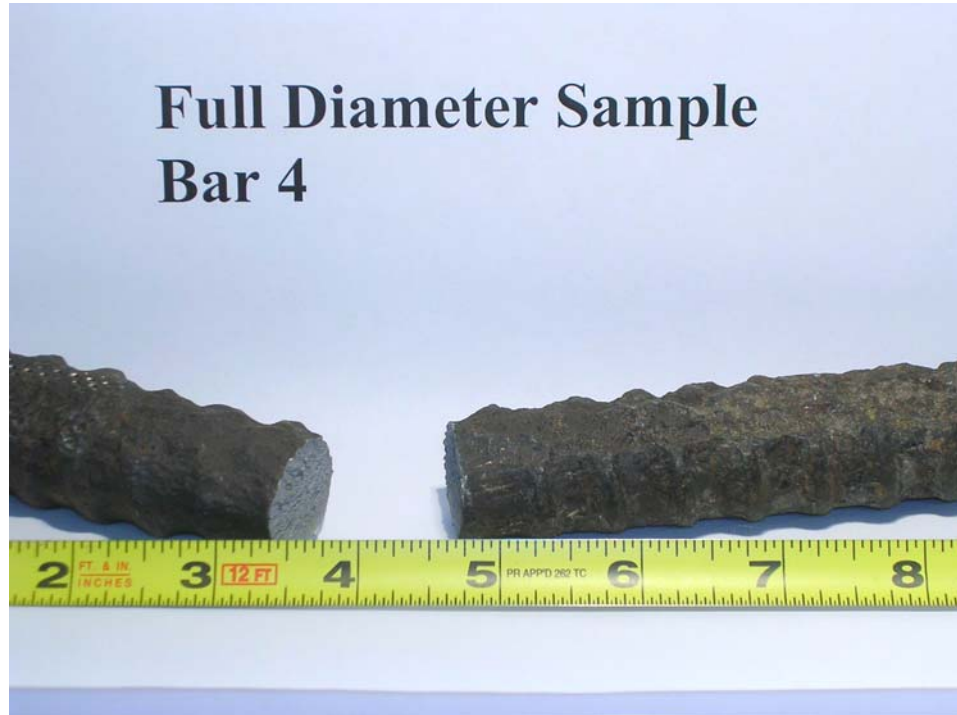
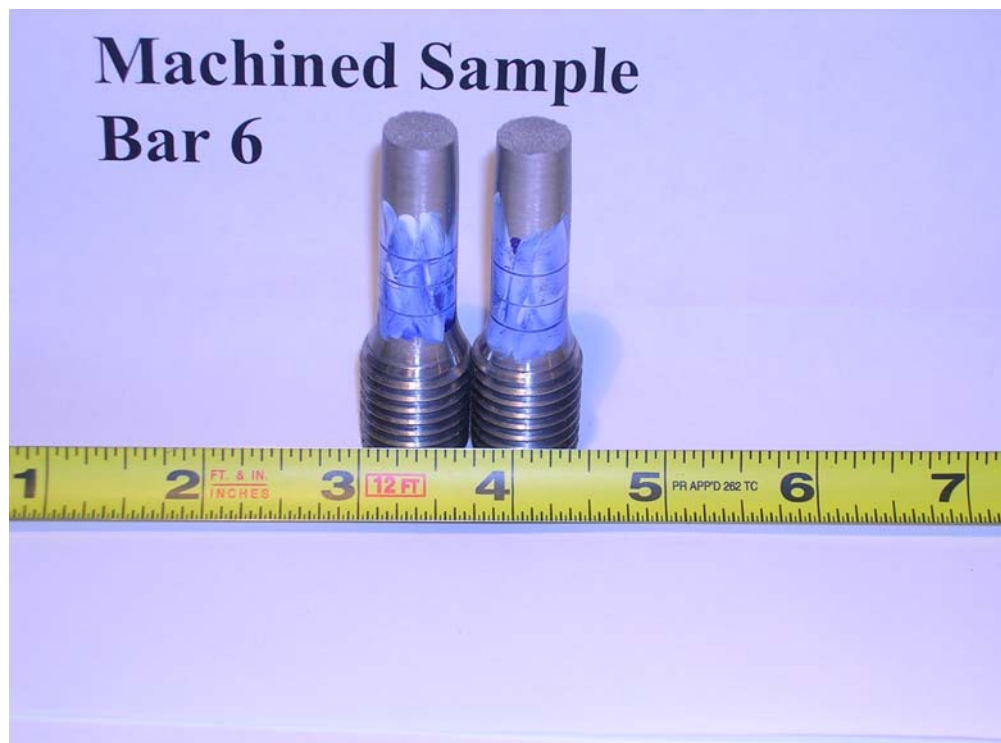
Figure 10. Tension Test Specimens

Full specimens had a lower strain at break compared to the machined specimens, and the break occurred near the grips used to secure the ends of the specimen. This may have affected the measurement of strain for the full sections because the break did not occur between the gage points. The machined specimens broke near the middle of the specimens. Otherwise, similar results were obtained from the full and machined sections. With one exception, the strength data are consistent with the specifications for Dywidag Grade 150 thread bar (ASTM A722 steel). Specimen 16A, had a larger strain at break compared to the other specimens and a yield stress below expectations. The ultimate tensile stress for Specimen 16A was consistent with the other samples. A possible explanation for the discrepancy is that specimen 16A was weakened from intergranular corrosion as evidenced from the SEM examination of the fracture surface for this bolt and described in the preceding section. Figures 11 (a) and (b) depicts the stress strain curve for specimen 16A compared to a typical stress-strain curve obtained for the thread bar.

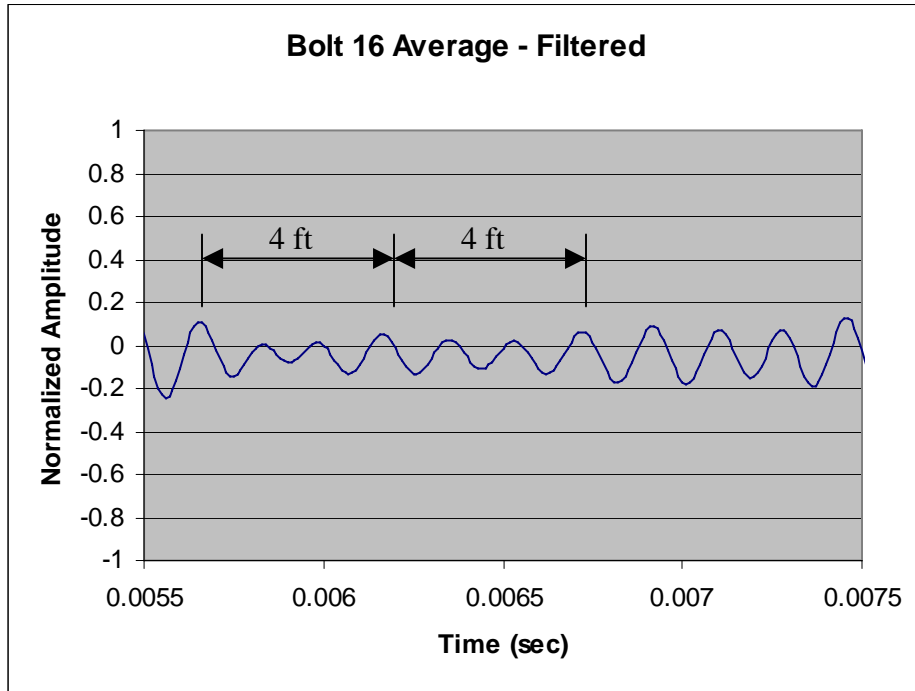
(c) Rock Bolt – MMCE #16

Evaluation of test data from MMCE #16, as shown in Figure 12 (c), indicates that a preexisting fracture surface at four feet from the proximal end of the bolts may be evident in the impact test data. However, these reflections are very subtle and could easily be overlooked without knowledge of the existence of this fracture surface.
