**Conditions Assessment of the  
Old State House  
Concord, New Hampshire**

**CONDITIONS ASSESSMENT REPORT**

Christine Miller

January 2008

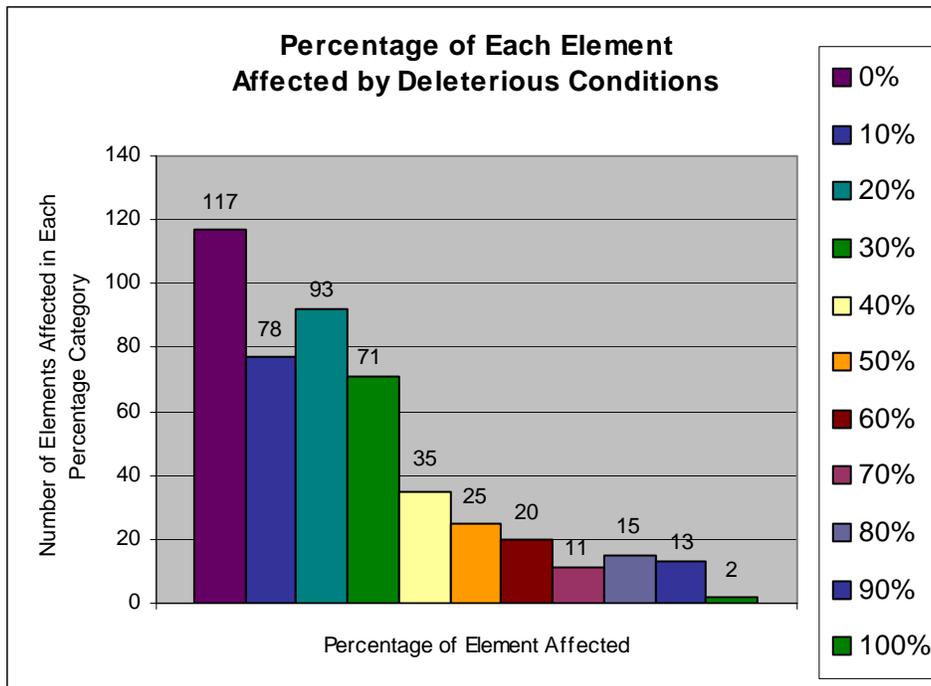
Chart 1 - Percentage of Each Element Negatively Affected by Deleterious Conditions

The goal of recording the percentage of each element that was negatively affected by deleterious condition was to understand the overall condition and integrity of the assemblage or architectural elements. Based on the analysis of this database field, the overwhelming majority of the elements—357 in total, are 0% to 30% affected by deleterious conditions (see Chart 1). Relatively few elements—121 in total—show the deterioration of 40% to 100% of the historic fabric. Overall, the elements retain a high degree of integrity.

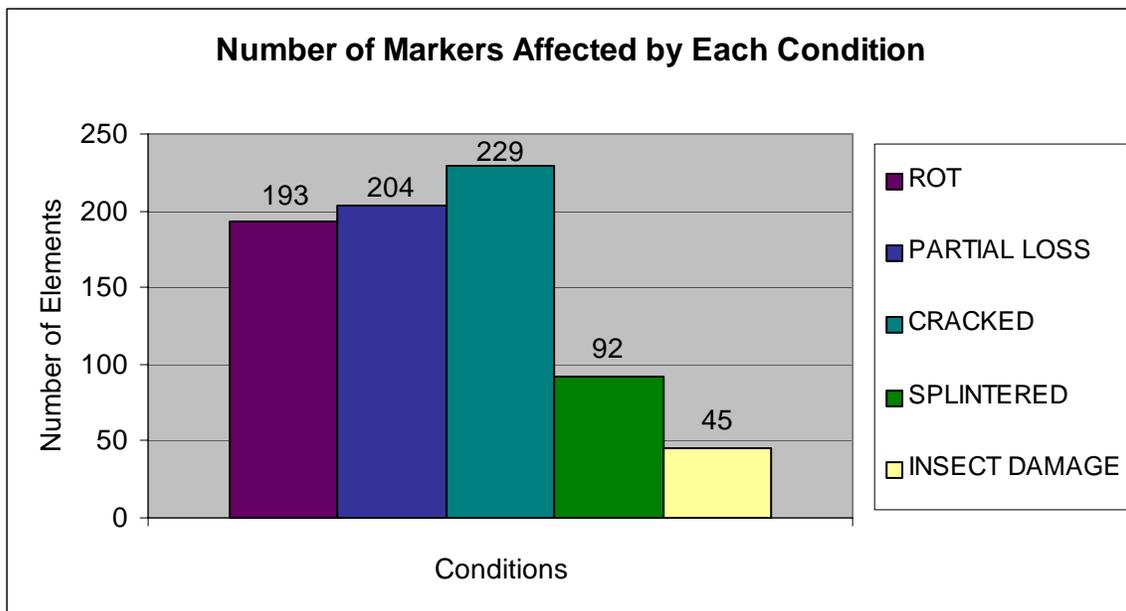
Chart 2 - Number of Markers Affected by Each Condition

The individual conditions were inventoried during the assessment and analyzed (see Chart 2). The most common condition recorded was cracked wood (229 elements), followed by partial loss (204 elements), and rot (193 elements). Splintered wood and insect damage only affected 92 and 45 elements, respectively.

Although not quantitatively analyzed for this assessment, qualitatively it seemed that nearly all of the exterior wall and roof sheathing elements were cracked due to the weathering those elements endured. Similarly, the rot seemed to primarily affect the structural members, studs, window framing materials, and sheathing elements. Partial loss is a condition that results from other conditions, and was equally present throughout all of the elements. The splintering seemed to be most common throughout the exterior wall and roof sheathing elements. Finally, insect damage seemed to be primarily concentrated in the structural members.
