APPENDIX G

GRANITE SPLITTING TOOLS AND TECHNIQUES

NEW HAMPSHIRE DIVISION OF HISTORICAL RESOURCES

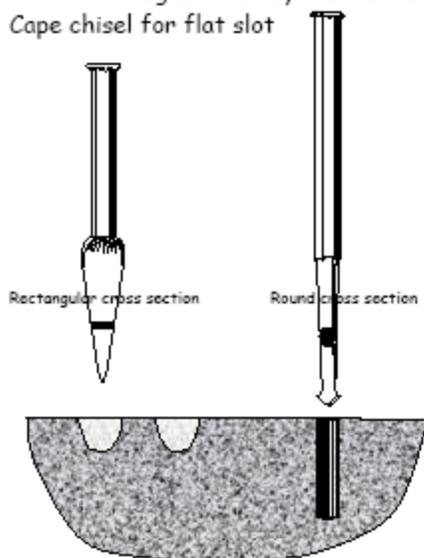
Prior to about 1830, the procedure for splitting granite entailed the cutting of a line of shallow slots in the face of the stone, using a tool called a cape chisel, struck with a heavy hammer. Small, flat steel wedges were placed between shims of sheet iron and driven into these slots, splitting the stone. The new splitting method of circa 1830 used a “plug drill,” which had a V-shaped point and was rotated slightly between each blow of the hammer, creating a round hole two or three inches deep.

Plug drill for cylindrical hole
Cape chisel for flat slot

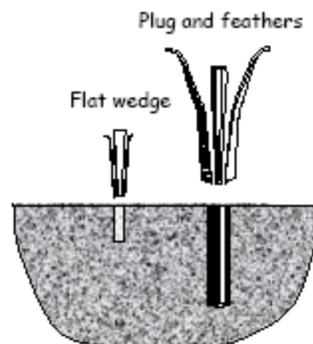
Into this hole were placed a pair of half-round steel shims or “feathers,” and between these was driven a wedge or “plug” which exerted outward pressure and split the stone. The advantage of the “plug-and-feathers” method of splitting was the greater depth within the stone at which the wedges exerted their pressure, thus allowing larger pieces to be split more accurately.

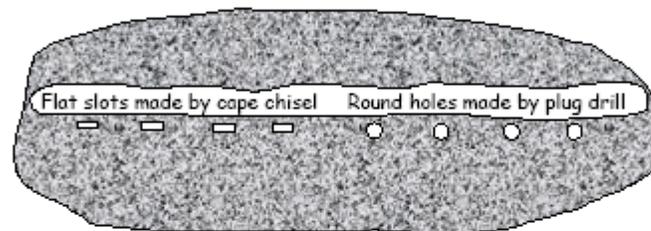
The new splitting technology seems to have spread rather rapidly through the granite quarrying centers of New England, although one is likely to find evidence of both old and new methods being used concurrently in stonework of the 1830s, especially in rural areas. The technique employed on a given stone can usually be seen on the split face, and provides some aid in dating granite masonry. The old, flat-wedge method is marked by a series of slot-like depressions which extend inward an inch or so from the edges of the split stone. The plug-and-feathers method leaves a row of rounded holes, two or three inches deep and usually about six inches apart.

When seen on the surface of a stone that was prepared for splitting but never split, these slots or holes appear as shown below:
