**Report Title**

*Instrumentation, Digital Image Correlation, and Modeling to Monitor Bridge Behavior and Condition*

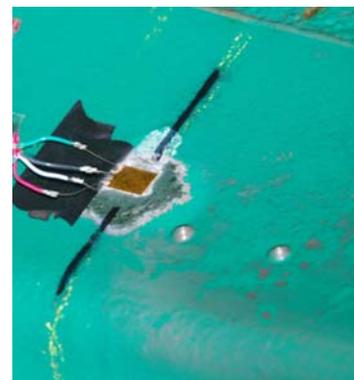
Strain gauge attachment to the exposed metal on the bridge beam

Appropriate, proactive maintenance makes bridges last longer. Engineers need to know how bridge respond to the loads from traffic. Strain gauges are sensors that measure how a bridge responds to a load. A small area of the paint that protects the metal from corrosion must be removed to attach these gauges directly to the metal. This study looked at whether digital cameras could be used to gather the needed data and eliminate impacting the protective paint.

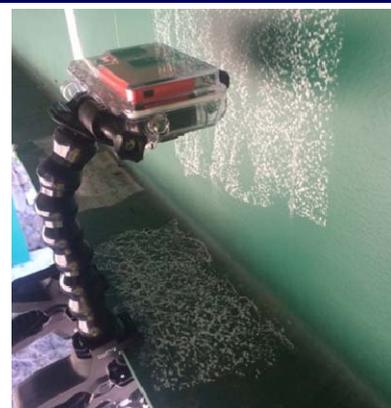
A camera clamped onto the flange of the bridge beam without damage to protective paint

The bridge carrying Bagdad Road over US Route 4 in Durham, New Hampshire was fitted with both strain gauges and GoPro® cameras to determine if off-the-shelf digital cameras could provide accurate measurement of bridge movements. Chalk markings on the bridge allow measurements to be taken from the images. The strain gauge data were compared to measurements from the camera images.

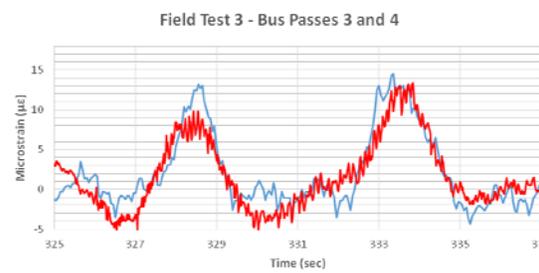
Correlation of measurements between strain gauges (blue) and camera (red)

Cameras are easily clamped onto the bridge and provide data that correlates well with the strain gauge measurements. Removing the camera requires no paint repairs and the chalk easily rinses off.
