REPORT - 30TH APRIL, 2014

STATE OF NEW HAMPSHIRE - DEPARTMENT OF RESOURCES & ECONOMIC DEVELOPMENT

DIVISION OF FORESTS & LANDS

**IMPROVEMENTS AND CONSTRUCTION ADMINISTRATION TO FIRE TOWERS
AND AUXILIARY BUILDINGS IN VARIOUS STATE RESERVATIONS**

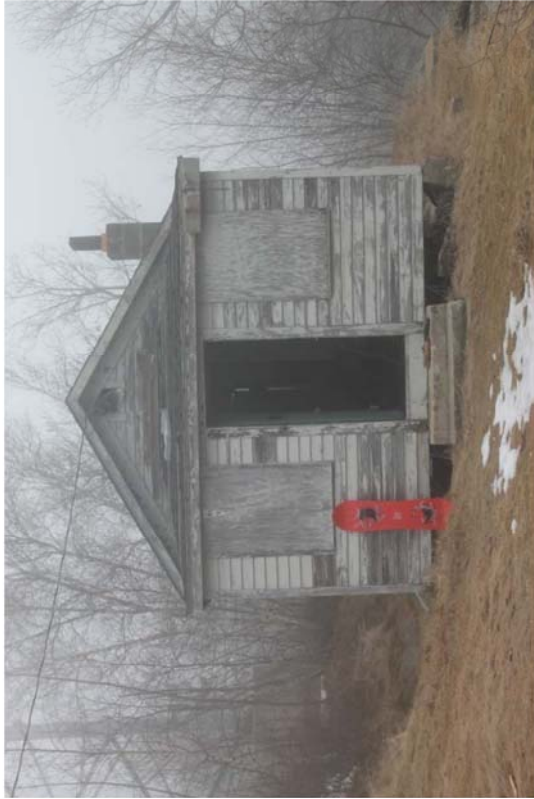
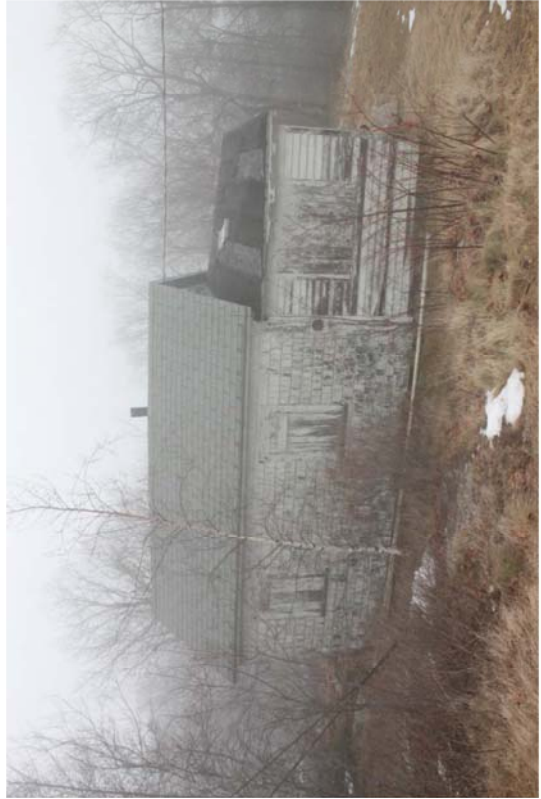
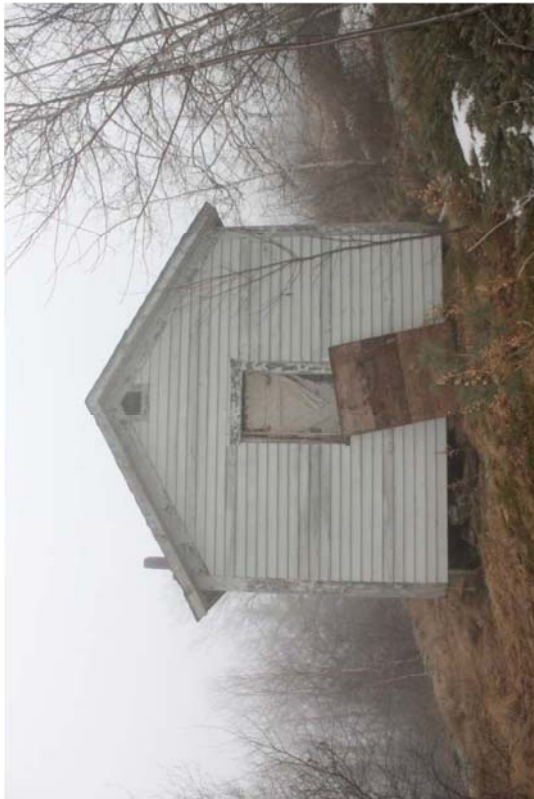
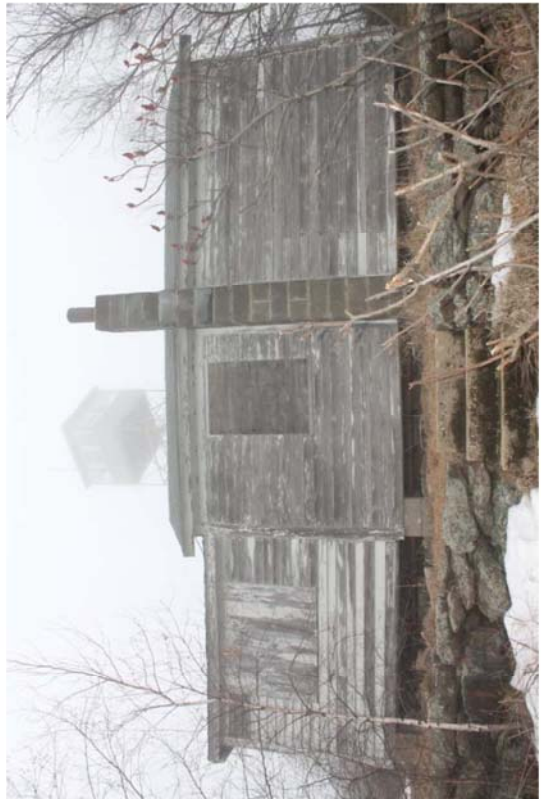
BLUE JOB - WATCHMAN CABIN

date: 16th January, 2014 - weather conditions: overcast, poor visibility, approx. 20 degrees F.

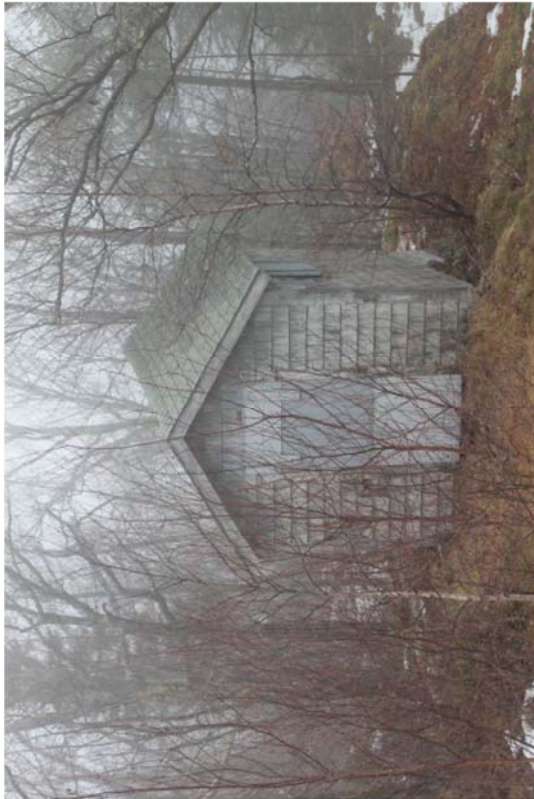
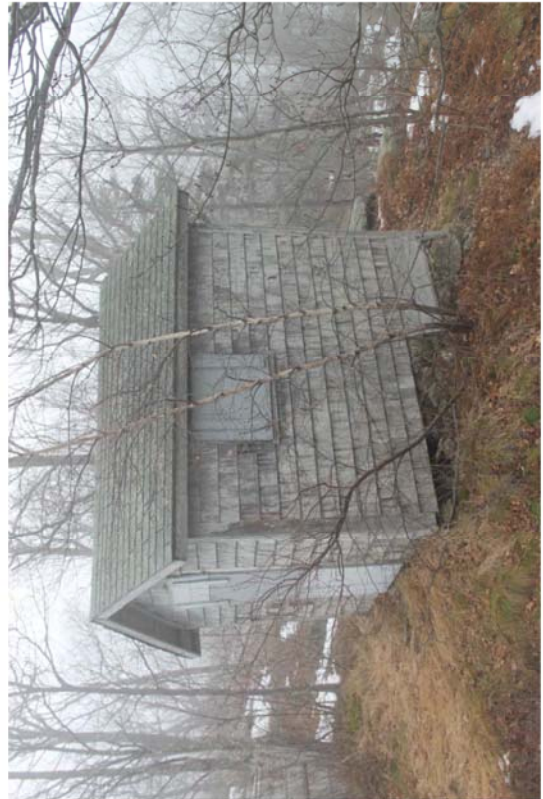
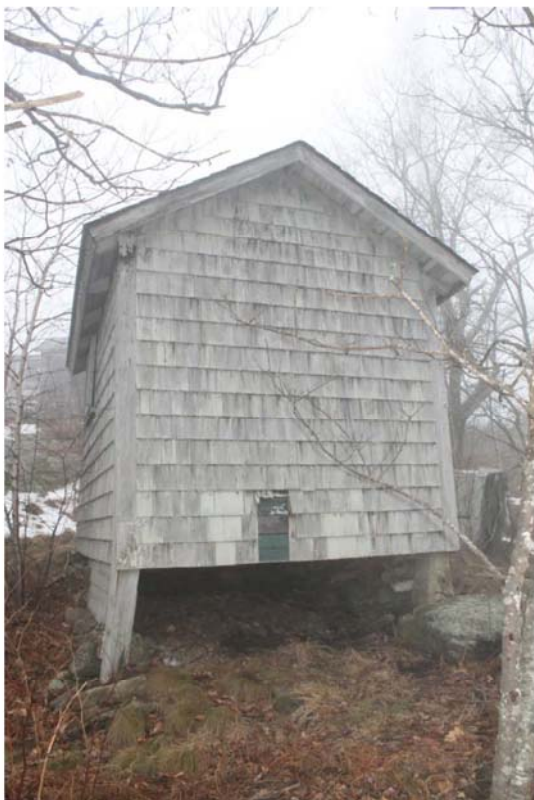
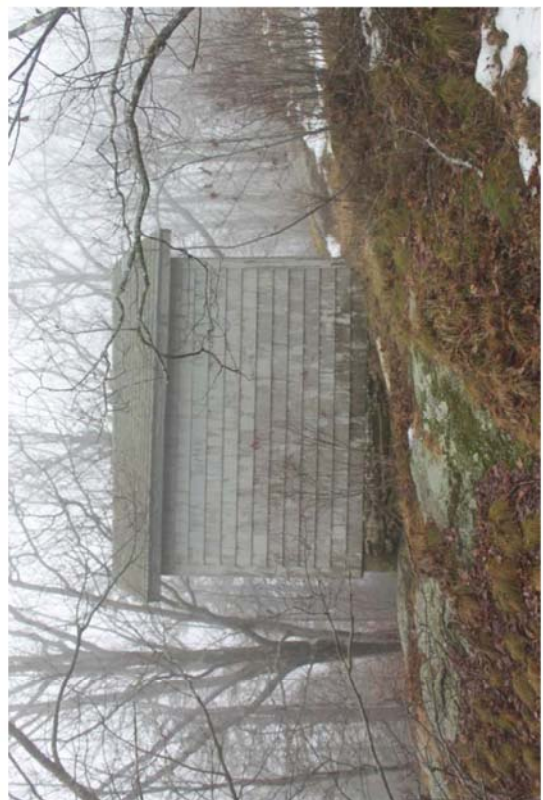
BLUE JOB - STORAGE / WOOD SHED

date: 16th January, 2014 - weather conditions: overcast, poor visibility, approx. 20 degrees F.

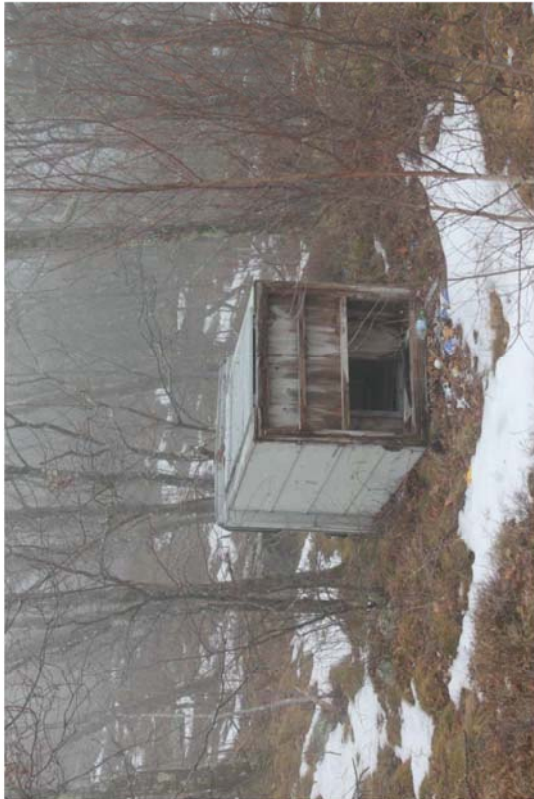
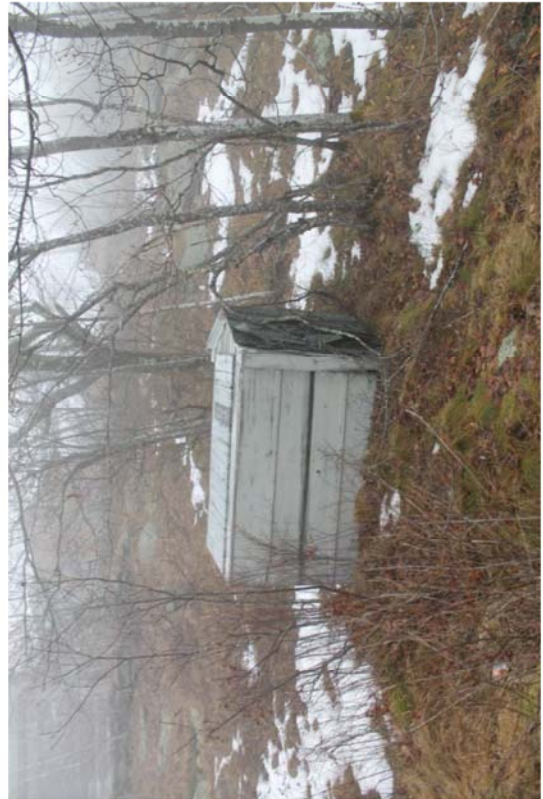
BLUE JOB - OUTHOUSE

date: 16th January, 2014 - weather conditions: overcast, poor visibility, approx. 20 degrees F.

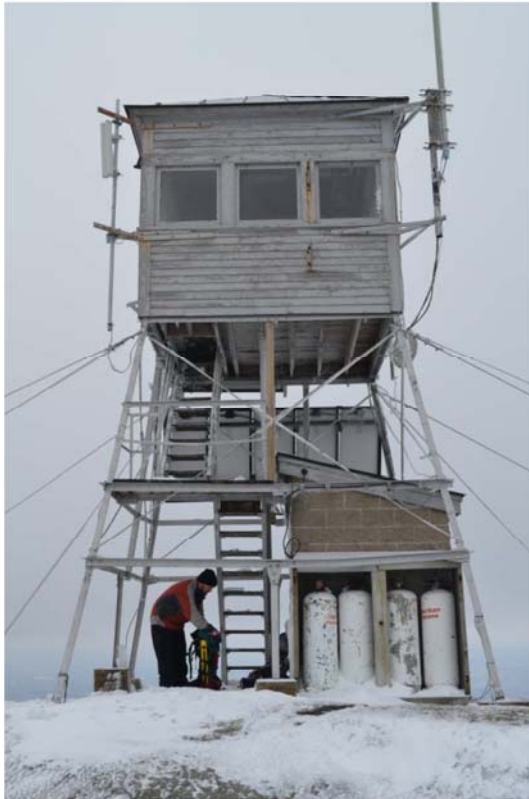
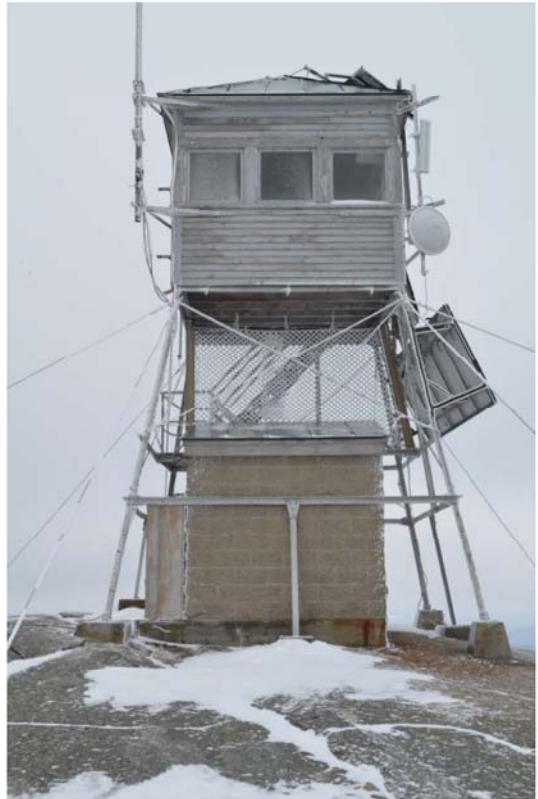
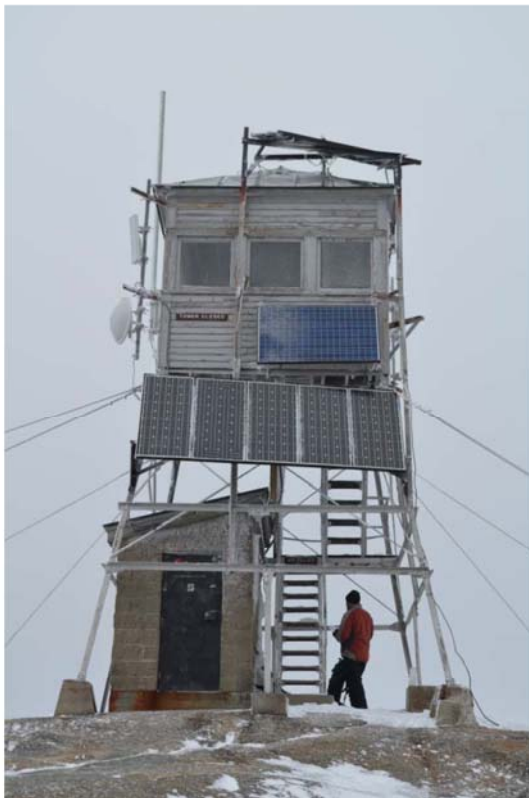
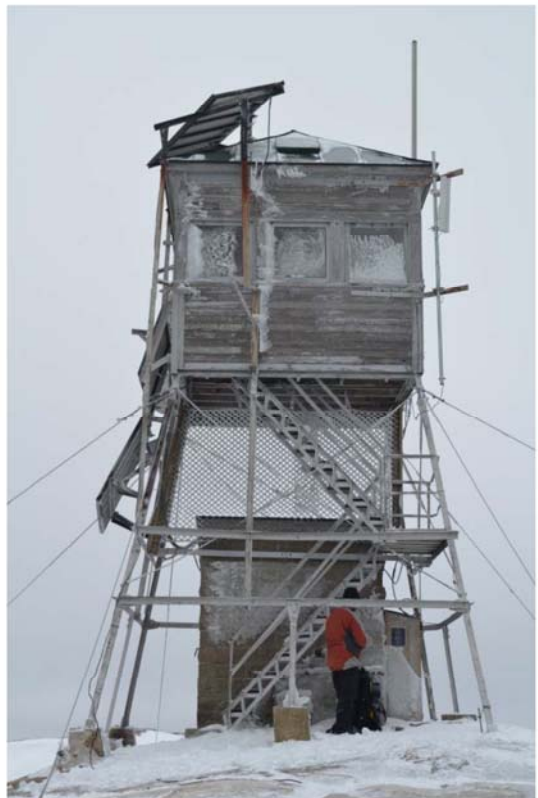
CARDIGAN MOUNTAIN (Orange)

date: 10th march, 2014 - weather conditions: overcast, approx. 28 degrees F.

The fire tower frame consists of painted steel angles and flat bar elements, as noted on the attached drawings. The frame members do exhibit some substantial rust and potential section loss and some may require replacement. The frame will require refinishing in the near future to insure no further loss of integrity. Several horizontal members are bowed, though it appears the damage was done during installation, possibly because member lengths were not cut exact. The tower includes three arrays of solar panels mounted at various angles and locations. Under the tower is a cmu constructed communications building with four 100lb propane tanks adjacent to it. Several footings/piers require patching.

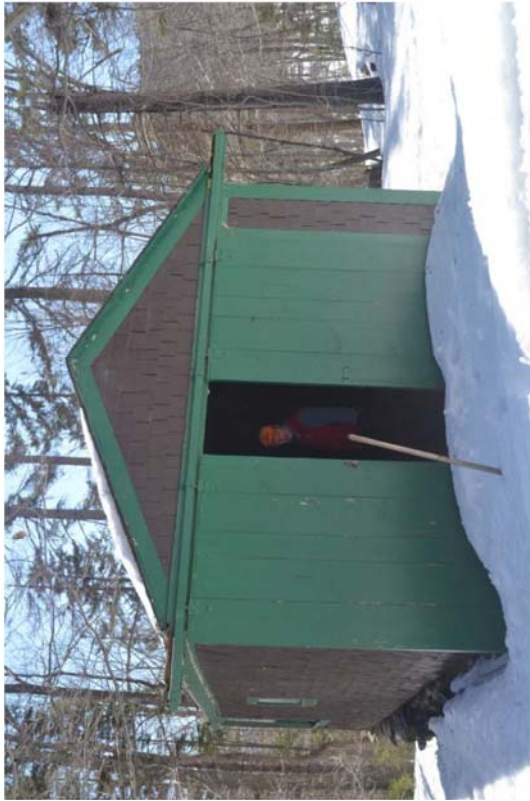
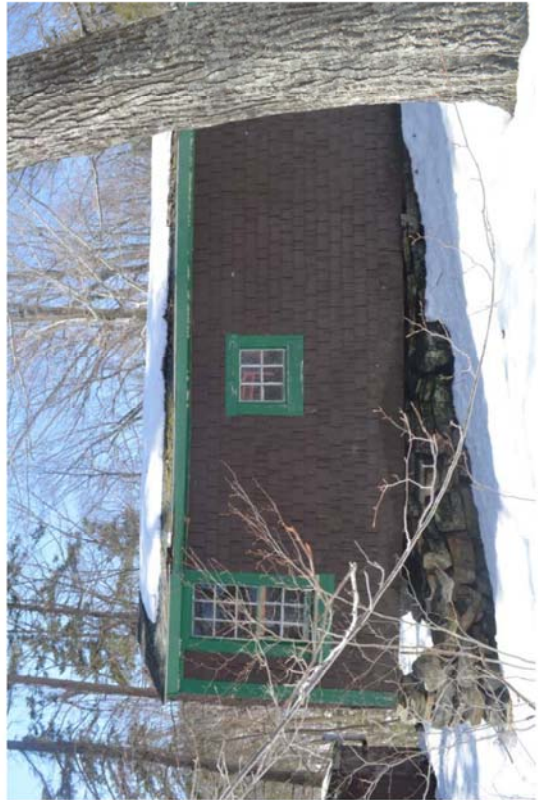
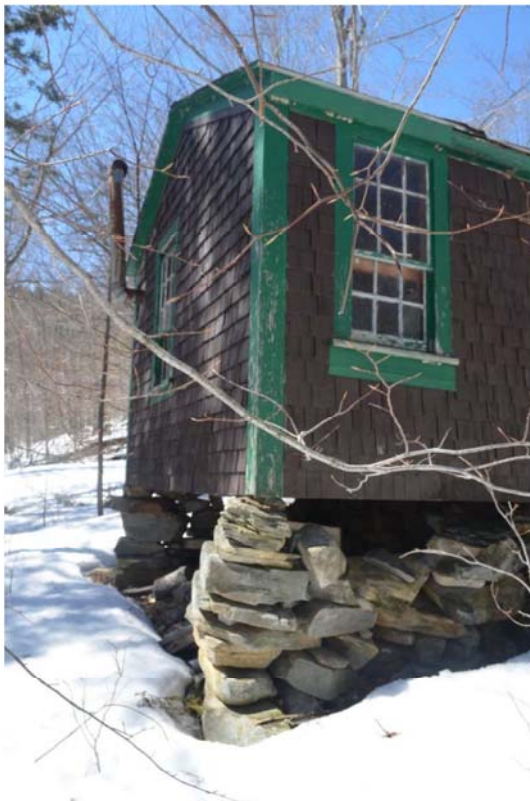
CROYDON MOUNTAIN - GARAGE / CABIN

date: 3rd April, 2014 - weather conditions: mostly sunny, approx. 36 degrees F.

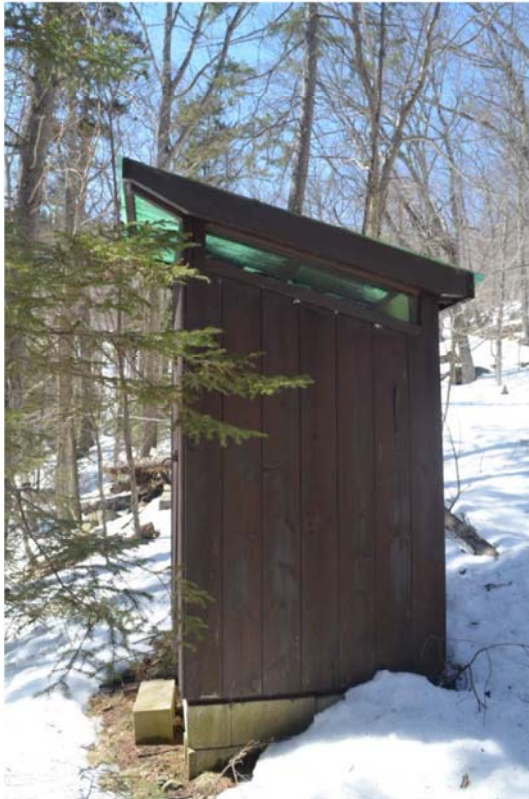
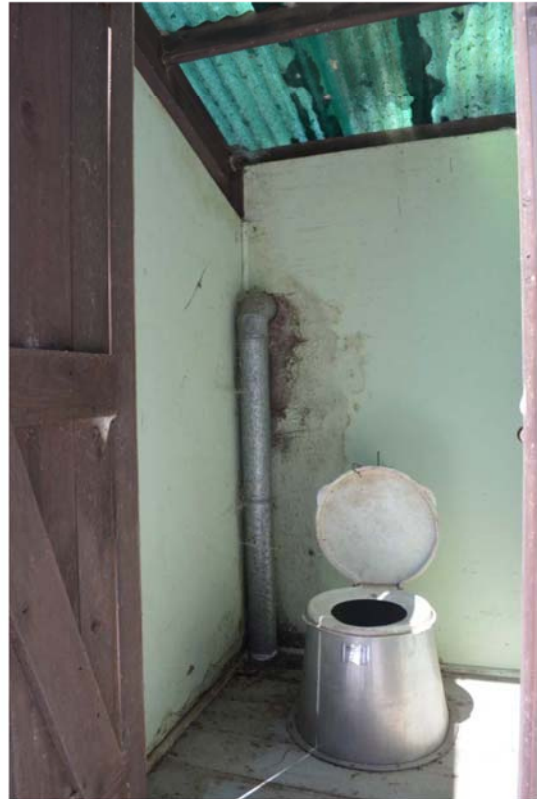
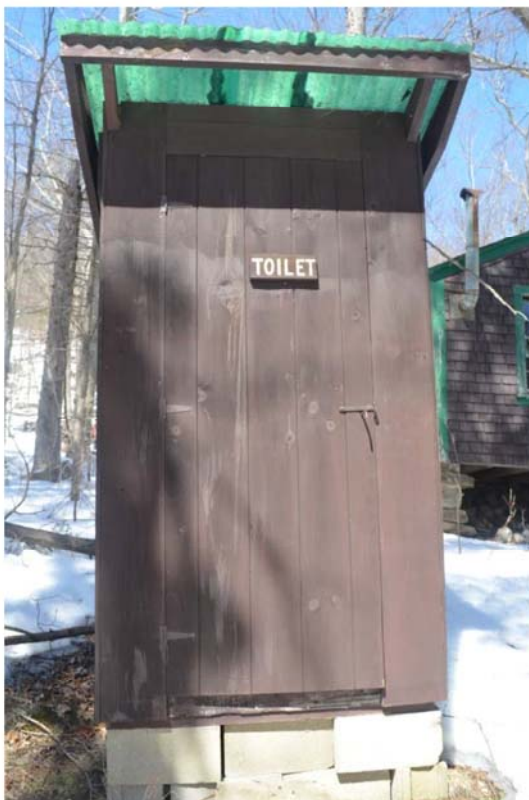
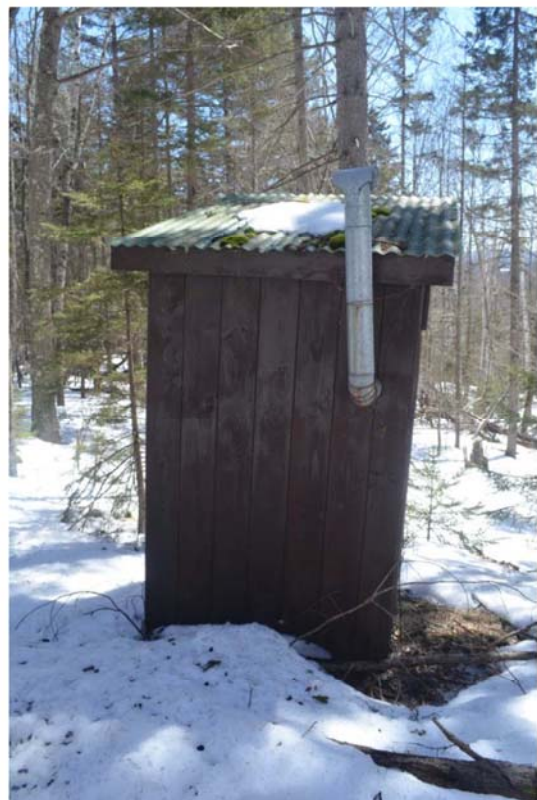
CROYDON MOUNTAIN - OUTHOUSE

date: 3rd April, 2014 - weather conditions: mostly sunny, approx. 36 degrees F.

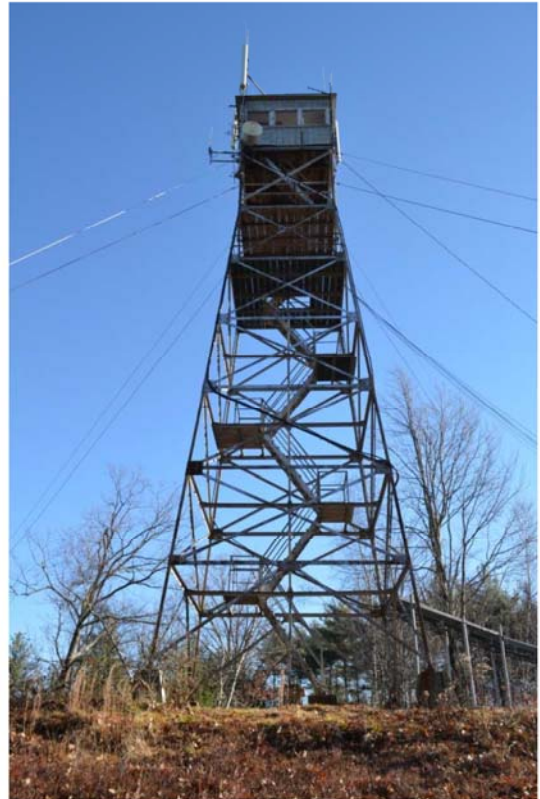
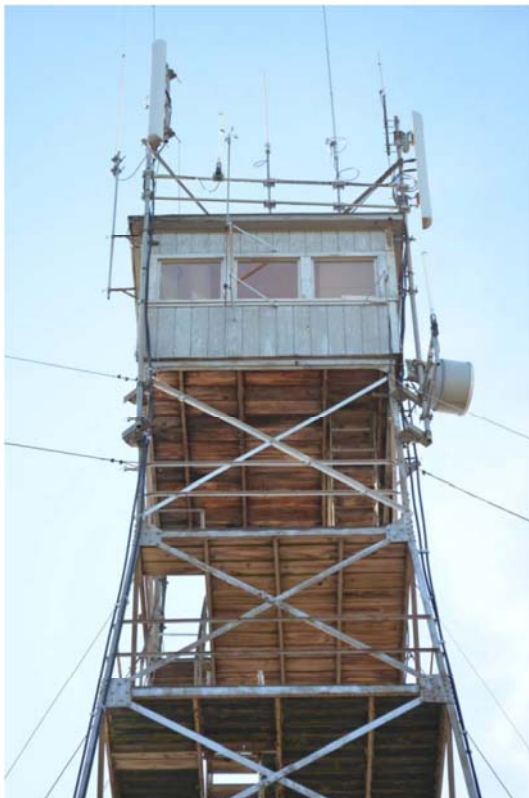
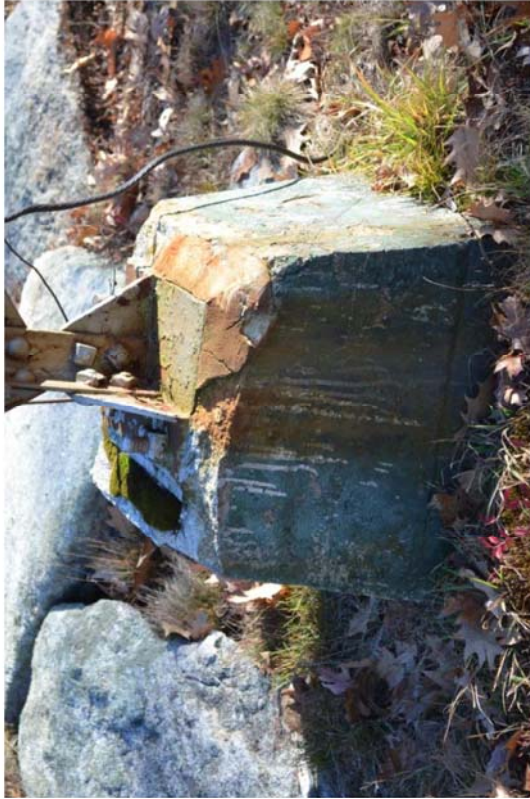
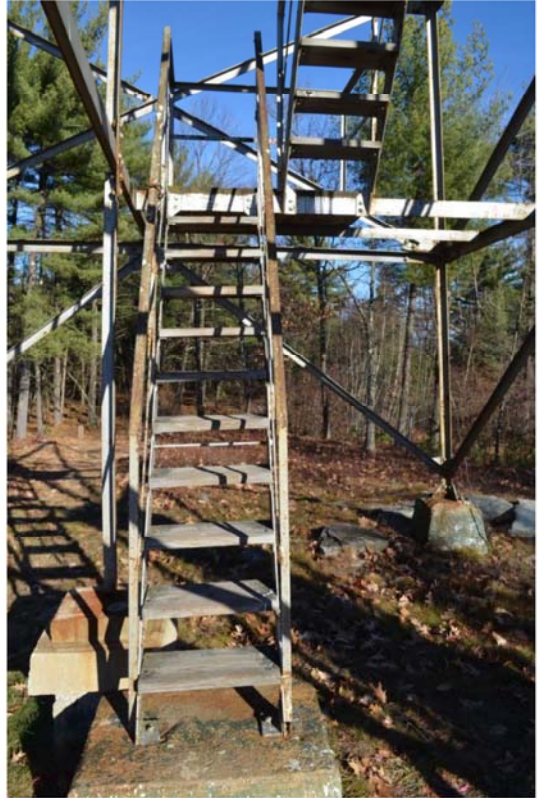
FEDERAL HILL (Milford)

EXISTING CONDITION PHOTOGRAPHS

date: 21th November, 2013 - weather conditions: sunny, approx. 45 degrees F.

The fire tower frame consists of painted steel angles and flat bar elements, as noted on the attached drawings. The frame members do exhibit some substantial rust and potential section loss and some may require replacement. A full structural analysis is recommended due to the height of the tower. The frame will require refinishing in the near future to insure no further loss of integrity.

The tower stairs consist of painted 2x10 pt treads bolted to 1.5x1.5" steel angles, which in turn are welded to 6x3/8" plate steel stringers. Handrail/guardrail consists of 1.5x1.5" steel top bar and uprights welded to plate stringer, with 1x3/8" flat bar mid-rail. As per the main tower frame, significant superficial rust is exhibited and will require refinishing in a timely manner to stop progression into loss of integrity. Stair treads will at minimum require refinishing, as they are generally in sound condition, but have a limited useful life left to them. Landings/Platforms exhibit the same conditions and requirements.

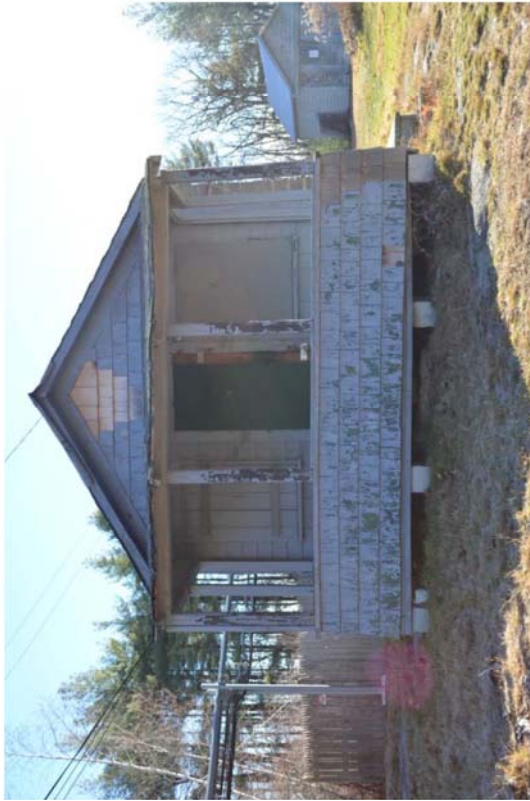
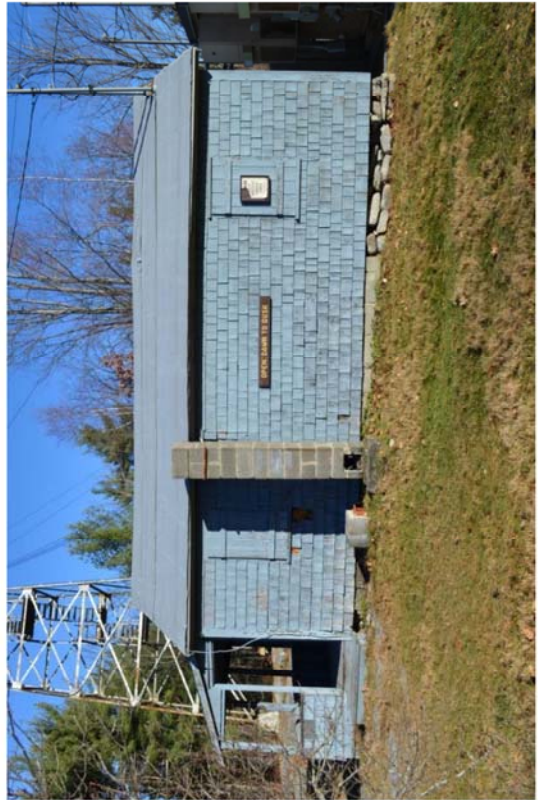
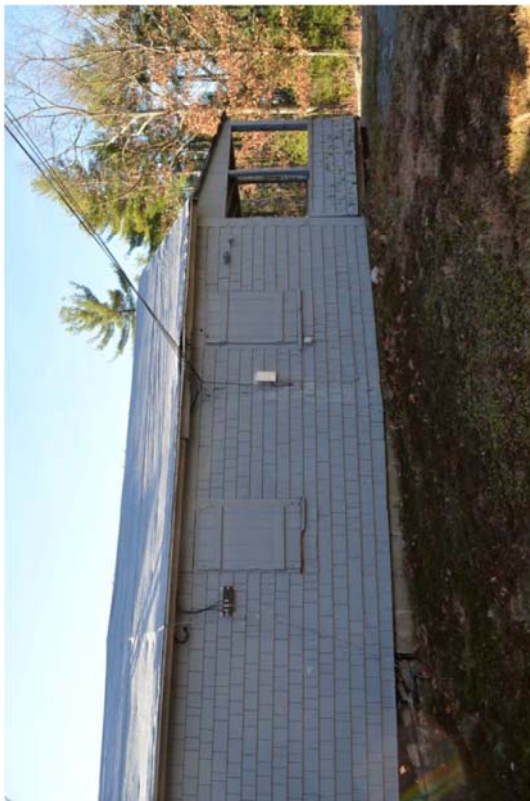
FEDERAL HILL - WATCHMAN CABIN

date: 21th November, 2013 - weather conditions: sunny, approx. 45 degrees F.

The watchman's cabin was inaccessible at the time of inspection. Visual exterior inspections indicates that the substructure, from below, is sound and useful. The cabin sits on concrete blocks, which are crumbling and would need replacement, and raising the cabin floor elevation would be recommended. Exterior finishes have experienced accelerated degradation due to the proximity to the ground/snow. Generally, the exterior finishes would be better replaced. Roof structure indicates some sagging, but appears to be performing. CMU chimney is not useful and should be removed. If a chimney is required in future uses, a new one would be recommended.

component	description	comments	condition
Function	watchman cabin	not in use	Fair
Approximate Footprint	12'-4" x 32'-3"	no access, number of rooms undetermined	-
Foundation	natural stone rubble & cmu block		Poor
Structure	wood framing		Fair
Exterior Walls	wood shingle, painted	missing shingle & peeling evident	Poor
Windows	undetermined	boarded over	Fair
Roof	rolled roofing		Fair
Interior Walls	undetermined	-	-
Interior Floor	undetermined	-	-
Interior Ceiling	undetermined	-	-

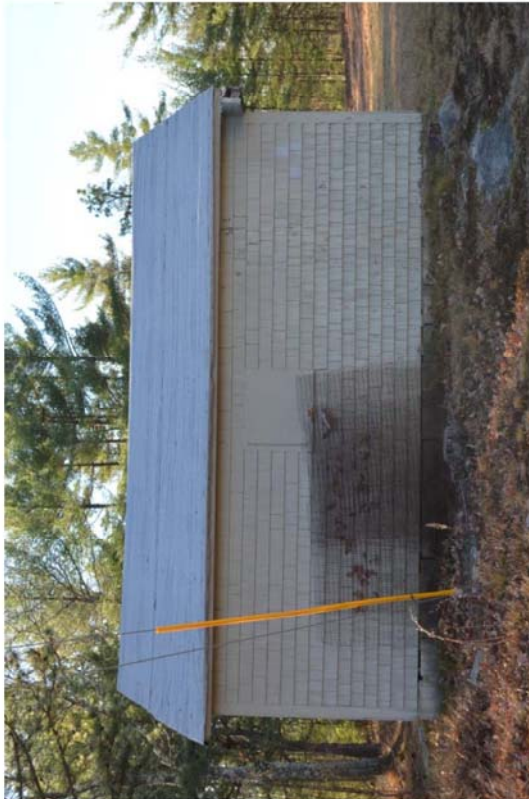
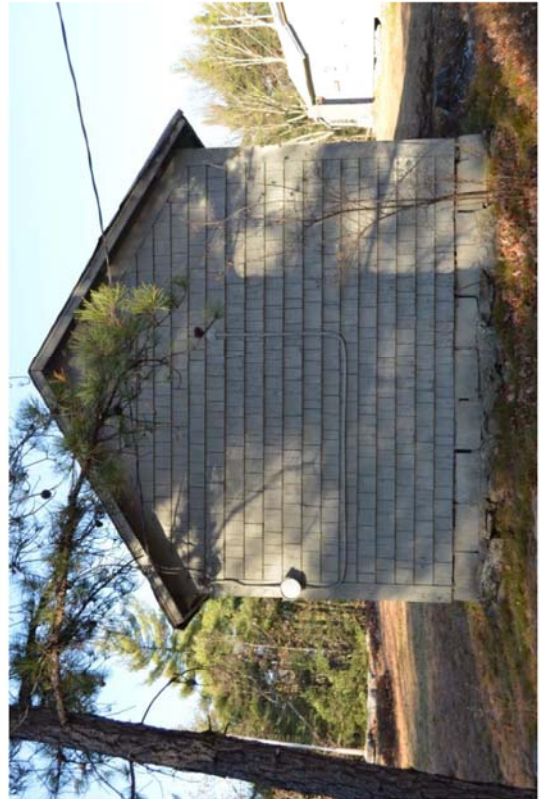
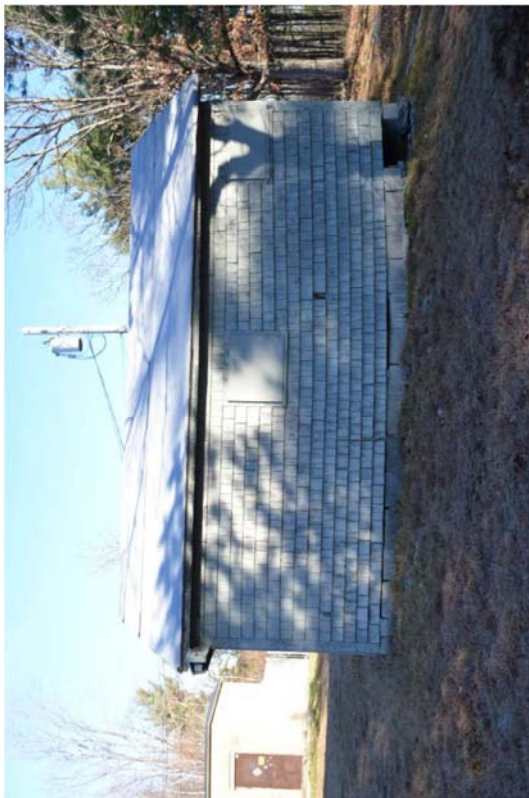
FEDERAL HILL - STORAGE

date: 21th November, 2013 - weather conditions: sunny, approx. 45 degrees F.

The storage building was also inaccessible at the time of the visit, but from a visual inspection to the outside it is felt there are several significant repairs required. The concrete block foundation would need to be rebuilt; the large doors have been vandalized to the point of needing replacement; sill shows signs of dropping/bowing and could need replacement; built-up membrane of roof and wall shingles appear to be functioning, but would likely require replacement soon.

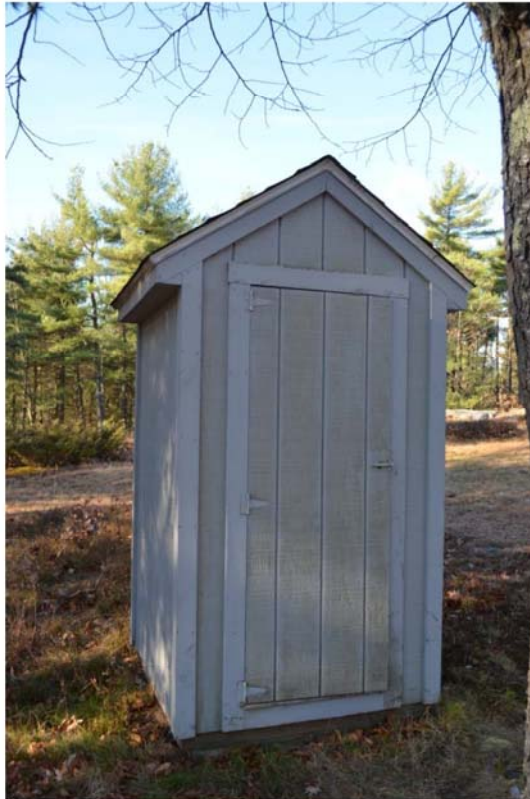
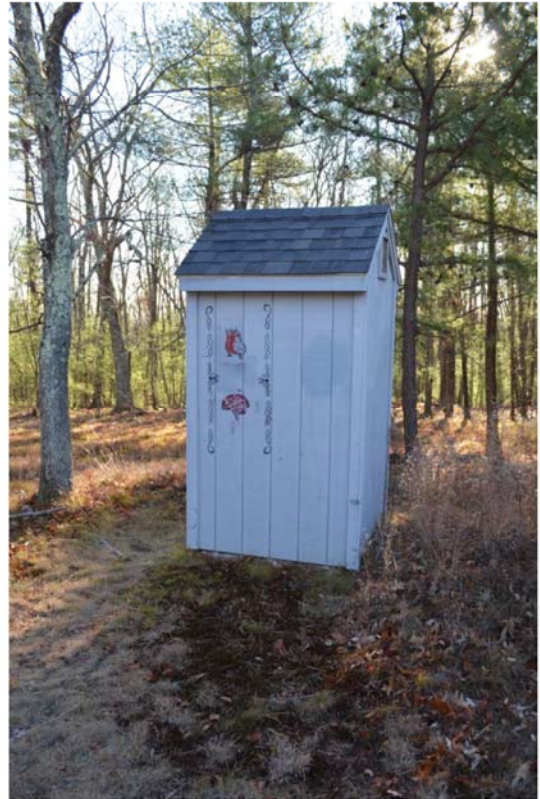
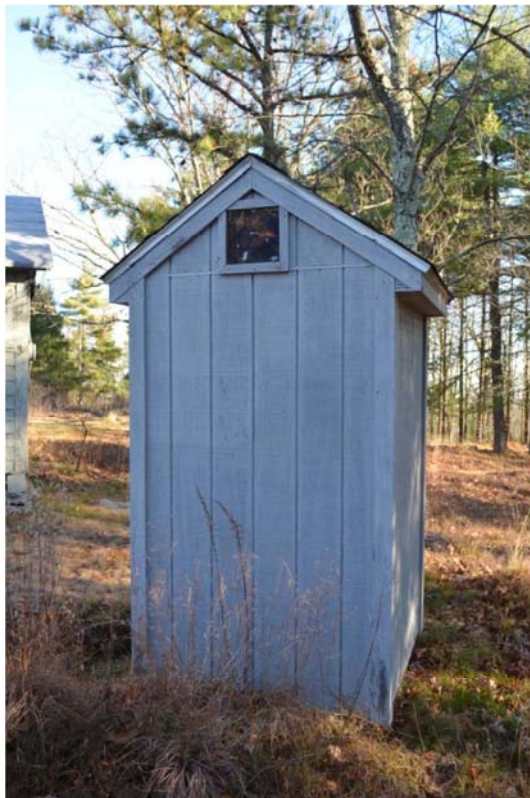
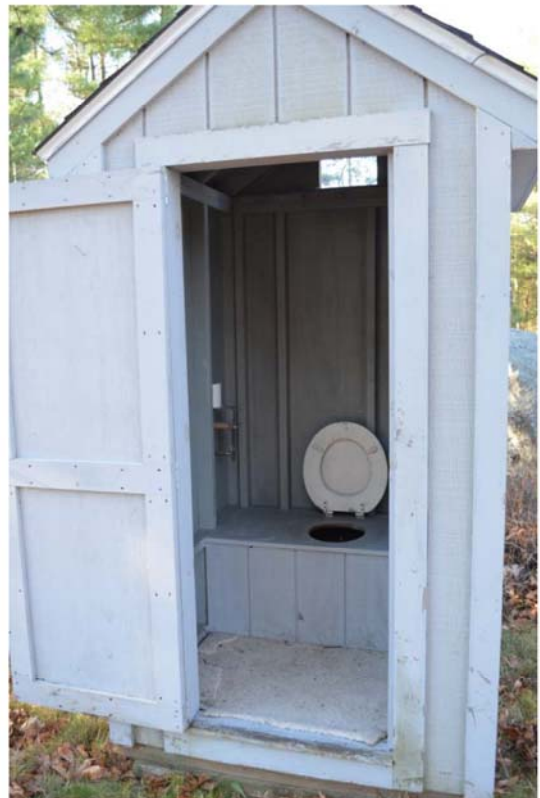
FEDERAL HILL - OUTHOUSE

date: 21th November, 2013 - weather conditions: sunny, approx. 45 degrees F.

The outhouse appears to be in reasonable condition, for its use and construction, but would also benefit from raising off the ground a bit more. It will soon require repainting at the minimum.

component	description	comments	condition
Function	outhouse	functional	Good
Approximate Footprint	4' x 4'	1 room	-
Foundation	natural stone rubble	-	Fair
Structure	wood framing		Good
Exterior Walls	wood vertical board, painted	clean	Good
Windows	none	1 daylight portal	Good
Roof	asphalt shingle	relatively new	Good
Interior Walls	inside face of siding, painted	-	Good
Interior Floor	carpet		Fair
Interior Ceiling	inside face of roof sheathing, painted	-	Good

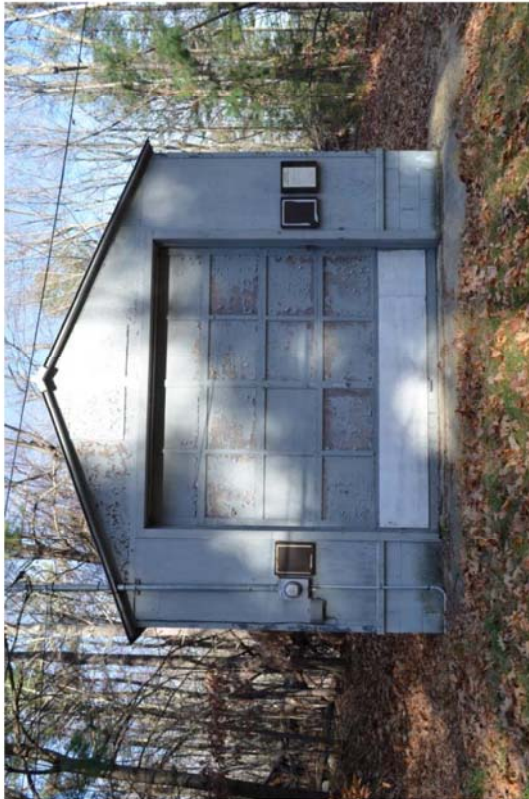
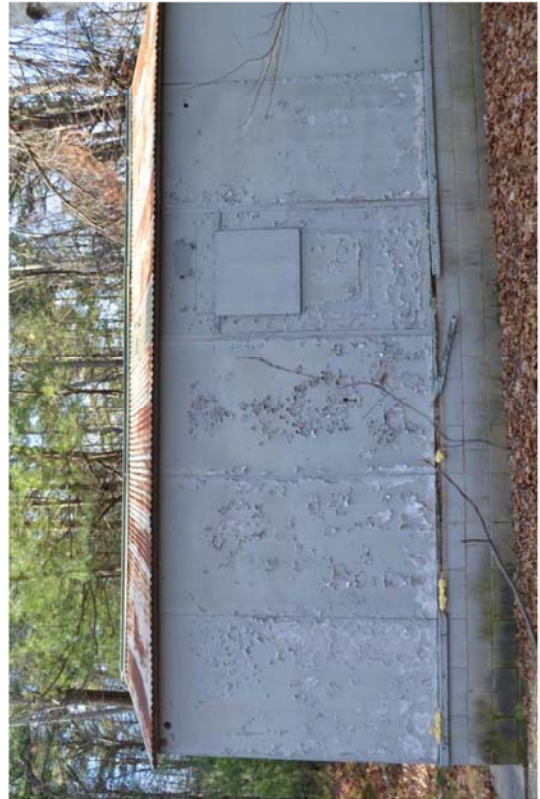
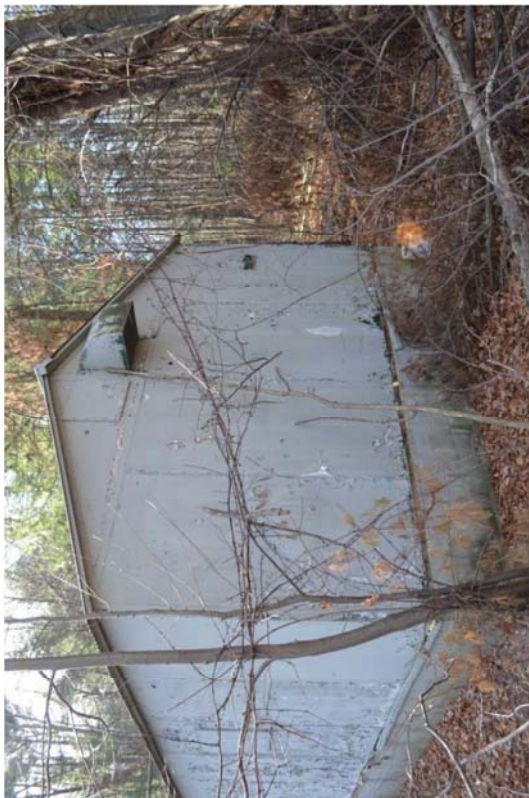
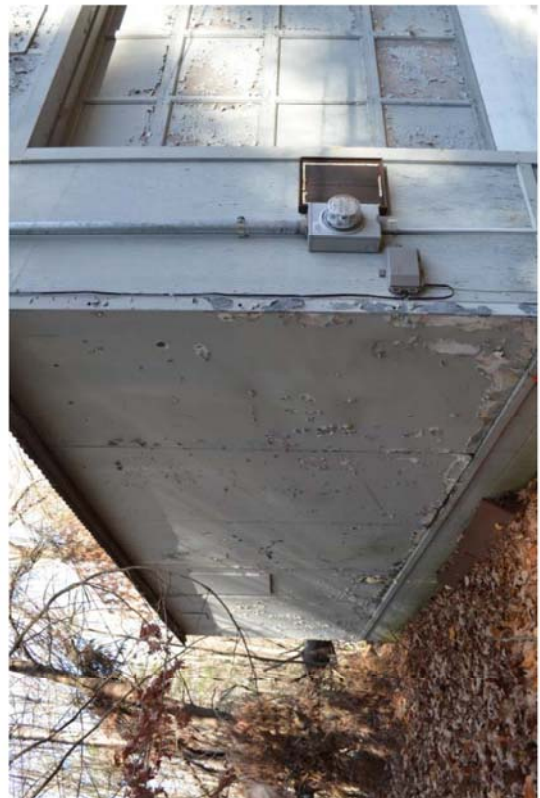
FEDERAL HILL - GARAGE

date: 21th November, 2013 - weather conditions: sunny, approx. 45 degrees F.

The garage, at the base of the access road, has little value as its construction is minimal at best and it has not held up well to the elements. Repairing for alternative uses would likely be more expensive than new.

component	description	comments	condition
Function	garage / storage	not in use	Fair
Approximate Footprint	12'-6" x 21'-3"	1 room	-
Foundation	natural stone rubble & cmu block	evidence of distress	Poor
Structure	wood framing		Fair
Exterior Walls	wood shingle, painted	scrape and re-finish	Fair
Windows	undetermined	boarded over	-
Roof	building paper, no finish	add finish roofing	Poor
Interior Walls	undetermined	-	-
Interior Floor	undetermined	-	-
Interior Ceiling	undetermined	-	-

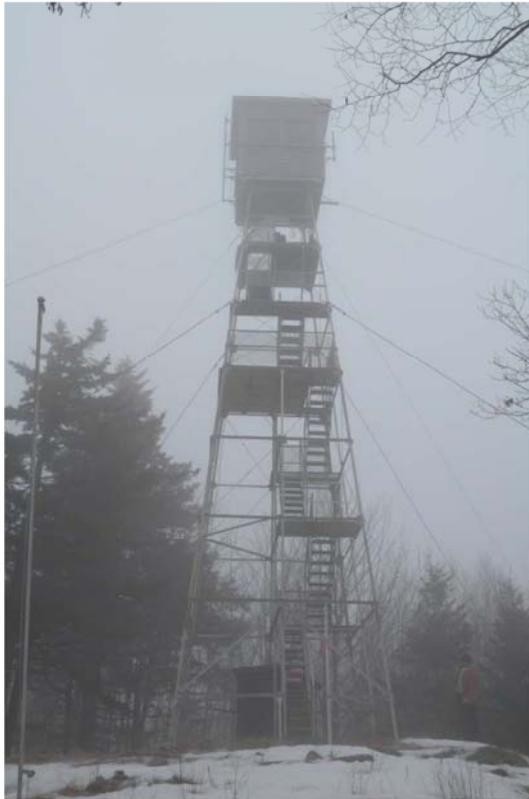
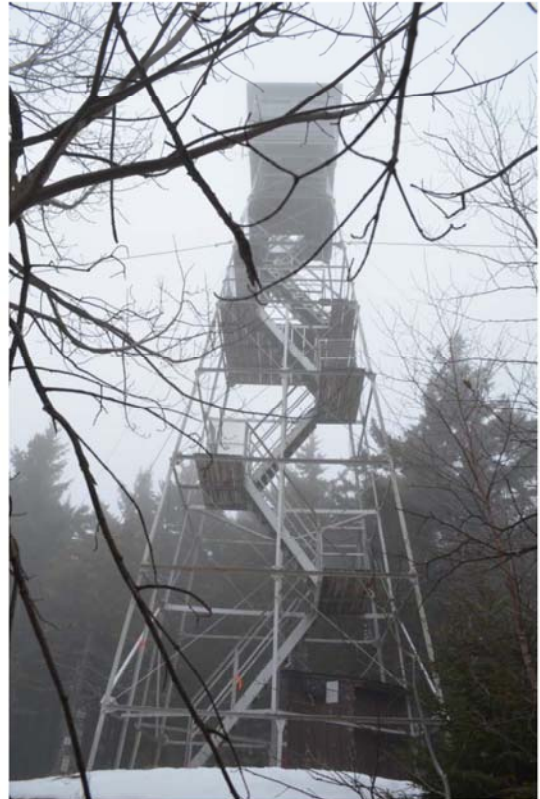
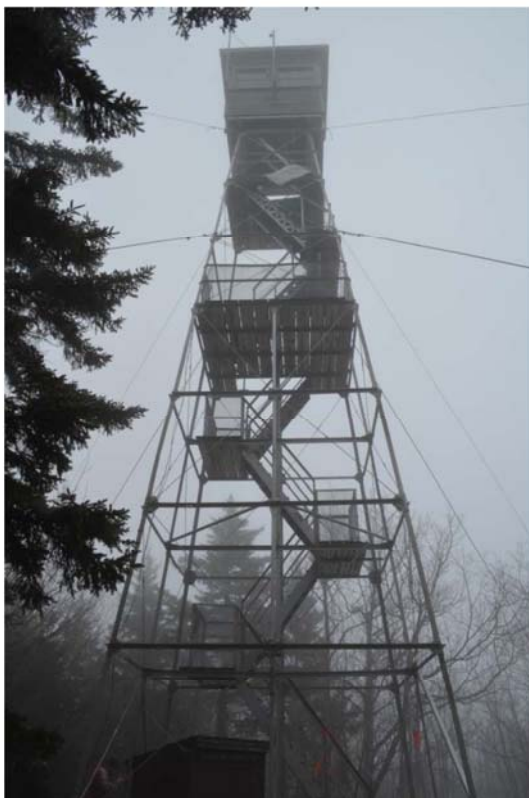
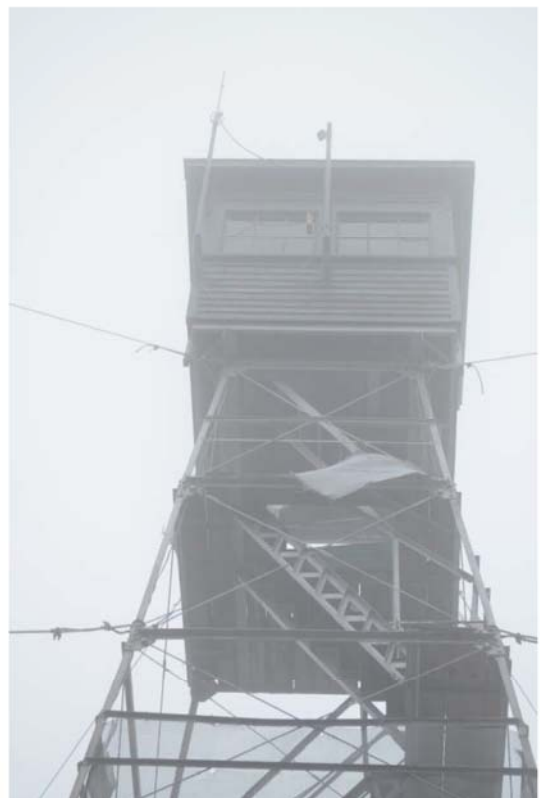
EXISTING CONDITION PHOTOGRAPHS

GREEN MOUNTAIN (Effingham)

date: 16th January, 2014 - weather conditions: overcast, snow flurries, approx. 32 degrees F.

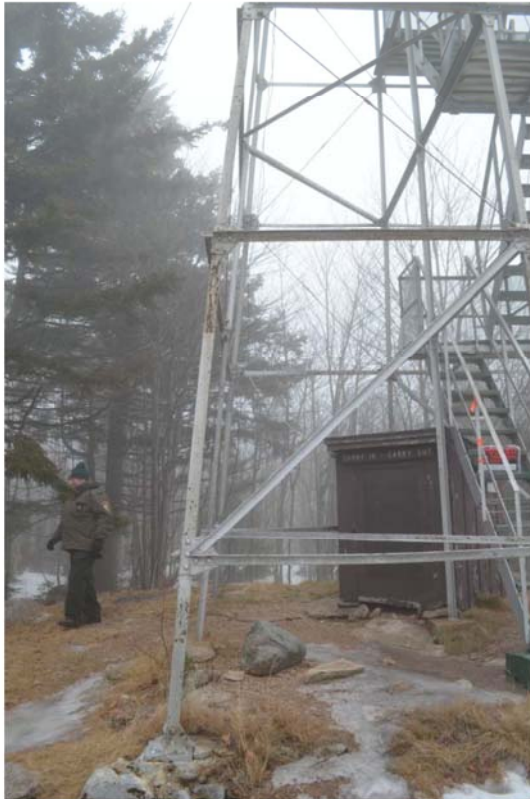
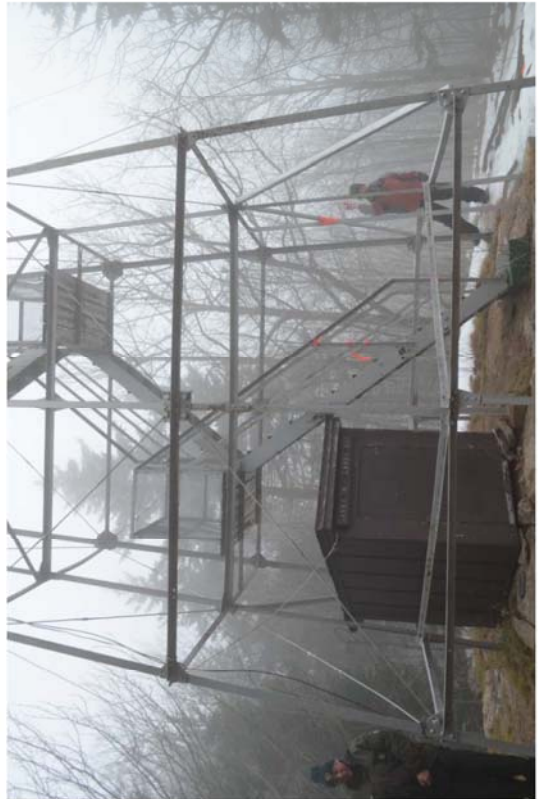
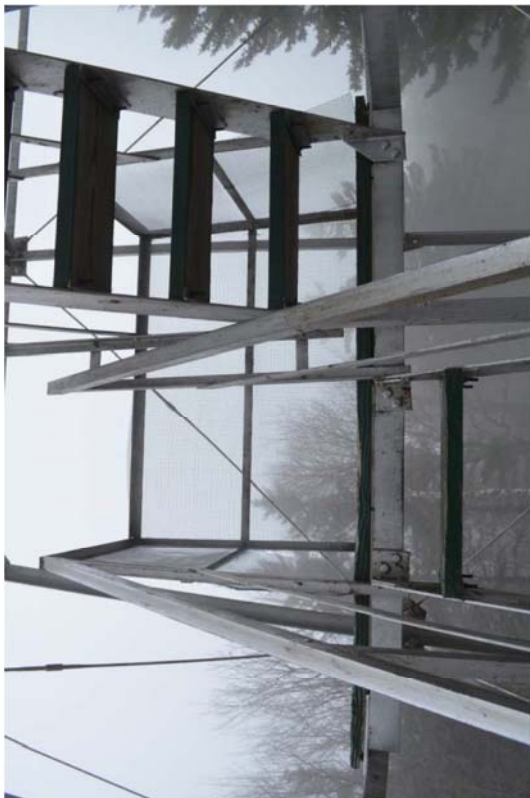
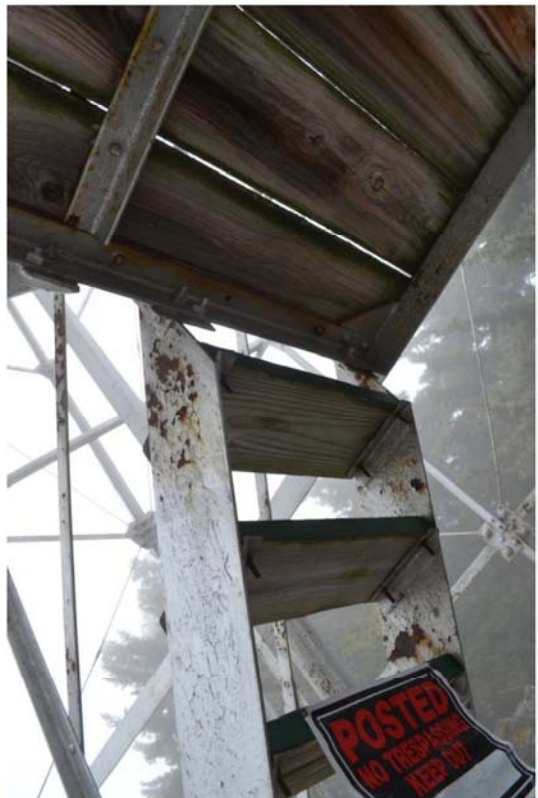
EXISTING CONDITION PHOTOGRAPHS

GREEN MOUNTAIN (Effingham)

date: 16th January, 2014 - weather conditions: overcast, snow flurries, approx. 32 degrees F.
