REPORT - 30TH APRIL, 2014

STATE OF NEW HAMPSHIRE - DEPARTMENT OF RESOURCES & ECONOMIC DEVELOPMENT

DIVISION OF FORESTS & LANDS

**IMPROVEMENTS AND CONSTRUCTION ADMINISTRATION TO FIRE TOWERS
AND AUXILIARY BUILDINGS IN VARIOUS STATE RESERVATIONS**

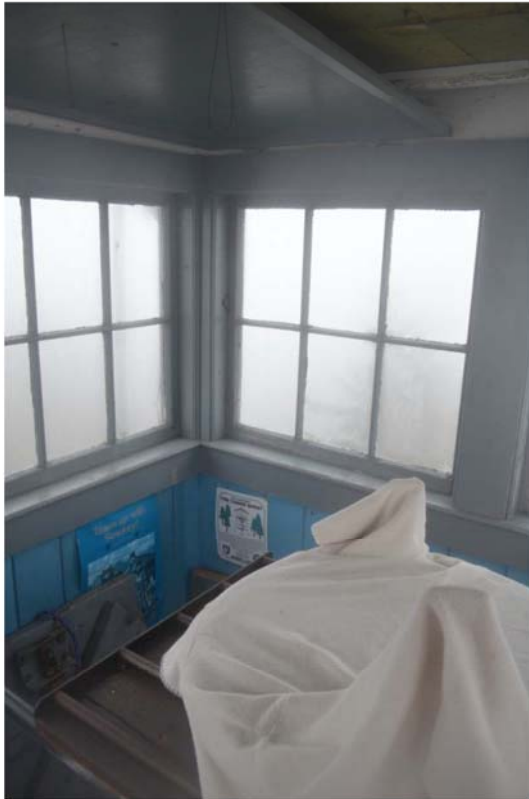
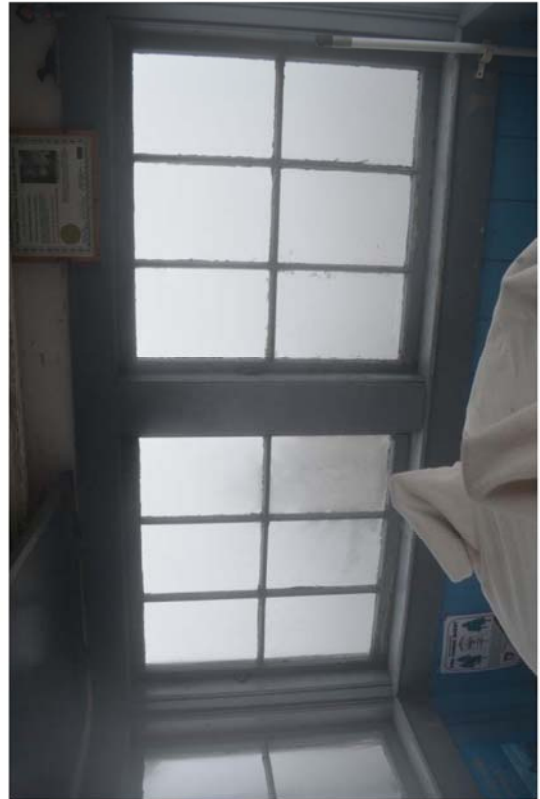
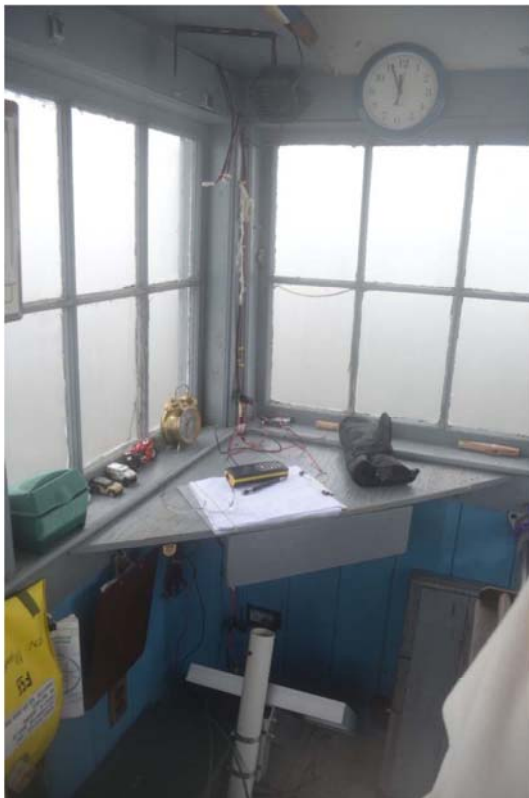
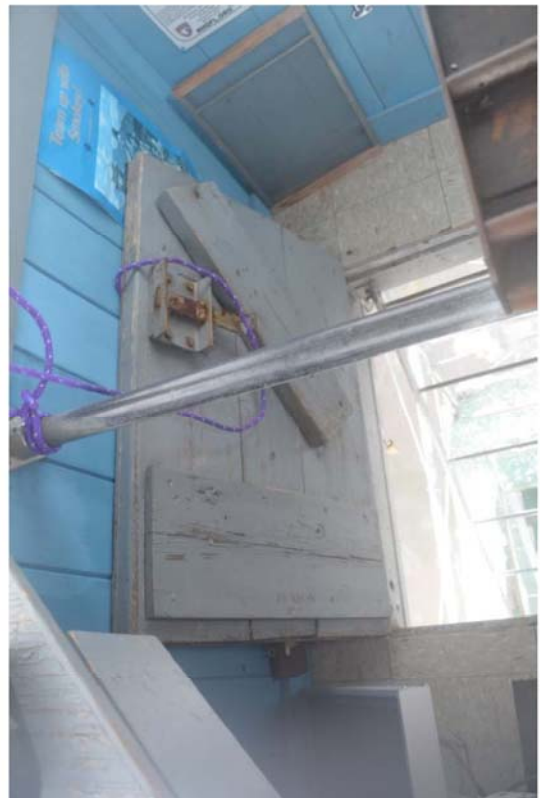
EXISTING CONDITION PHOTOGRAPHS

GREEN MOUNTAIN (Effingham)

date: 16th January, 2014 - weather conditions: overcast, snow flurries, approx. 32 degrees F.

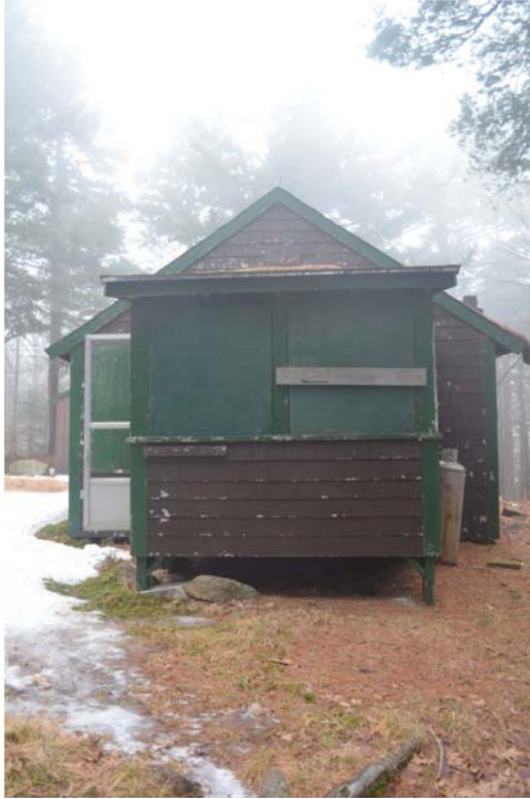
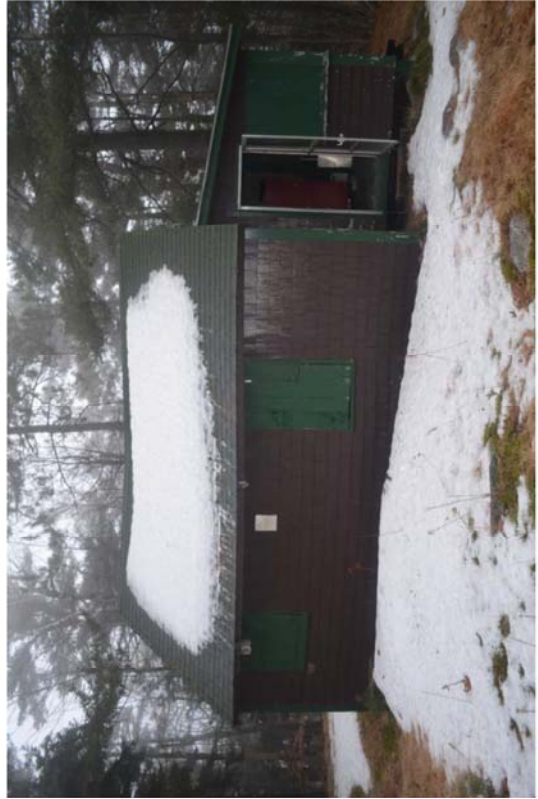
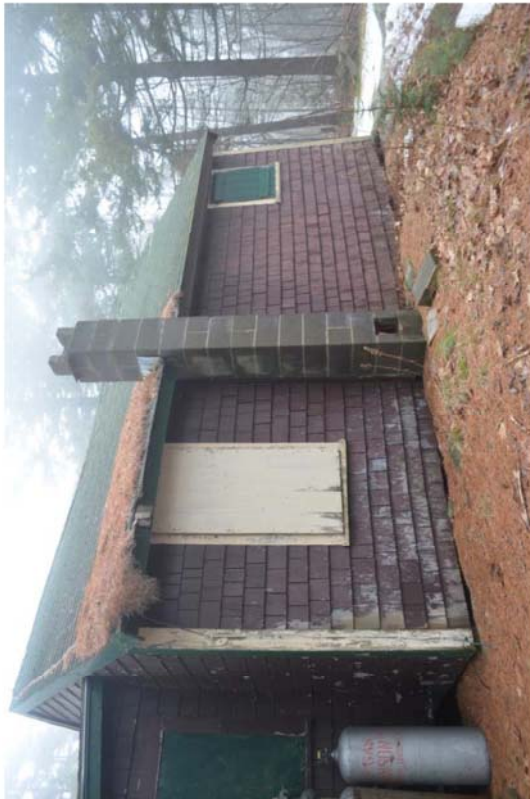
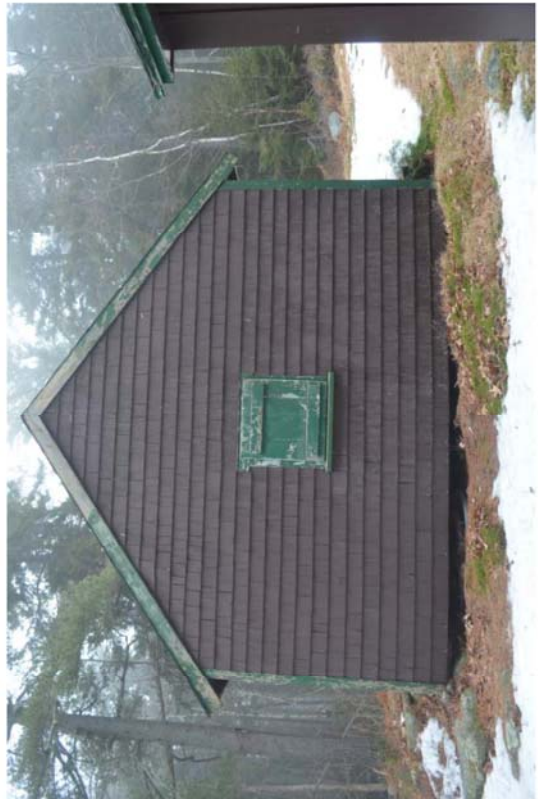
EXISTING CONDITION PHOTOGRAPHS

GREEN MOUNTAIN - WATCHMAN CABIN

date: 16th January, 2014 - weather conditions: overcast, snow flurries, approx. 32 degrees F.

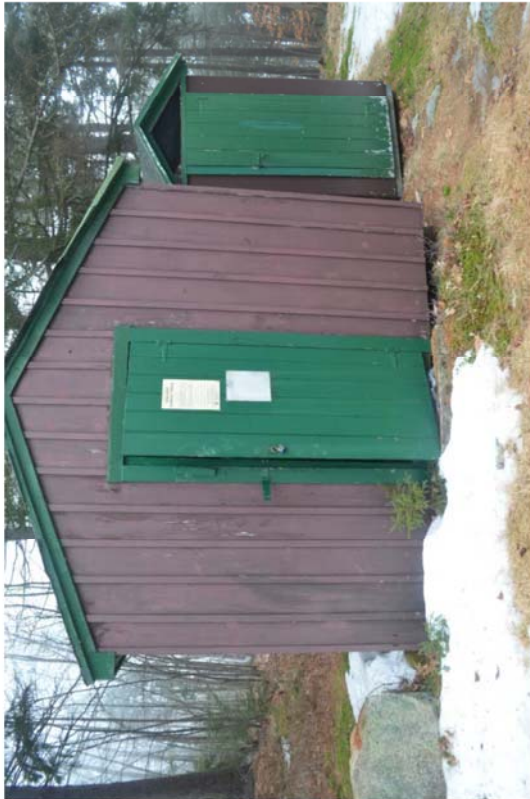
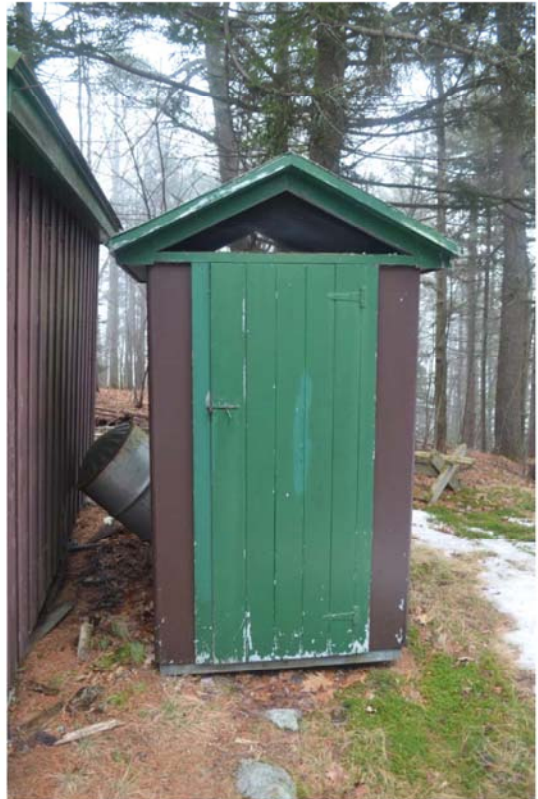
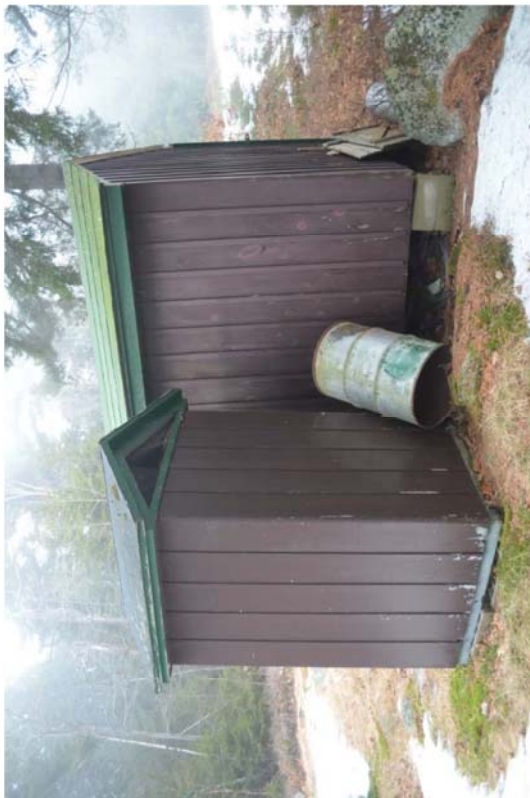
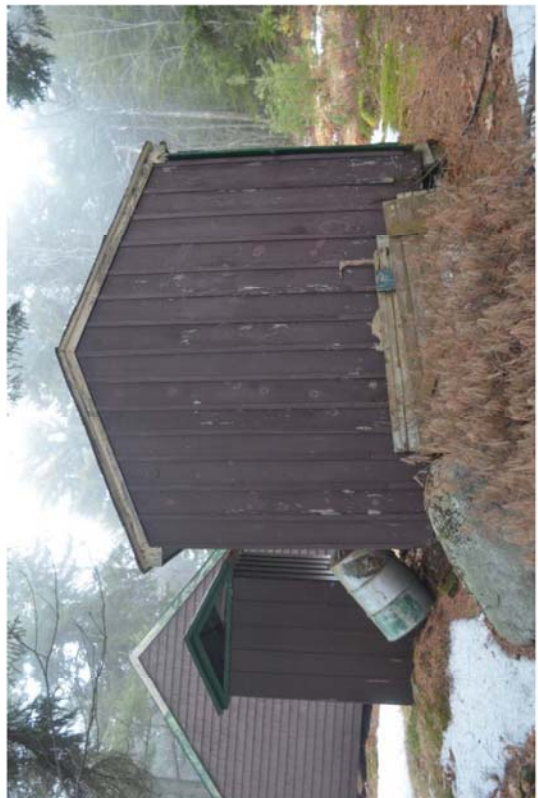
EXISTING CONDITION PHOTOGRAPHS

GREEN MOUNTAIN - STORAGE & OUTHOUSE

date: 16th January, 2014 - weather conditions: overcast, snow flurries, approx. 32 degrees F.

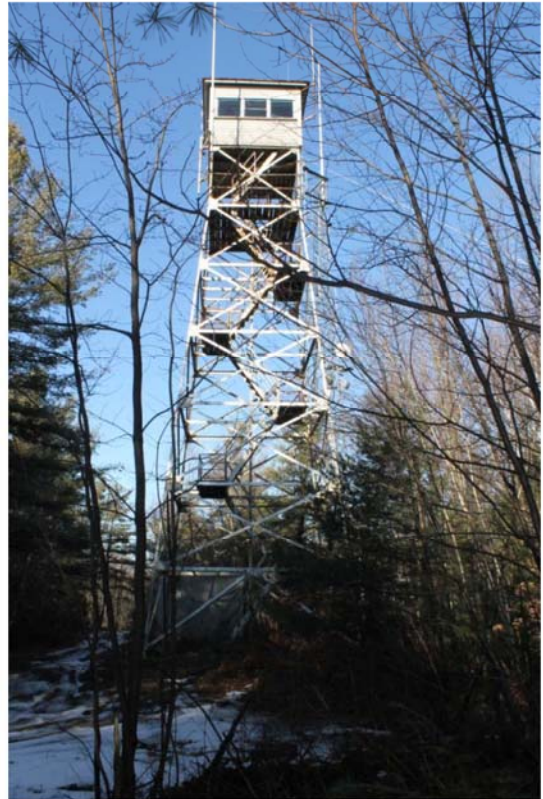
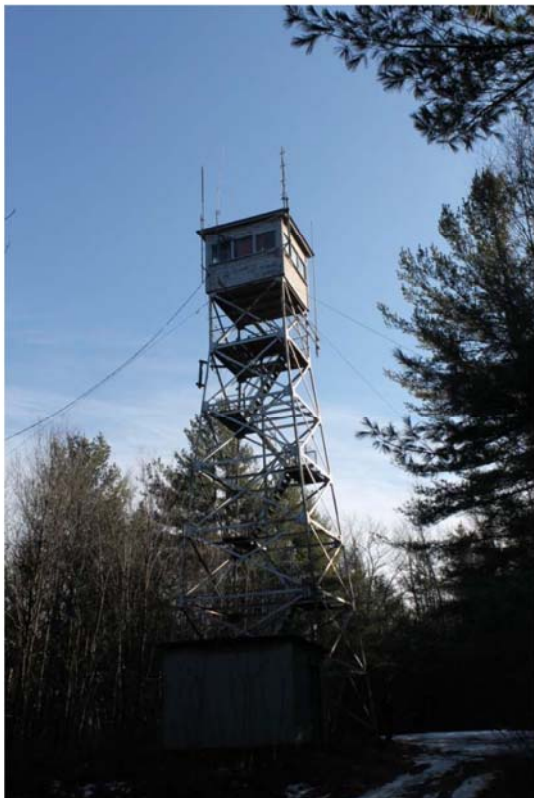
EXISTING CONDITION PHOTOGRAPHS

HYLAND HILL (Westmoreland)

date: 15th January, 2014 - weather conditions: sunny, approx. 30 degrees F.

The fire tower frame consists of painted steel angles and flat bar elements, as noted on the attached drawings. The frame members do exhibit some substantial rust and potential section loss and some may require replacement. A full structural analysis is recommended due to the height of the tower. The frame will require refinishing in the near future to insure no further loss of integrity to the frame.

The six flights of the tower stairs consist of painted 2x10 pt treads bolted to 1.5x1.5" steel angles, which in turn are welded to 6x3/8" plate steel stringers. As with the frame, significant surface rust exists and will need treatment should the tower be retained.

Due to the fact that Hyland Hill tower has been left abandoned for several years, the tower cab has reached a level of disrepair that suggest only replacement is an option, should the tower be deemed worthy of retention. Interior and exterior finishes are beyond repair. Little is worthy of salvage. Should cab be replaced, steel corner posts integral to the frame will need to be addressed.

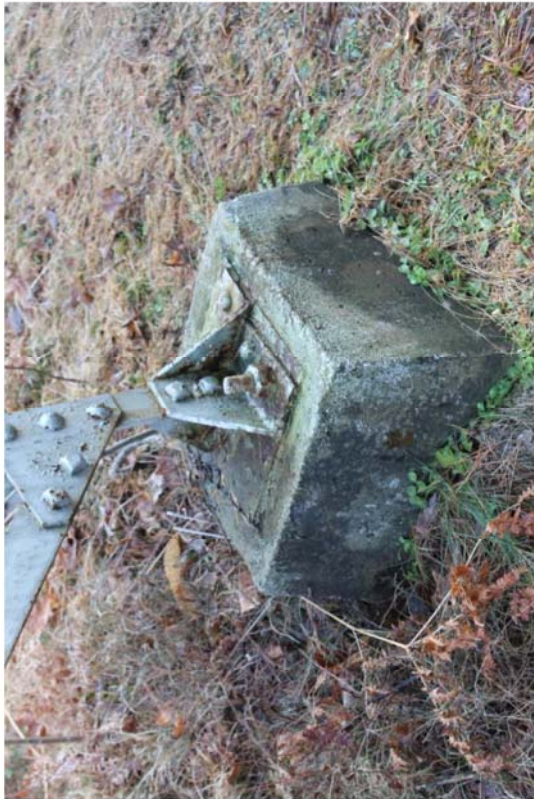
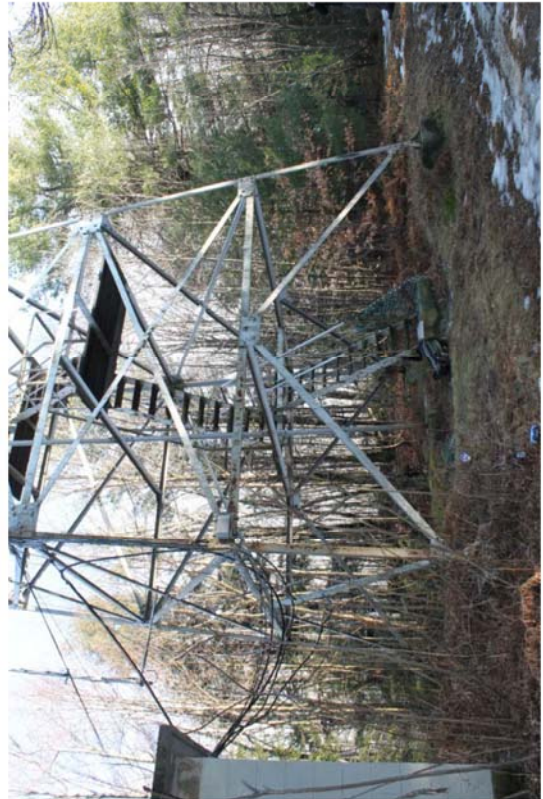
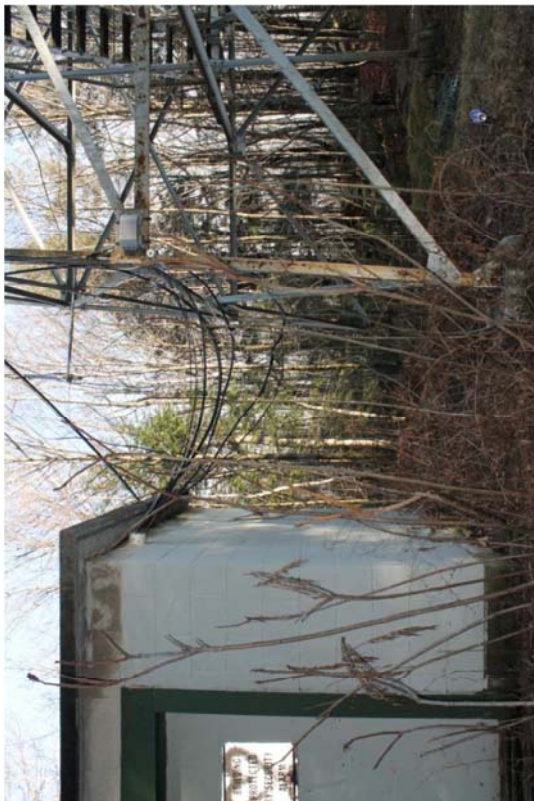
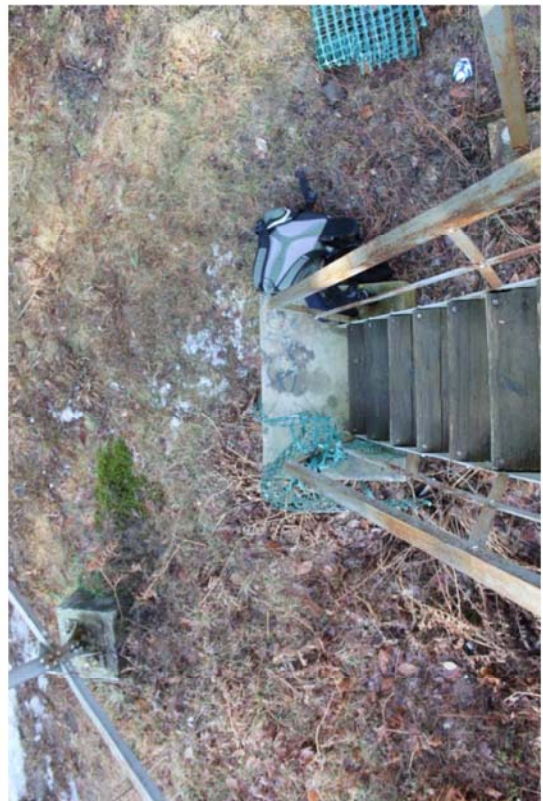
EXISTING CONDITION PHOTOGRAPHS

HYLAND HILL (Westmoreland)

date: 15th January, 2014 - weather conditions: sunny, approx. 30 degrees F.

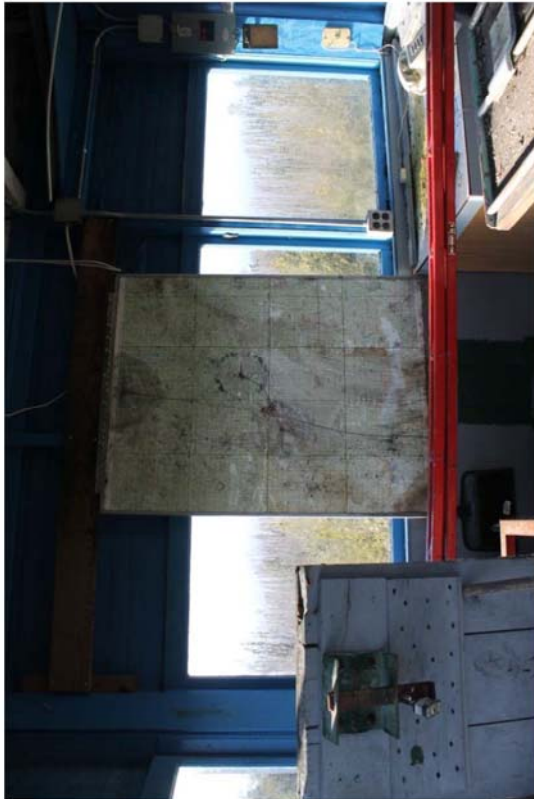
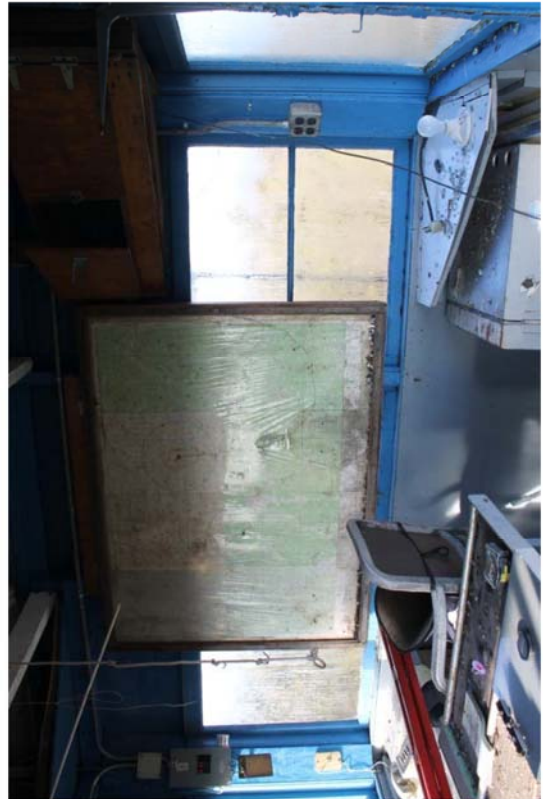
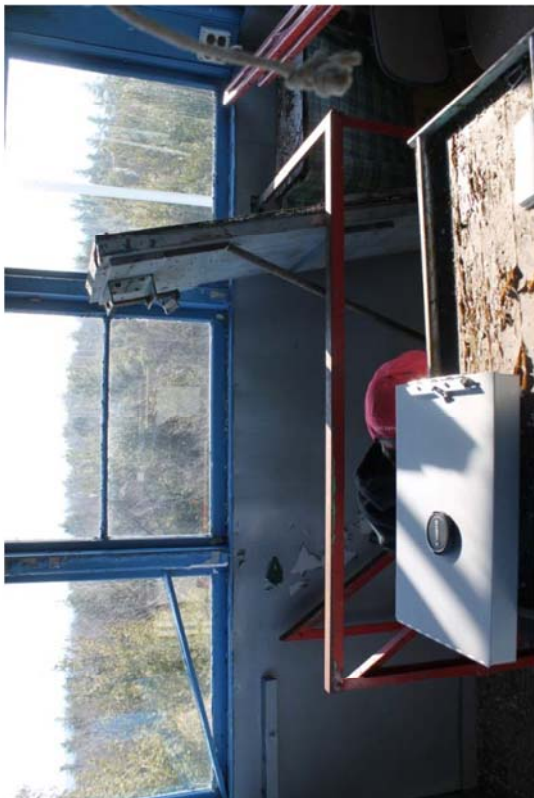
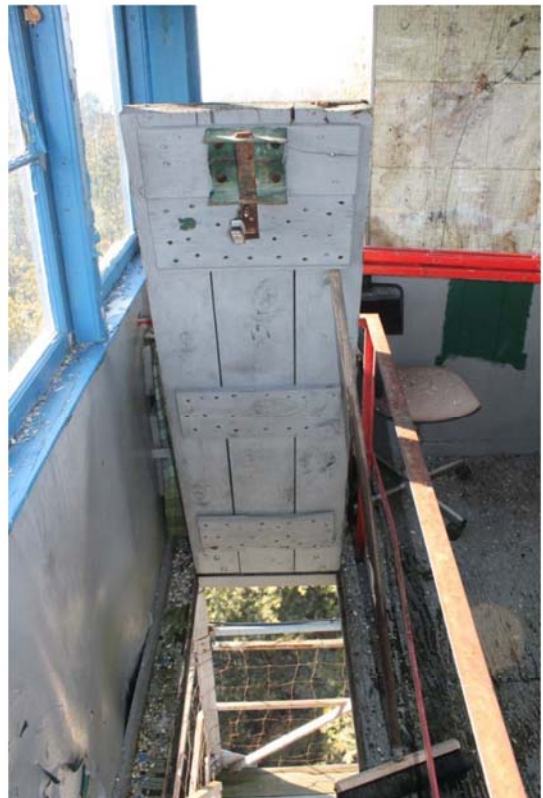
EXISTING CONDITION PHOTOGRAPHS

HYLAND HILL (Westmoreland)

date: 15th January, 2014 - weather conditions: sunny, approx. 30 degrees F.

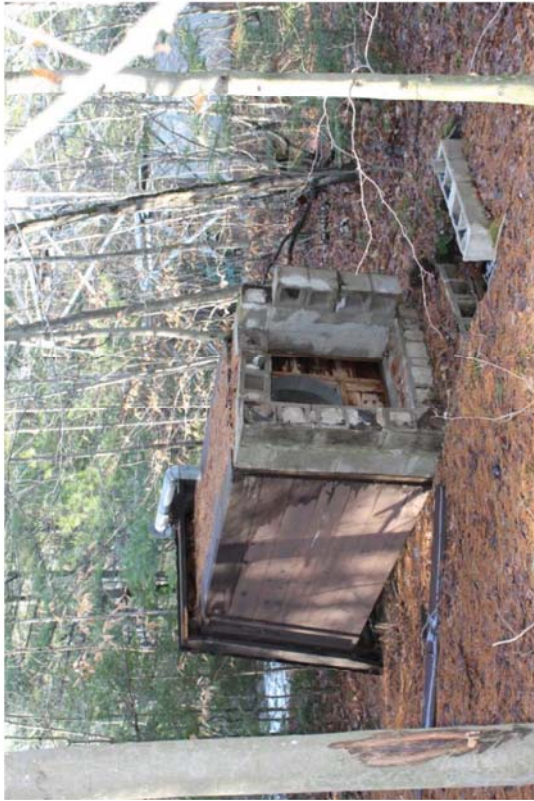
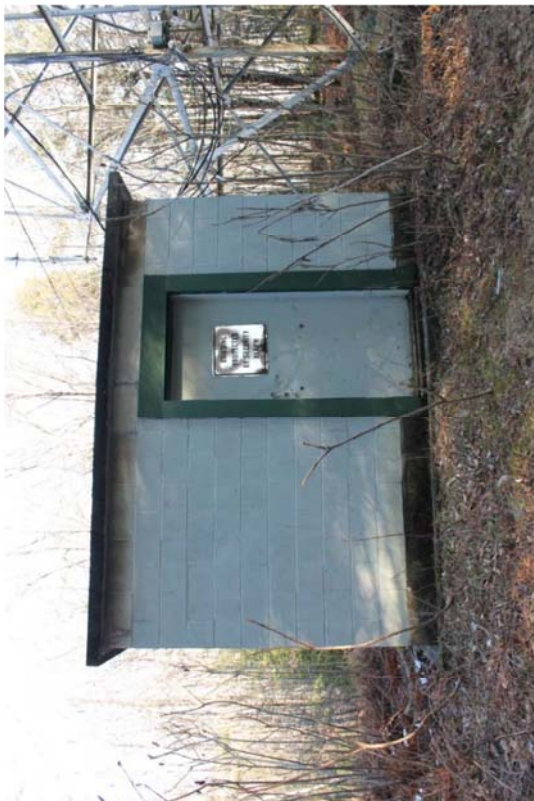
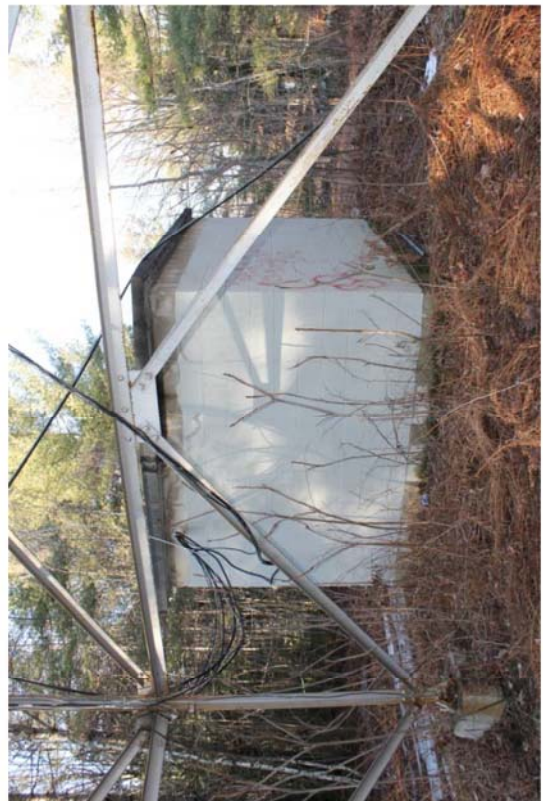
HYLAND HILL - OUTHOUSE

date: 15th January, 2014 - weather conditions: sunny, approx. 30 degrees F.

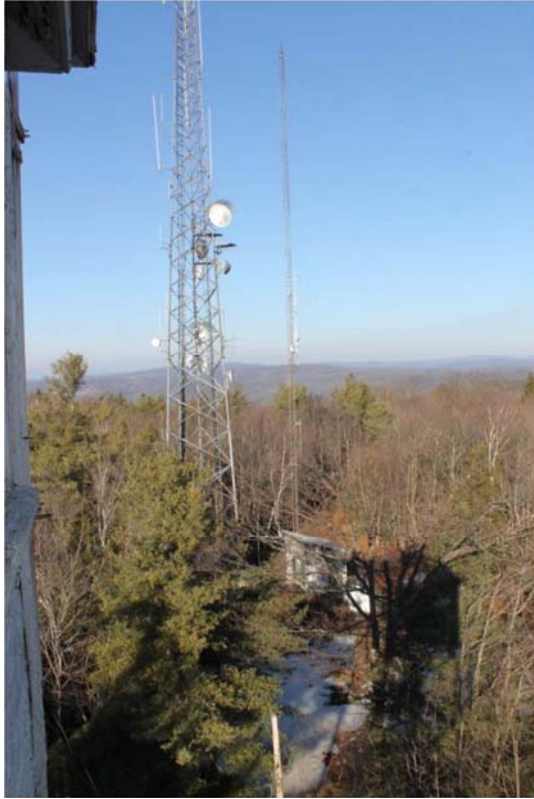
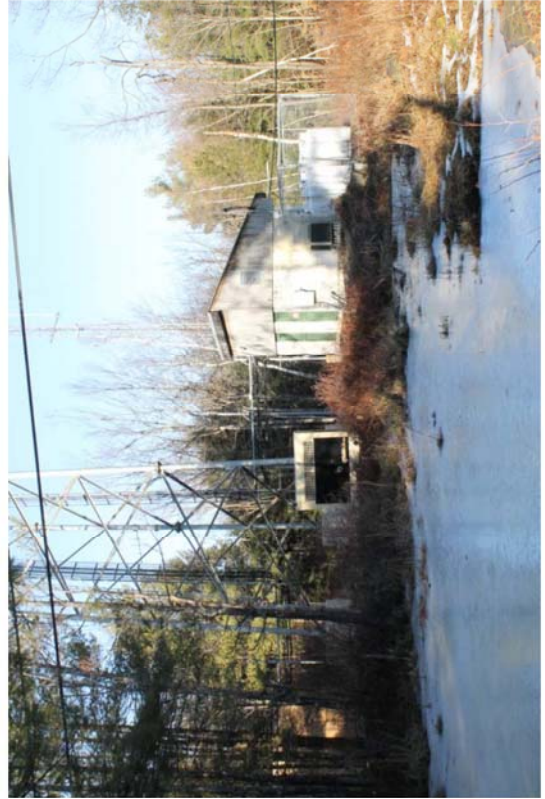
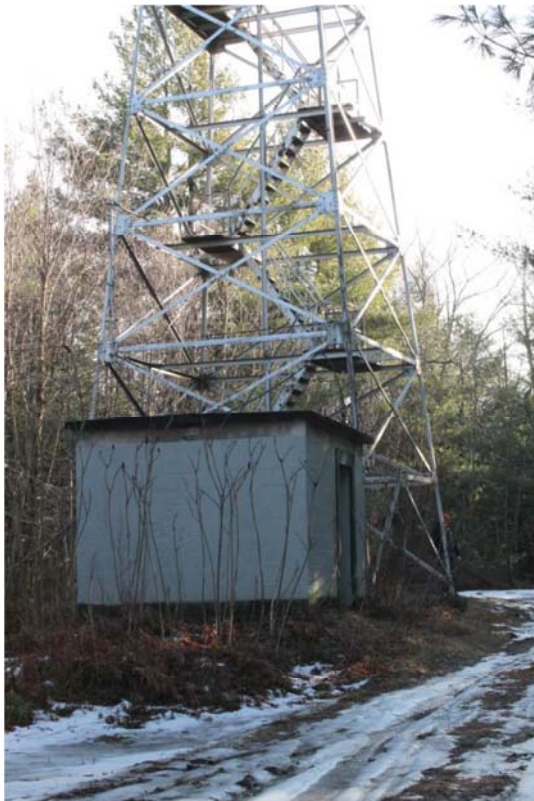
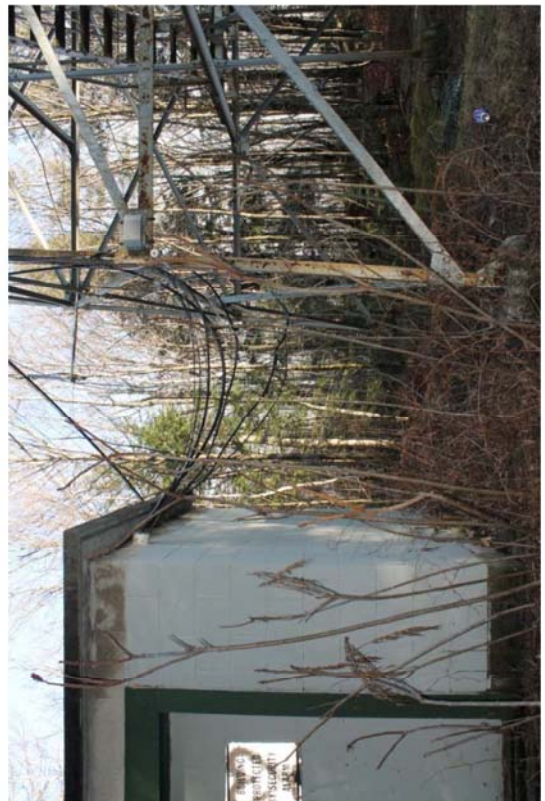
HYLAND HILL - ADJACENT STRUCTURES

date: 15th January, 2014 - weather conditions: sunny, approx. 30 degrees F.

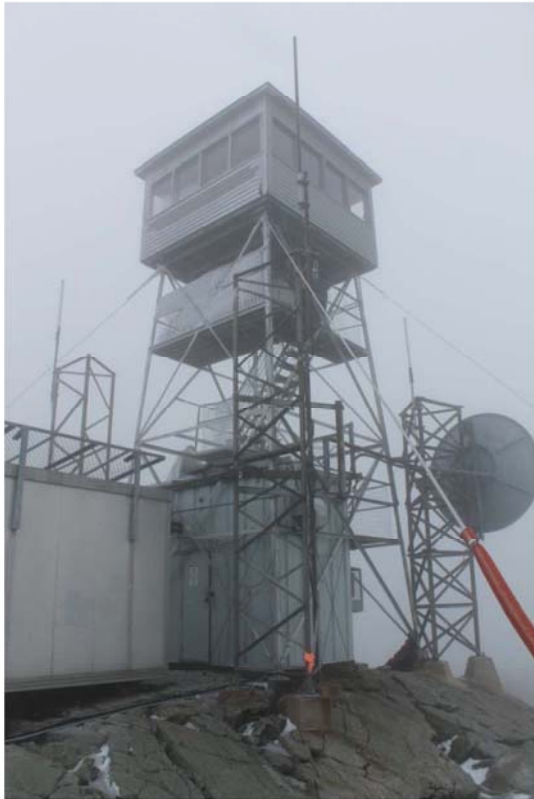
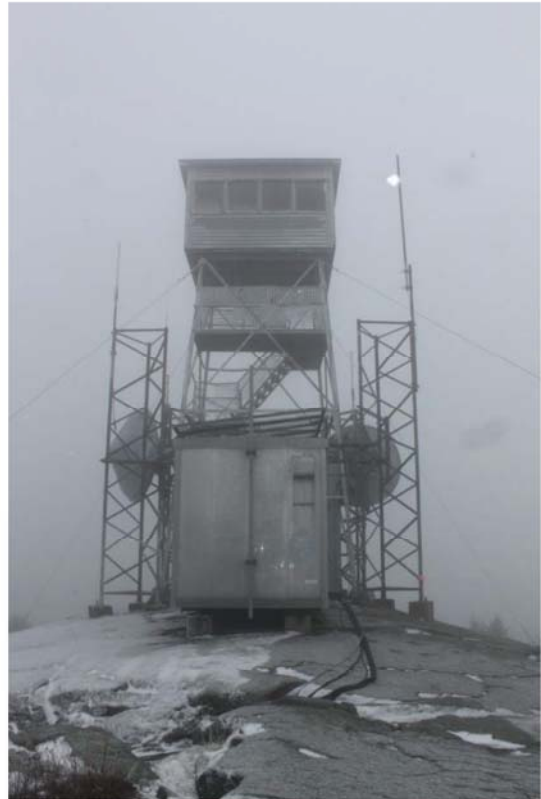
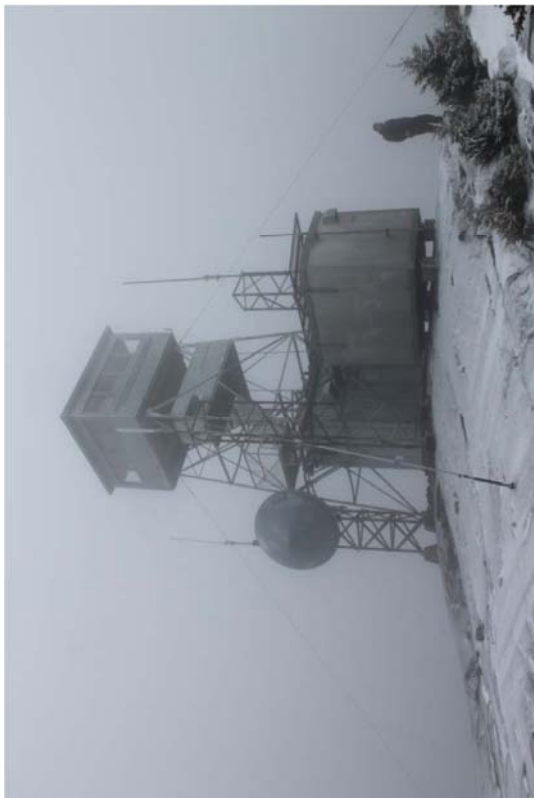
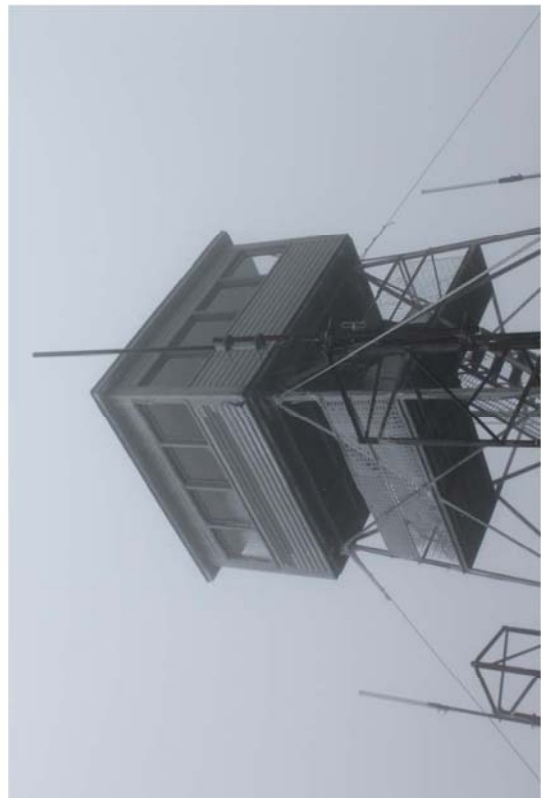
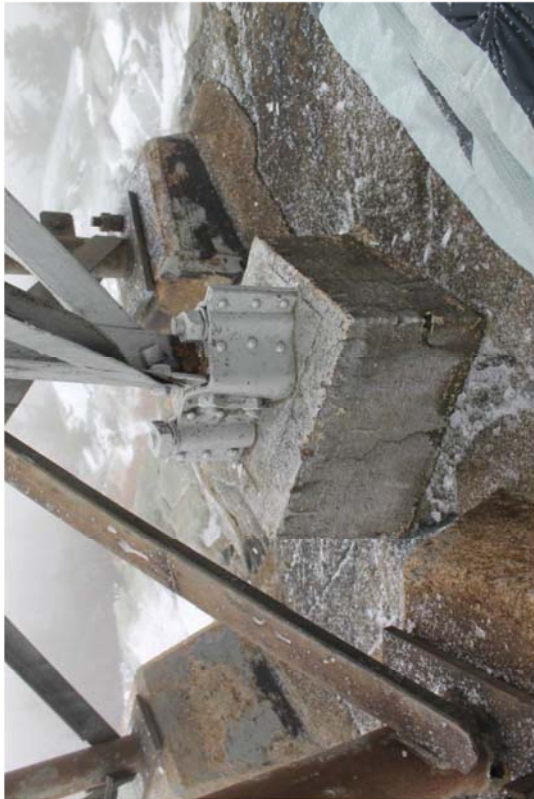
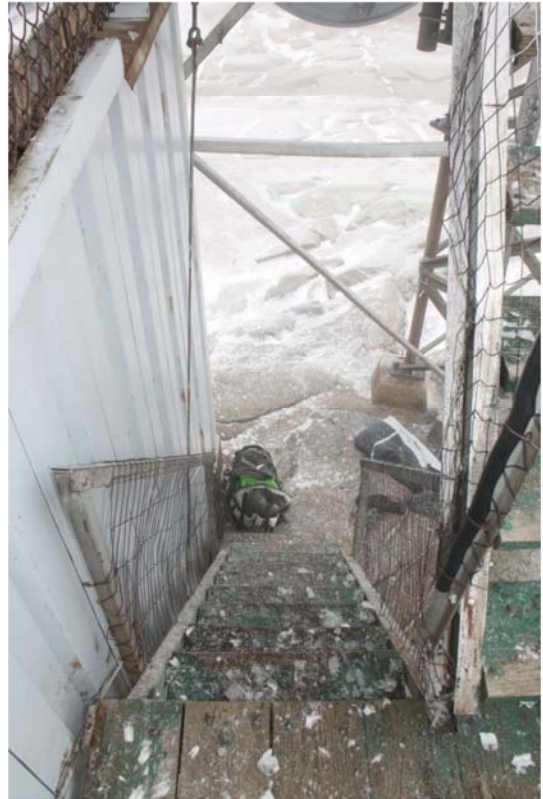
KEARSARGE MOUNTAIN (Wilmot & Warner)

date: 16th January, 2014 - weather conditions: overcast, poor visibility, approx. 20 degrees F.

The fire tower frame consists of painted steel angles and flat bar elements, as noted on the attached drawings. The frame members are generally in good condition but exhibit surface rust and will require refinishing soon.

The tower cab will require at the minimum refinishing of the walls and ceiling materials, as significant wear is apparent. The vinyl floor finish will require to be replaced and has been installed on a backer board fixed to the 2x8 pt subfloor. Windows are vertical sliding and functional, but also show signs of wear. They are single glazed wood sashes. Exterior siding is in need of refinishing as soon as possible, if not replacement.

Wire mesh infill has been added to several of the landing guardrails, but has only been marginally effective and is in need of replacement.

Some elements of the footing are showing significant spalling in the concrete and should be patched and sealed.

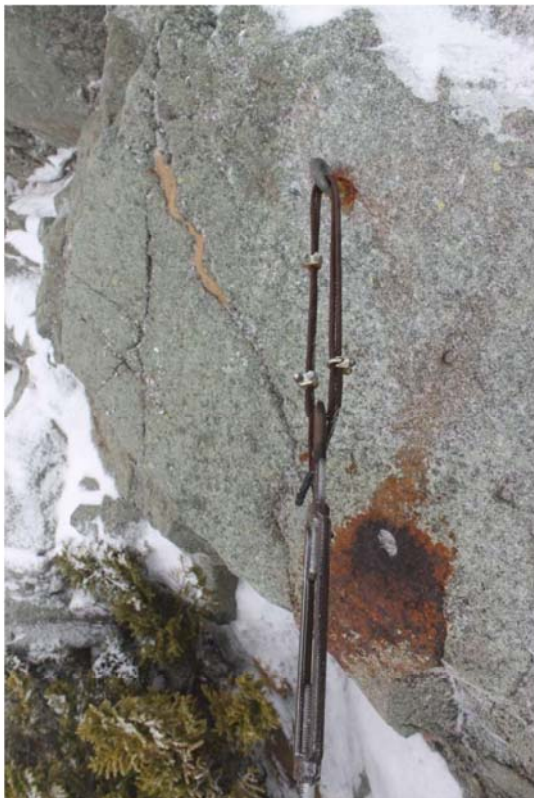
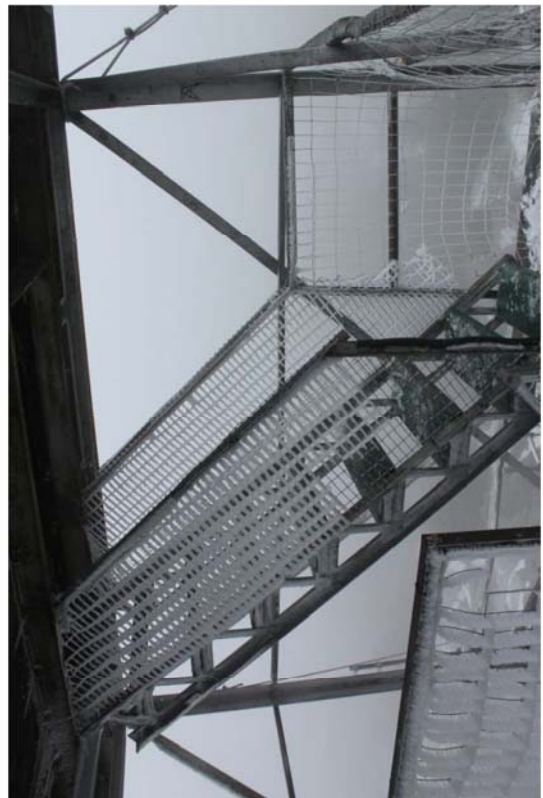
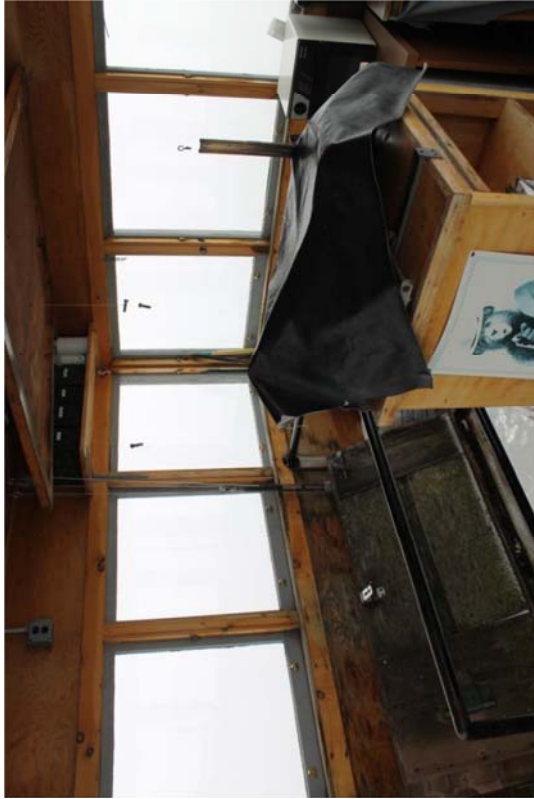
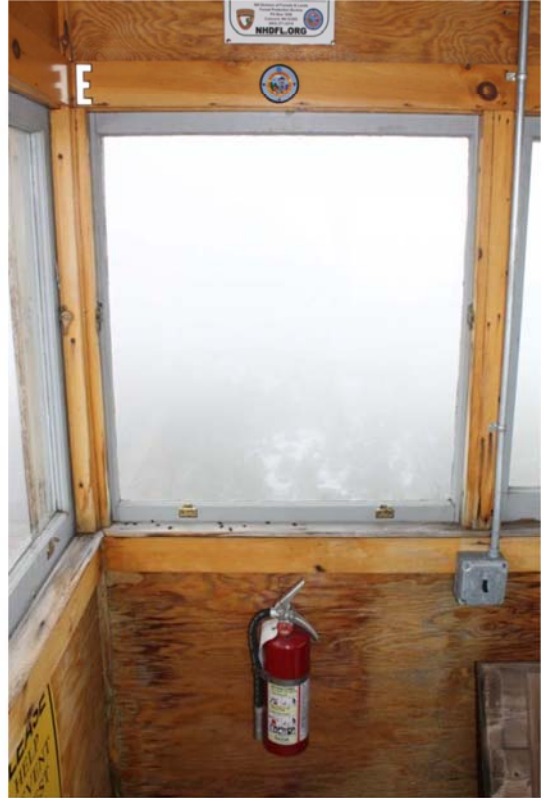
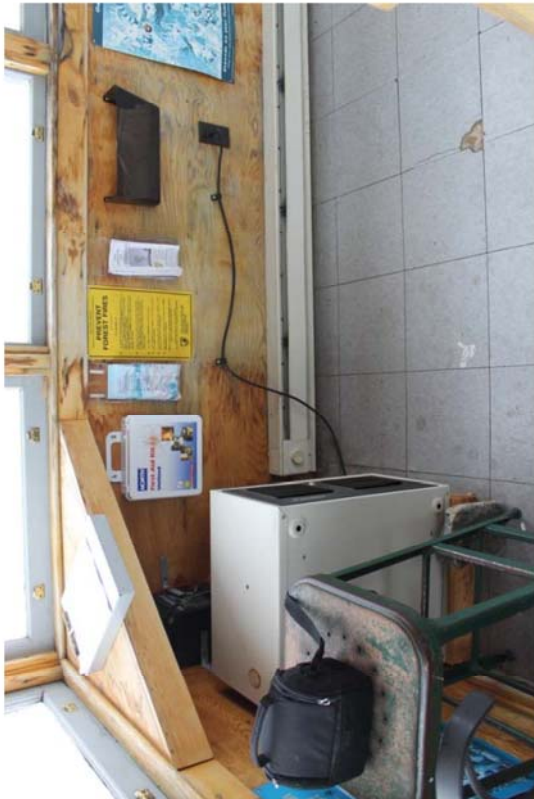
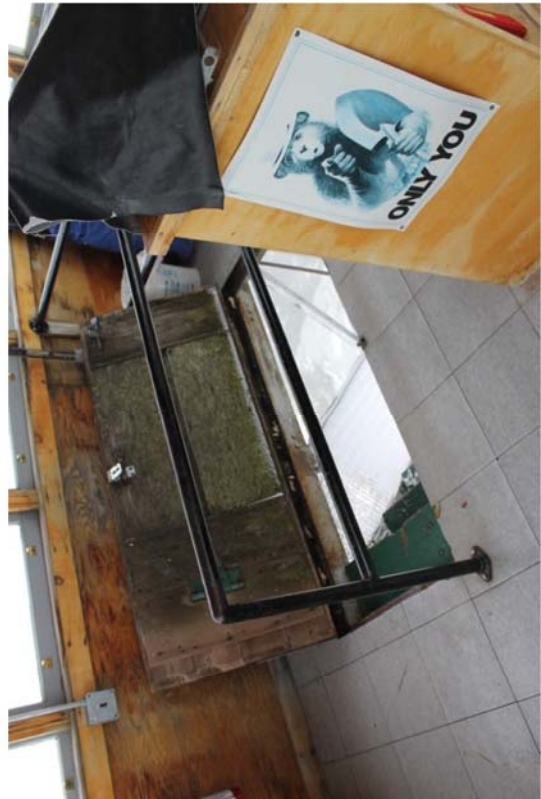
KEARSARGE MOUNTAIN (Wilmot & Warner)

date: 16th January, 2014 - weather conditions: overcast, poor visibility, approx. 20 degrees F.

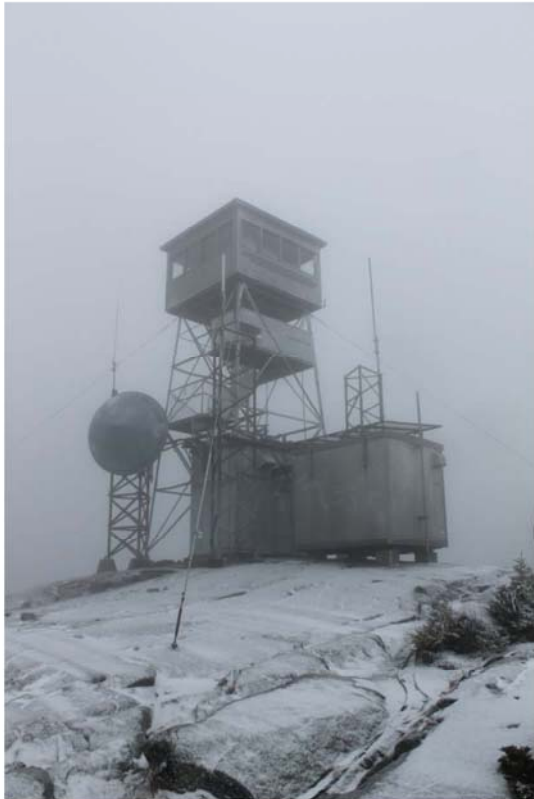
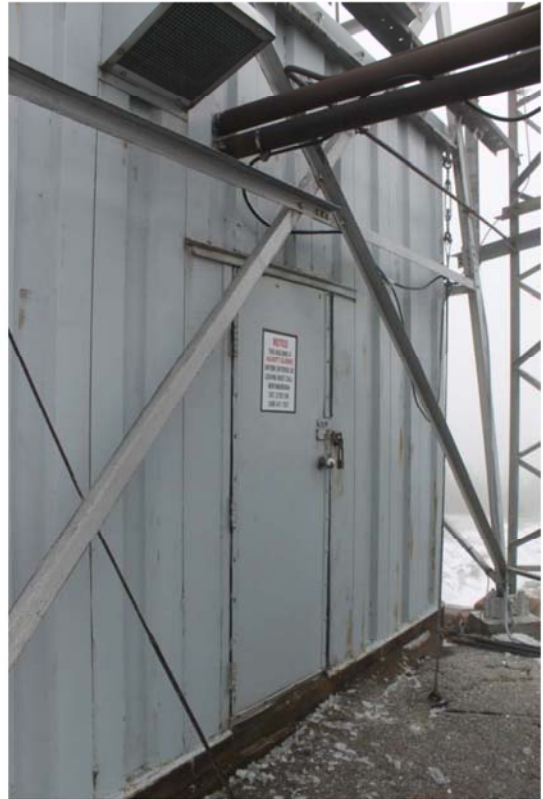
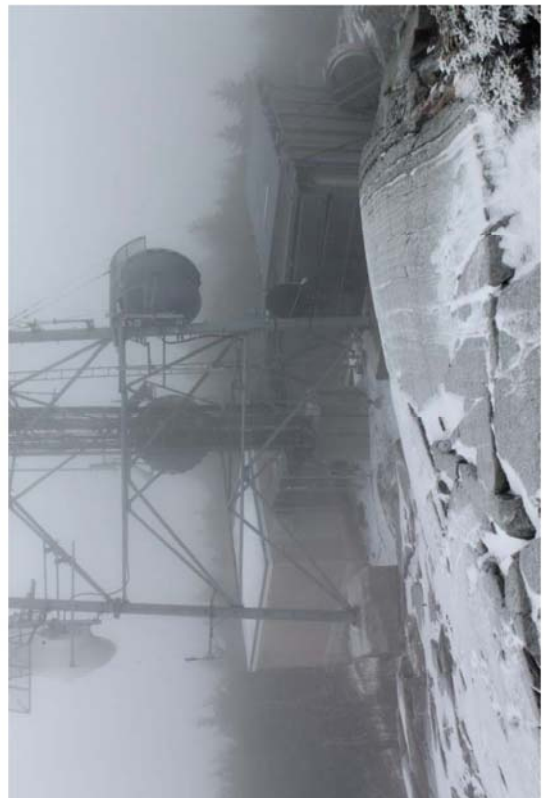
KEARSARGE MOUNTAIN - ADJACENT STRUCTURES

date: 16th January, 2014 - weather conditions: overcast, poor visibility, approx. 20 degrees F.

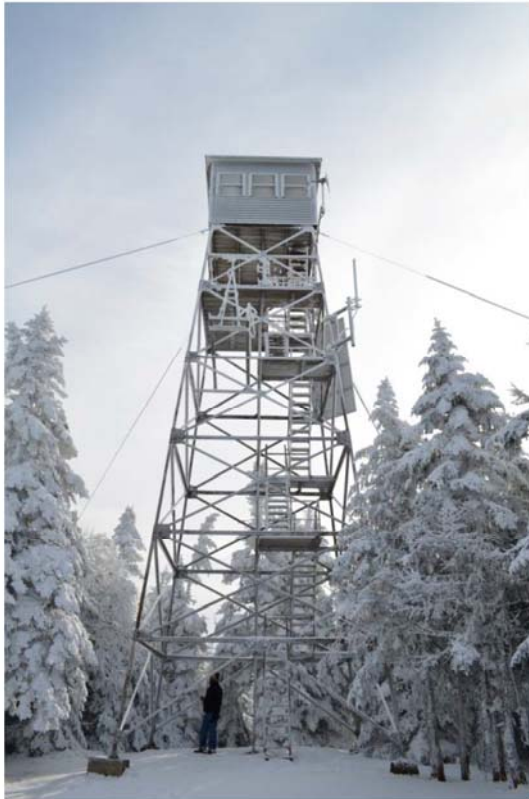
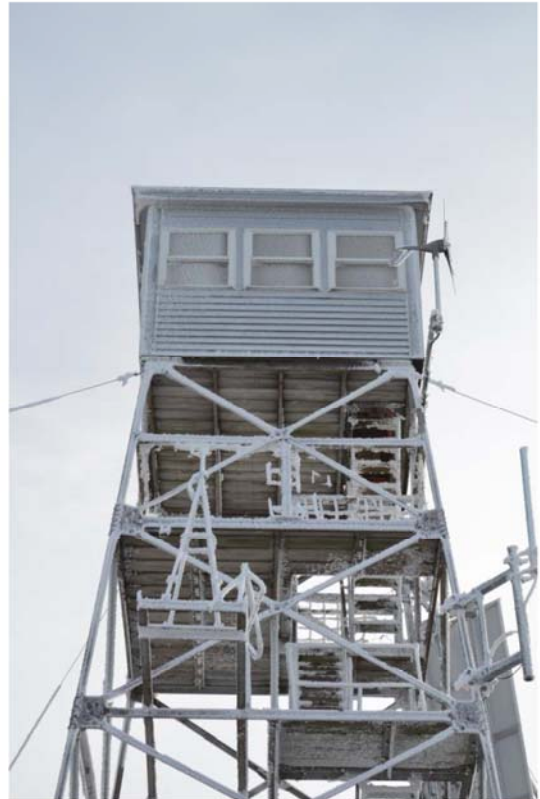
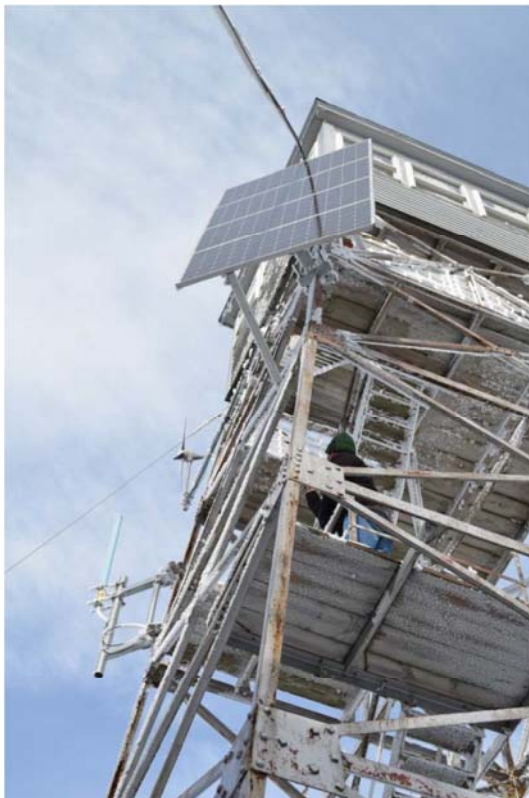
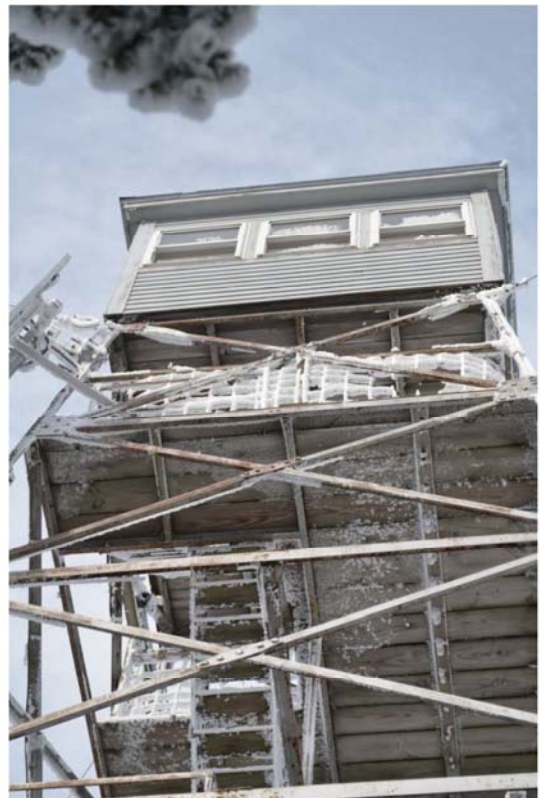
MAGALLOWAY MOUNTAIN (Pittsburg)

date: 15th November, 2013 - weather conditions: partly sunny, approx. 40 degrees F.

The fire tower frame consists of painted steel angles and flat bar elements, as noted on the attached drawings. The frame members are generally in good condition with numerous areas of superficial rust. At this point, the rust poses no structural concerns, and refinishing of the tower frame should be scheduled sooner rather than later.

The seven flights of the tower stairs consist of painted 20.5" long 2x8 pt treads bolted to 1.5x1.5" steel angles, which in turn are bolted to 6x3/8" plate steel stringers. Handrail/guardrail consists of 1.5x1.5" steel top bar and uprights bolted/riveted to plate stringer, with 1x3/8" flat bar mid-rail. As per the main tower frame, superficial rust is exhibited and will require refinishing in a timely manner to stop progression into loss of integrity. Stair treads will at minimum require refinishing, as they are generally in sound condition, but have a limited useful life left to them. Landings/Platforms exhibit the same conditions and requirements. Some wire mesh infill has been installed at landings, but does not appear to be holding up well. Guardrails are typically 33" above stair treads and 44" high at main landings.

The tower cab to Magalloway has been recently replaced in its entirety. The cedar clapboards and trims to the exterior are showing signs of wear, but are generally in good shape and do not require immediate attention. Vinyl double hung/double glazed windows were utilized and require little more than regular, visual inspection. Interior has been finished with finish grade ply to walls and ceiling, with strip/battens at joints, and narrow strip oak boarding to floor, installed over what appears to be the 2x8 pt deck retained from the previous cab construction. Electrical wiring has been incorporated into the cab, however there is no electrical service to the cab apart from minimal power provided by one 4x8 pv panel.
