REPORT - 30TH APRIL, 2014

STATE OF NEW HAMPSHIRE - DEPARTMENT OF RESOURCES & ECONOMIC DEVELOPMENT

DIVISION OF FORESTS & LANDS

**IMPROVEMENTS AND CONSTRUCTION ADMINISTRATION TO FIRE TOWERS
AND AUXILIARY BUILDINGS IN VARIOUS STATE RESERVATIONS**

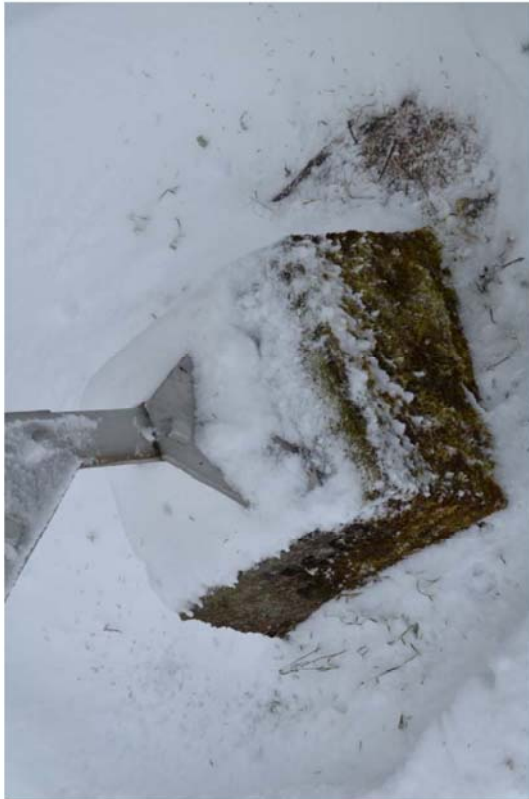
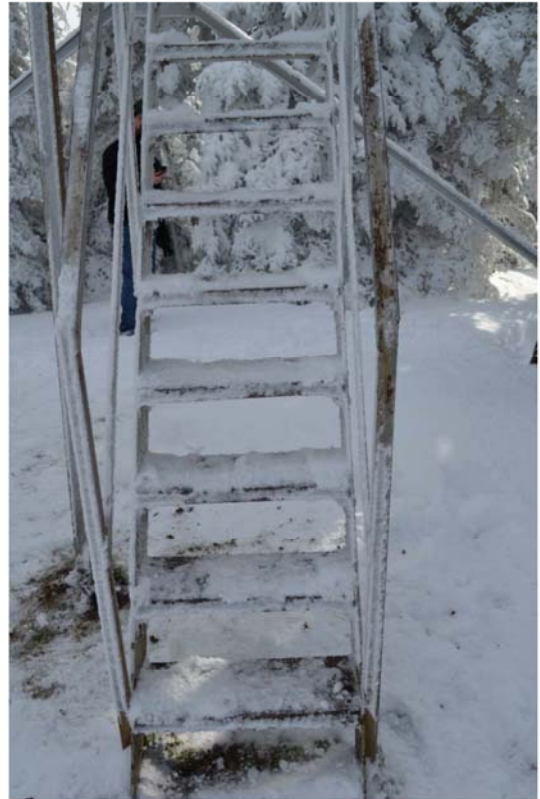
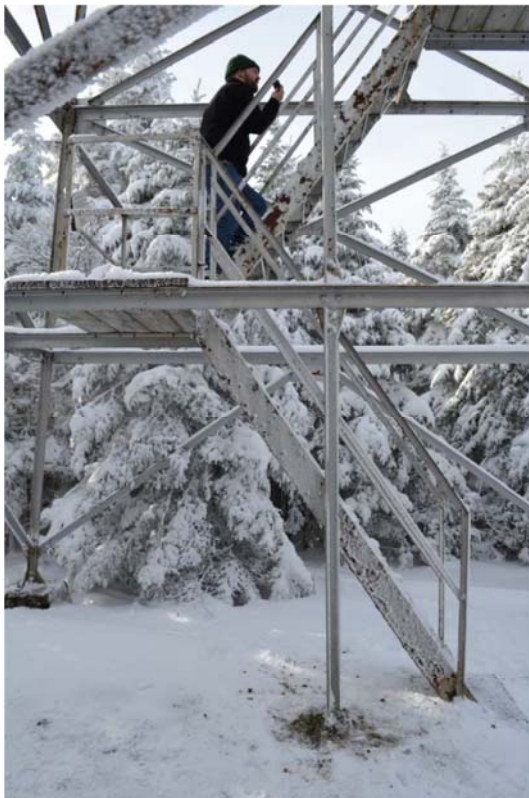
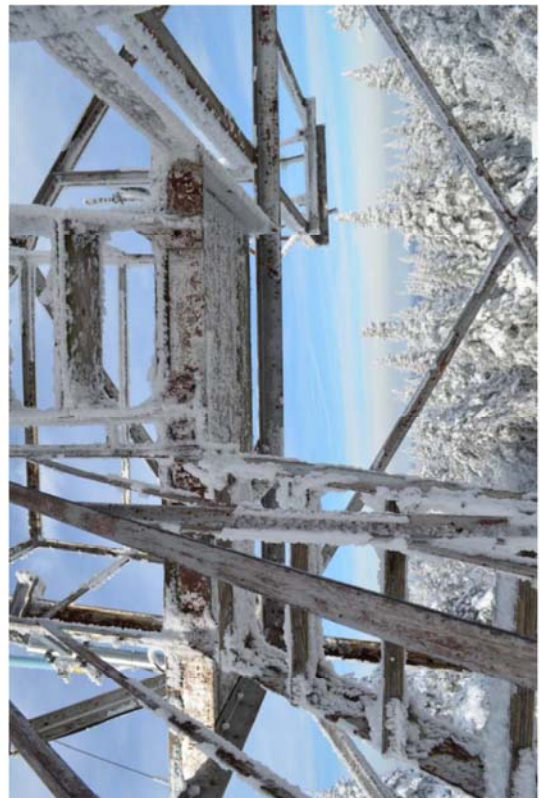
MAGALLOWAY MOUNTAIN (Pittsburg)

date: 15th November, 2013 - weather conditions: partly sunny, approx. 40 degrees F.

The fire tower frame consists of painted steel angles and flat bar elements, as noted on the attached drawings. The frame members are generally in good condition with numerous areas of superficial rust. At this point, the rust poses no structural concerns, and refinishing of the tower frame should be scheduled sooner rather than later.

The seven flights of the tower stairs consist of painted 20.5" long 2x8 pt treads bolted to 1.5x1.5" steel angles, which in turn are bolted to 6x3/8" plate steel stringers. Handrail/guardrail consists of 1.5x1.5" steel top bar and uprights bolted/riveted to plate stringer, with 1x3/8" flat bar mid-rail. As per the main tower frame, superficial rust is exhibited and will require refinishing in a timely manner to stop progression into loss of integrity. Stair treads will at minimum require refinishing, as they are generally in sound condition, but have a limited useful life left to them. Landings/Platforms exhibit the same conditions and requirements. Some wire mesh infill has been installed at landings, but does not appear to be holding up well. Guardrails are typically 33" above stair treads and 44" high at main landings.

The tower cab to Magalloway has been recently replaced in its entirety. The cedar clapboards and trims to the exterior are showing signs of wear, but are generally in good shape and do not require immediate attention. Vinyl double hung/double glazed windows were utilized and require little more than regular, visual inspection. Interior has been finished with finish grade ply to walls and ceiling, with strip/battens at joints, and narrow strip oak boarding to floor, installed over what appears to be the 2x8 pt deck retained from the previous cab construction. Electrical wiring has been incorporated into the cab, however there is no electrical service to the cab apart from minimal power provided by one 4x8 pv panel.

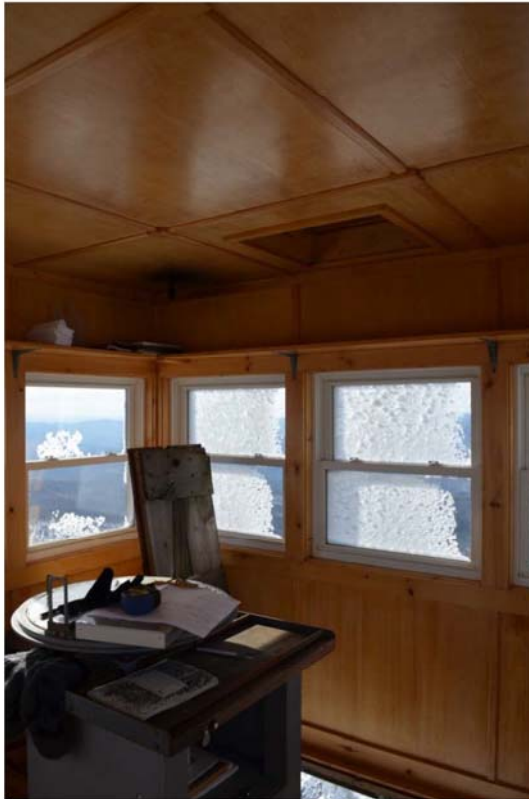
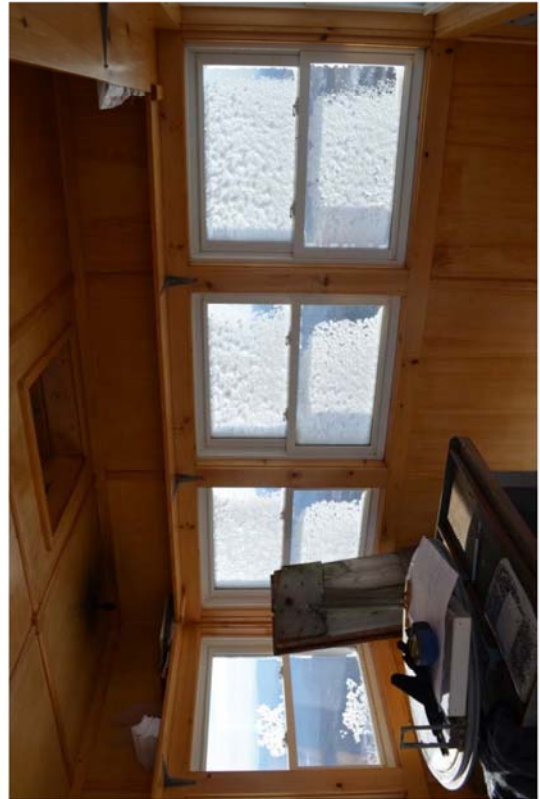
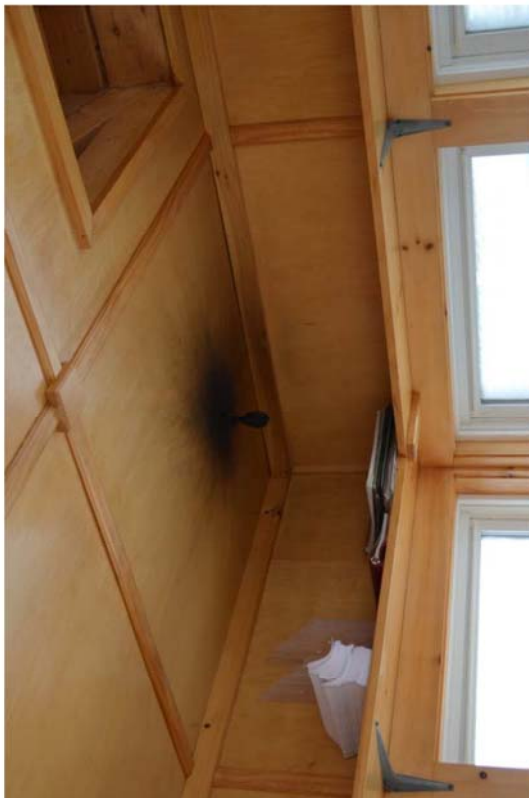
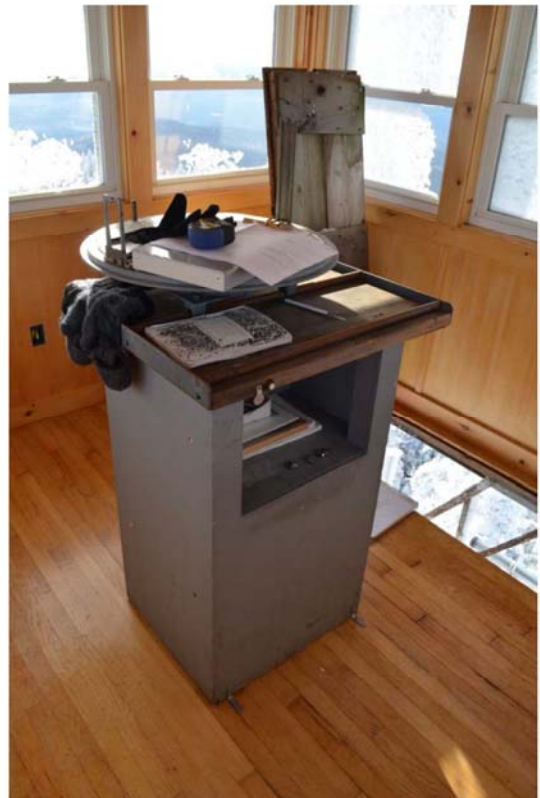
MAGALLOWAY MOUNTAIN (Pittsburg)

date: 15th November, 2013 - weather conditions: partly sunny, approx. 40 degrees F.

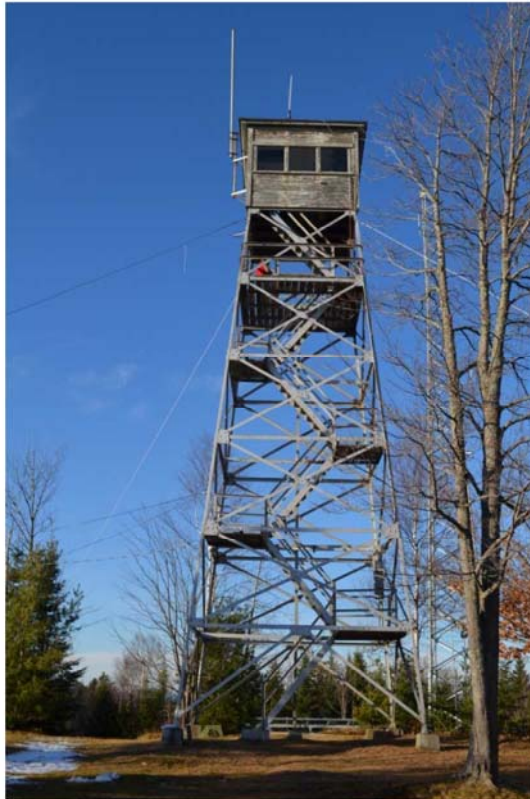
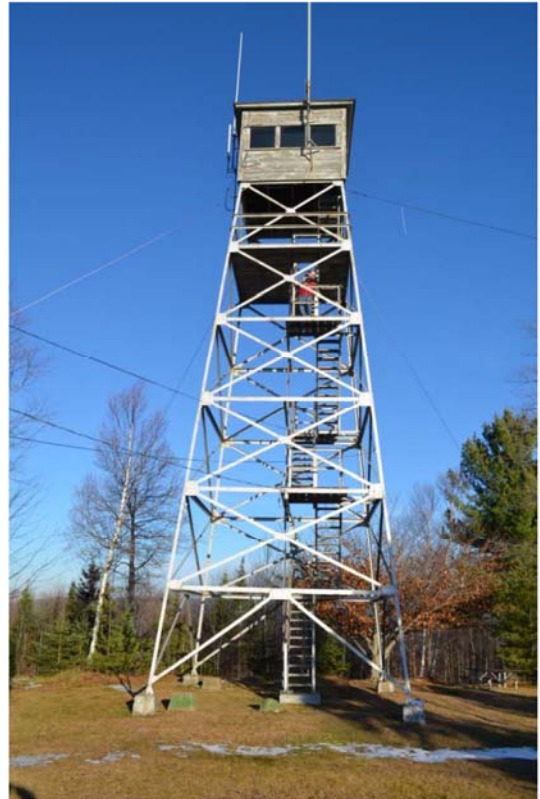
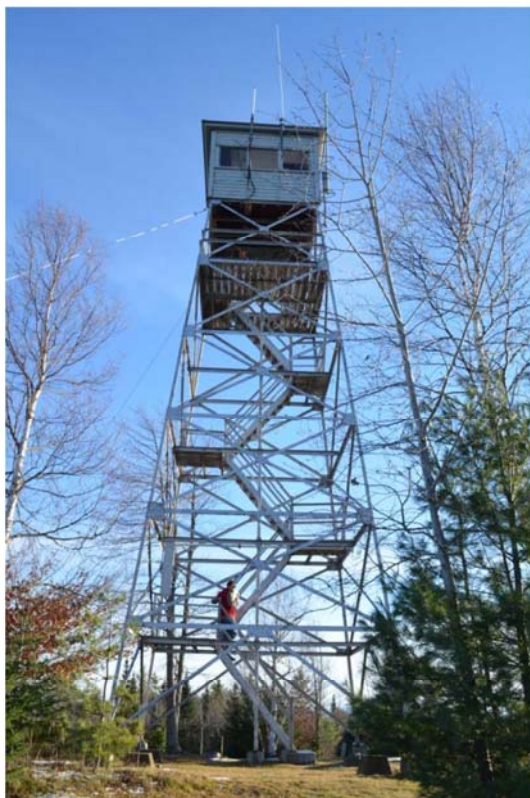
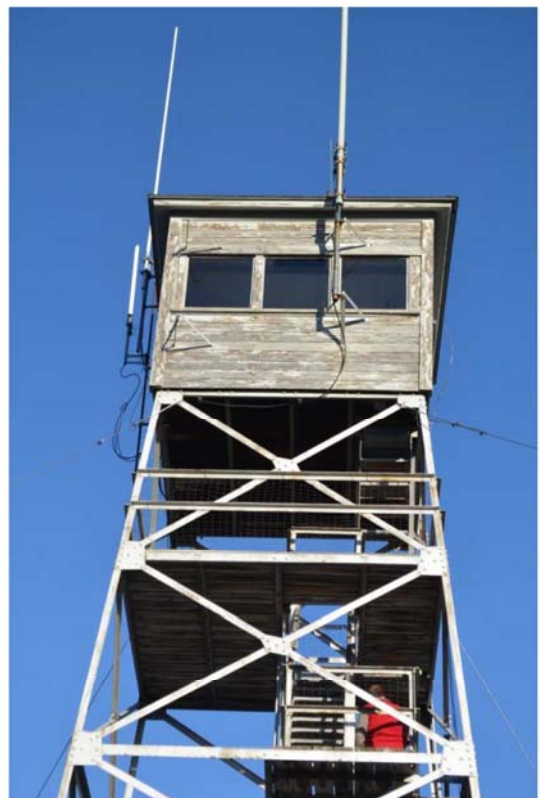
MILAN HILL (Milan)

EXISTING CONDITION PHOTOGRAPHS

The fire tower frame consists of painted steel angles and flat bar elements, as noted on the attached drawings. The frame members are generally in good condition though most exhibit significant areas of superficial rust. At this point, the rust poses no structural concerns, but the frame will require refinishing in the near future to insure no loss of integrity to the frame.

The six flights of the tower stairs consist of painted 22.25" long 2x8 pt treads bolted to 1.5x1.5" steel angles, which in turn are bolted to 6x3/8" plate steel stringers. Handrail/guardrail consists of 1.5x1.5" steel top bar and uprights bolted to plate stringer, with 1x3/8" flat bar mid-rail. As per the main tower frame, significant superficial rust is exhibited and will require refinishing in a timely manner to stop progression into loss of integrity. Stair treads will at minimum require refinishing, as they are generally in sound condition, but have a limited useful life left to them. Landings/Platforms exhibit the same conditions and requirements.

Exterior finishes of the cab are beyond usefulness and will need replacing. Windows appear to be minimally operable and only satisfy the most basic of functions, but will require refinishing at the minimum. Wind/air tightness is limited with these units, although water ingress seems to be minimal. Significant signs of rot and deterioration of all wood finishes is present and indicates necessary replacement is not far off. Interior has no wall finishes on the top half and is composed of painting the back side of the exterior board sheathing. The lower half has thin particle board finish painted, as is the ceiling. The floor consists of narrow plank hardwood flooring on the 2x8 pt sub-floor. All interior finishes are still functional but not of particularly high standard and would not warrant salvage. The frame of the cab appears to be in reasonable condition and includes steel angle members in the corners, a continuation of the tower structural frame. Whichever route is chosen will need to address the corner members, either building around them or cutting them off. The 2x8 pt substructure appears to still be viable, from the underside, and could continue to be the substructure for a new floor, or cab, as it appears to have had very limited exposure to moisture.

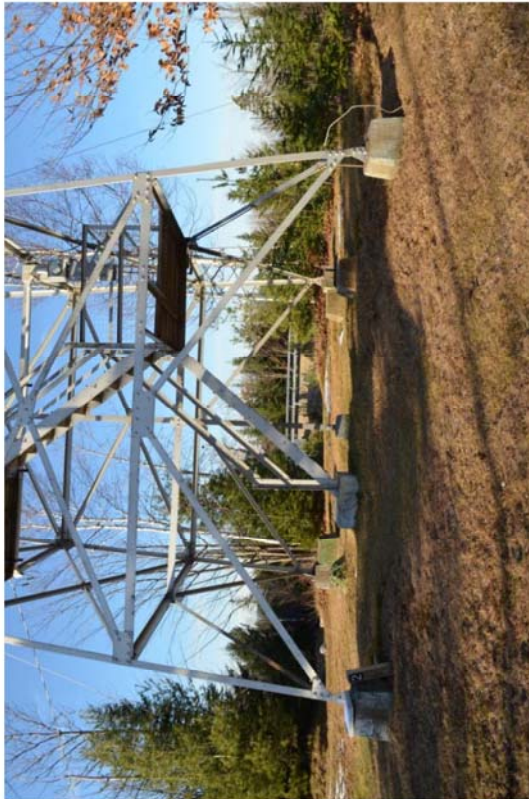
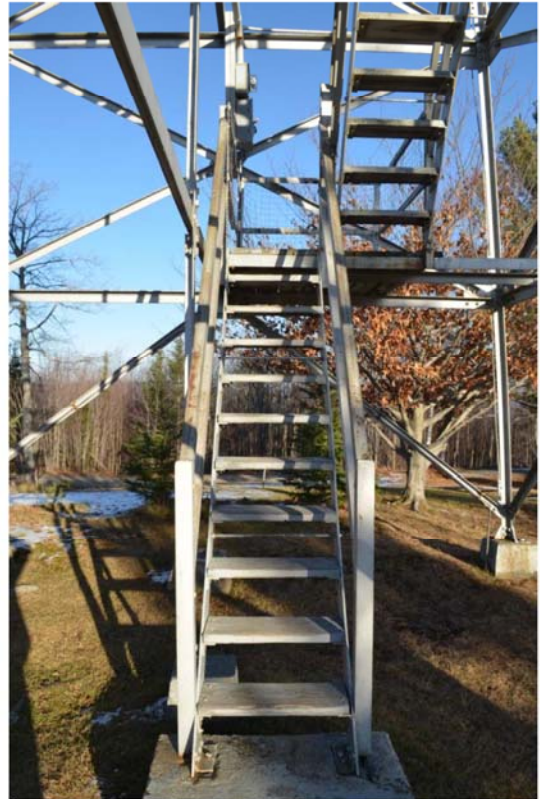
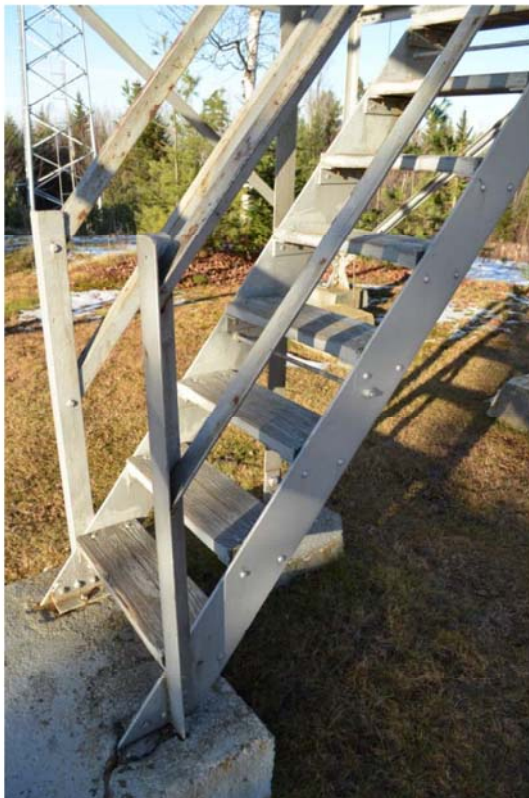
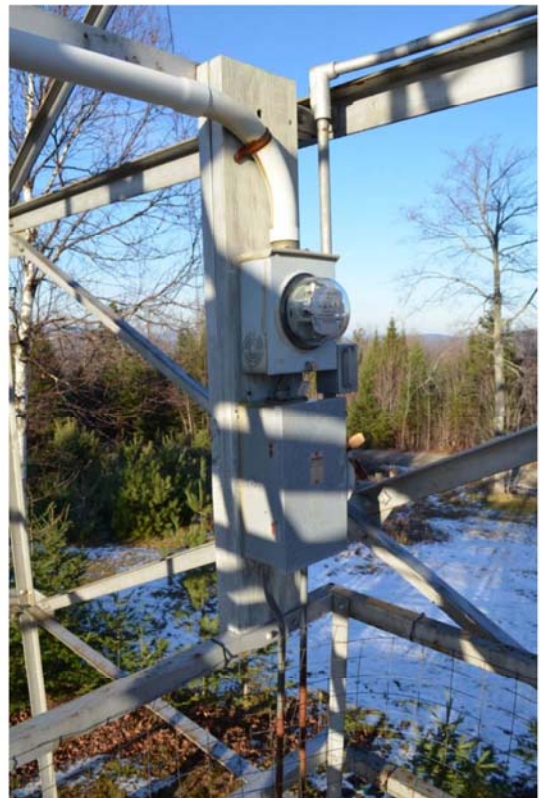
MILAN HILL (Milan)

EXISTING CONDITION PHOTOGRAPHS

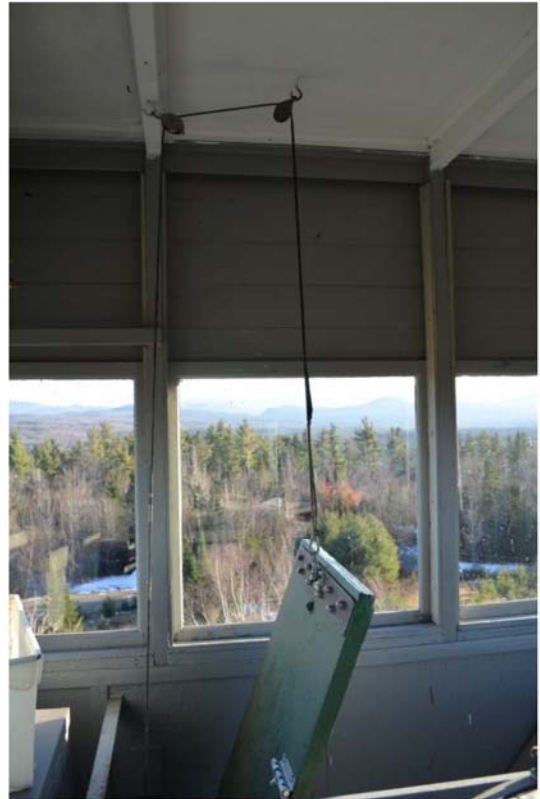
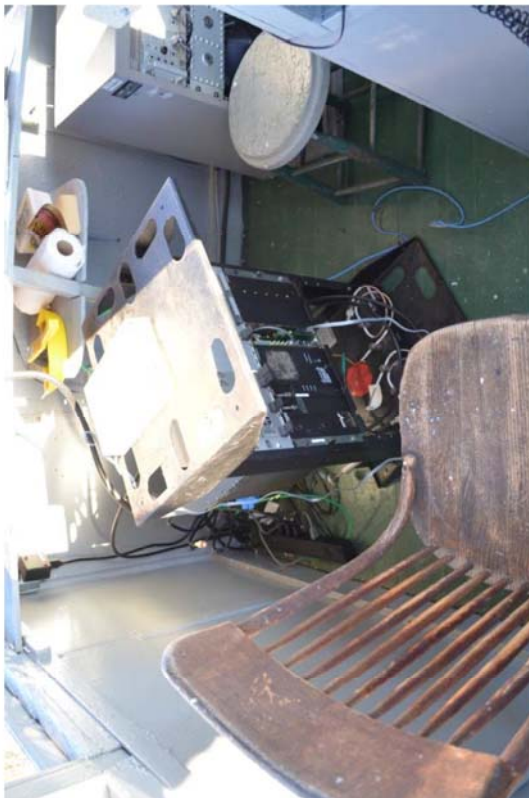
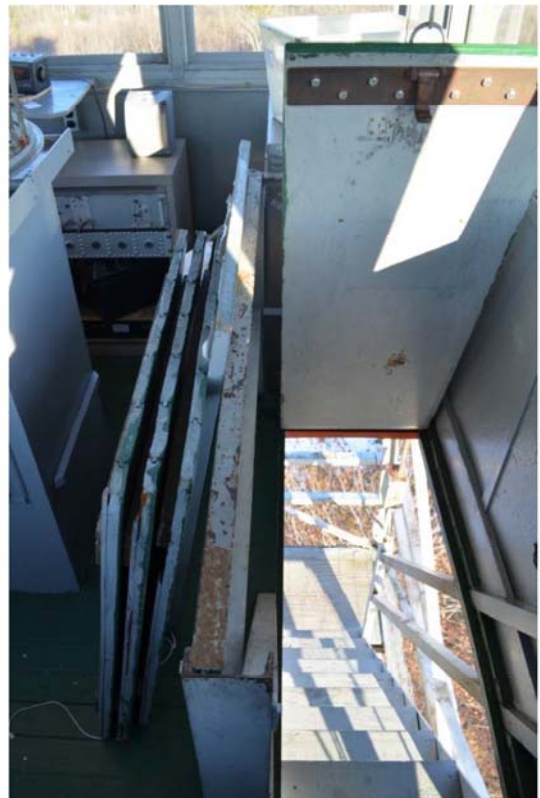
MILAN HILL (Milan)

EXISTING CONDITION PHOTOGRAPHS

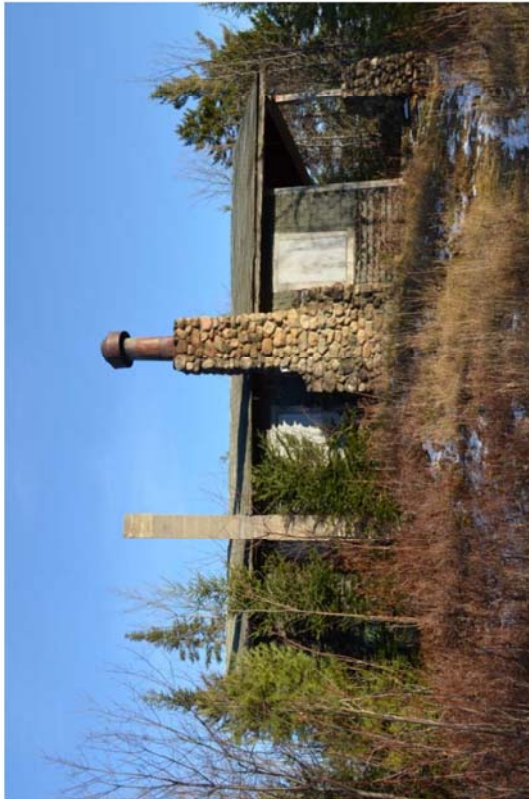
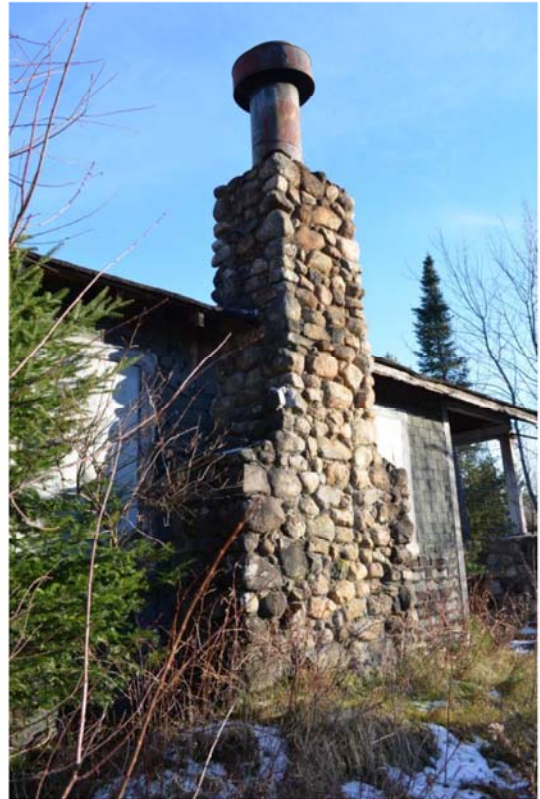
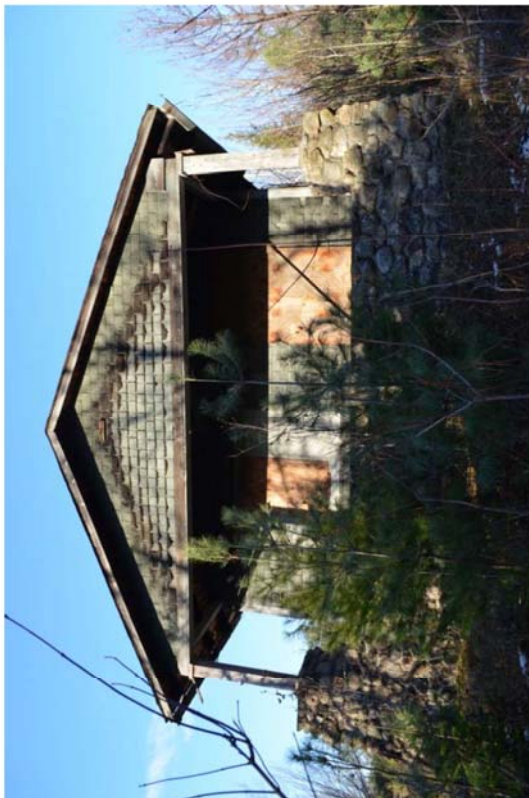
MILAN HILL - WATCHMAN CABIN

EXISTING CONDITION PHOTOGRAPHS

The watchman's cabin was only inspected from the outside, as continued vandalism required plywood sheathing over all openings. Observing the interior through small penetrations in the ply covers suggest the condition of the structure and finishes are badly deteriorated. Any consideration of reuse of the structure will require further investigation. However, the structure is potentially one of the most interesting and historically notable structures for the watchman's cabin. The exterior includes stone foundation and piers to the covered entry deck, as well as a stone chimney and presumably fireplace. The exterior walls are covered in asphalt shingles, as is the roof. All exterior finishes and, as noted, interior finishes would have to be replaced. The refurbishment of this structure would be a very involved and relatively expensive venture. However, as the hill is not of notable significance and is fully accessible by vehicles, it suggests that there would not be a strong draw for campers to rent as overnight accommodation. The underutilization of nearby campsites supports this conclusion.

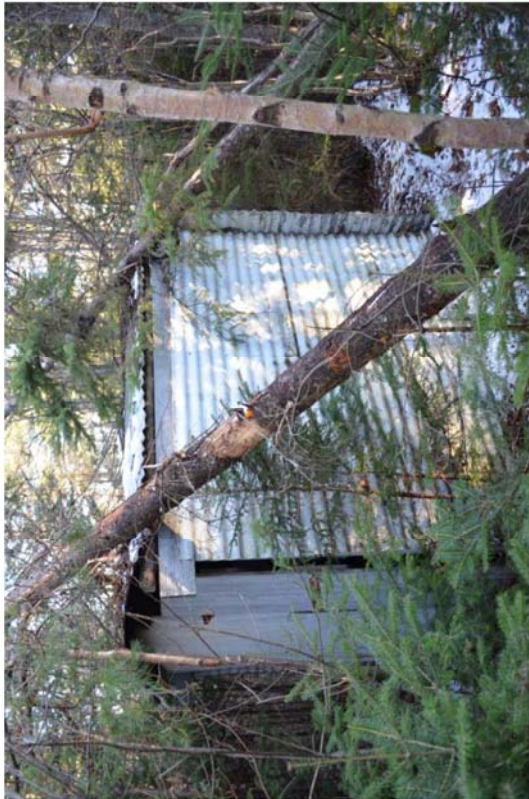
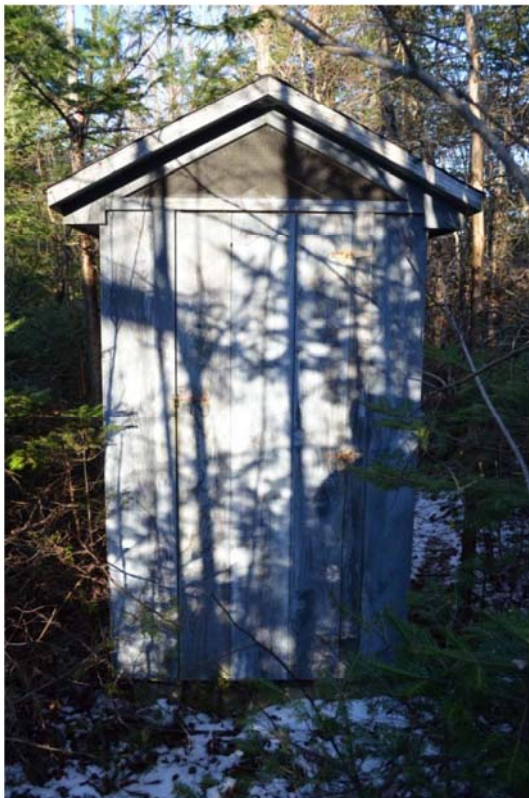
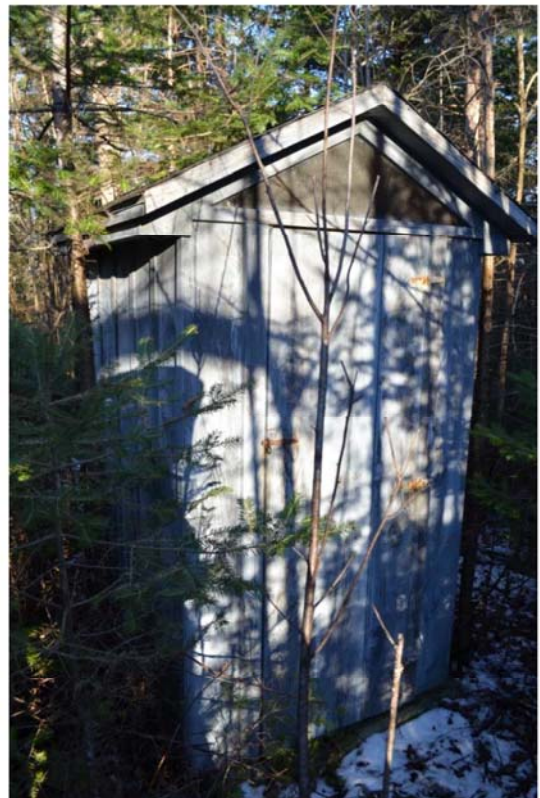
MILAN HILL - STORAGE & OUTHOUSE

EXISTING CONDITION PHOTOGRAPHS

The Milan Hill fire tower site consists of the fire tower, a watchman's cabin, a corrugated steel storage building and an abandoned outhouse. Neither the storage building nor outhouse warrant further consideration and should be removed from the site.

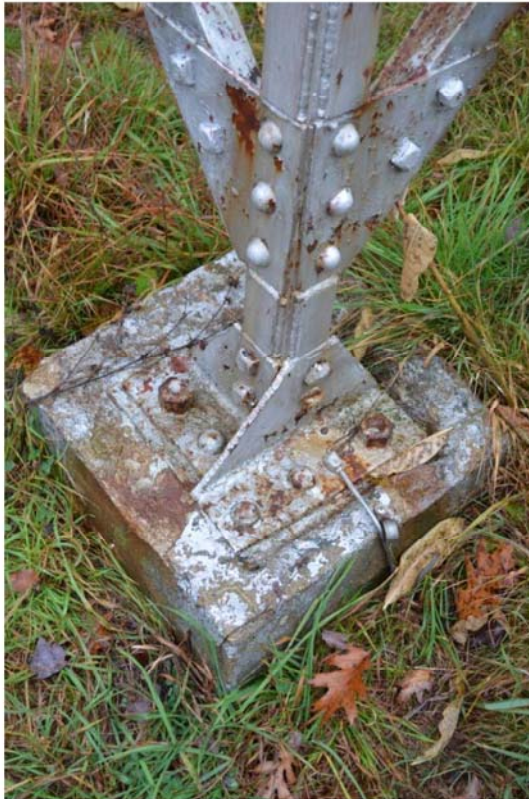
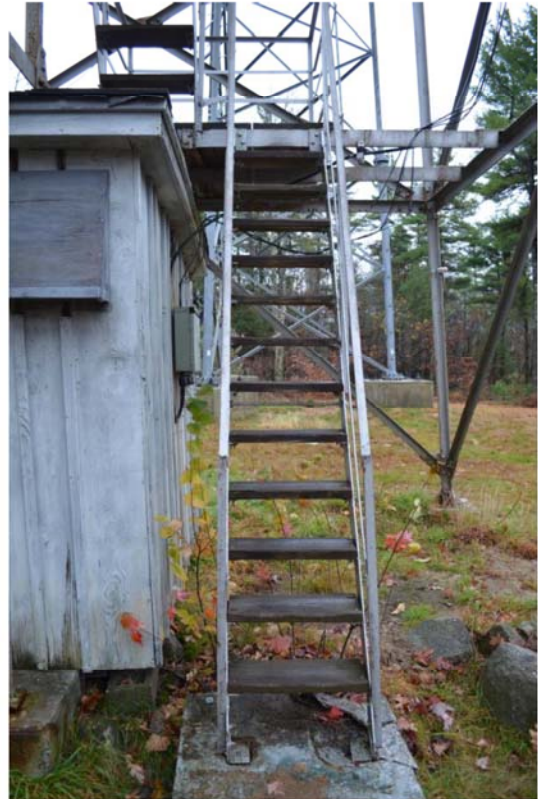
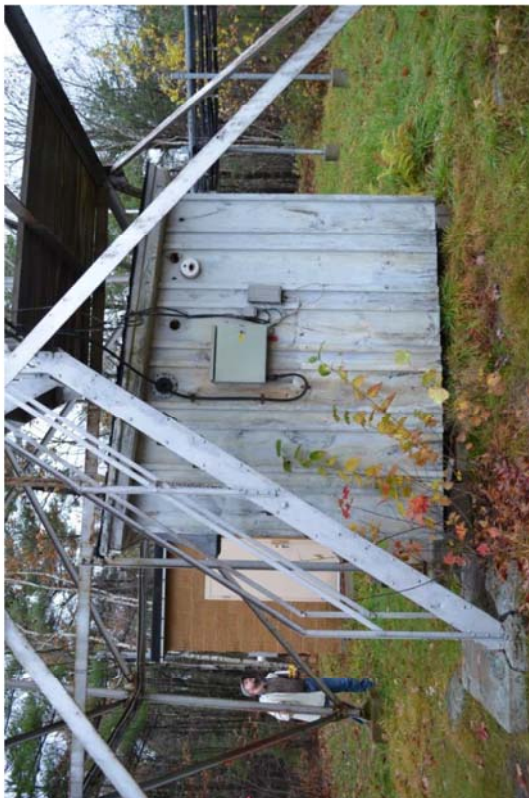
OAK HILL (Loudon)

EXISTING CONDITION PHOTOGRAPHS

The Oak Hill fire tower site consists of the tower, a garage storage building, an outhouse and an insulated shed at the base of the tower previously used in connection with the communication equipment. This building is beyond use and should be removed as soon as it is feasible.

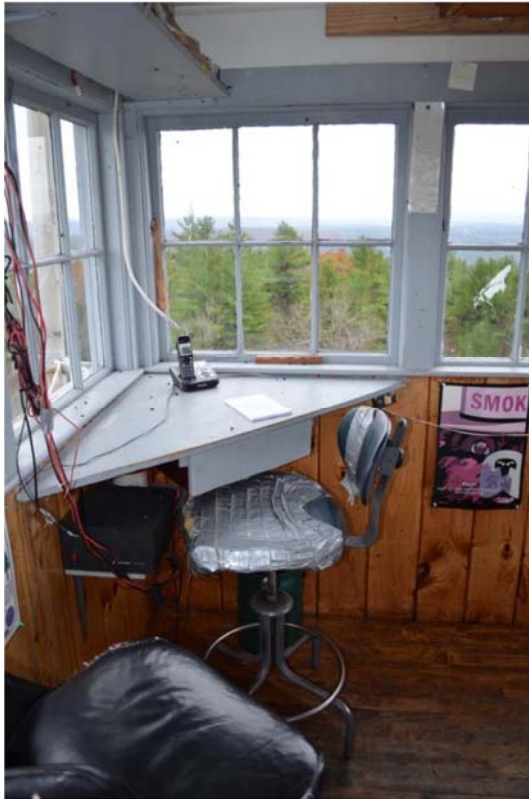
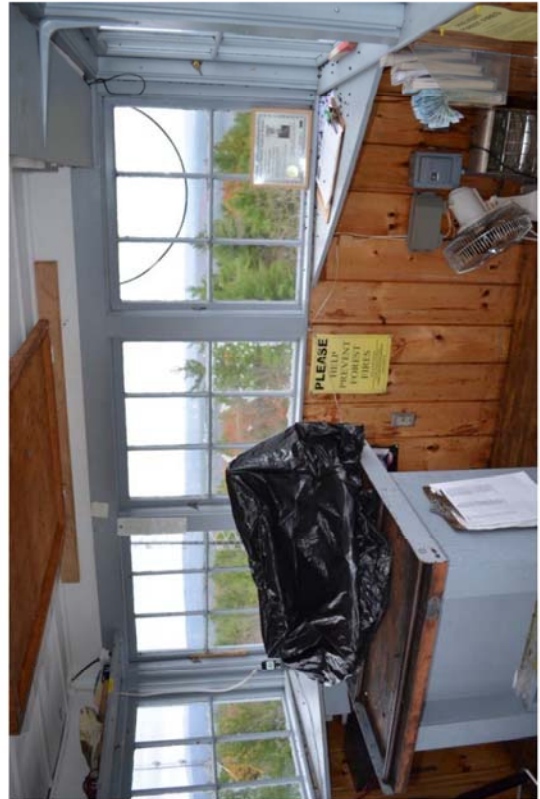
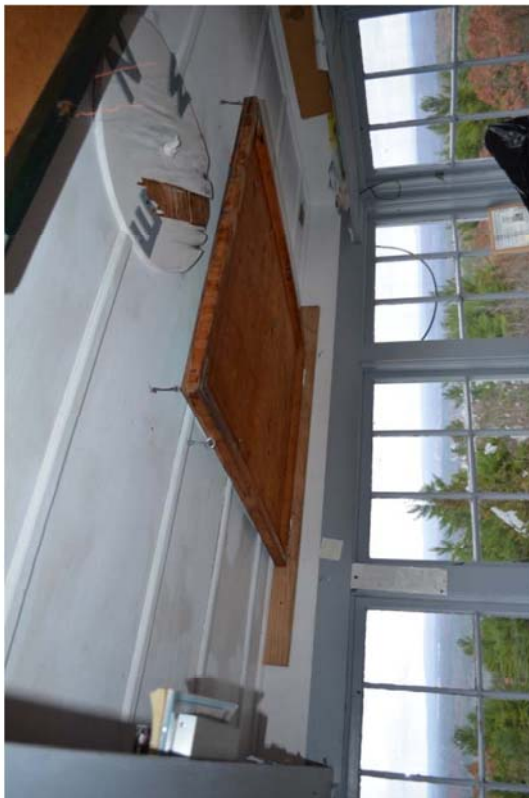
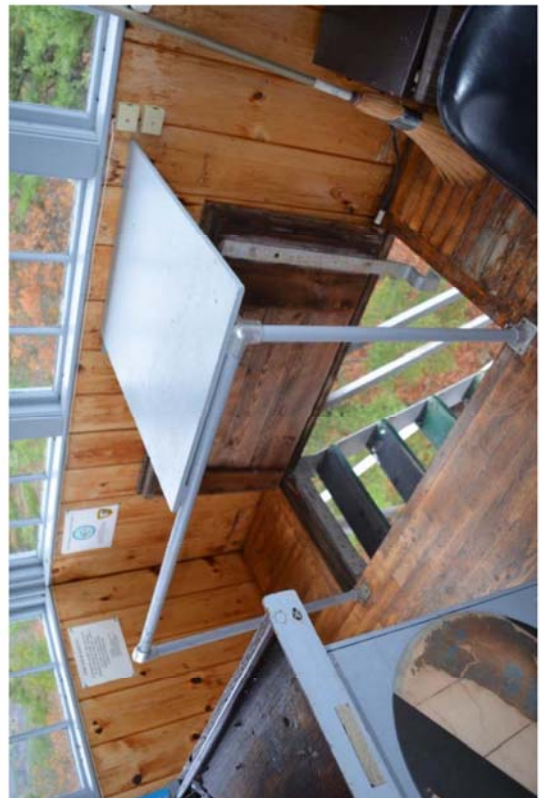
OAK HILL (Loudon)

EXISTING CONDITION PHOTOGRAPHS

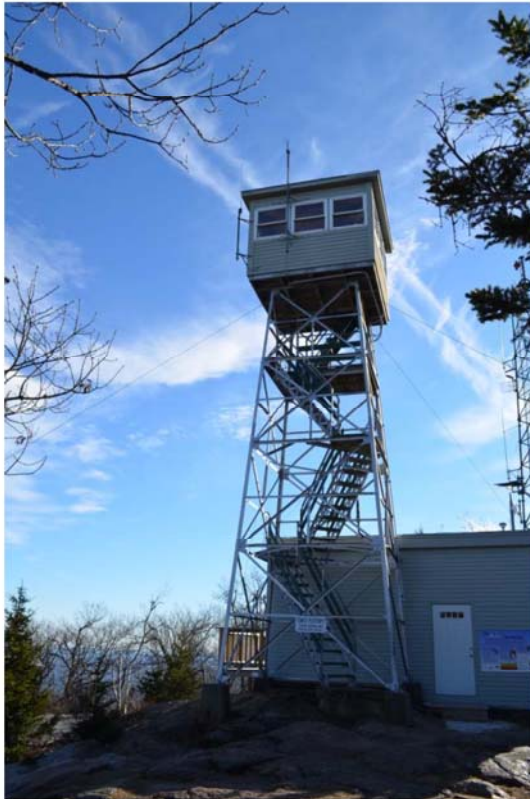
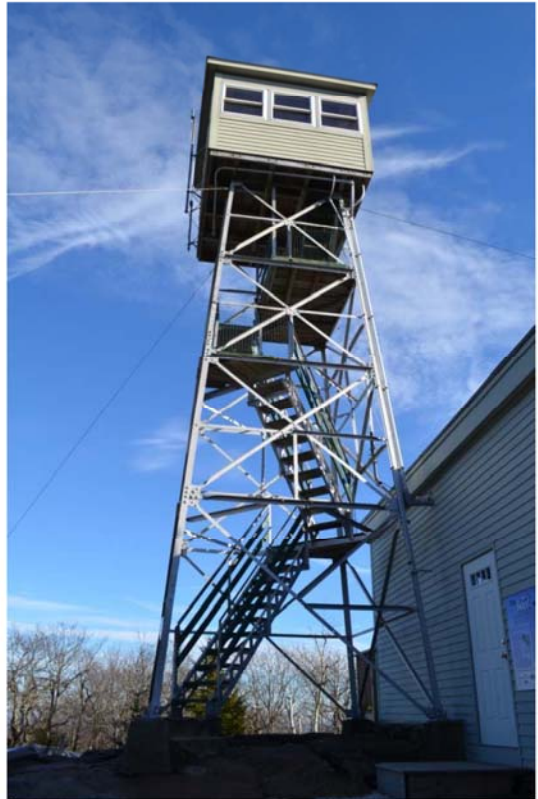
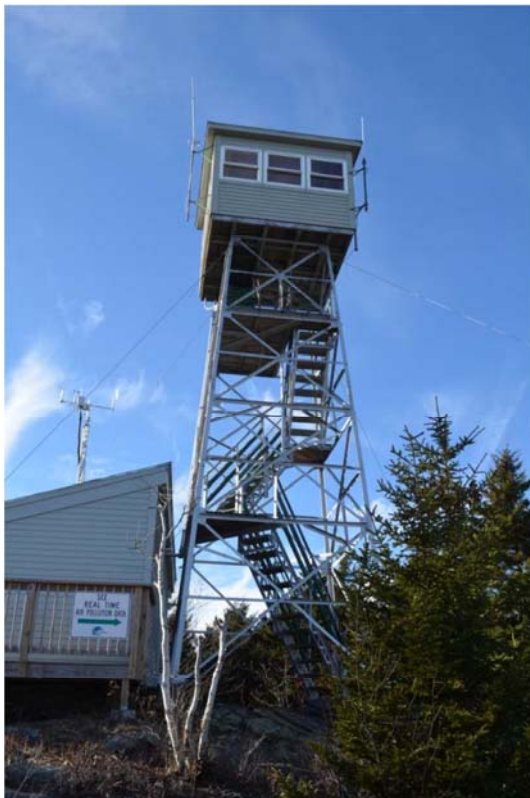
PACK MANADNOCK (Peterborough)

date: 21st November, 2013 - weather conditions: mostly sunny, approx. 38 degrees F.

The fire tower frame consists of painted steel angles and flat bar elements, as noted on the attached drawings. The frame members are generally in good condition with less rust noted than on most towers. Repainting of this frame is not immediately necessary, but will benefit from regular inspection and a regular maintenance schedule.

The tower cab has been recently replaced, as was Magalloway, and is finished in similar fashion and standard. The cedar clapboards and trims to the exterior are showing signs of wear, more so than Magalloway, and will need attention sooner. There seems to be some issue of moisture in the wood, as the paint appears to be deteriorating quicker than would be expected and shows signs of impending blistering, as well as deterioration of the wood. There is some suggestion that maybe moisture coming through the wall from the interior is affecting the exterior finish. Vinyl double hung / double glazed windows were utilized and require little more than regular, visual inspection. Interior has been finished with finish grade ply to walls and ceiling, with strip/battens at joints. The floor has been carpeted and presumably consists of a thin backing board over the 2x8 pt decking and carpet. Electrical wiring has been incorporated into the cab which has been fully energized, including baseboard heating.

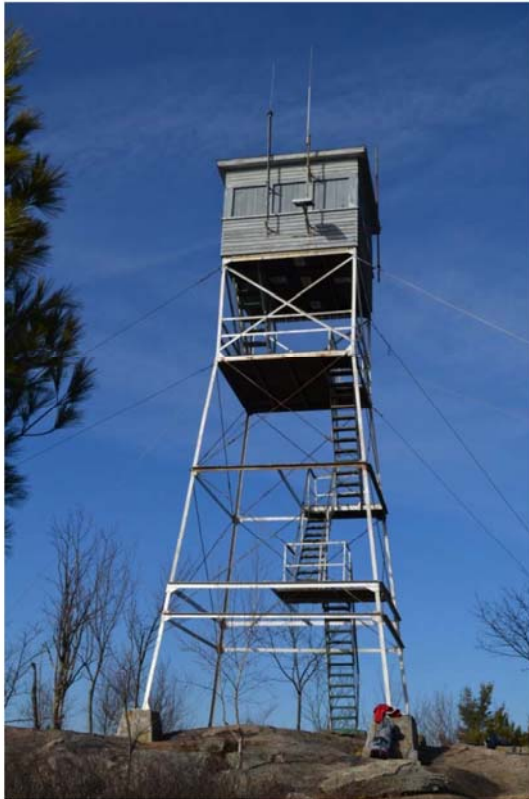
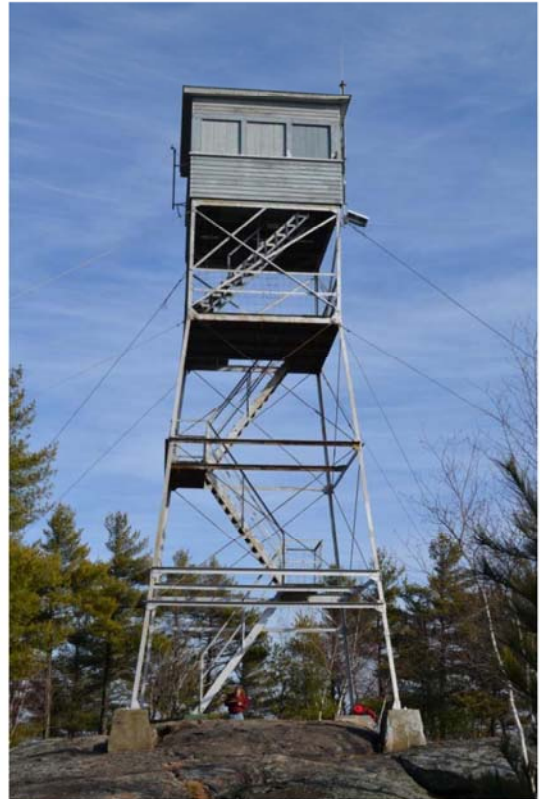
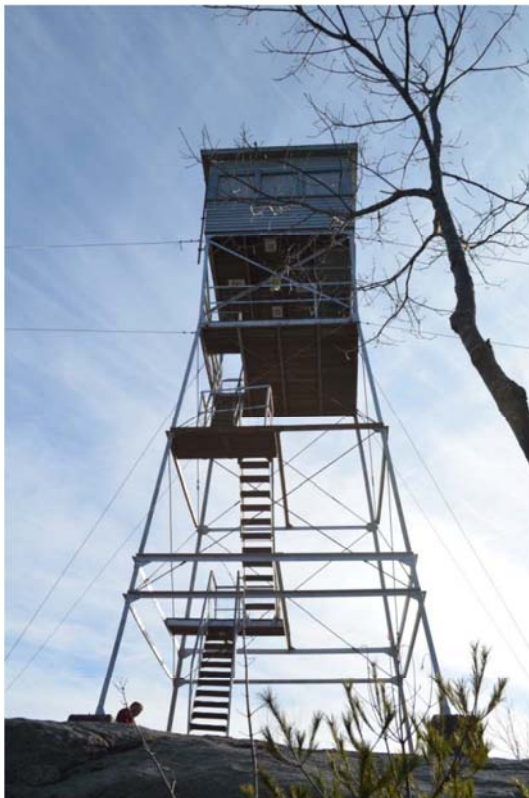
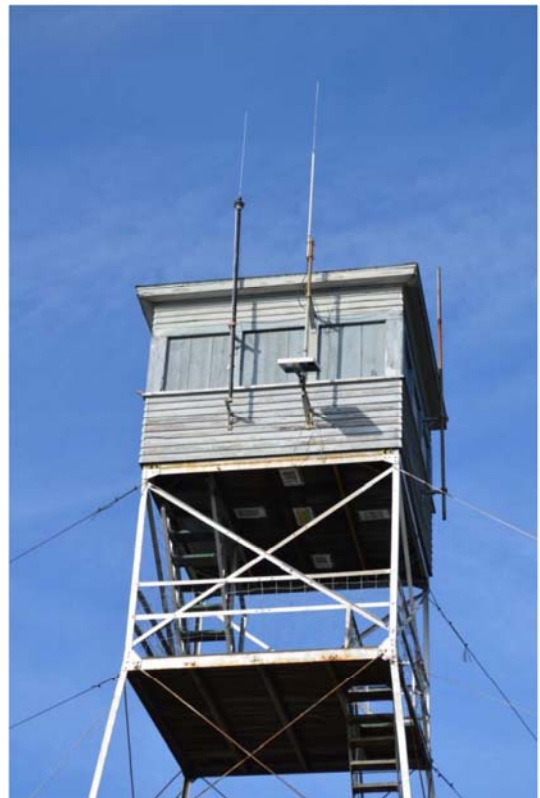
PAWTUCKAWAY (Nottingham)

date: 15th January, 2014 - weather conditions: mostly sunny, approx. 38 degrees F

The fire tower frame consists of painted steel angles and flat bar elements, as noted on the attached drawings. The frame members do exhibit some substantial rust and potential section loss and some may require replacement. The frame will require refinishing in the near future to insure no further loss of integrity.

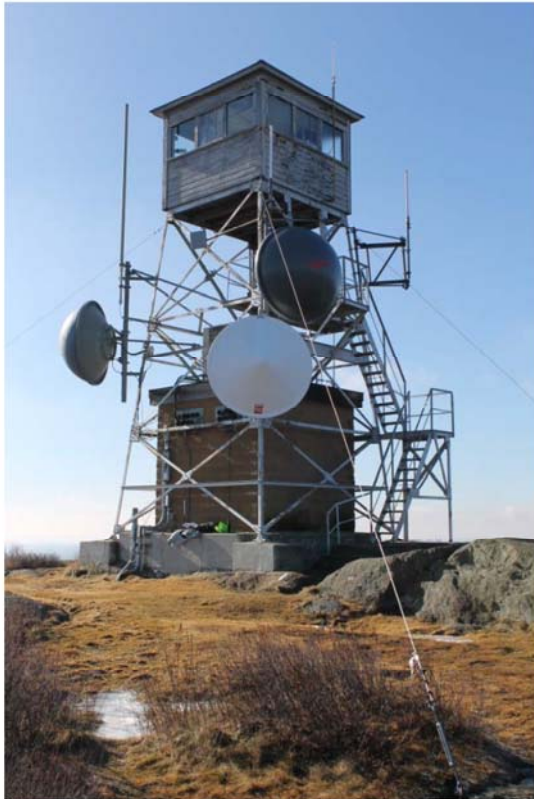
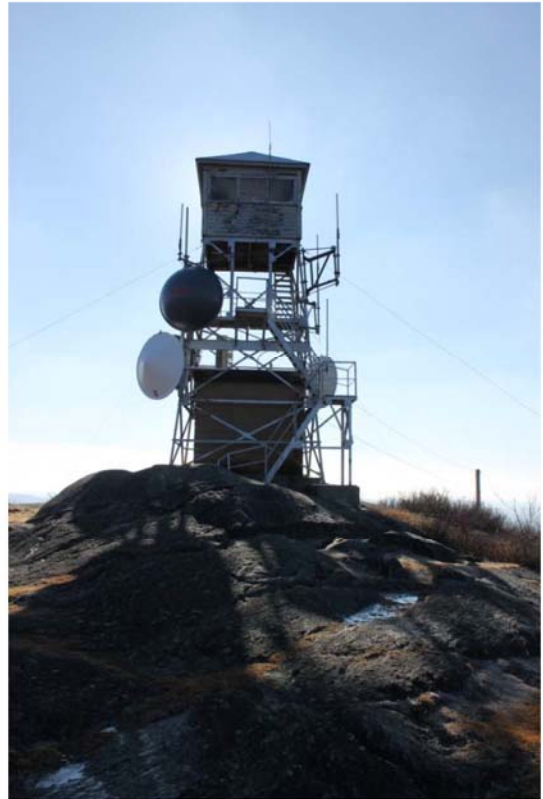
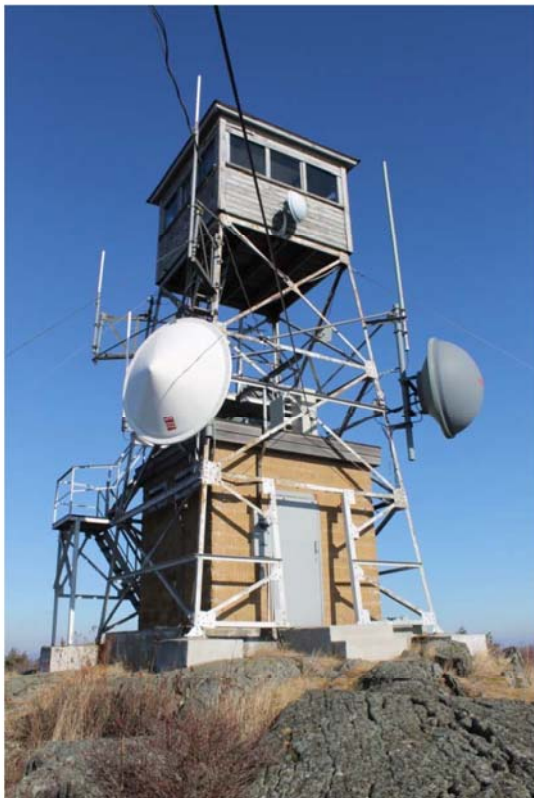
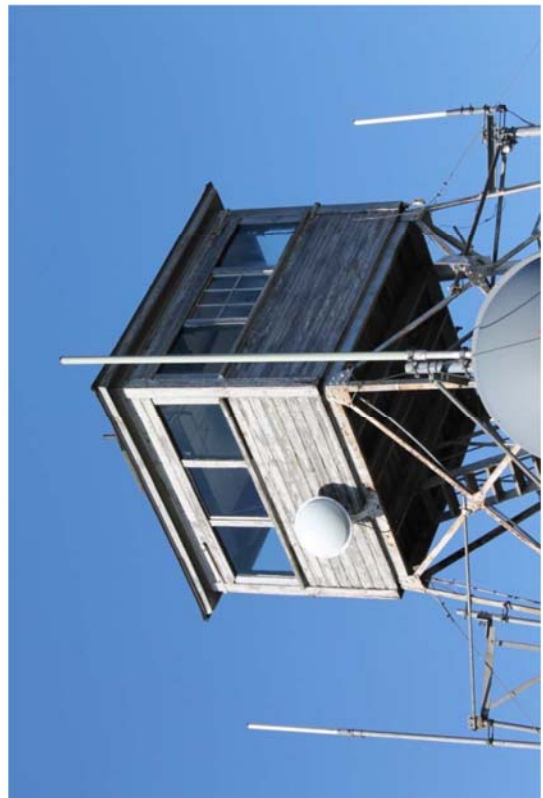
EXISTING CONDITION PHOTOGRAPHS

The fire tower frame consists of painted steel angles and flat bar elements, as noted on the attached drawings. The frame members do exhibit some substantial rust and potential section loss and some may require replacement. The frame will require refinishing in the near future to insure no further loss of integrity to the frame.

The fire tower cab is in a particularly advanced level of wear and deterioration. All finishes are past their useful life and require replacement. Evidence from the roof hatch and space indicates residents larger than wasps and insects. Wood window frames and trims show moisture issues on the inside. Exterior finishes are similarly beyond their usefulness and indicate a relatively short life to them. The cab has utility electric power supply and seems to be functional.

PITCHER MOUNTAIN (Stoddard)

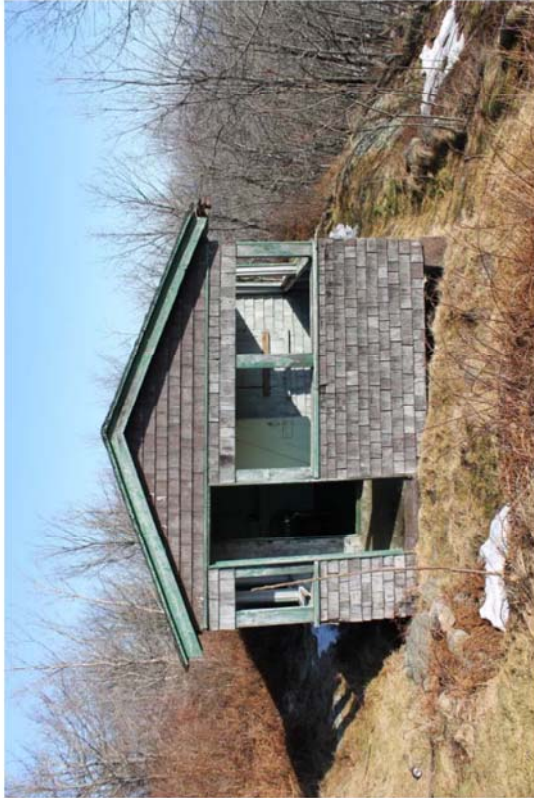
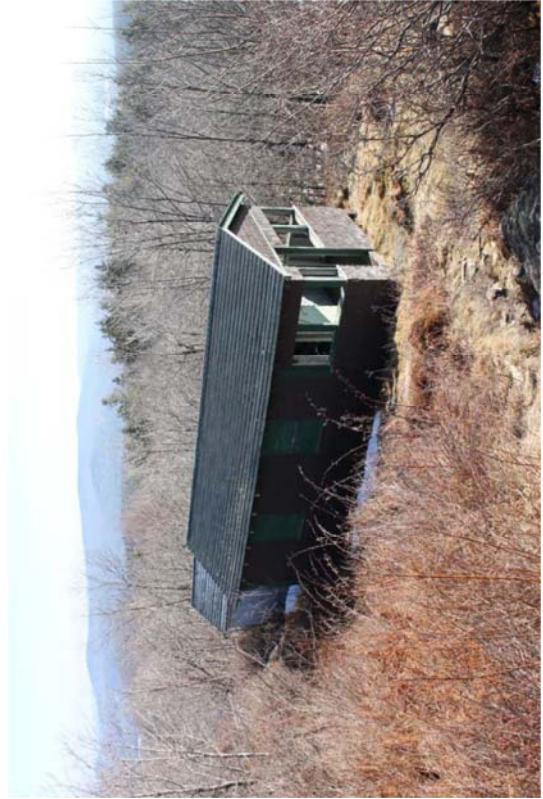
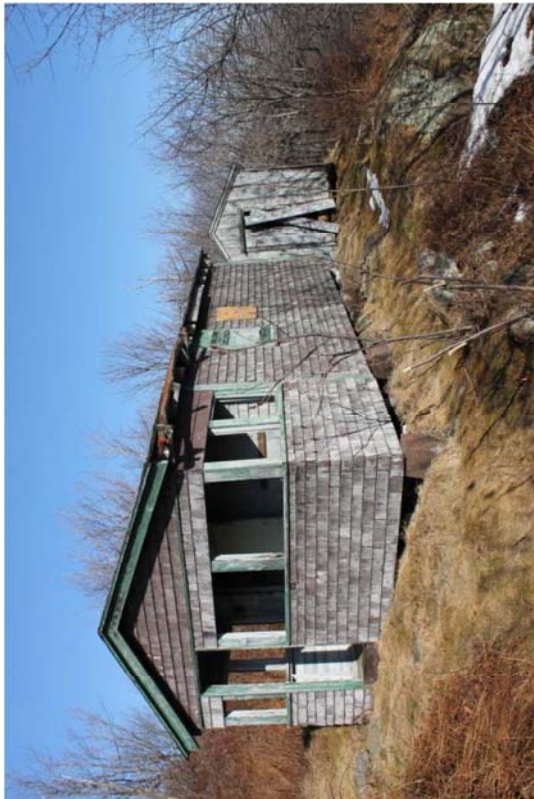
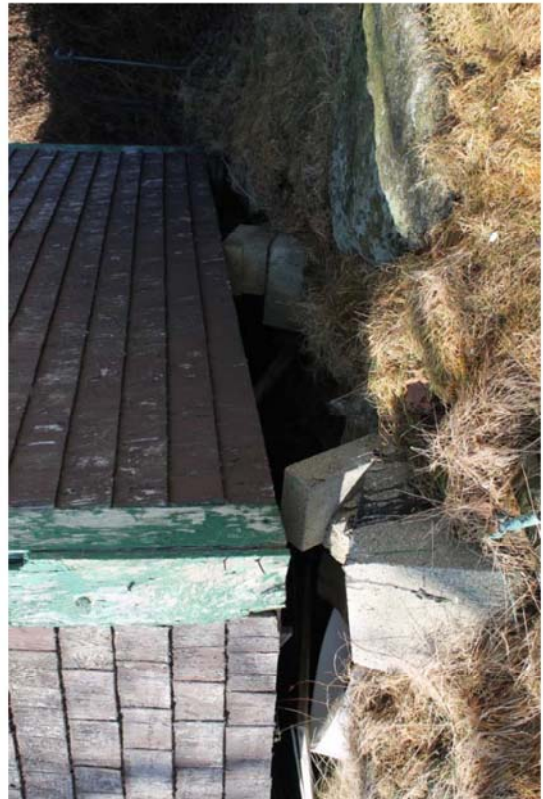
PITCHER MOUNTAIN - WATCHMAN CABIN

Watchman's cabin is well worn but not beyond repair. The pier foundation / CMU foundation is in bad shape with settling evident, this would require replacement should the cabin be retained. Exterior wood shingle wall finishes and asphalt roof finishes are in fair condition, although little maintenance is apparent. CMU chimney had been removed from the side of the building with many of the blocks randomly lying adjacent to the structure. The single pane, double hung window sashes are in poor shape with broken glass, many of these have been boarded over. Interior finishes are fair and appear to have been recently re-painted. A woodstove still sits in the main room of the cabin, although as note earlier the exterior chimney has been removed.

component	description	comments	condition
Function	watchman cabin	not in use	Fair
Approximate Footprint	12'-5" x 25'-6"	3 room (bedroom, living / kitchen, porch)	-
Foundation	tapered concrete pier / cmu block	failing in some locations	Poor
Structure	wood framing		Fair
Exterior Walls	wood shingle, painted	peeling, scrape and re-finish	Fair
Windows	wood double hung, 6 over 6 single pane	boarded over, some broken sashes	Poor
Roof	asphalt shingle	some lichen growth	Fair
Interior Walls	wood board, painted	inside face of sheathing	Fair
Interior Floor	wood plank, painted		Fair
Interior Ceiling	panelized, painted		Fair
