REPORT - 30TH APRIL, 2014

STATE OF NEW HAMPSHIRE - DEPARTMENT OF RESOURCES & ECONOMIC DEVELOPMENT

DIVISION OF FORESTS & LANDS

**IMPROVEMENTS AND CONSTRUCTION ADMINISTRATION TO FIRE TOWERS
AND AUXILIARY BUILDINGS IN VARIOUS STATE RESERVATIONS**

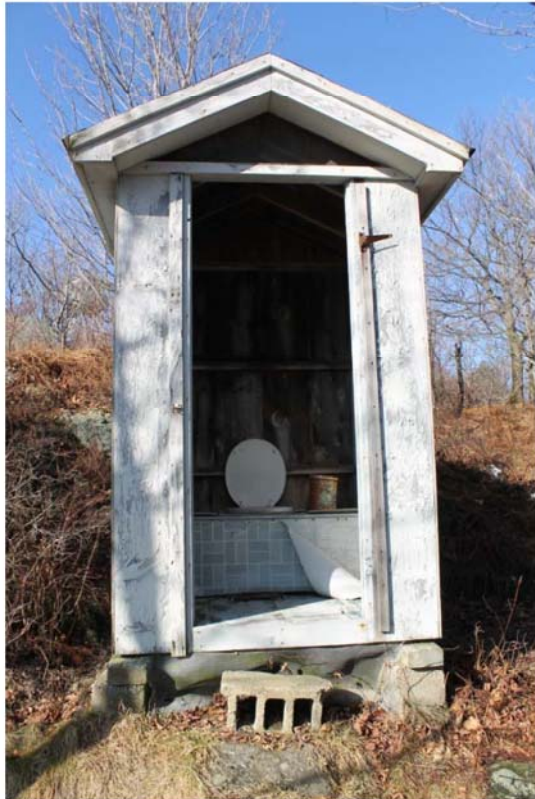
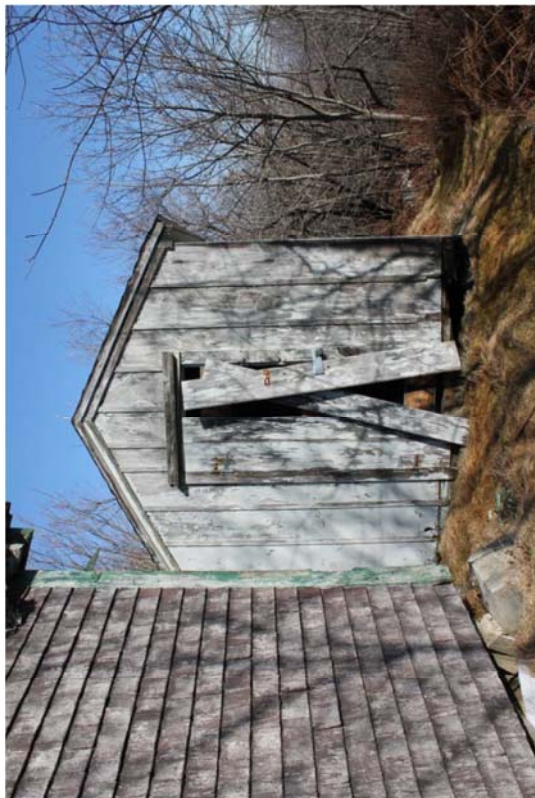
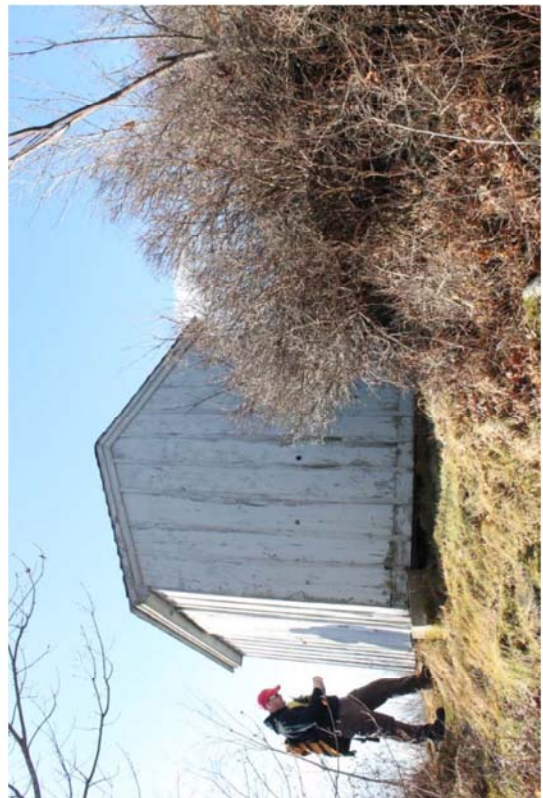
PITCHER MOUNTAIN - OUTHOUSE & STORAGE

An adjacent shed is probably of little value and has reached the stage that repair would likely cost as much as replacement.

The outhouse seems functional, although missing a door. This structure could be retained but raises the question of usefulness, and effective use of funds.

component	description	comments	condition
Function	outhouse	not in use, vandalism evident, tipped over	Poor
Approximate Footprint	4' x 4'	no exterior door	-
Foundation	cmu block	-	Fair
Structure	wood framing		Fair
Exterior Walls	vertical board and batten	scrape and re-finish	Fair
Windows	none	-	-
Roof	rolled roofing		Fair
Interior Walls	inside face of siding	-	-
Interior Floor	wood board, painted	little finish intact	Fair
Interior Ceiling	inside face of roof sheathing	-	-

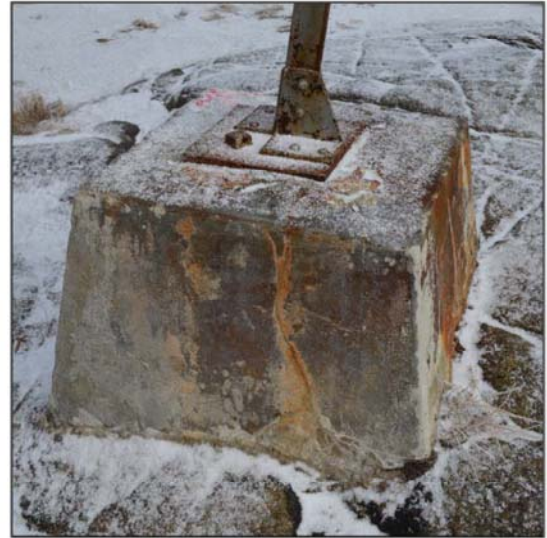
The foundation of the structure consists of square concrete footings that bear directly on ledge. Some of the footings were observed to have heavy cracking and efflorescence. It is unknown whether the concrete is anchored to ledge.

Cracked concrete footing.

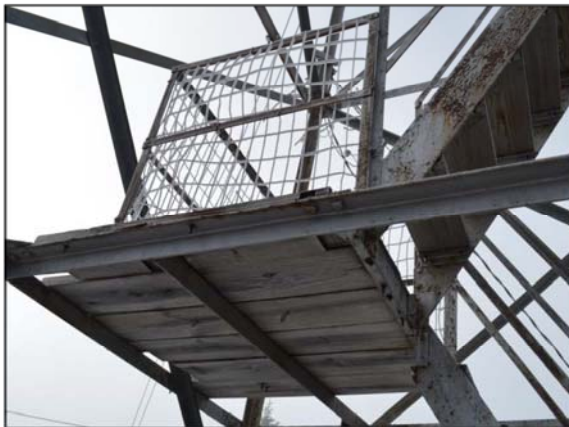
Railings along platform.

The stairs and platforms are framed with a combination of pressure treated lumber planks along with steel channels, angles, and plates. The 2x8 decking was observed to have minor surface wear. The railings along the edge of the stairs and around the platforms are constructed of steel angles and wire mesh fencing. The railings do not appear to meet code requirements for height, load capacity, or member spacing. Based on observations, some of the floors may not meet the required live load capacity for stairways and elevated platforms.

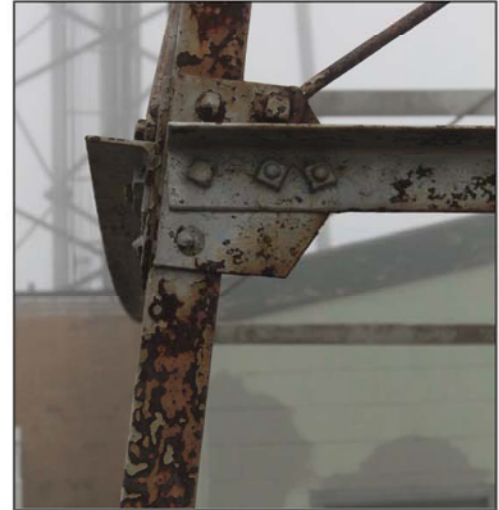
The tower structure consists of steel angles and channels that are bolted and riveted together. Surface rust was observed over the entire structure. In some locations, the rust is heavy and there is some minor to heavy section loss of the structural members. The structure appears to have been added onto and made taller than the original tower. There are two sets of guy cables at each corner of the tower that appear not to be part of the original structure. The cables are wrapped around the structure at the upper panel points. The anchorage to the ground is unknown.

Rusted steel with minor section loss.

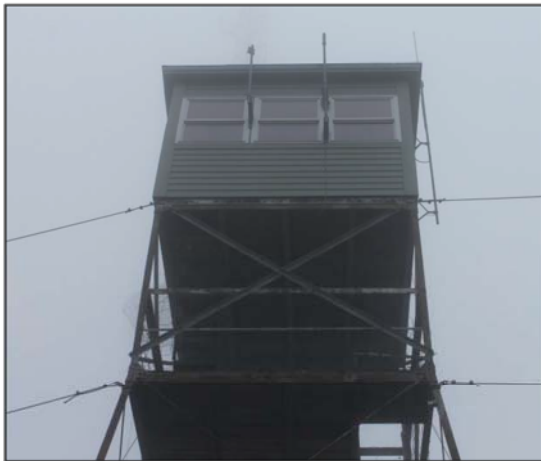
Guy cables at corners of structure.

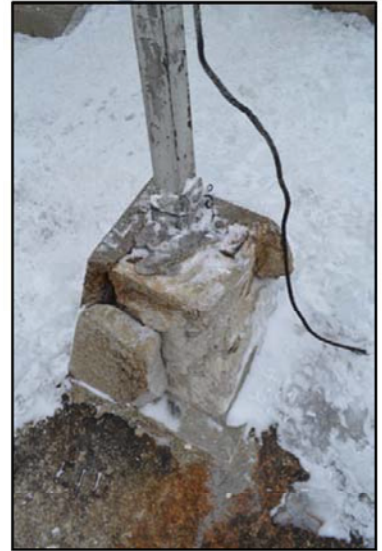
The foundation of the structure consists of square concrete footings that bear directly on ledge. Minor cracks were observed on the face of the concrete footings. One footing on the south side of the structure is severely cracked and spalled. It is unknown whether the concrete is anchored to ledge.

Spalled concrete footing.

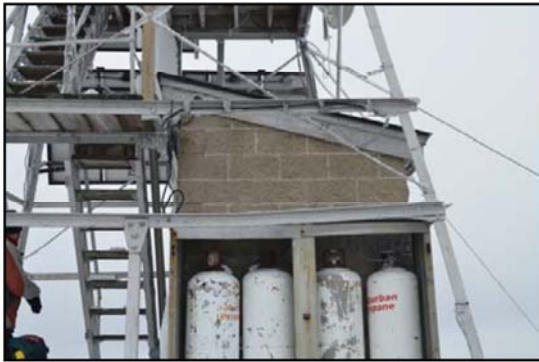
Bent member on north side of structure.

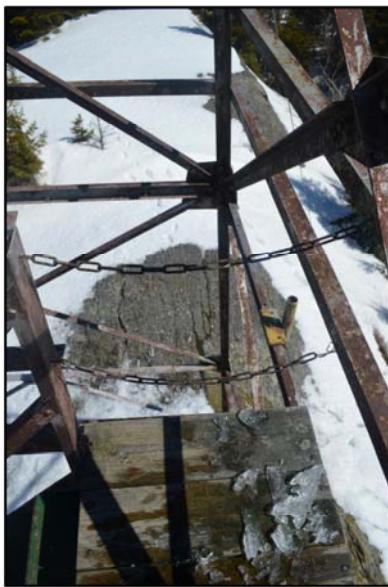
Chain railing at upper level.

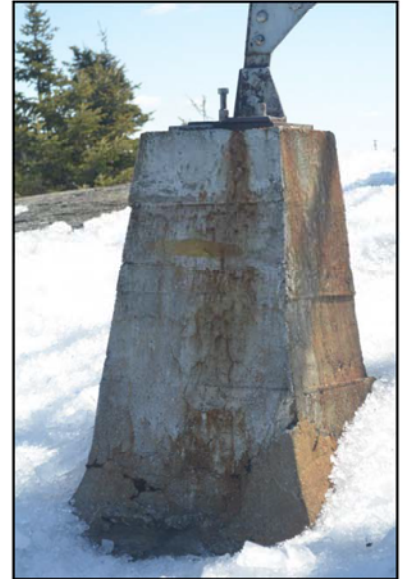
The foundation of the structure consists of square concrete footings that bear directly on ledge. Cracks were observed on the face of the concrete footings. One footing on the south side of the structure is in poor condition. It is unknown whether the concrete is anchored to ledge.

Cracked footing.

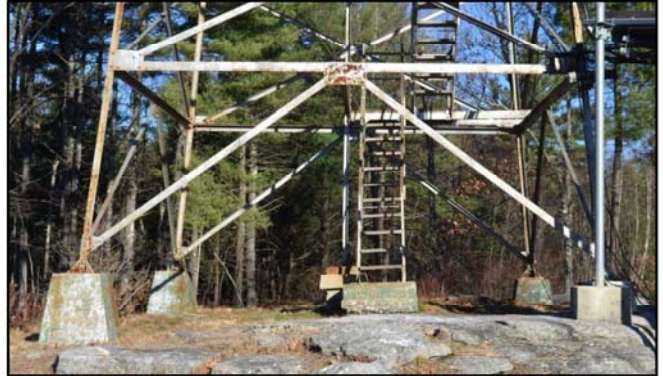
The foundation of the structure consists of square concrete footings that bear directly on ledge. The concrete has been painted. Minor cracks and spalls were observed on the face of the concrete footings. It is unknown whether the concrete is anchored to ledge. The concrete footing under the stairway is severely cracked.

Footings on bedrock.

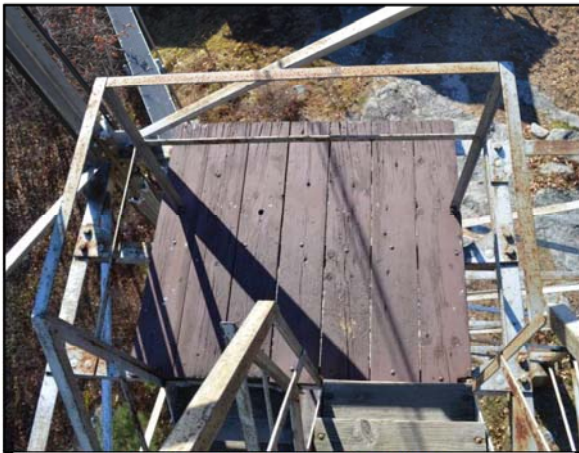
Stairs, platform, and railings.

The stairs and platforms are framed with a combination of pressure-treated lumber planks along with steel channels, angles, and plates. The 2x8 decking was observed to be painted brown and has some minor surface wear and weathering. The railings along the edge of the stairs and around the platforms are constructed of steel angles and wire mesh. The railings do not appear to meet code requirements for height, load capacity, or member spacing. Based on observations, some of the floors may not meet the required live load capacity for stairways and elevated platforms.

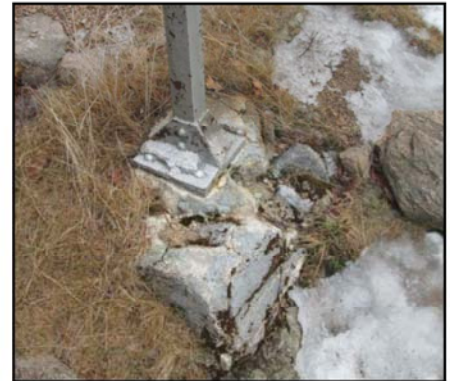
The foundation of the structure consists of square concrete footings that bear directly on ledge. One footing is severely cracked and spalled. It is unknown whether the concrete is anchored to ledge.

Cracked and spalled footing.

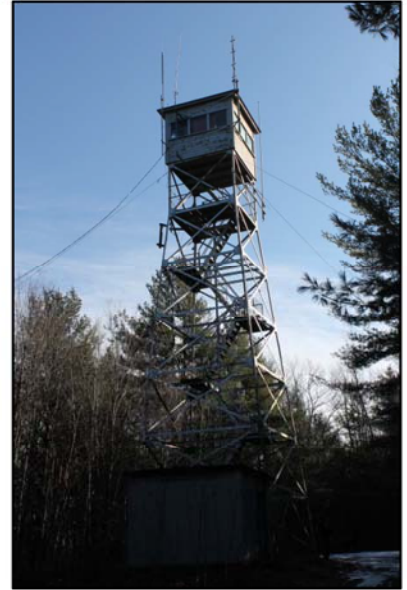
The tower structure consists of steel angles and channels that are bolted and riveted together. Surface rust was observed in several locations and there appears to be some minor to heavy section loss of the structural members. The structure is very tall and appears to have been added onto and made taller than the original tower. The steel structure extends through cab to bottom of roof. There is one set of guy cables at each corner of the tower that appear not to be part of the original structure. The cables are wrapped around the structure at the upper panel points. The anchorage to the ground is unknown. There are several unused antenna supports on the side of the tower.

Tall tower structure.

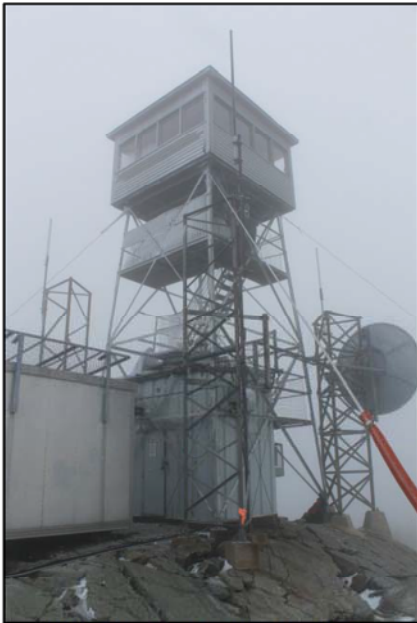
Fire tower and surrounding structures.

The tower structure consists of steel angles and channels that are bolted and riveted together. Minor surface rust was observed in several locations, but there does not appear to be significant section loss of the structural members. The structure appears to have recently been painted. There is one set of guy cables at each corner of the tower that appear not to be part of the original structure. The cables are wrapped around the structure at the upper panel points. The anchorage to the ground is unknown. There are several other structures and antennas located around the fire tower.

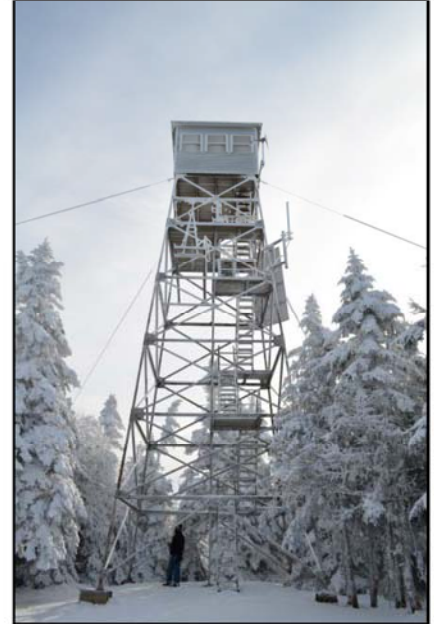
The tower structure consists of steel angles and channels that are bolted and riveted together. Minor surface rust was observed in several locations, but there does not appear to be significant section loss of the structural members. The structure is tall and appears to have been added onto and made taller than the original tower. There is one set of guy cables at each corner of the tower that appear not to be part of the original structure. The cables are wrapped around the structure at the upper panel points. The anchorage to the ground is unknown. There are several unused antenna supports, as well as solar panels and a wind turbine attached to the side of the structure.

Solar panels & turbine on structure.

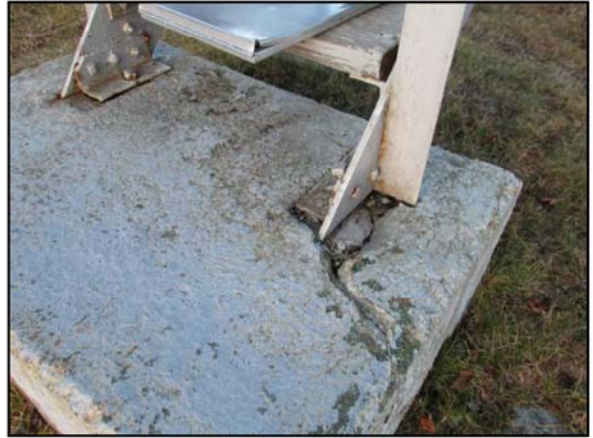
The foundation of the structure consists of square concrete footings that are in fair condition. It is unknown whether the concrete is anchored to ledge or how deep they extend. The concrete footing under the stairway is broken.

Broken footing under stairs.

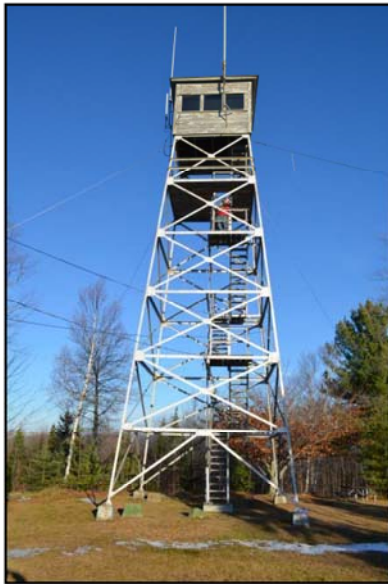
The tower structure consists of steel angles and channels that are bolted and riveted together. Minor surface rust was observed in several locations, but there does not appear to be any section loss in the structural members. The steel structure extends through cab to bottom of roof. There is one set of guy cables at each corner of the tower that appear not to be part of the original structure. The cables are wrapped around the structure at the upper panel points. The anchorage to the ground is unknown.

Tower structure.

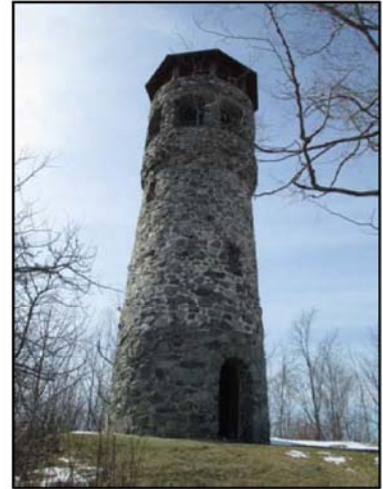
The stone masonry is assumed to be unreinforced. Based on the multiple colors of grout observed between the stones, the tower has been repointed many times. The grout on the outside of the structure appears to be in good condition. The inside face of the structure has multiple large cracks up to 1/4" wide. There is a concrete floor slab at the lowest level of the structure, but the rest of the foundation is unknown.

Stone tower.

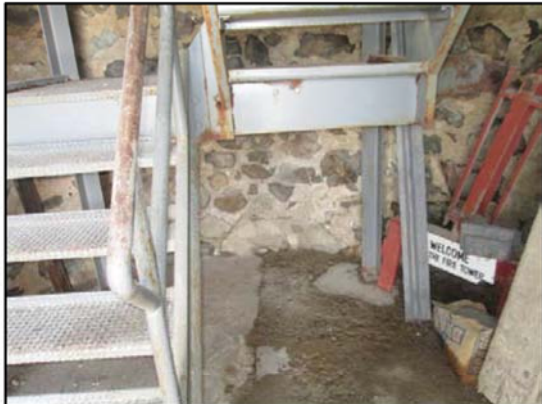
The interior steel stairway is approximately 5'-8" wide x 8'-10" long. It is constructed with steel angles, channels, and tube sections that have

been bolted and welded together and painted grey. Surface rust was observed in several locations, with some minor to heavy section loss in the structural members. The railings do not appear to meet code requirements for height, load capacity, or member spacing.

Steel stairway structure.

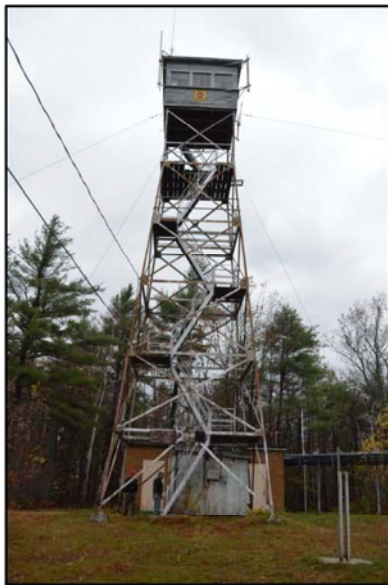
Tower elevation.

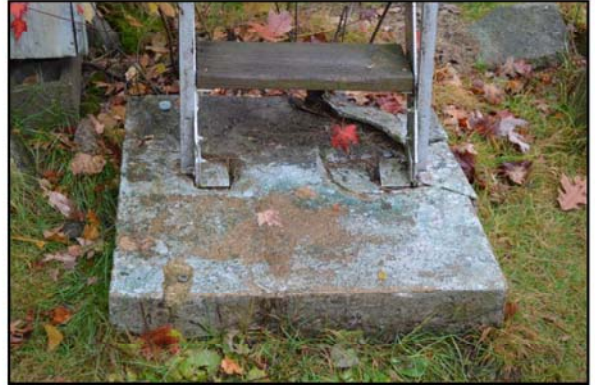
Broken concrete under stairway.

The foundation of the structure consists of square concrete footings that bear directly on ledge. The concrete appears to be in fair condition with some minor cracks and spalls. It is unknown whether the concrete is anchored to ledge. The concrete footing under the stairway is in poor condition.

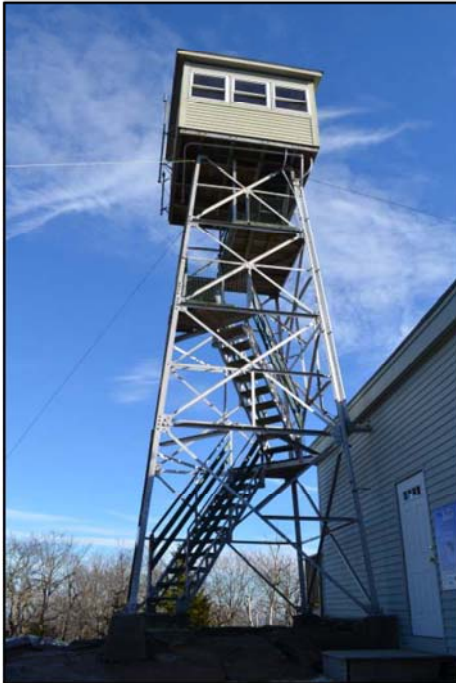
Stairs crossing diagonally across tower.

The stairs and platforms are framed with a combination of pressure-treated lumber planks along with steel channels, angles, and plates. There is a wooden stairway from the top level into the cab. The stairs cross diagonally across the tower structure. The 2x8 decking was observed to be painted green and is in good condition. The railings along the edge of the stairs and around the platforms are constructed of steel angles and wire mesh. The railings do not appear to meet code requirements for height, load capacity, or member spacing. Based on observations, some of the floors may not meet the required live load capacity for stairways and elevated platforms.

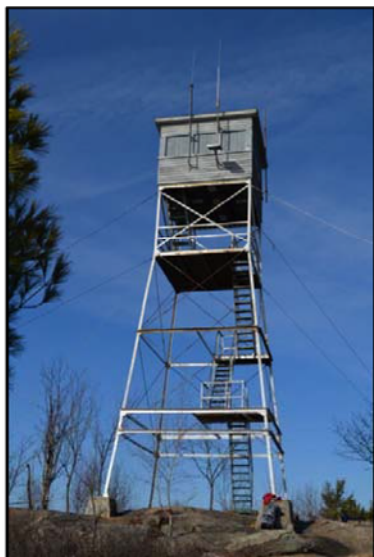
The tower structure consists of steel angles and channels that are bolted and riveted together. The structure appears to have been added onto and made taller than the original tower. Surface rust was observed in several locations with some minor to heavy section loss in the structural members. There is one set of guy cables at each corner of the tower that appear not to be part of the original structure. The cables are wrapped around the structure at the upper panel points. The cables are anchored into bedrock.

Tower elevation.

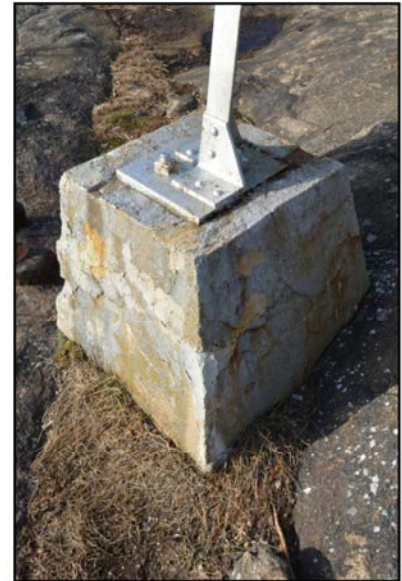
The foundation of the structure consists of square concrete footings that bear directly on ledge. The concrete appears to be in poor condition with cracks and spalls. It is unknown whether the concrete is anchored to ledge. The concrete footing under the stairway is also in poor condition with large cracks.

Cracked footing under structure.

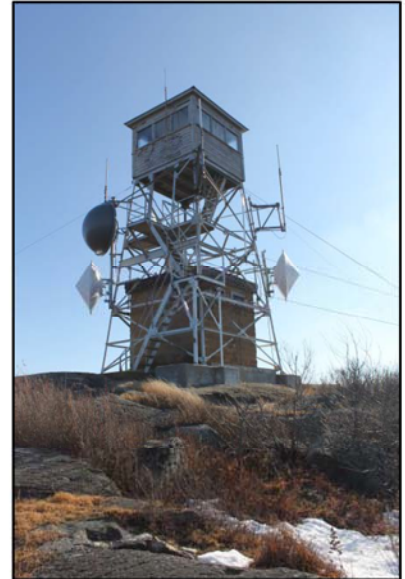
The tower structure consists of steel angles and channels that are bolted and riveted together. Surface rust was observed in several locations, with some minor to heavy section loss in the structural members. There is one set of guy cables at each corner of the tower that appear not to be part of the original structure. The cables are wrapped around the structure at the upper panel points. The cables are anchored into bedrock. There is a CMU building within the footprint of the tower. There are also many large antennas attached to the side of the tower.

Antennas on side of structure.

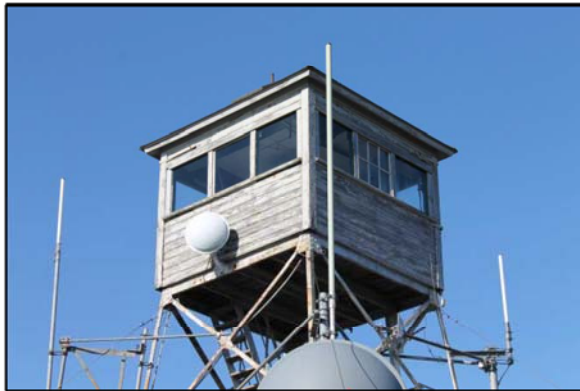
Weathered cab.

The cab is attached to the top of the steel tower. It is a wood framed structure, with windows on all four sides, and a hipped roof. The cab framing appears to be very weathered with water damage inside the structure.

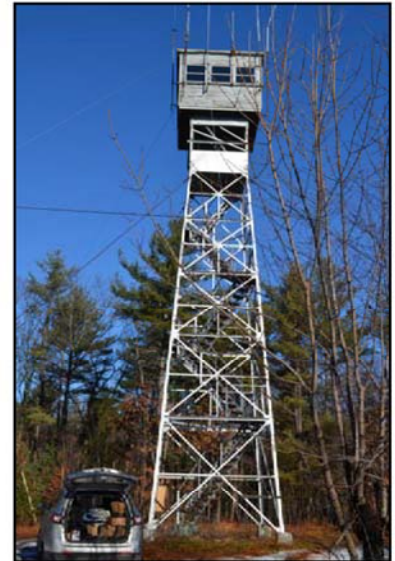
The tower structure consists of steel angles and channels that are bolted and riveted together. The steel appears to have been recently painted, however there is still some minor rust and the paint is peeling in several locations. There does not appear to be significant section loss in the structural members. The structure is very tall and appears to have been added onto and made taller than the original tower. There are several missing diagonal members at the top level, as well as turnbuckles that are not attached to anything. There are guy cables at each corner of the tower that appear not to be part of the original structure. The cables are wrapped around the structure at the upper panel points. The anchorage to the ground is unknown.

Tower elevation.

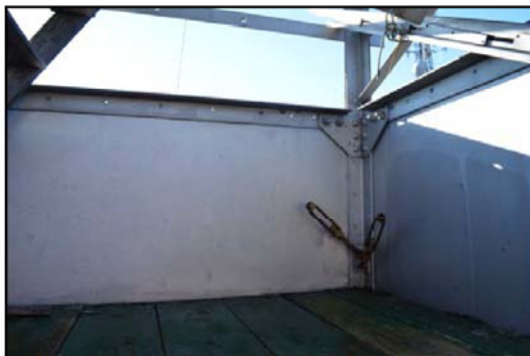
Missing diagonal members and sheet metal infill at upper platform level.

- Since the tower is so tall, perform structural analysis
- Sand-blast and re-paint the steel structure
- Properly connect the steel guy cables to the structure
- Replace missing diagonal members
- Replace weathered wooden decking/stair treads as necessary
- Re-paint the timbers as necessary
- Replace railings and fencing along the stairs and around the elevated platforms
